# Final Reclamation Inspection

Operator: PDC ENERGY INC - 69175

Location ID: 333292

Inspection Photos  
Location Name: Totems 34-24  
Location ID: 333292

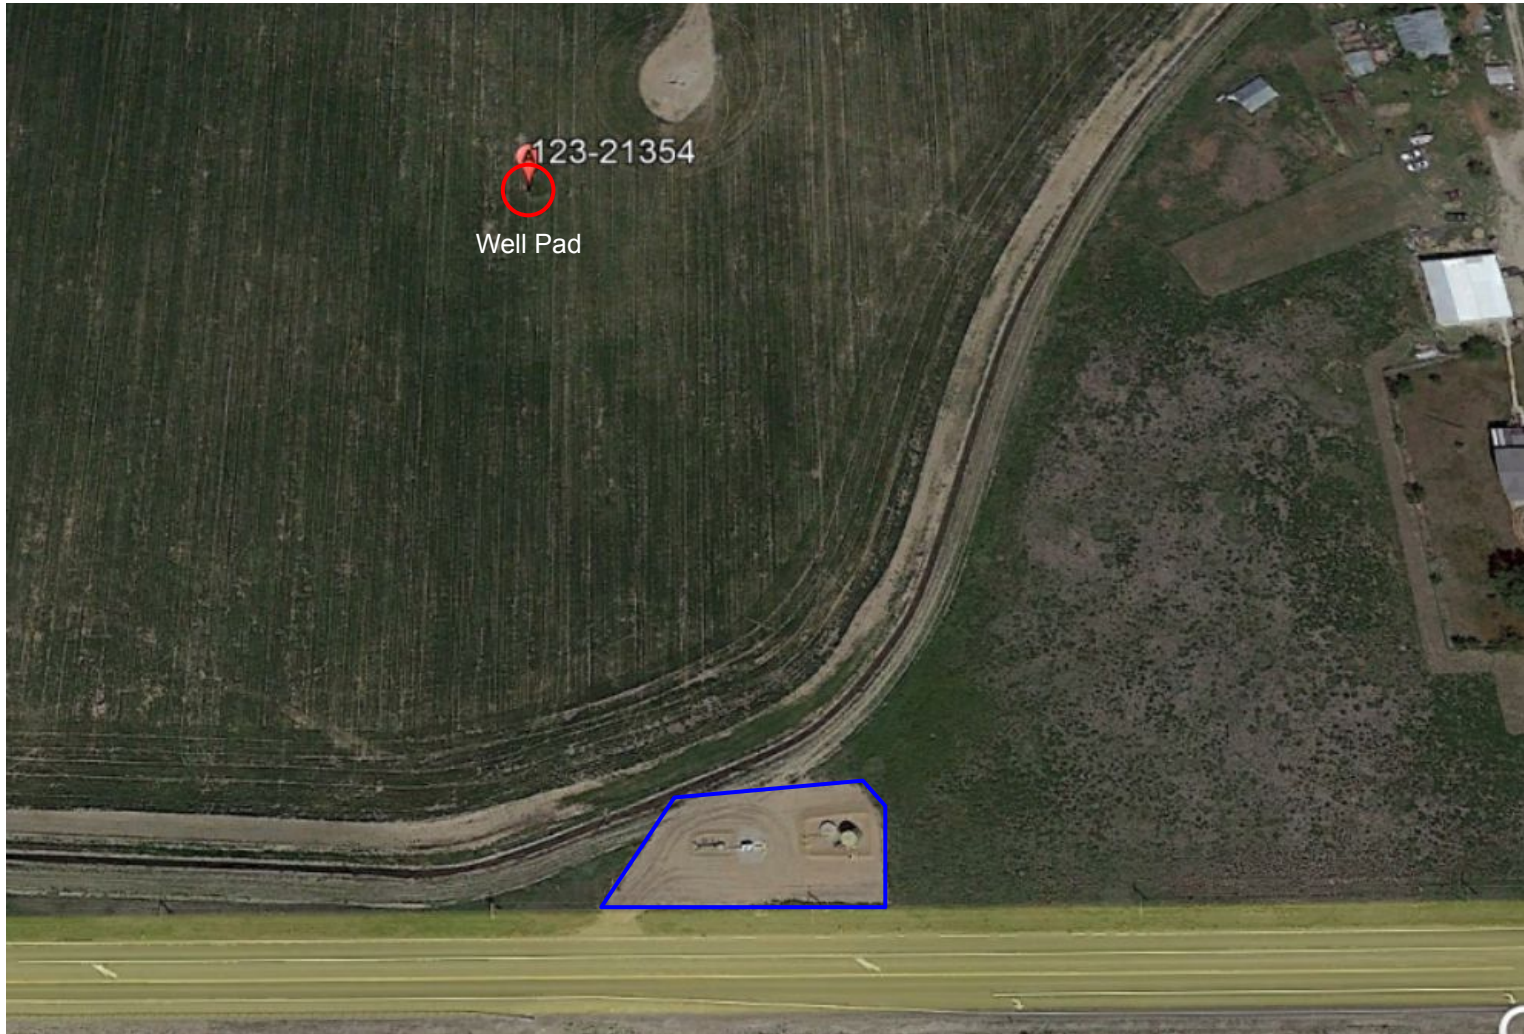
**Photo 1.** 2022 aerial imagery of the well pad. Tank battery highlighted in blue remains for the shut in Lawrence Totems 2 well API #123-08485.

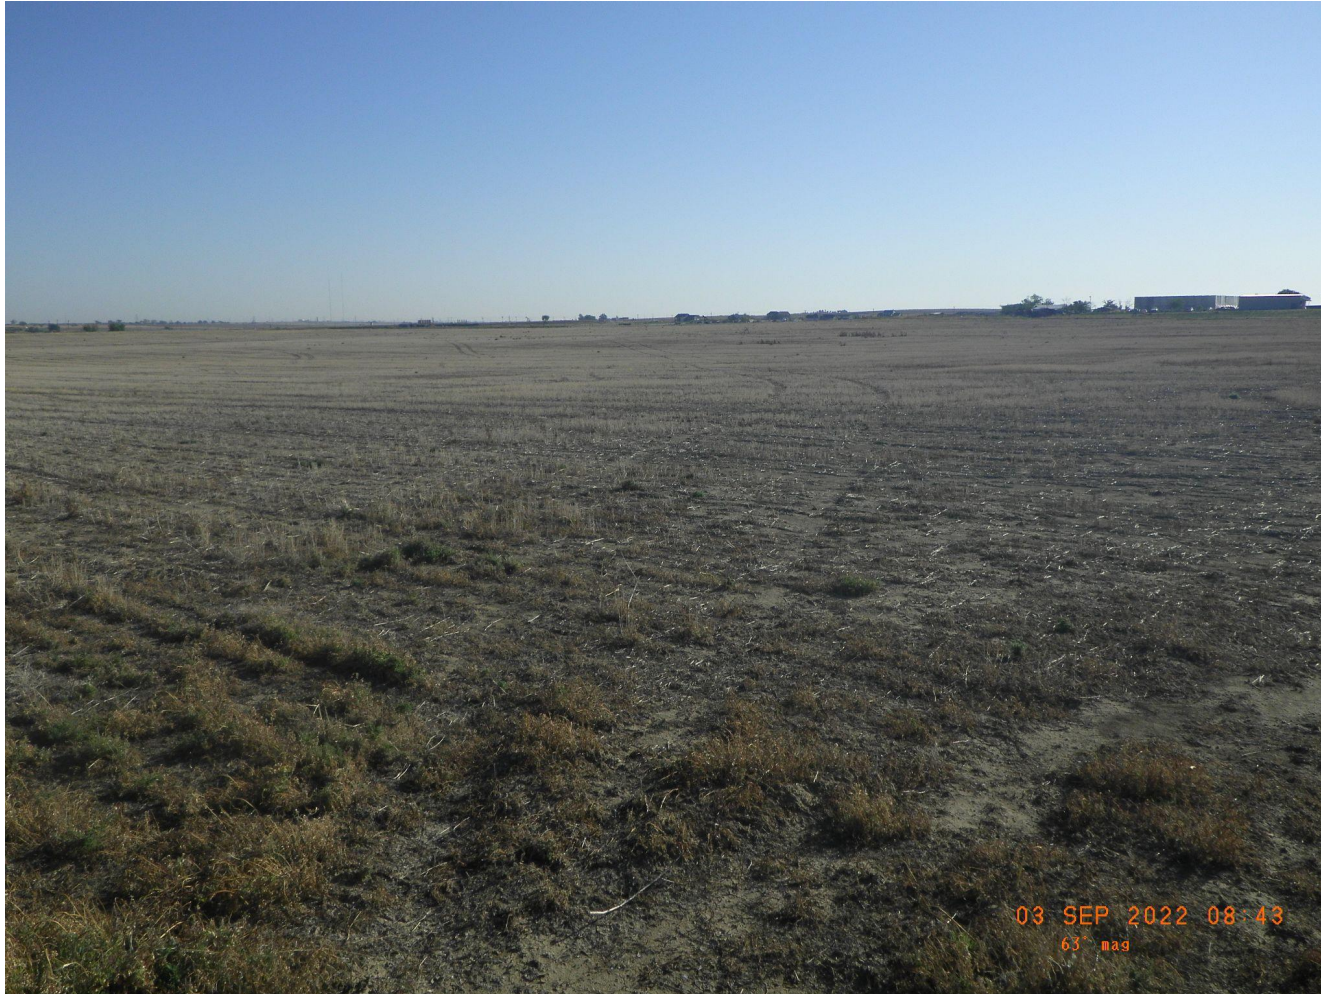
**Photo 2.** Well pad falls within a fallow field. Site will remain in process until field is planted with crop and site can be re-inspected.
