Final Reclamation Inspection

Operator: PDC ENERGY INC - 69175

Location ID: 332827

Inspection Photos
Location Name: McLeod 29-2
Location ID: 332827

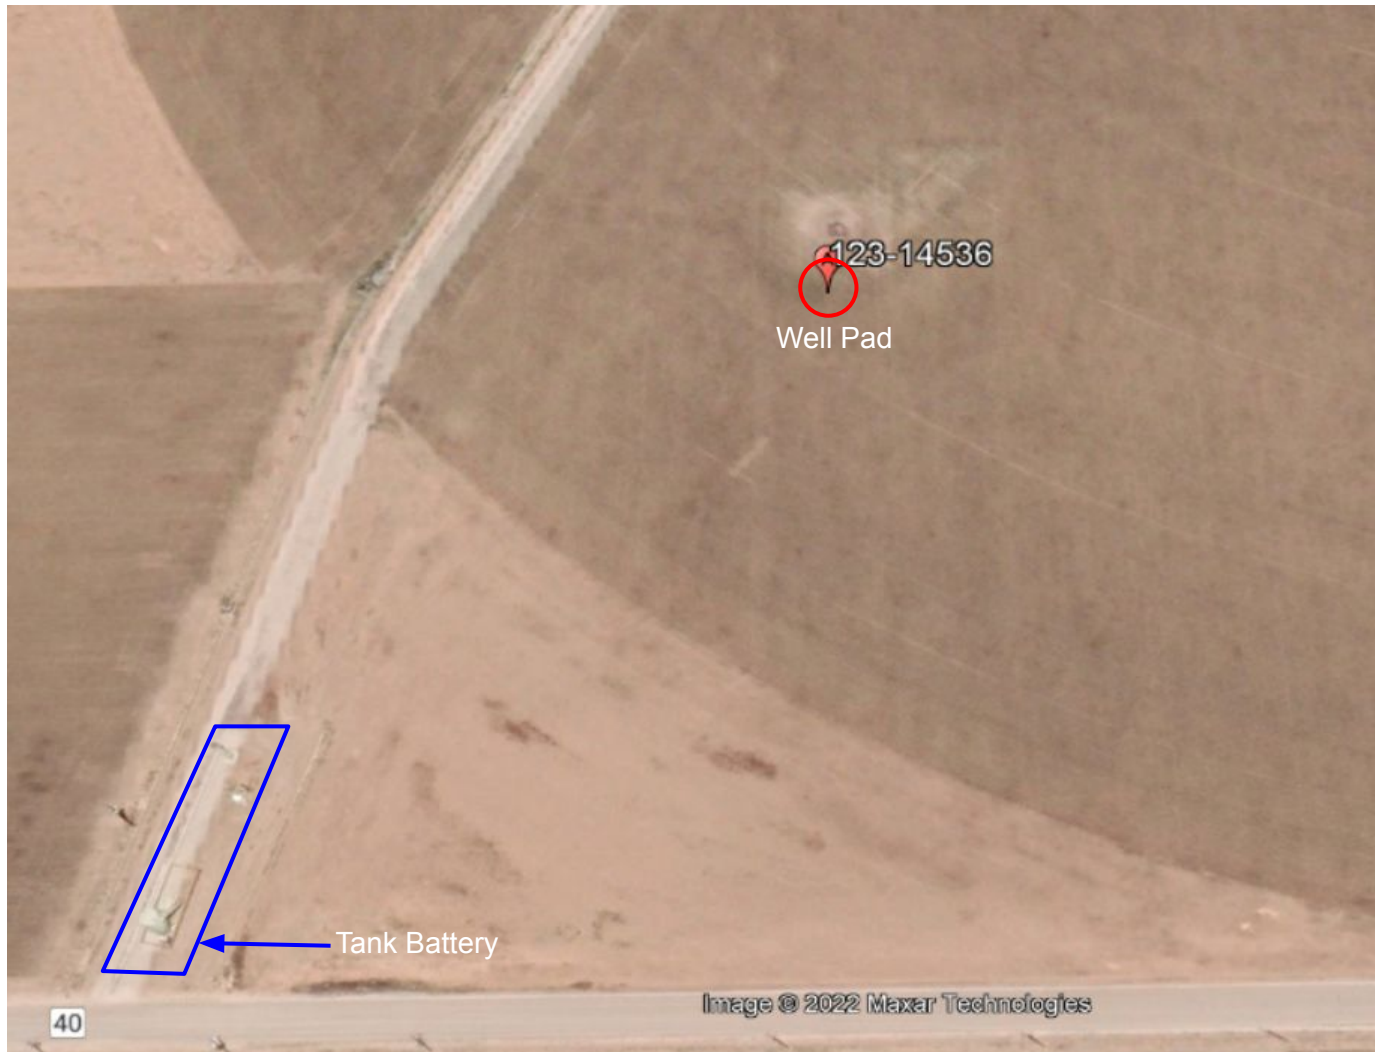
Photo 1. 2021 aerial imagery of the well pad. Note: tank battery highlighted in blue remains for the producing McLeod 29-29X well API #123-24664.

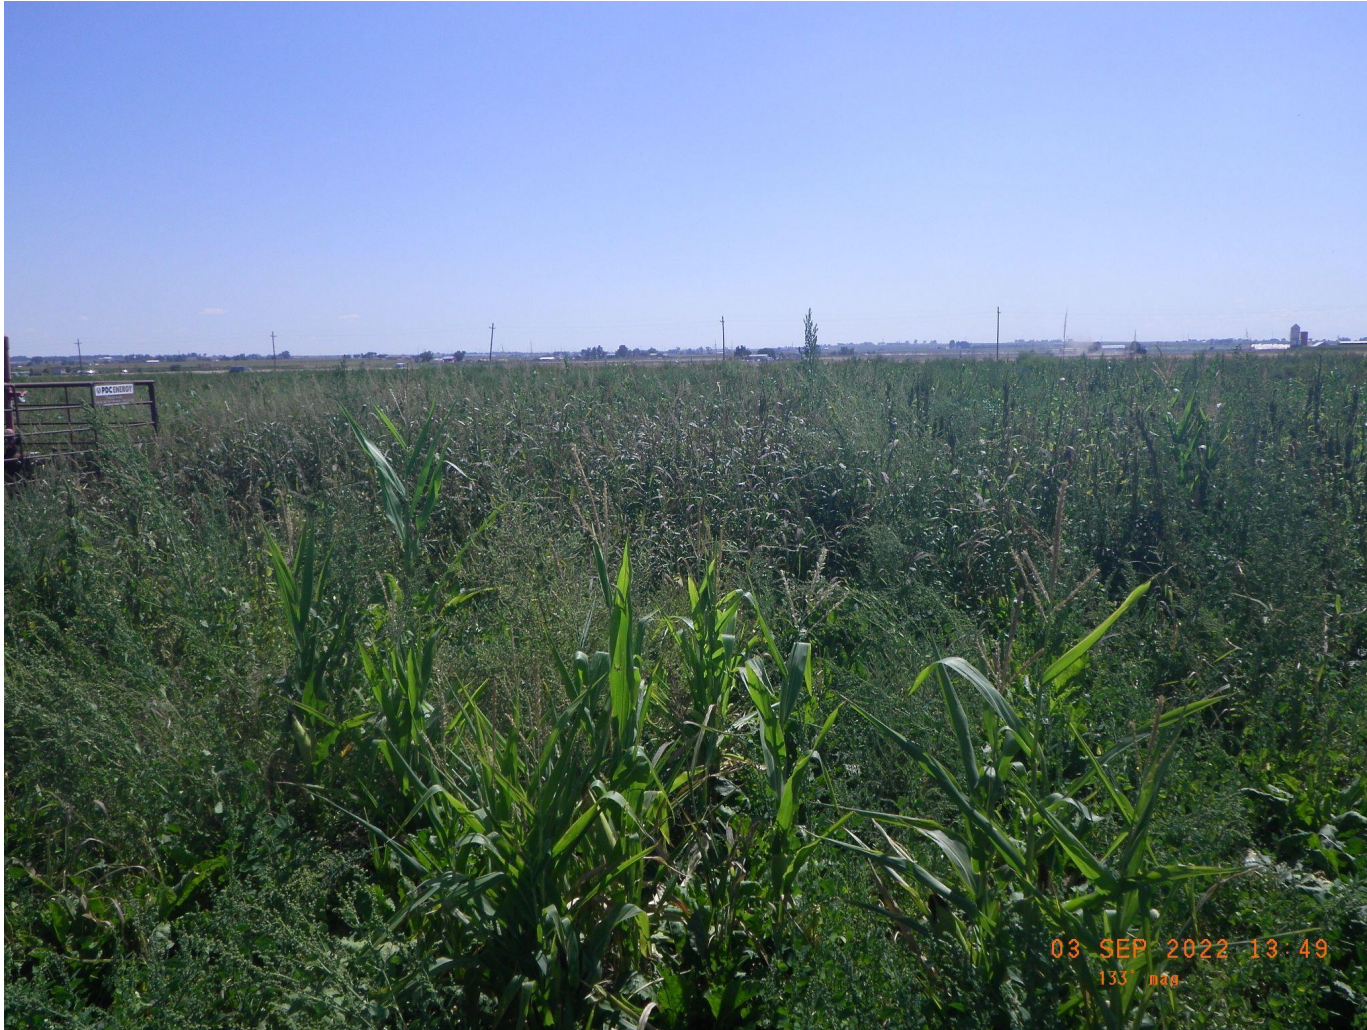
Photo 2. Overview photo taken at ground level from the northern edge facing south. Note: well pad falls in a bean crop field that is dominated by corn and barnyard grass. Appears consistent with adjacent reference area (see photo 3).

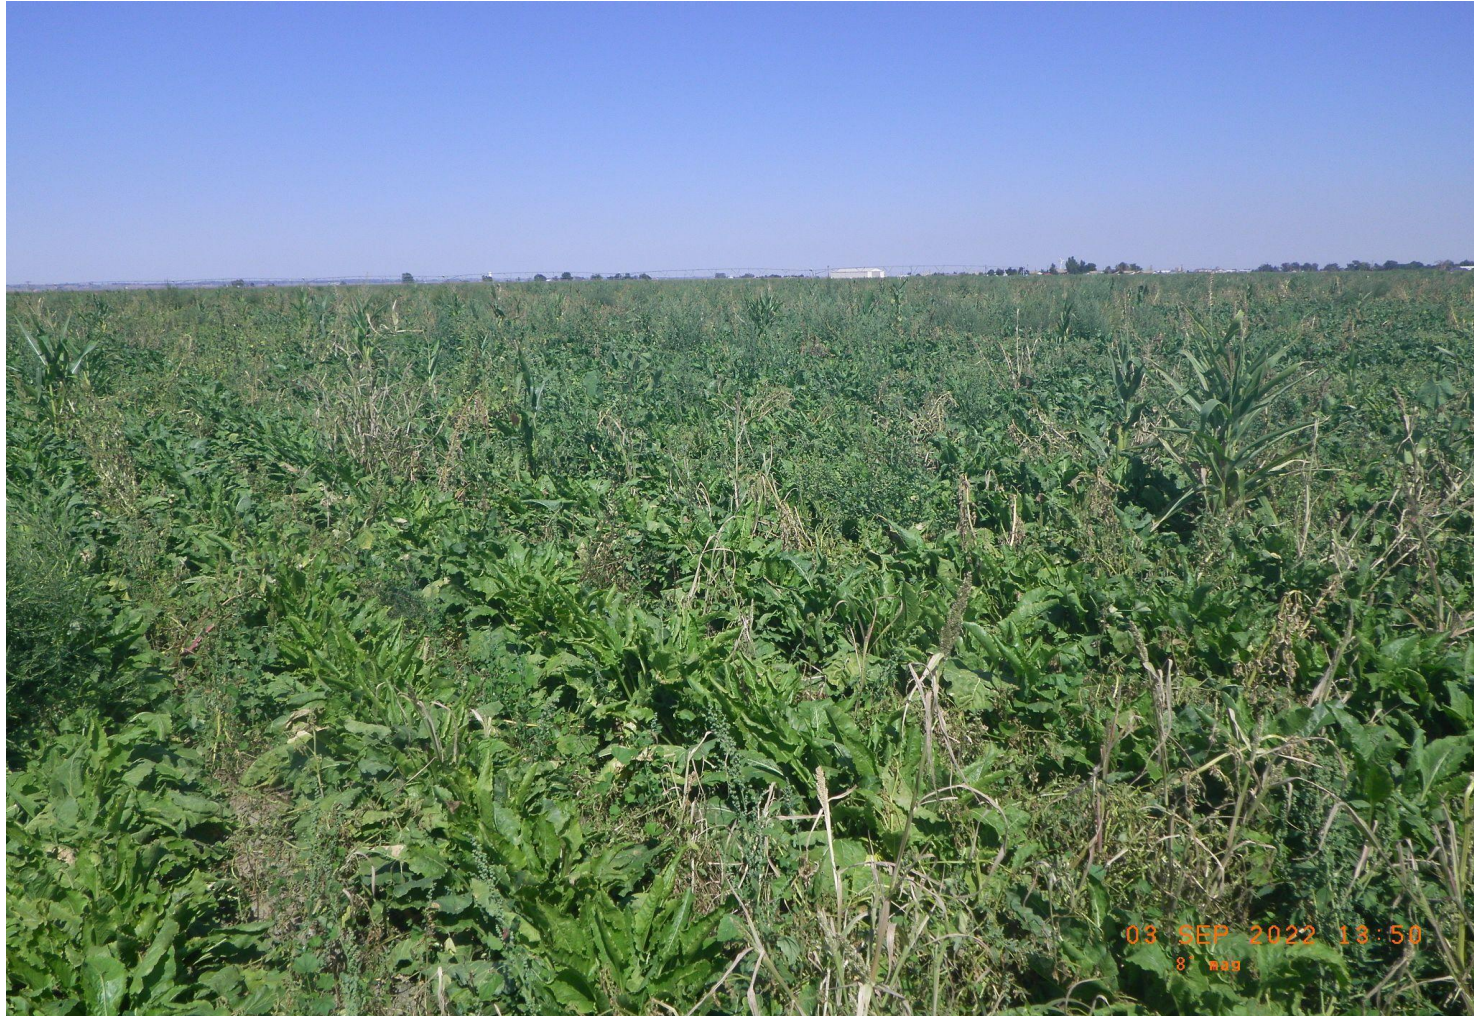
Photo 3. Well pad reference area.
