# Final Reclamation Inspection

Operator: PDC ENERGY INC - 69175

Location ID: 332061

Inspection Photos  
Location Name: Steinmetz 21-17  
Location ID: 332061

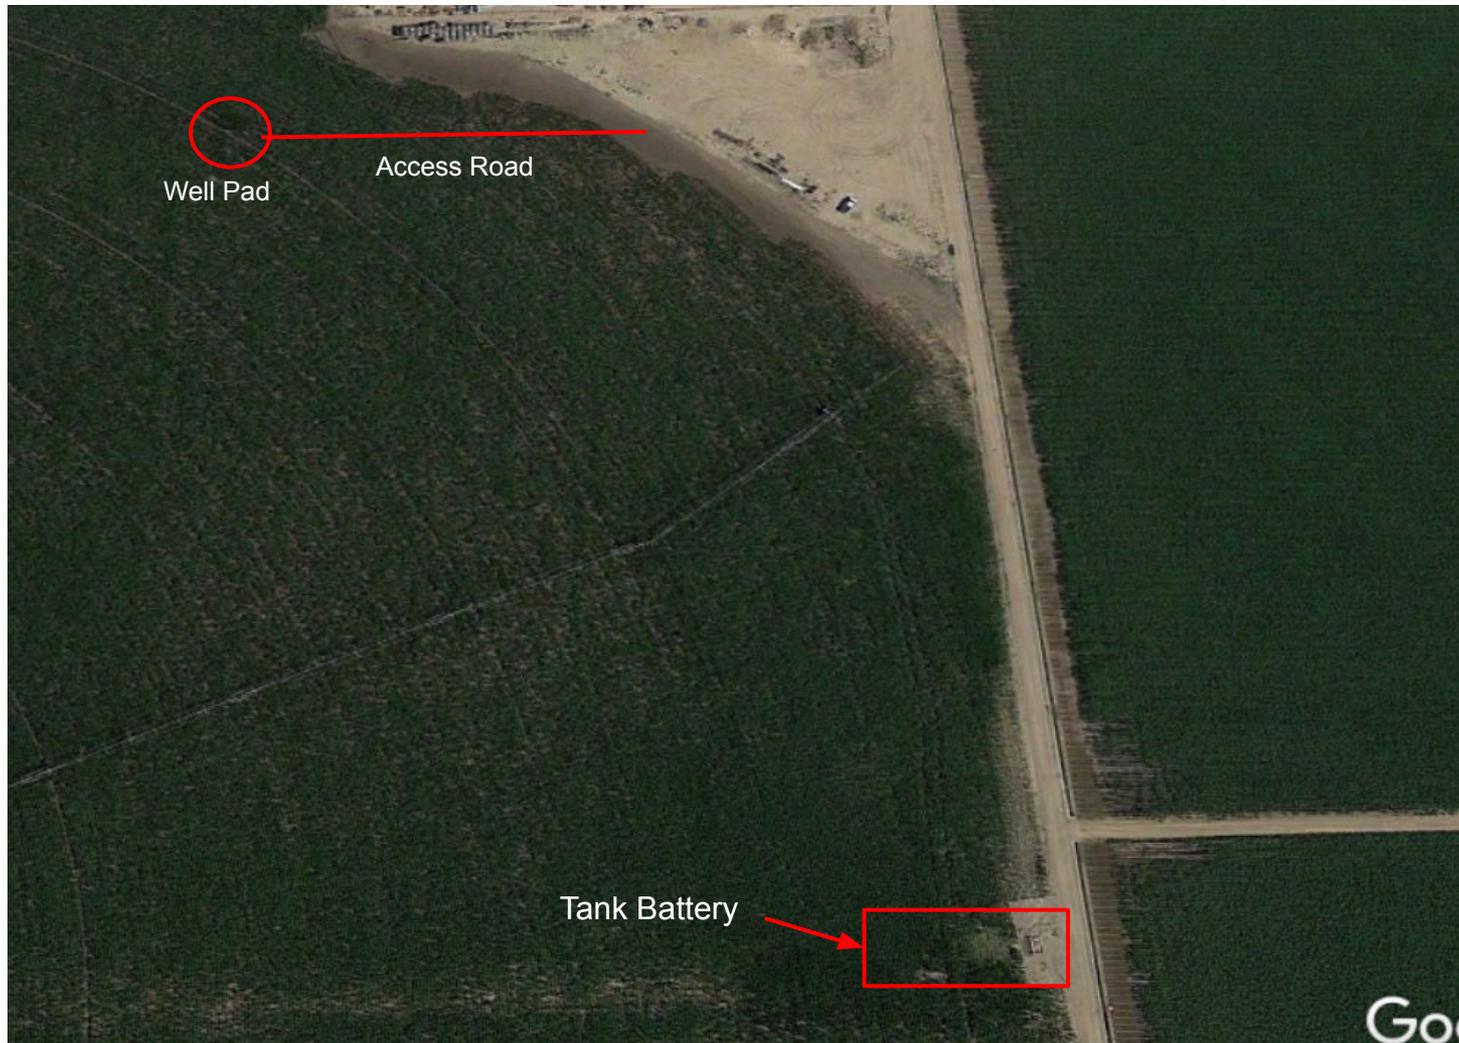
**Photo 1.** 2019 aerial imagery of the well pad and tank battery.

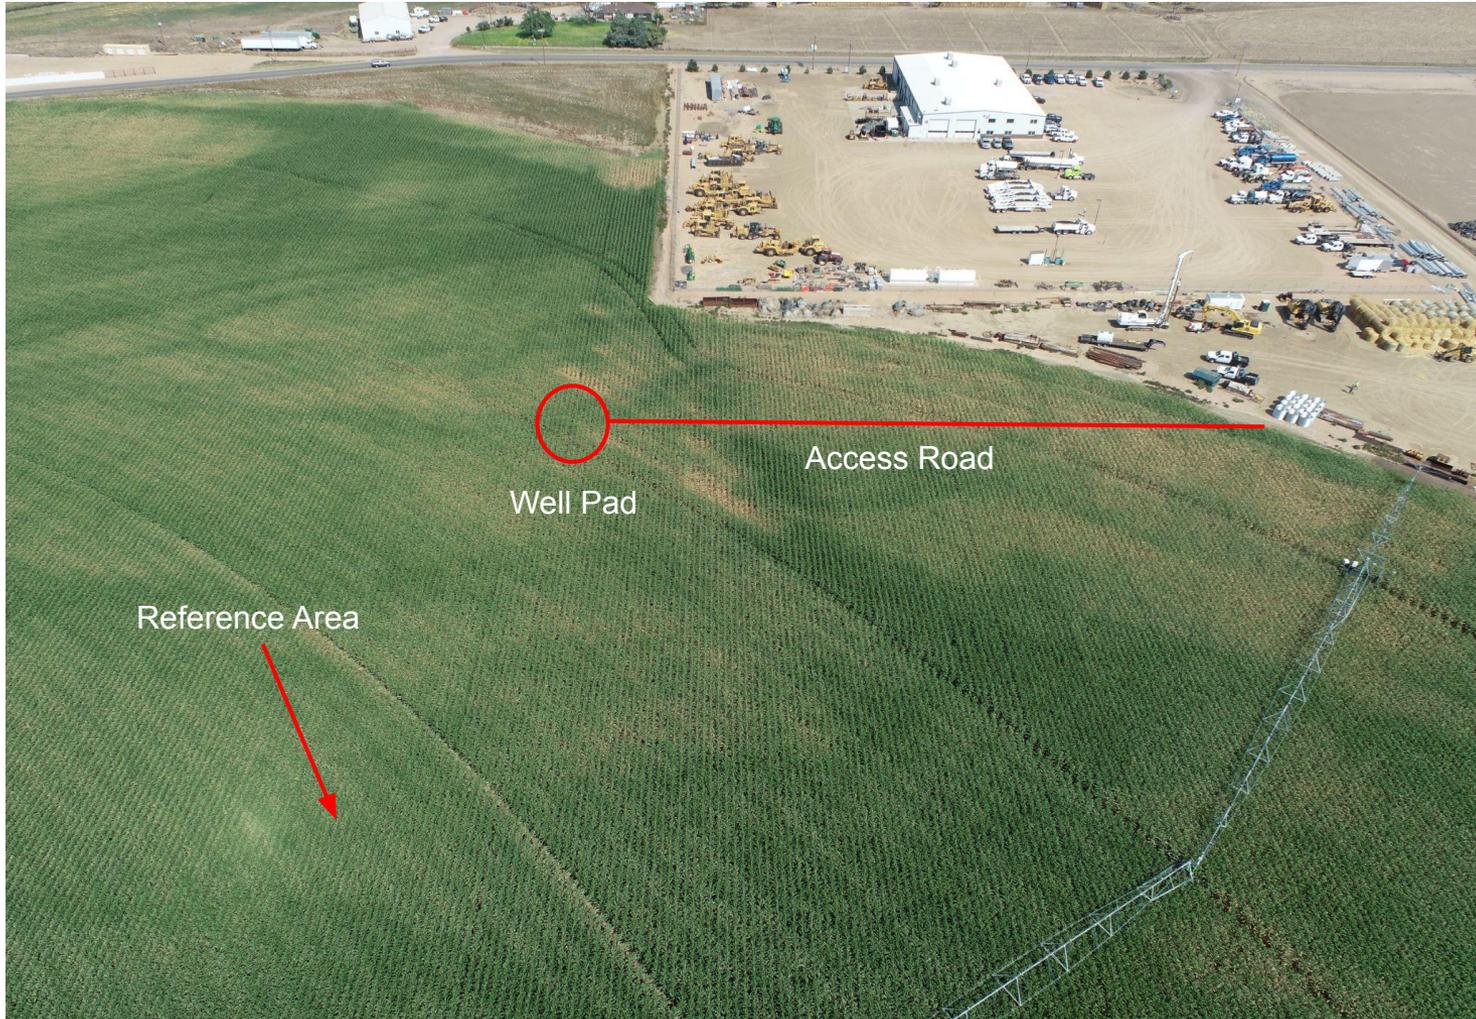
**Photo 2.** Overview photo of the well pad, access road and reference area taken from the southern edge facing north using a drone. Note: well pad appears consistent with reference area.

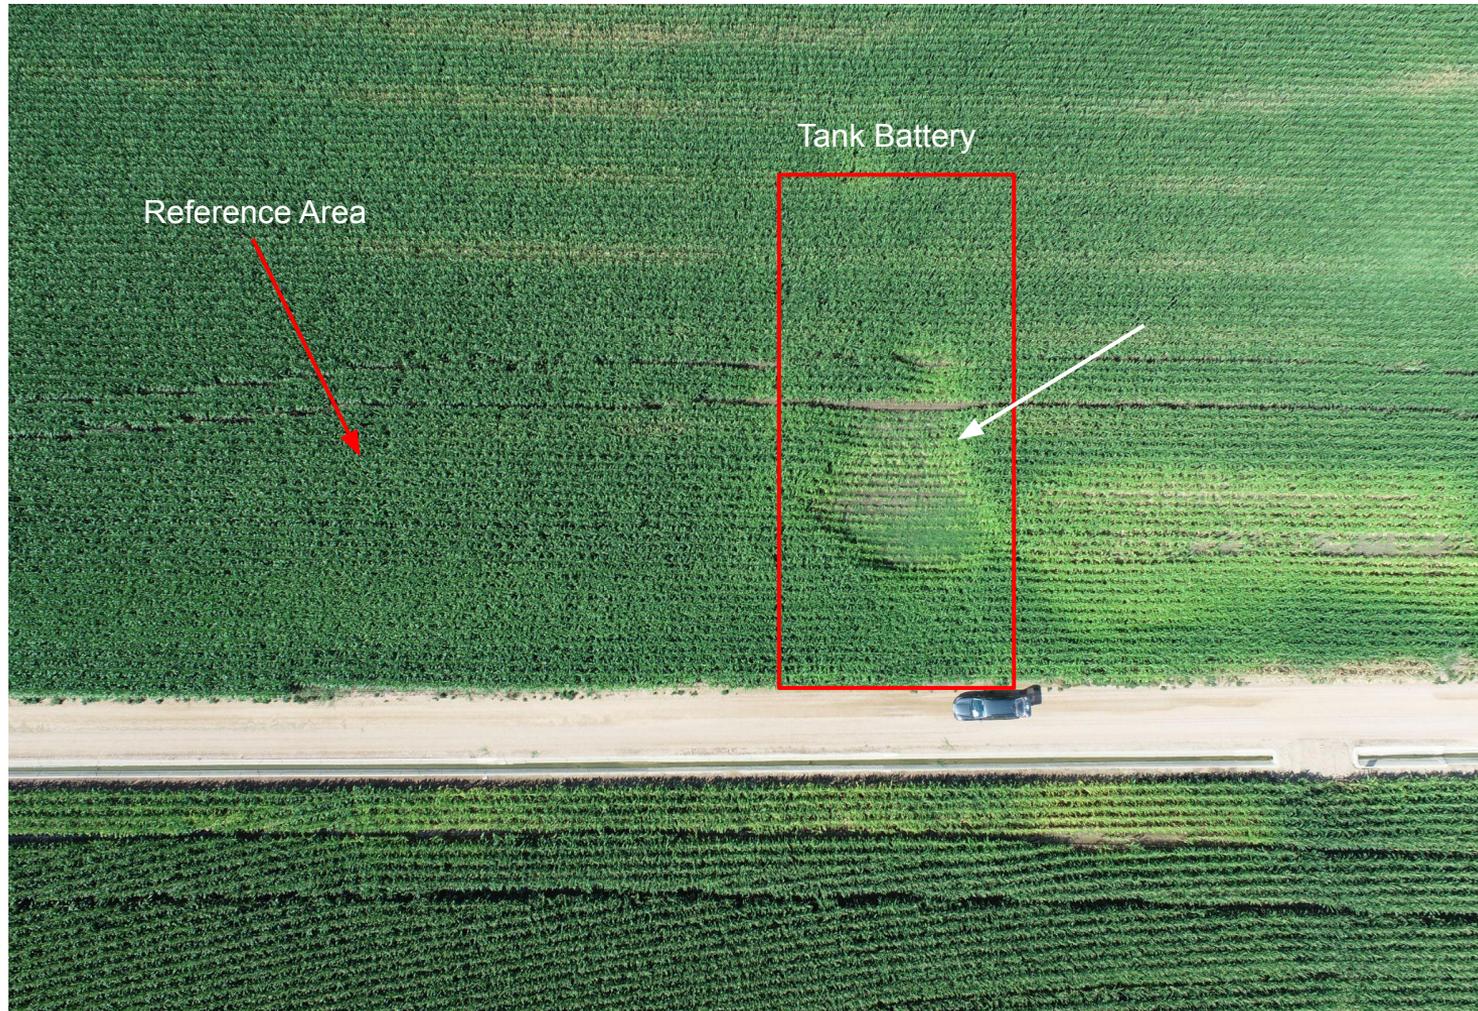
**Photo 3.** Overview photo of the tank battery and reference area taken from directly above the disturbance using a drone. Note: tank battery shows bare ground and stunted crop growth in the western half of the disturbance.

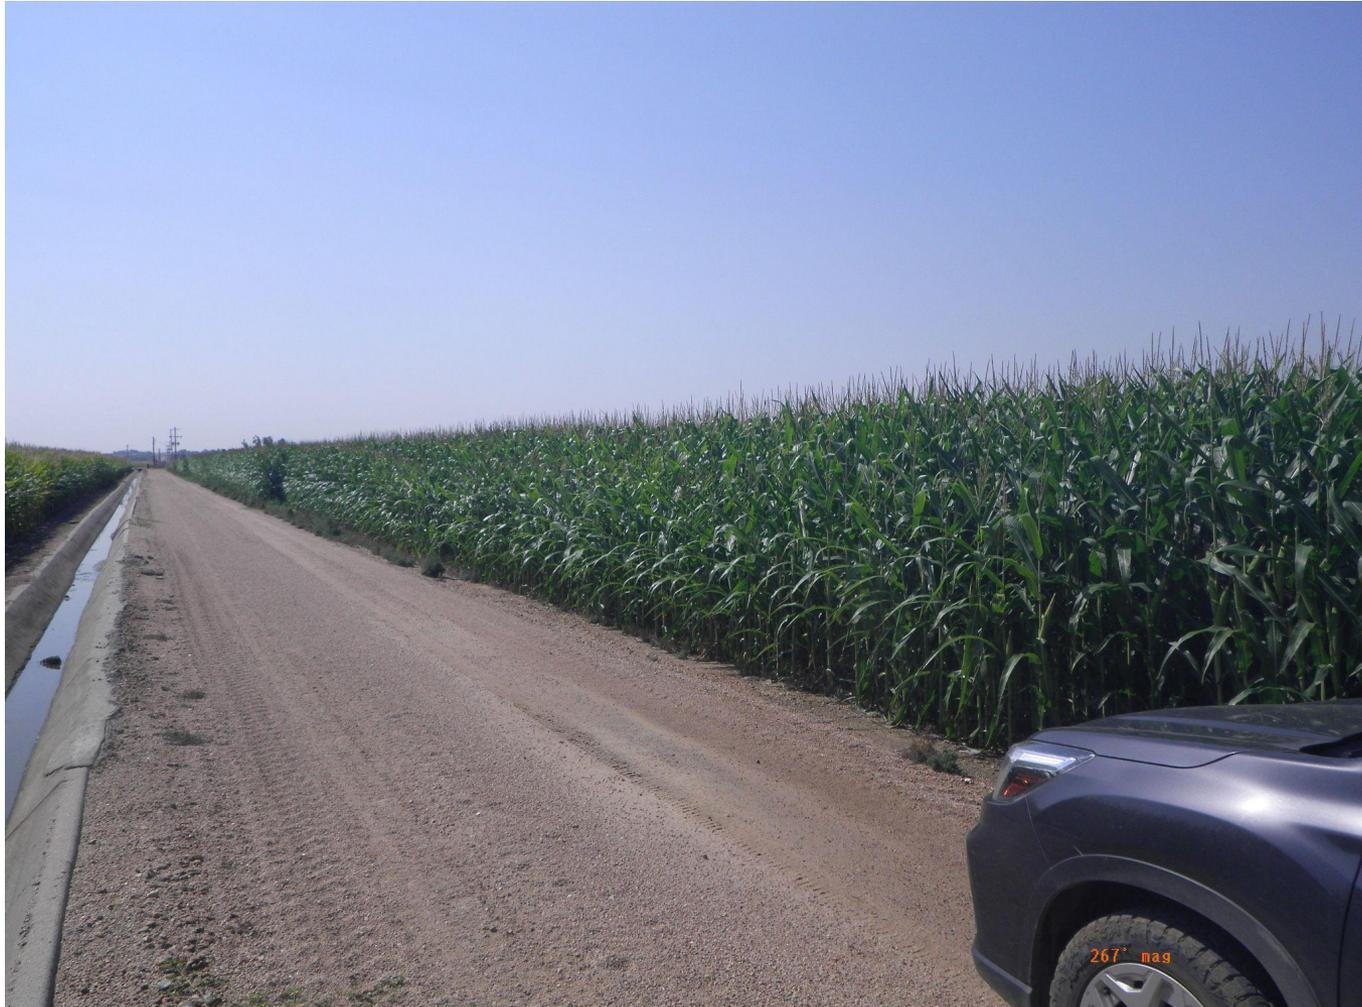
**Photo 4.** Ground photo of the well pad/tank battery crop field.
