ARKOMA OPERATIONS LLC

Well Name:	Olson-Smith Unit 2 IGE 127	API #	067-07911 067-09545	Location ID #	311924
Inspector:	Alex Klink				
Date Inspected:	11/10/2022				
Date Submitted:	11/10/2022				
Document Number:	702500775

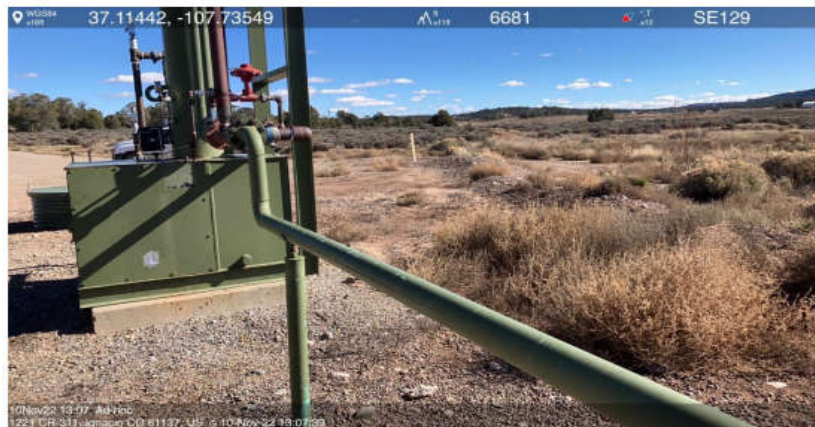
Type	WEEDS		
Comment:	Weeds are established at separator (IMG 06).		
Corrective Action:	Ensure within 25' of wellhead, tanks, and separators are free of combustible material per rule 610.k	Date:	11/18/2022

Removed weeds that were established at the separators

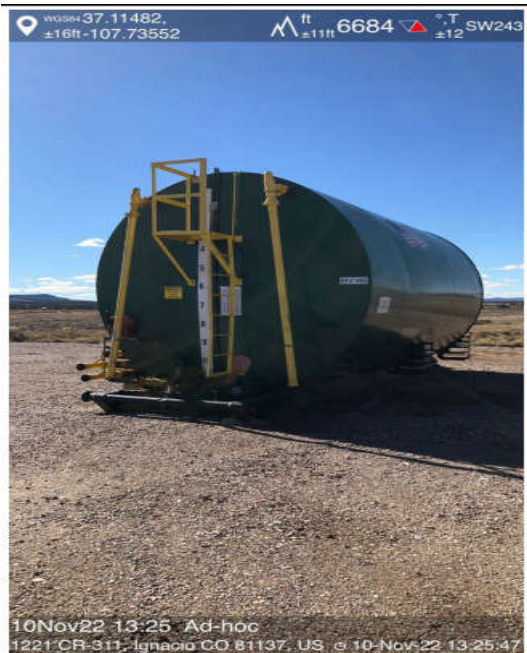
IMG 07

Type	STORAGE OF SUPL		
Comment:	400 bbl storage tank on north west corner of location is not in use (IMG 07 and IMG 08).		
Corrective Action:	All unused equipment must be returned to use or stored off location per rule 606.	Date:	12/11/2022

Unused storage tank

Will be removed week of 11/14 when trucking can be lined up and moved to an upcoming workover.

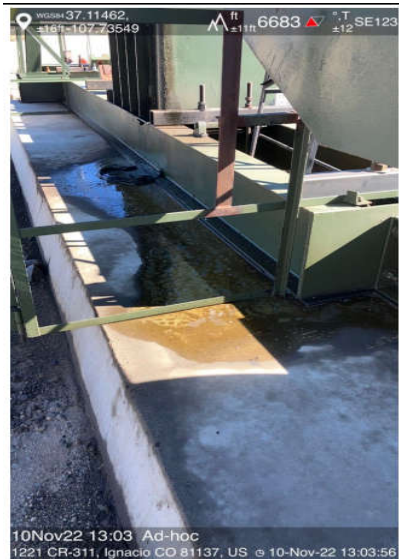
IMG 03
Lube oil

Type	OTHER		
Comment:	Lube oil at Olson Smith Gas Unit well is present on pump jack (IMG 05) and pooled on concrete (IMG 03).		
Corrective Action:	Remove lube oil and residue and dispose of in approved manner per rule 906 and 1002.f.	Date:	11/12/2022

Removed lube oil residue on concrete and disposed of it. Put pads and cleaner down.

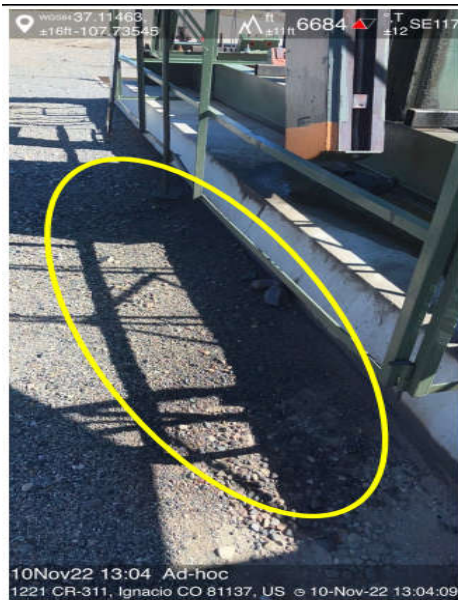
IMG 04
Impacted material

Comment:	Lube oil at Olson Smith Gas Unit well has impacted surface material (IMG 04).		
Corrective Action:	Remove impacted material and dispose of in approved manner per rule 906 and 1002.f.	Date:	11/25/2022

Removed impacted material and disposed of it
