Inspection Photos
KT Resources LLC

3-inch HDPE produced water line
Spill/Release ID: 483021
Inspection Date: November 8, 2022

COLORADO
Oil & Gas Conservation
Commission
Department of Natural Resources

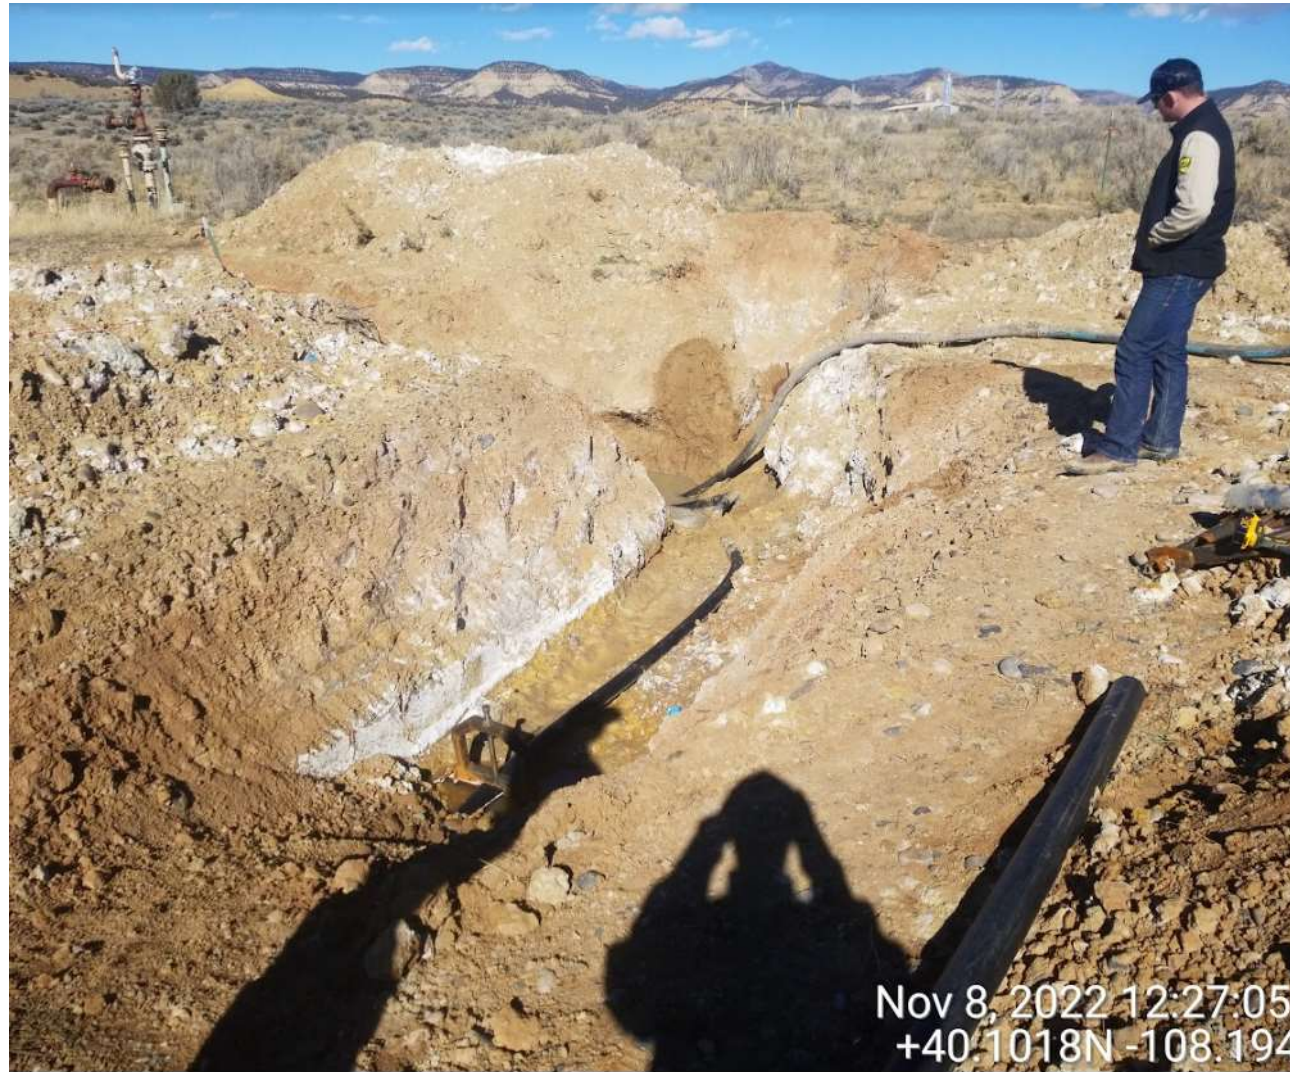
Nov 8, 2022 12:27:05
+40.1018N -108.194

Un-fenced excavation with a 3-inch HDPE produced water line. Note the salt staining within the excavation and the stockpiles of apparent E&P impacted soil in the background of the photo.

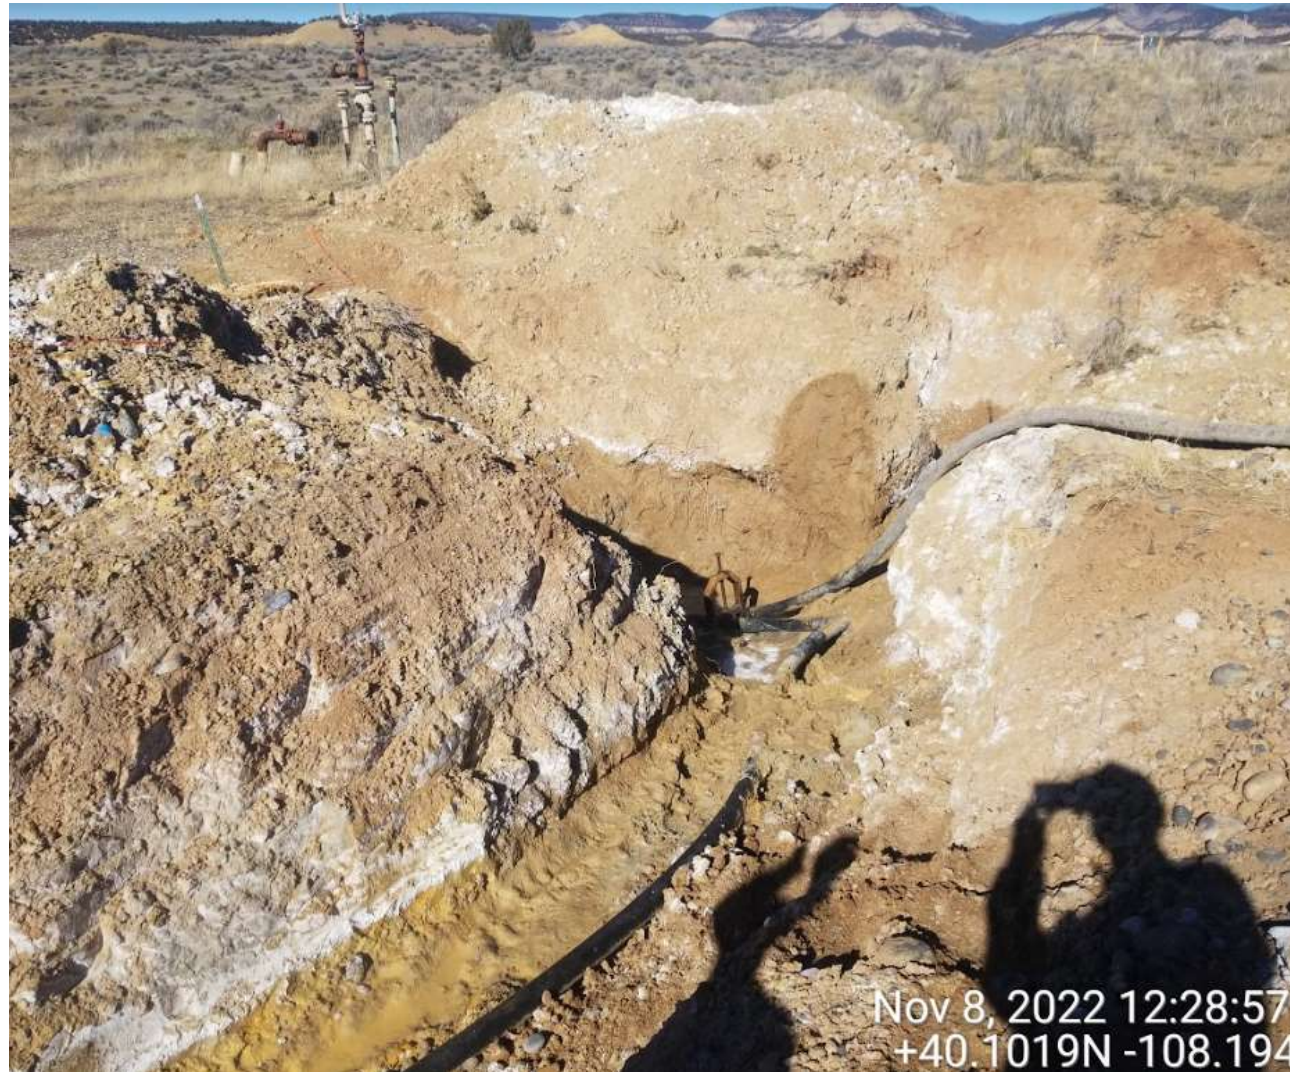
Nov 8, 2022 12:28:57
+40.1019N -108.194

Un-fenced excavation with a 3-inch HDPE produced water line. Note the fluids and salt staining within the excavation. Note the stockpiles of apparent E&P impacted soil in the background of the photo

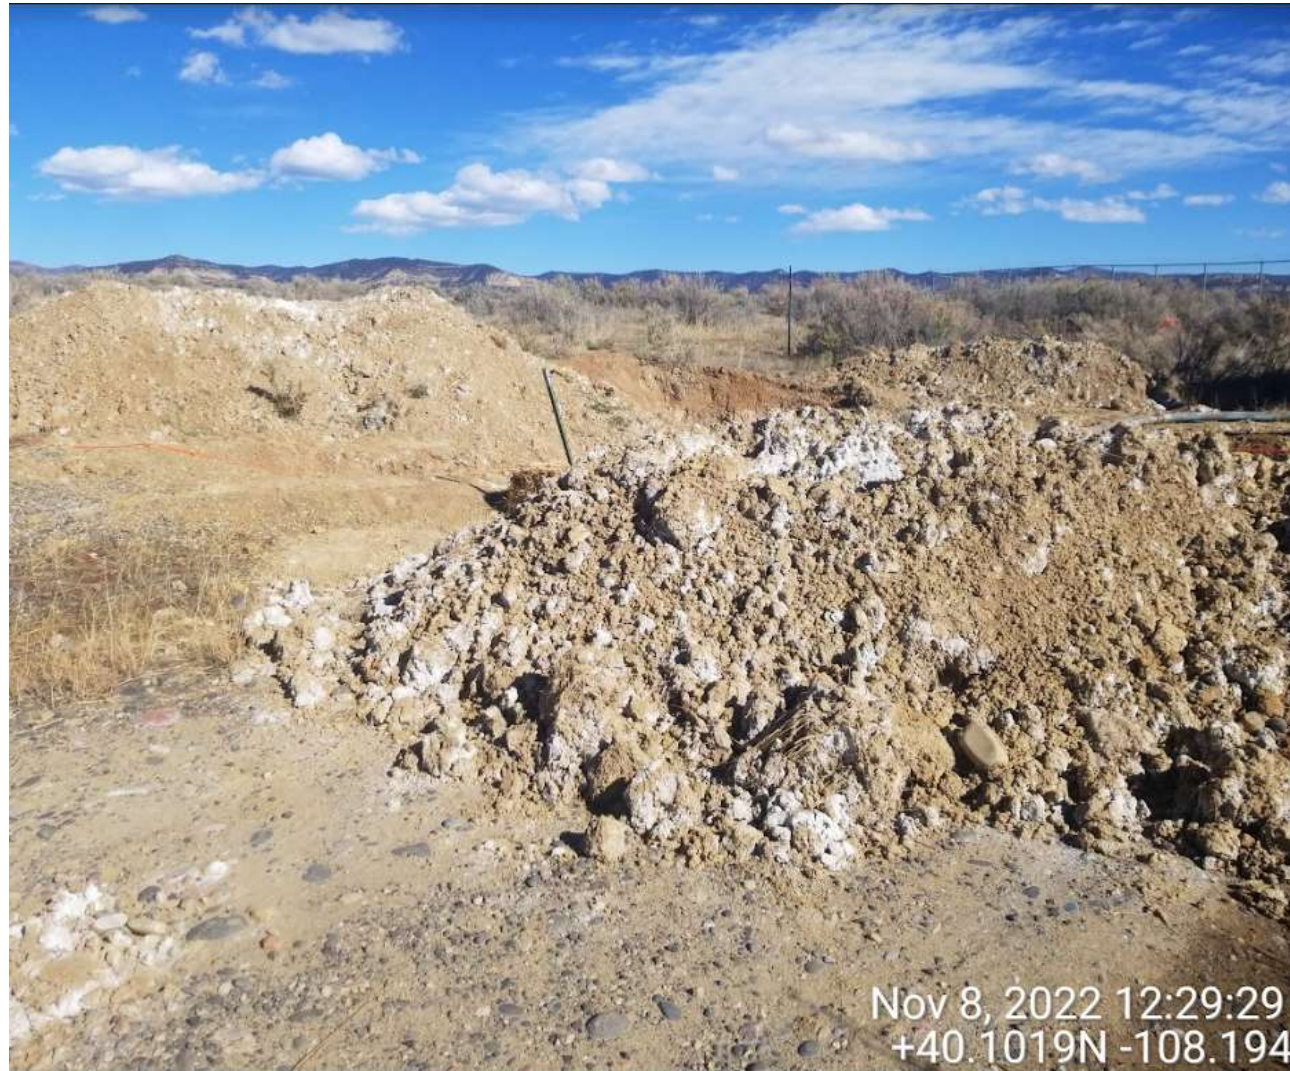
**Stockpiles of apparent E&P
impacted soil. Note the salt
staining.**

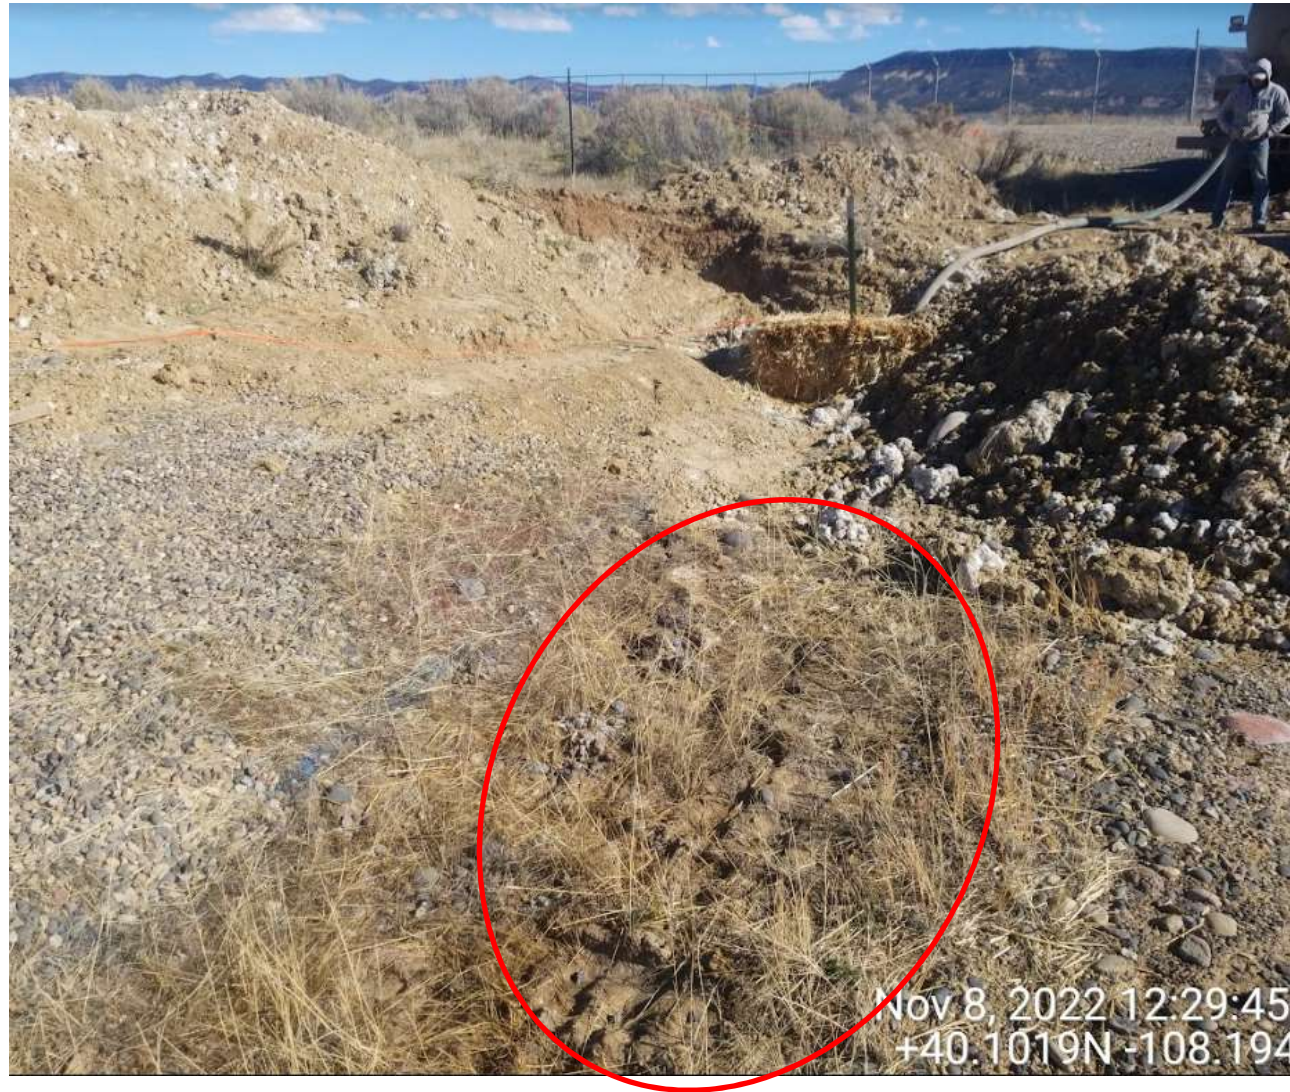
Nov 8, 2022 12:29:45
+40.1019N -108.194

Area where fluids had migrated west of the spill/release area along an access road (red area). Note the stockpiles of apparent E&P impacted soil and the excavation in the background.

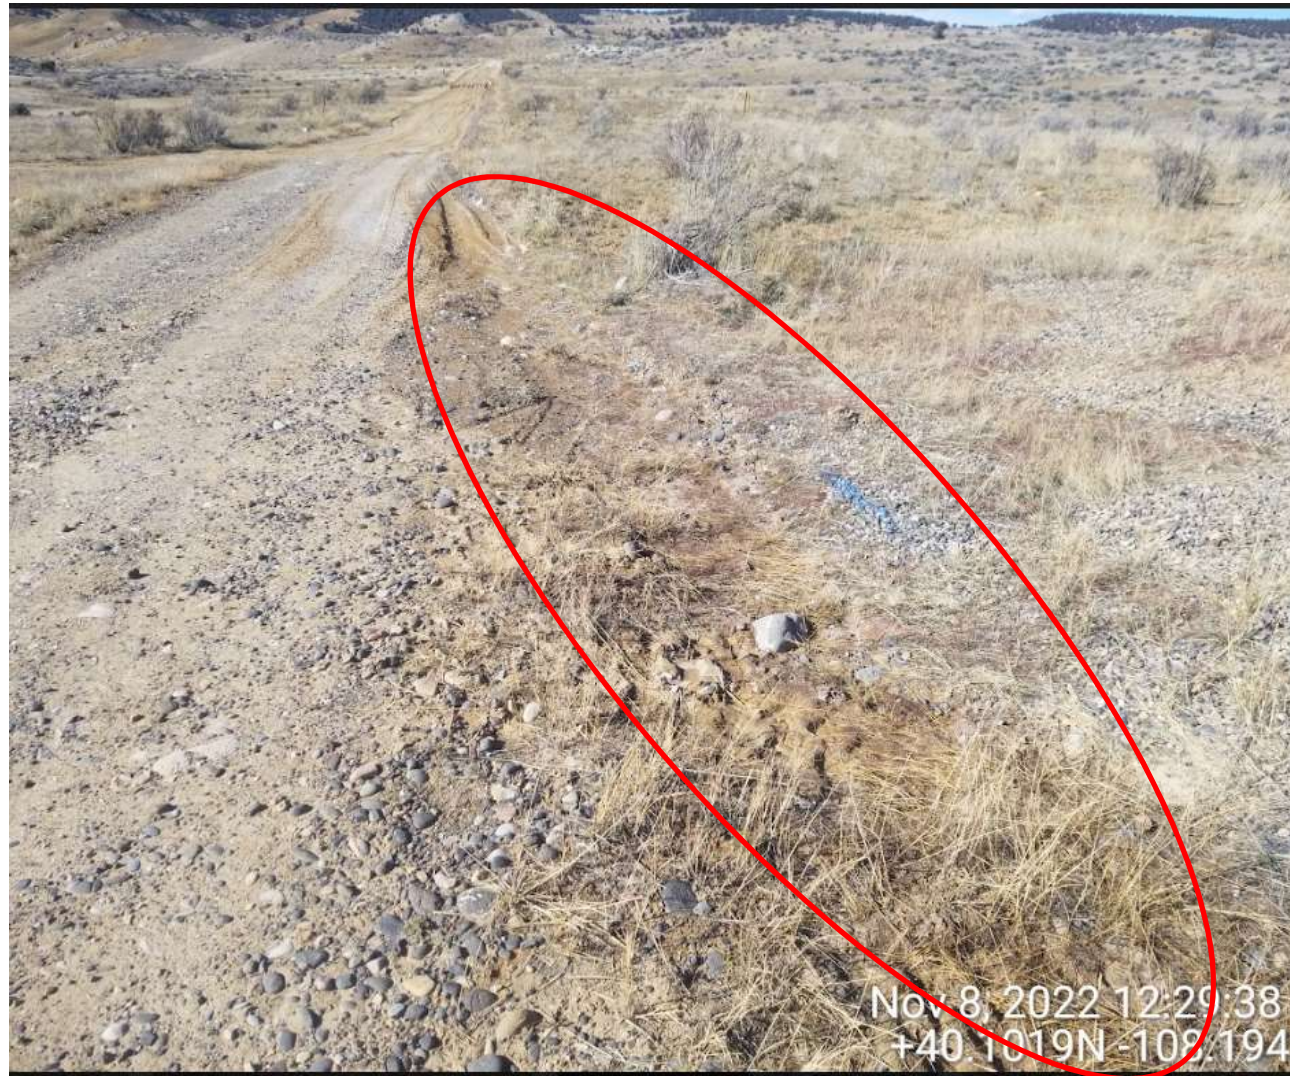
**Area where fluids had migrated
west of the spill/release area along
an access road (red area).**

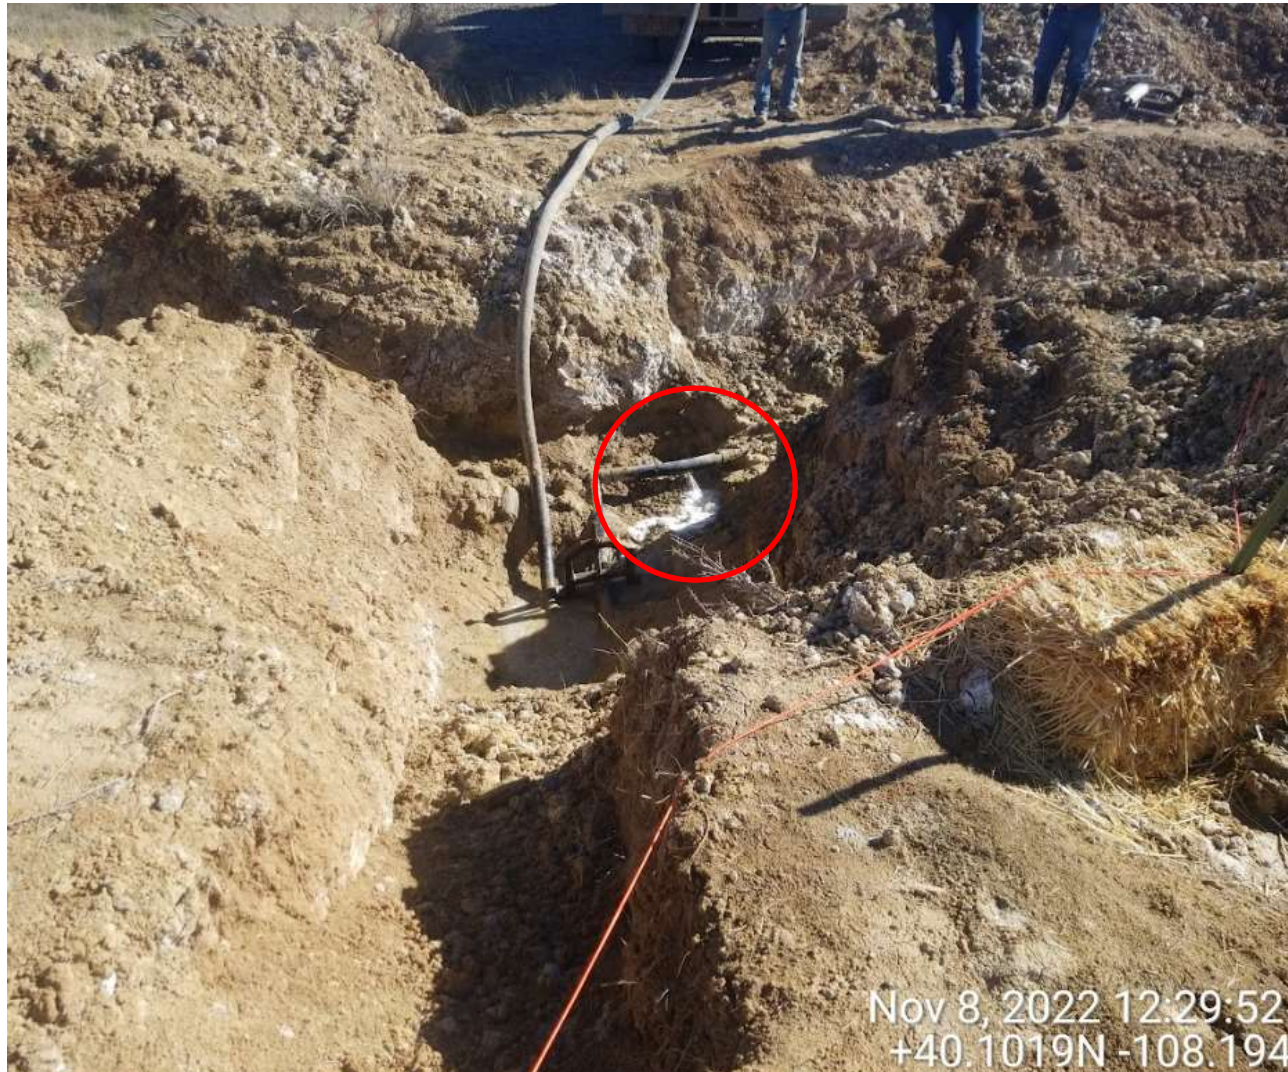
Excavation with a 3-inch HDPE
produced water line. Note the
produced water discharging into
the excavation from the water line
(red area).

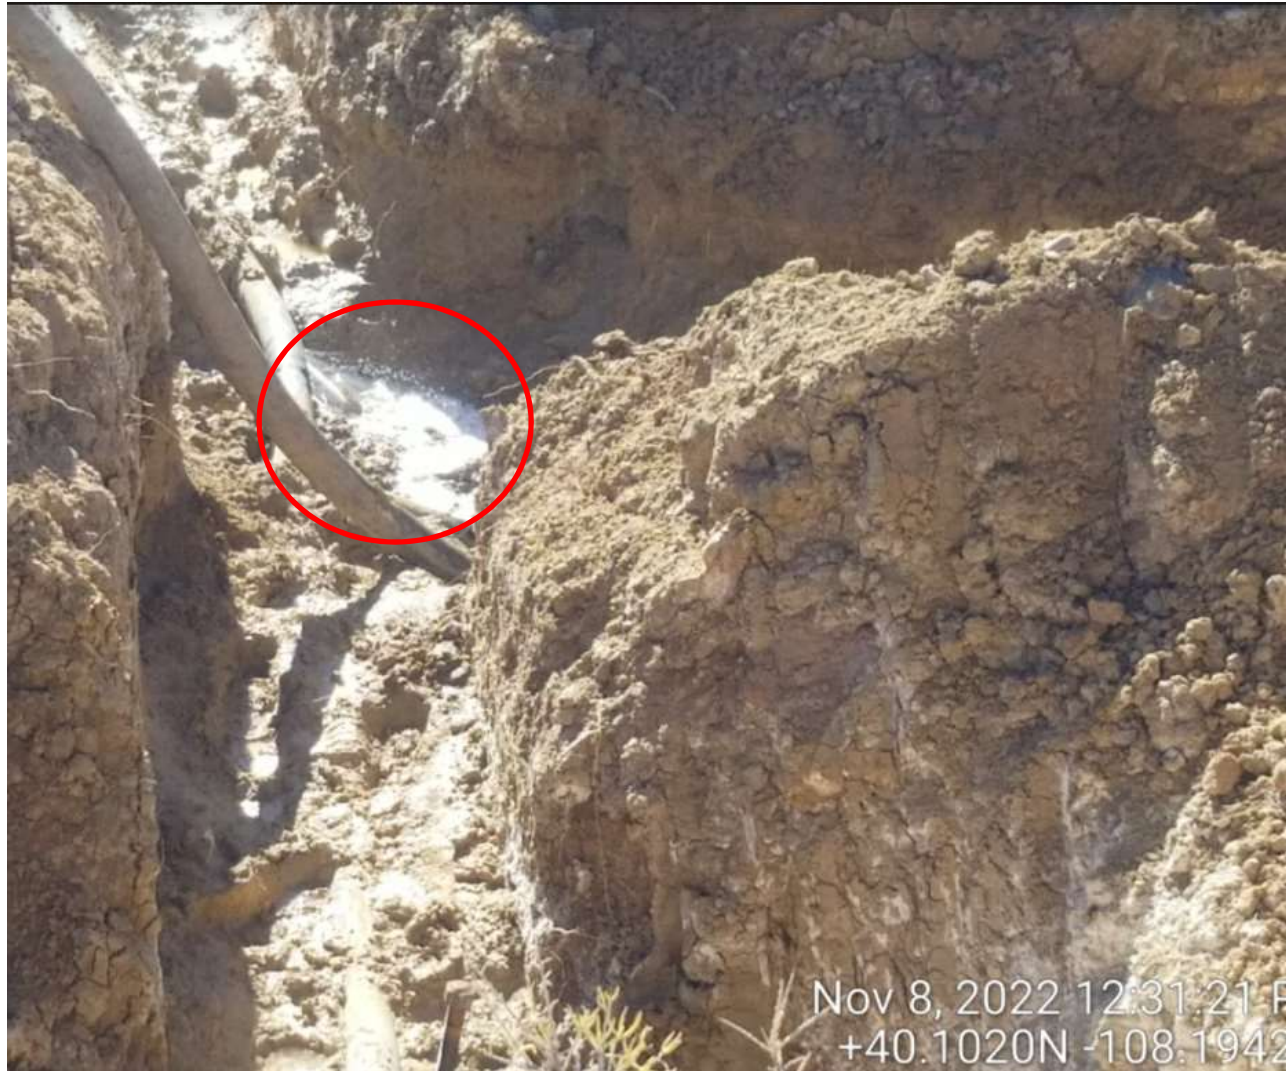
Excavation with a 3-inch HDPE produced water line. Note the produced water discharging into the excavation from the water line (red area).

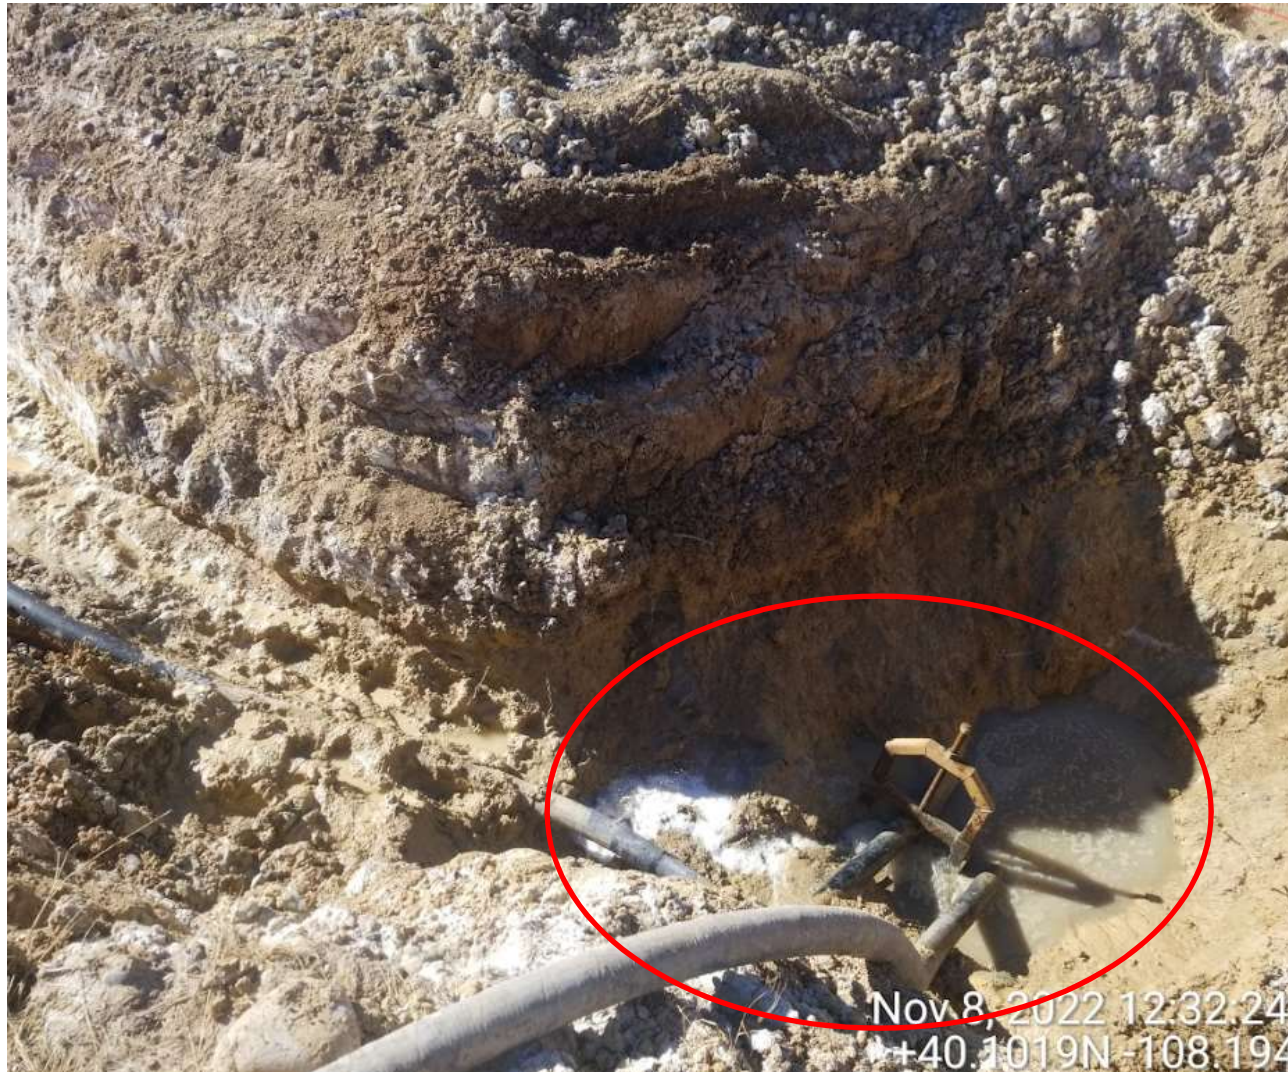
Excavation with a 3-inch HDPE
produced water line. Note the
produced water discharging into
the excavation from the water line
(red area).

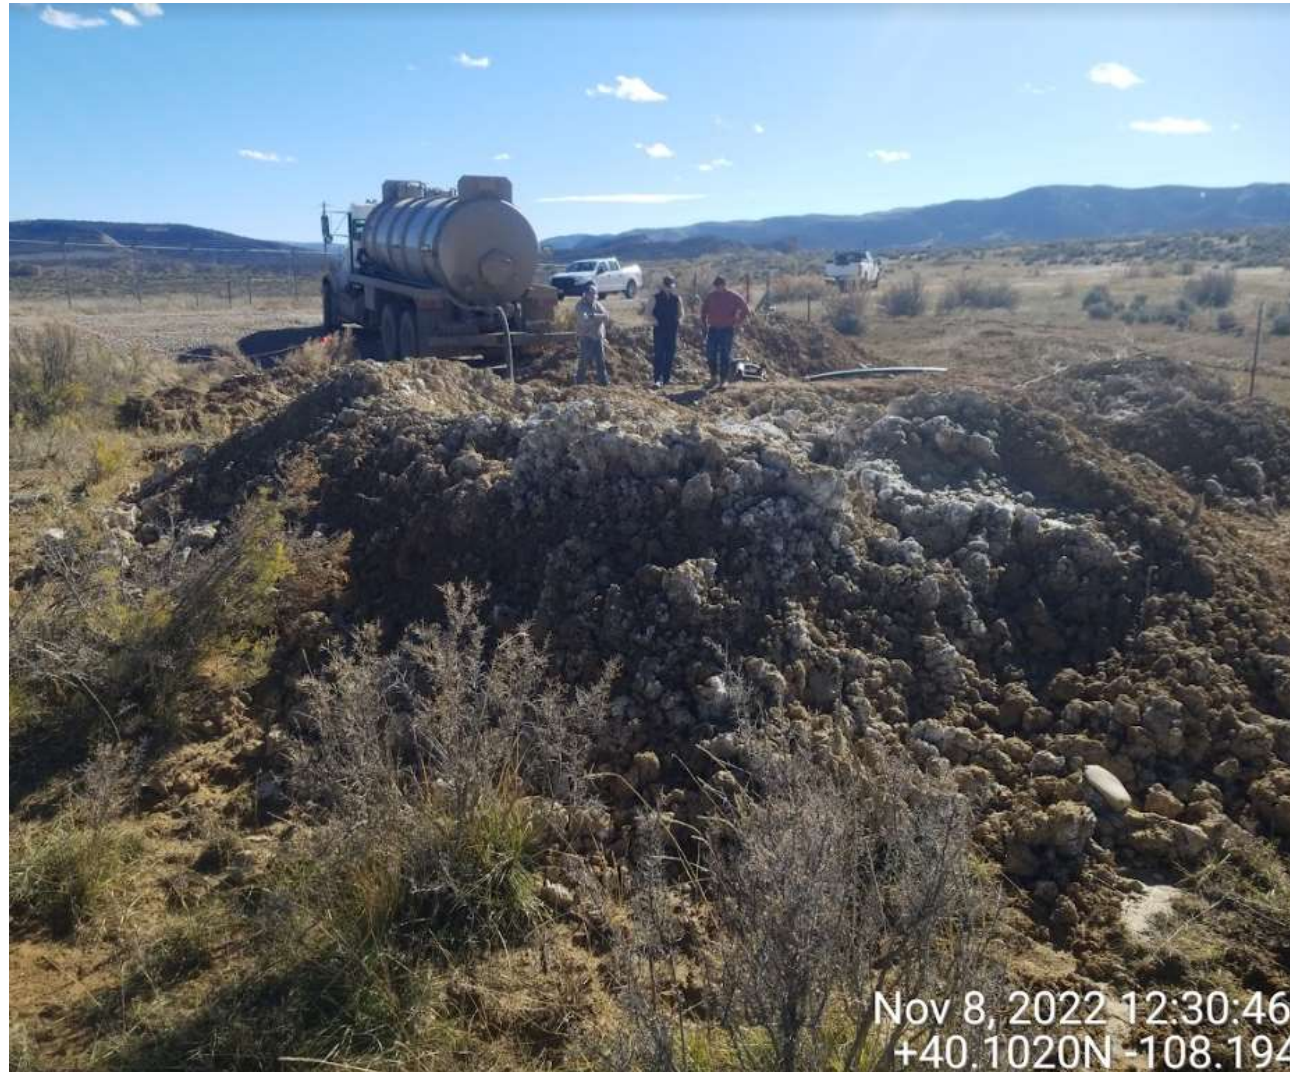
**Stockpiles of apparent E&P
impacted soil. Note the salt
staining.**

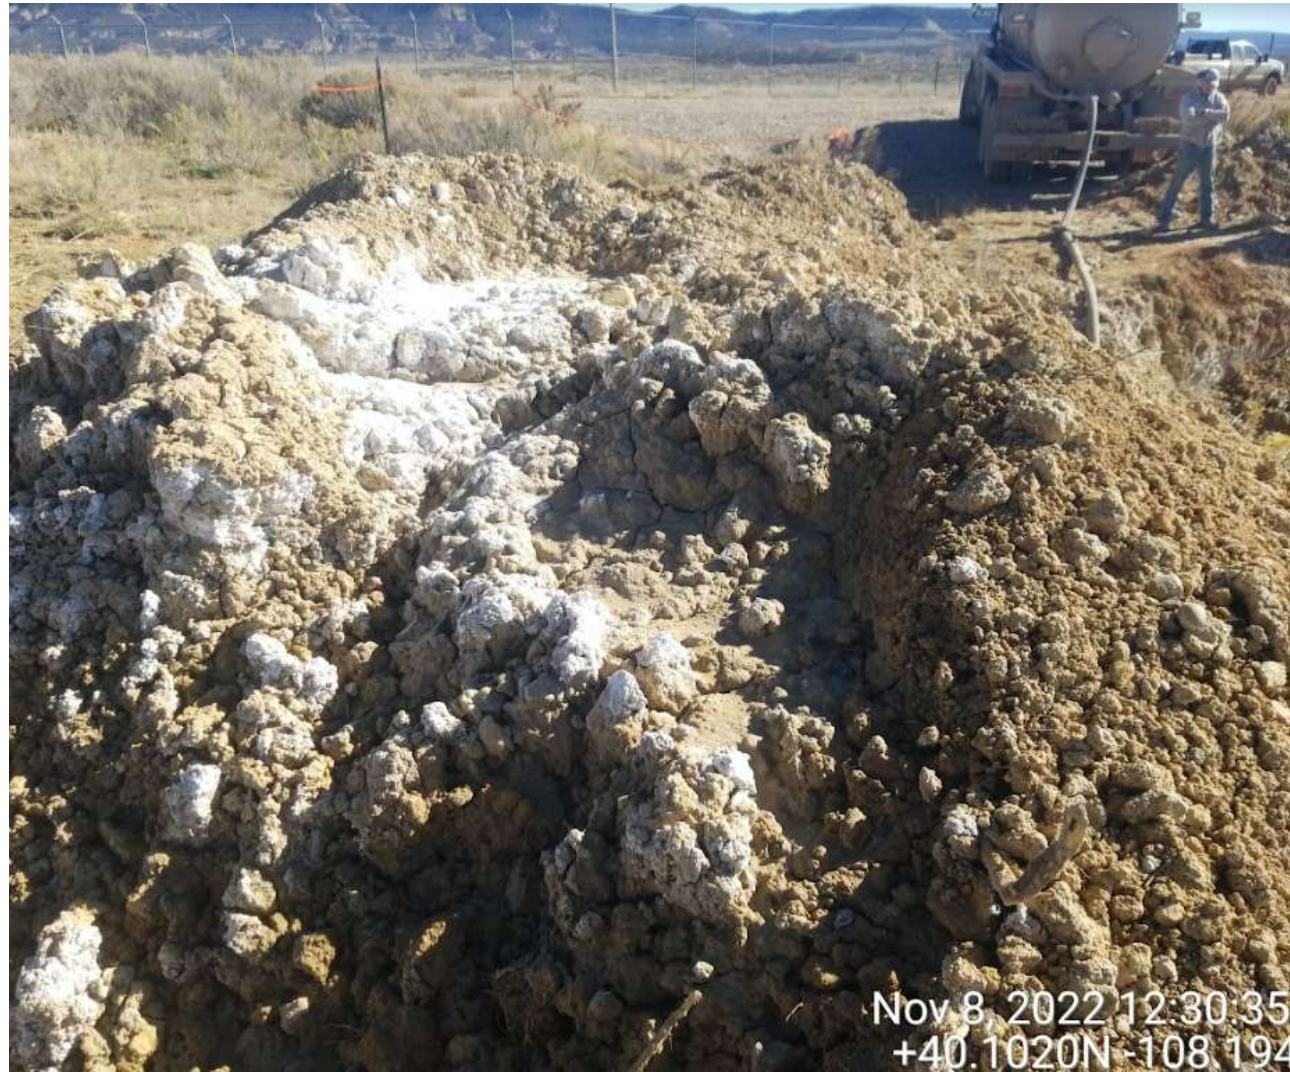
Nov 8, 2022 12:30:35
+40.1020N -108.194

**Stockpiles of apparent E&P
impacted soil. Note the salt
staining.**

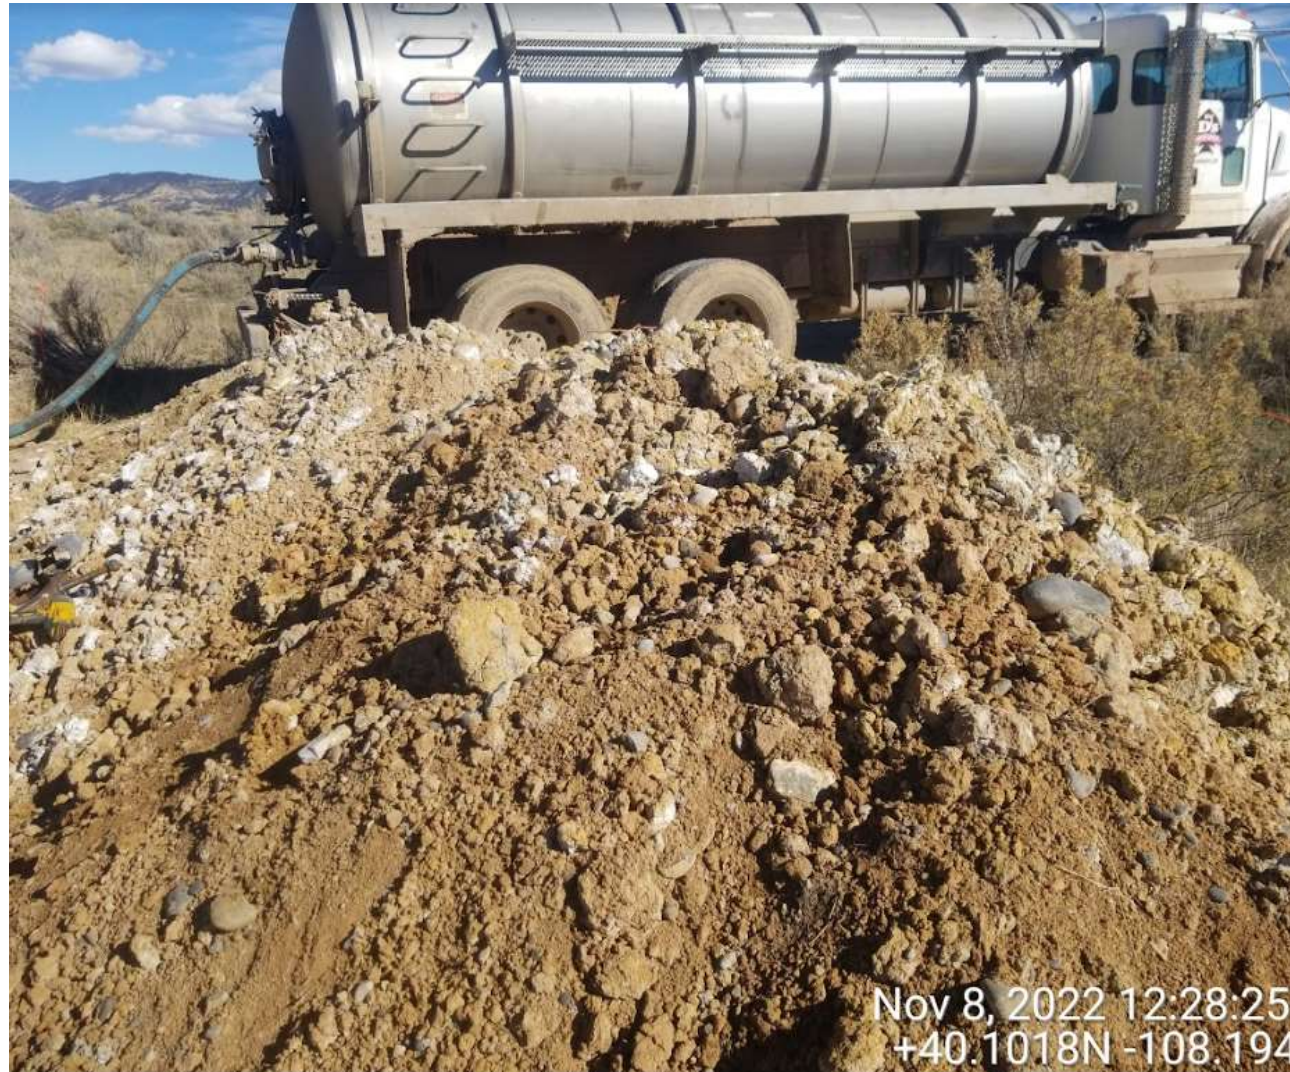
Stockpiles of apparent E&P
impacted soil. Note the salt
staining.
