Inspection Photos

Location Name: CLOUGH-66S94W/13SENE

Inspection Document #: 702800937

Anna O'Malley
Reclamation Specialist, COGCC

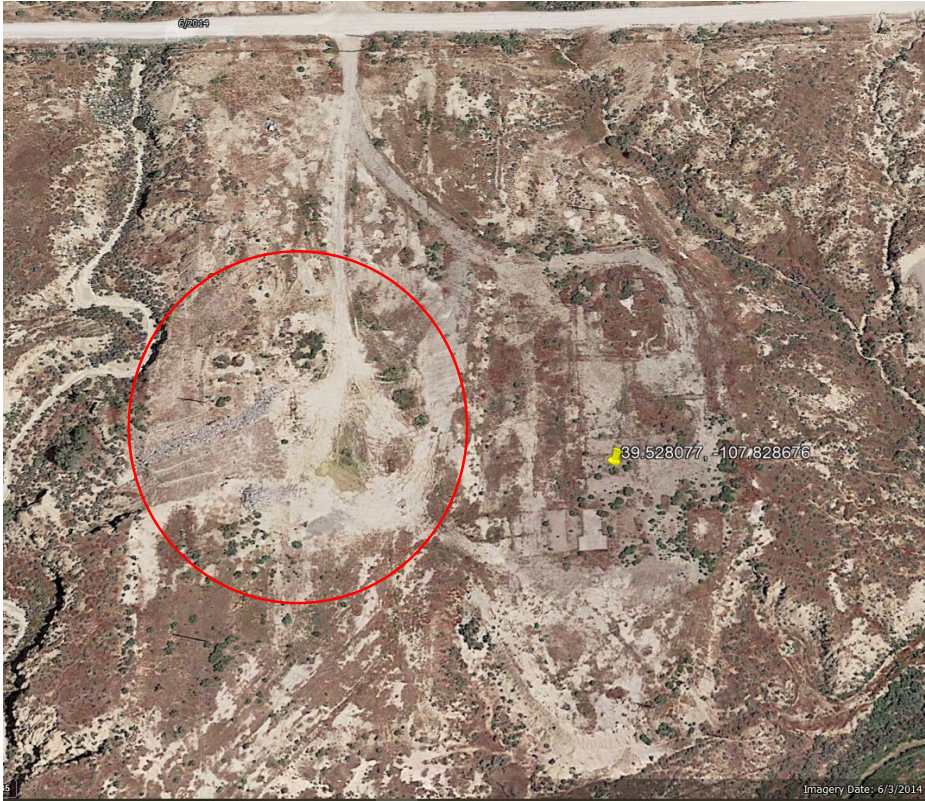
Photo 1. Photo shows satellite imagery of the location dated 6/3/2014. Note, roads and equipment footprints are evident indicating reclamation has not been performed.

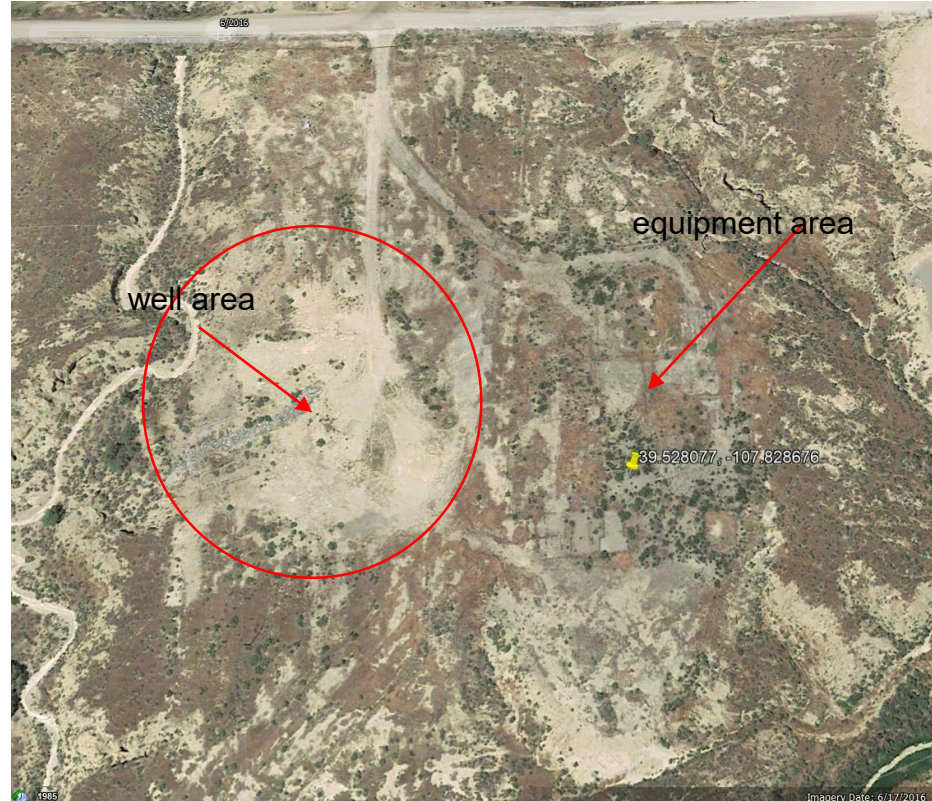
Photo 2. Photo shows satellite imagery of the location dated 6/17/2016, nine days after the Operator indicated final reclamation corrective action was addressed. Imagery shows evidence of potential work around the wellhead (increase in bare ground/change in vegetation). The rest of the Location (in particular the equipment areas to the east remain unchanged).

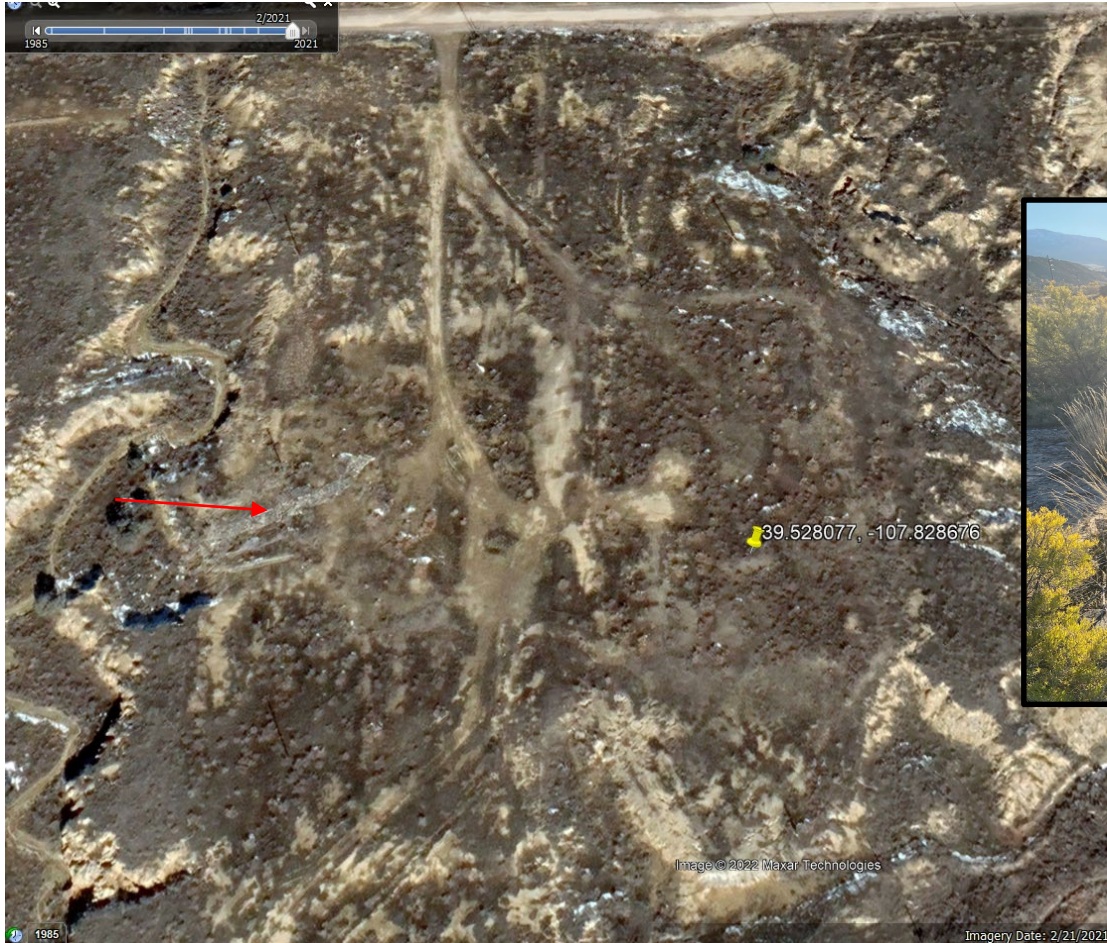
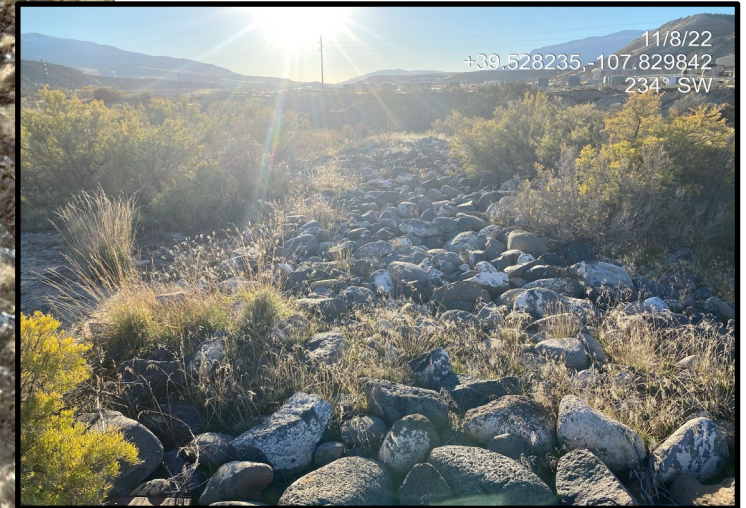
Photo 3. Photo shows satellite imagery of the location dated 2/21/2021. Roads and equipment footprints are still evident indicating reclamation (in particular gravel removal, compaction alleviation, road closure and seeding of the entire location was not performed. A large pile of rock remains (inset) seen on the imagery.

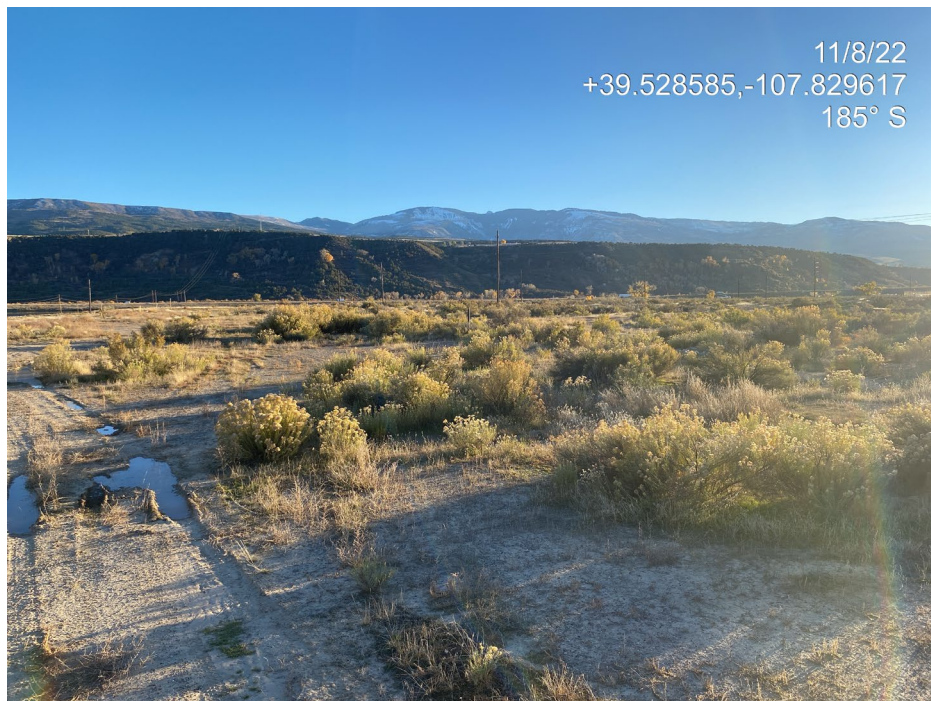
Photo 4. Photo taken from north shows an overview of the western portion of the location.

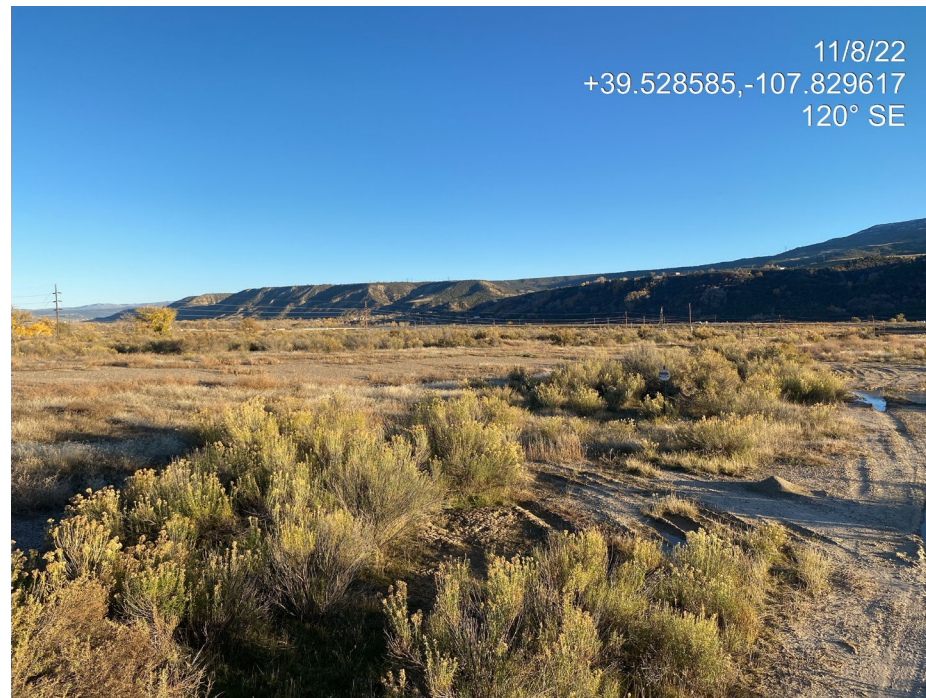
Photo 5. Photo taken from north shows an overview of the eastern portion of the location.

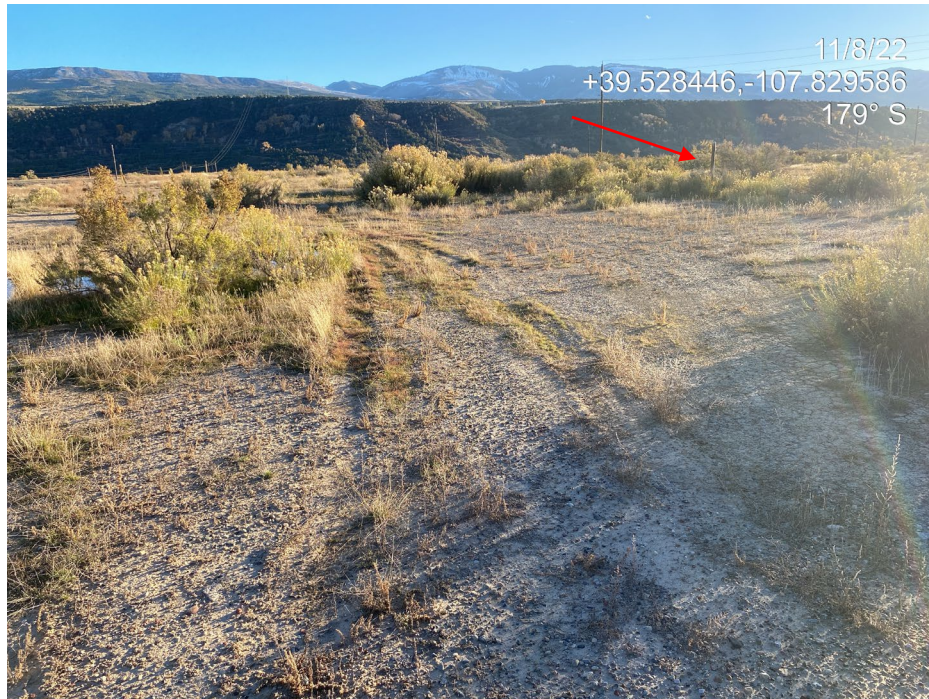
Photo 6. Photo shows an overview of the former well area from the north. Arrow indicates well marker. Note compacted, graveled pad.

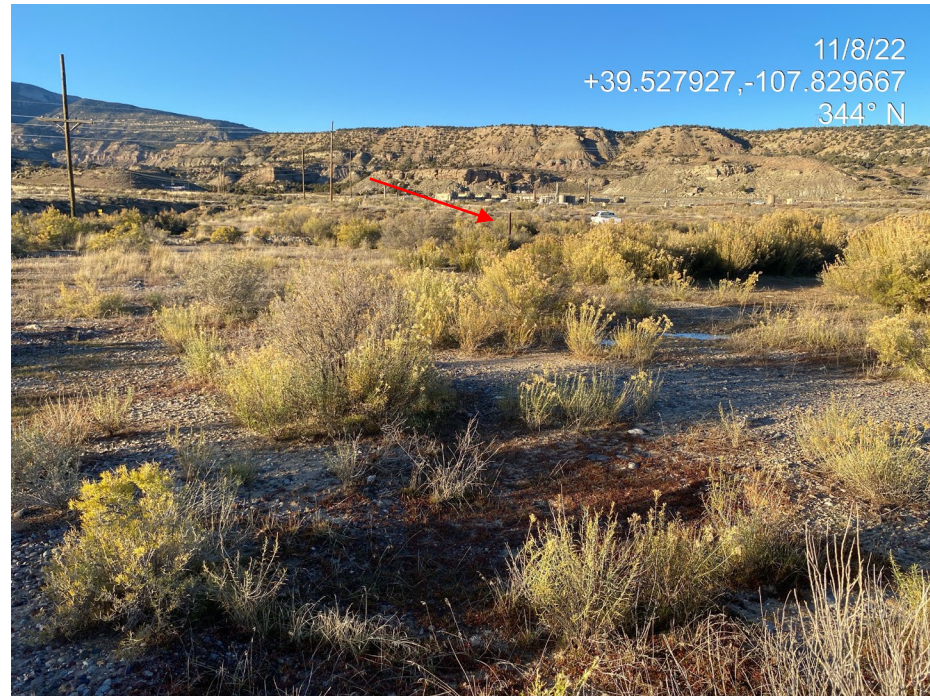
Photo 7. Photo shows an overview of the former well area from the south. Arrow indicates well marker. Note compacted, graveled pad.

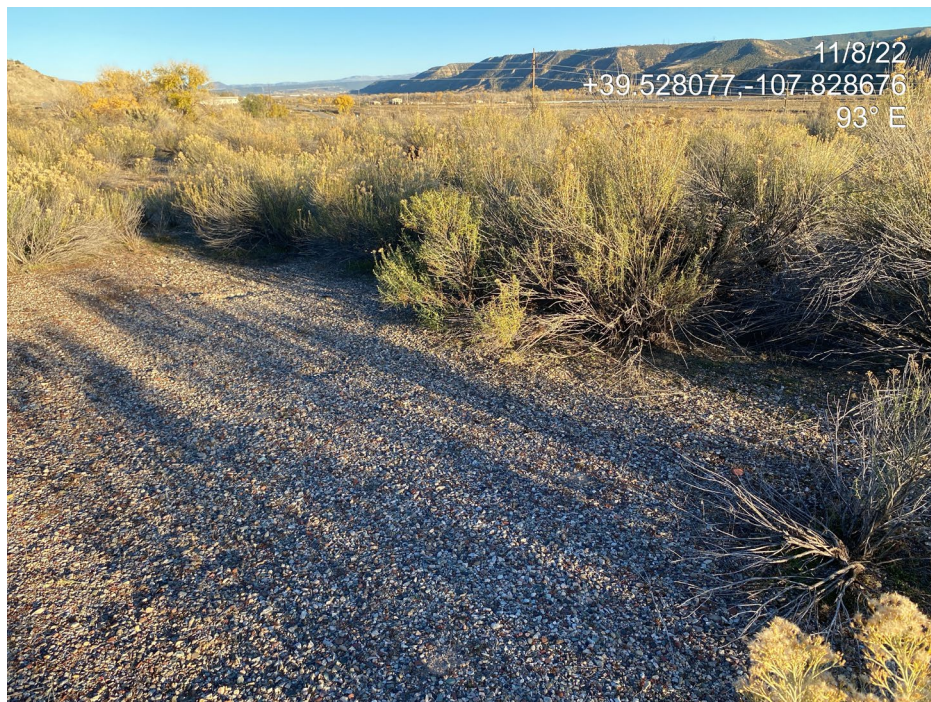
Photo 8. Photo shows a portion of the former equipment area at the east. Note compacted, graveled pad.

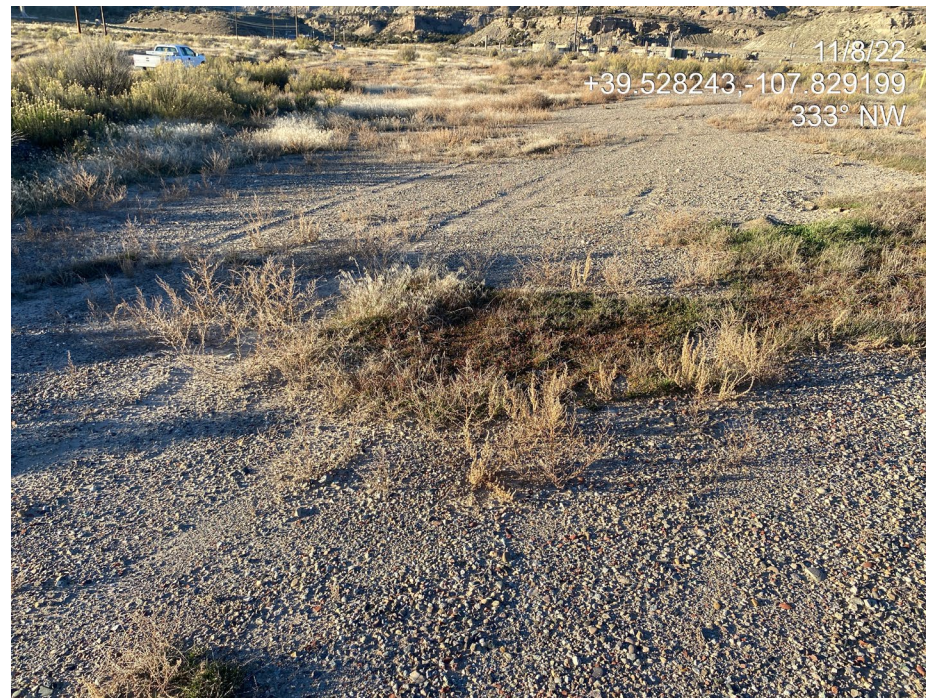
Photo 9. Photo taken from the center of the location disturbance. Note compacted, graveled pad.

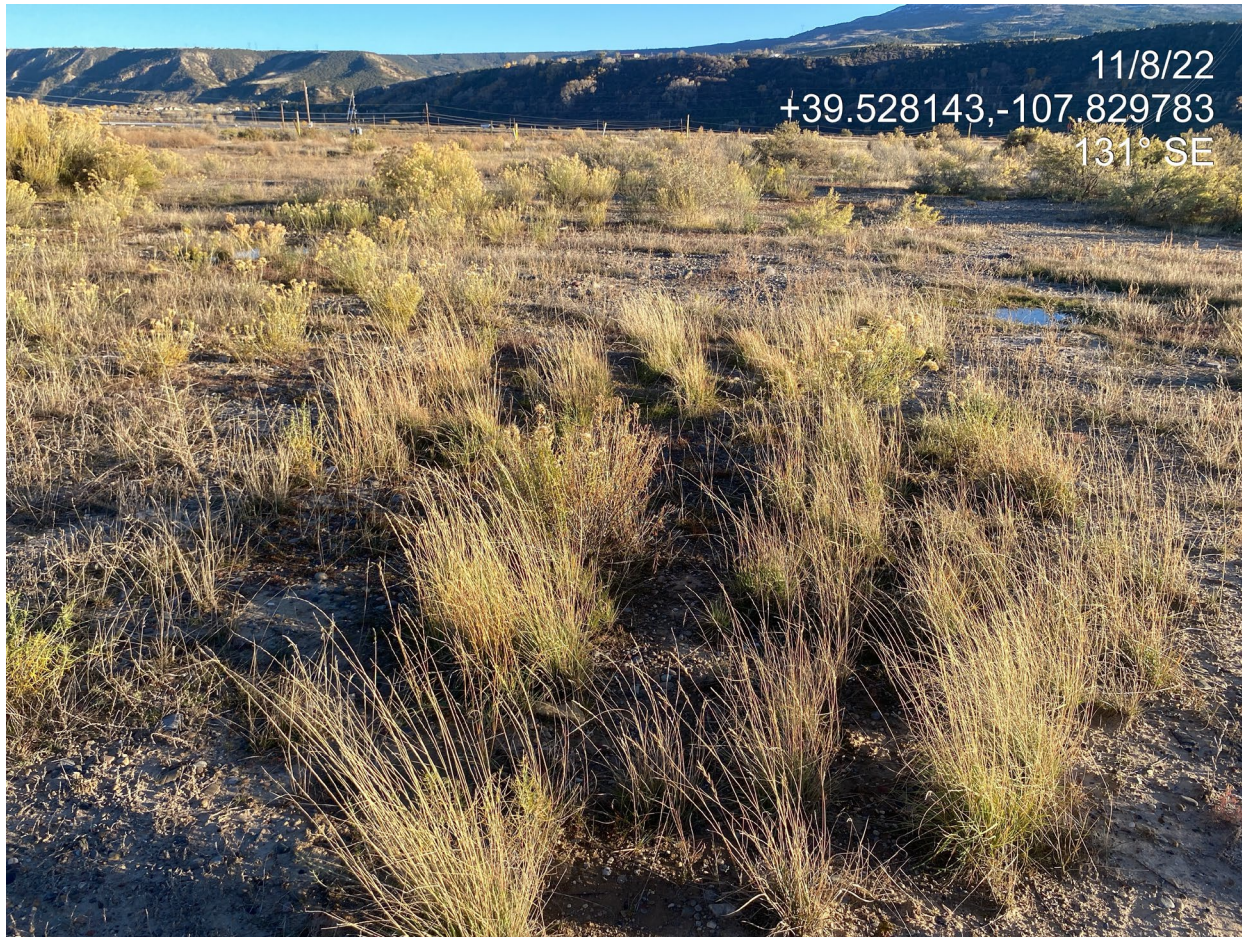
Photo 10. Photo taken adjacent to the well marker shows the area appears to have been seeded with perennial grasses. There is no other evidence of reclamation. Seeded species are sparse and restricted to a small area around the well.
