Inspection Photos

Operator: Beeman Oil & Gas Inc - #7125

Location Name: Bulldog /22-41V-890

Inspection Document #: 702800949

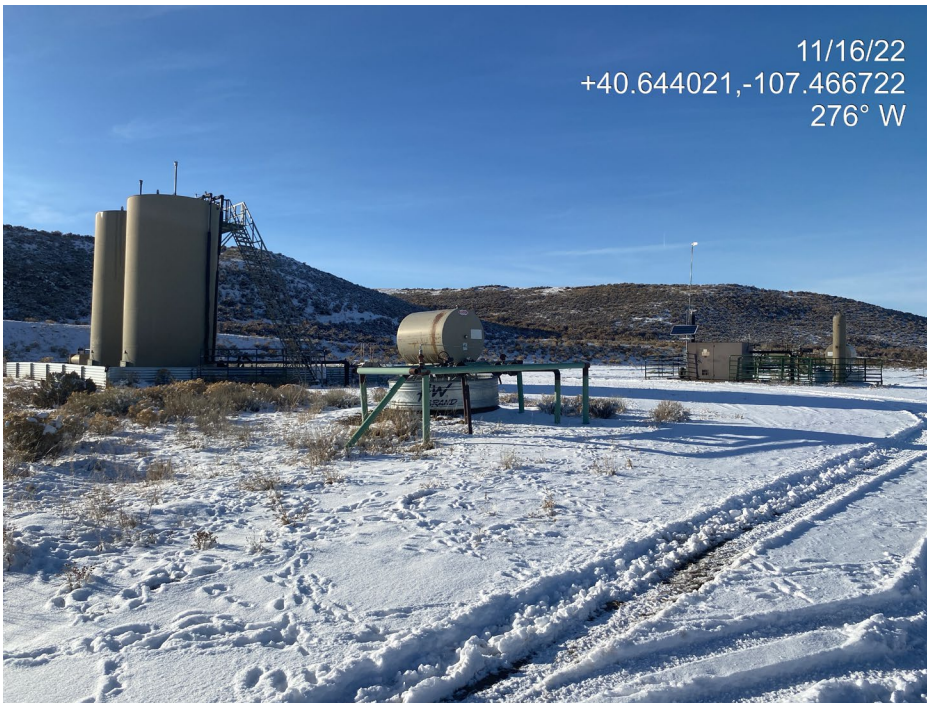
Photo 1. Photo taken from the Location entrance shows an overview of the Location to the west.

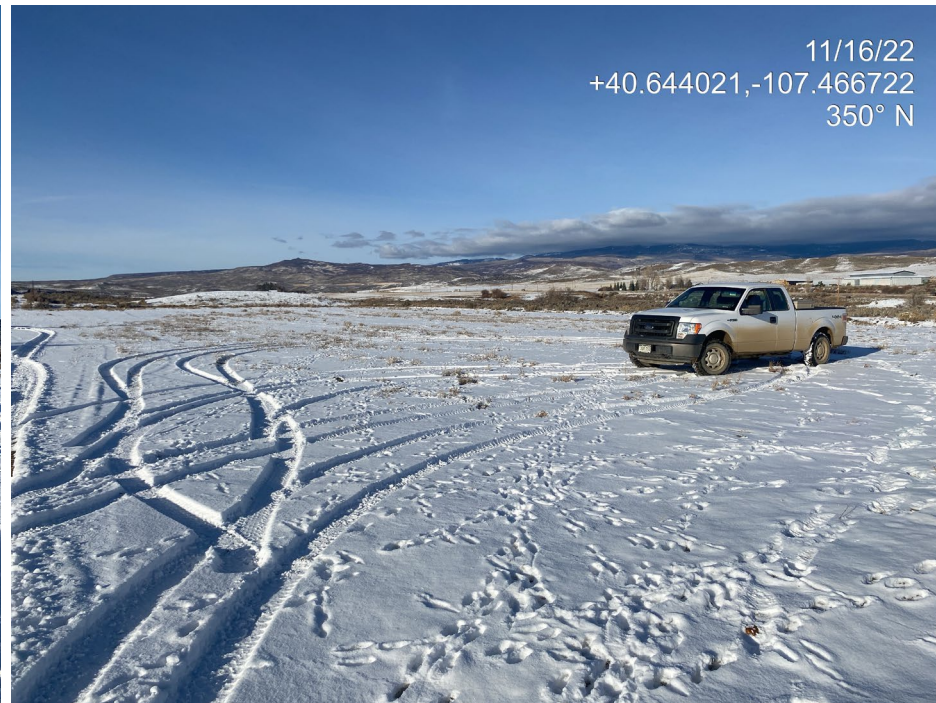
Photo 2. Photo taken from the Location entrance shows an overview of the Location to the east.

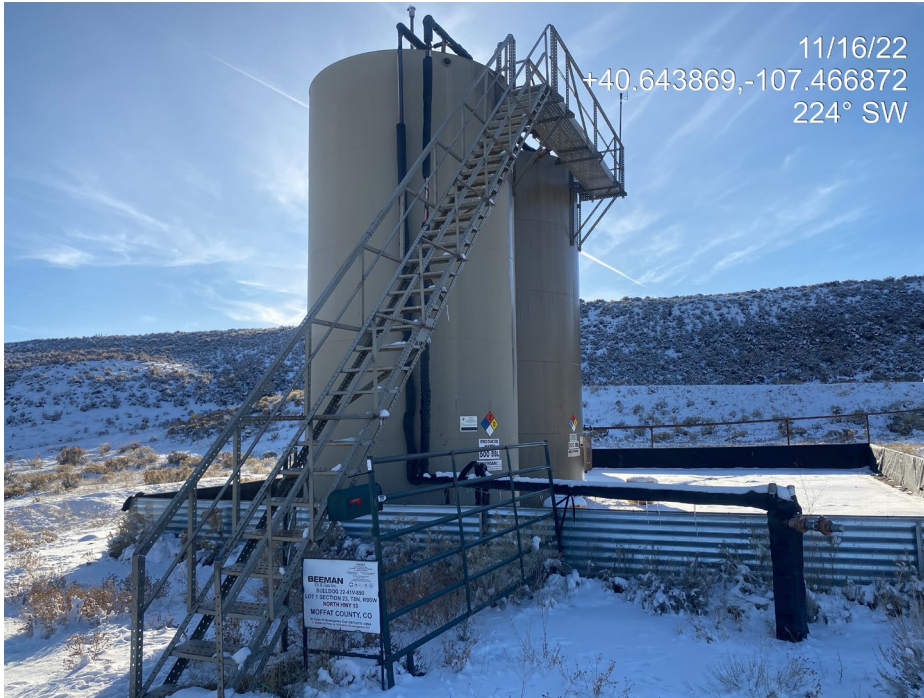
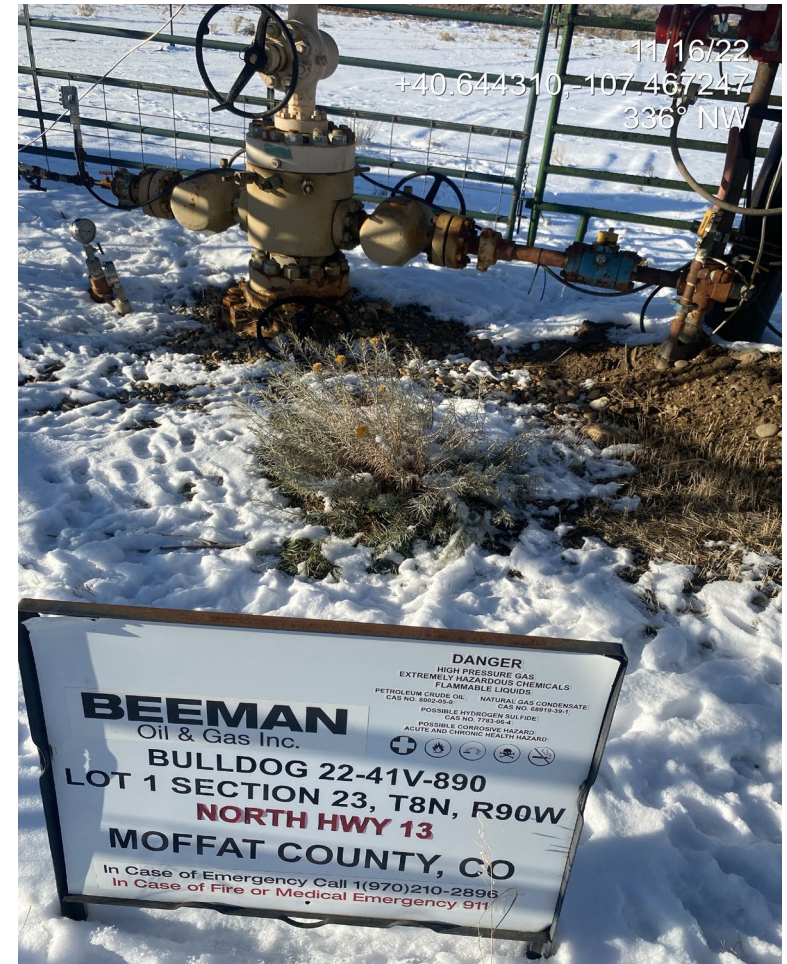
Photo 3. Photo shows the tank battery sign (left) and wellhead sign (right) both lack the well API number. Photos also show vegetation and vegetation debris around production equipment.

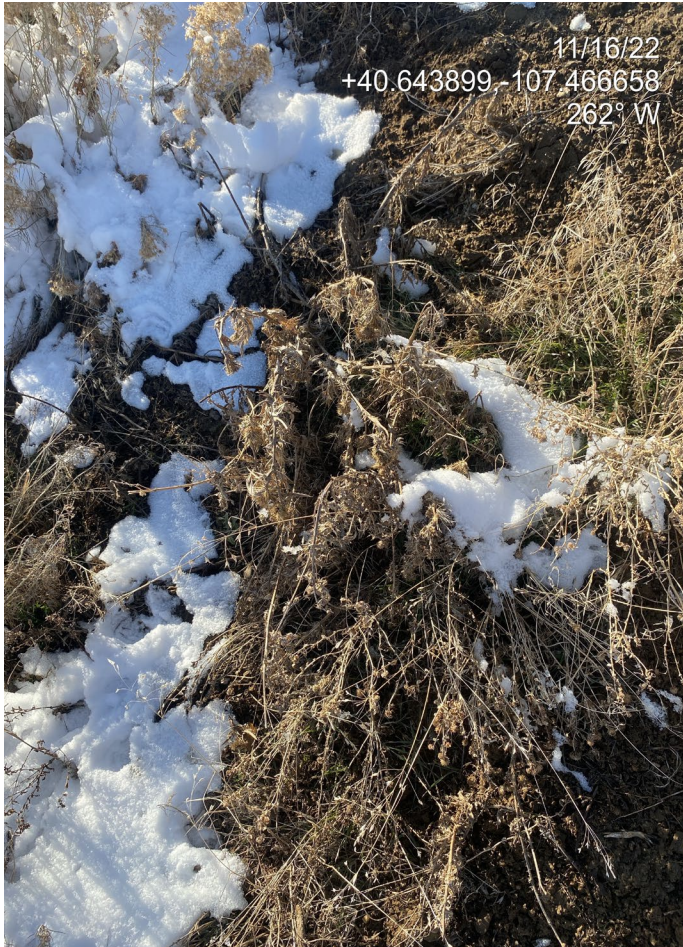
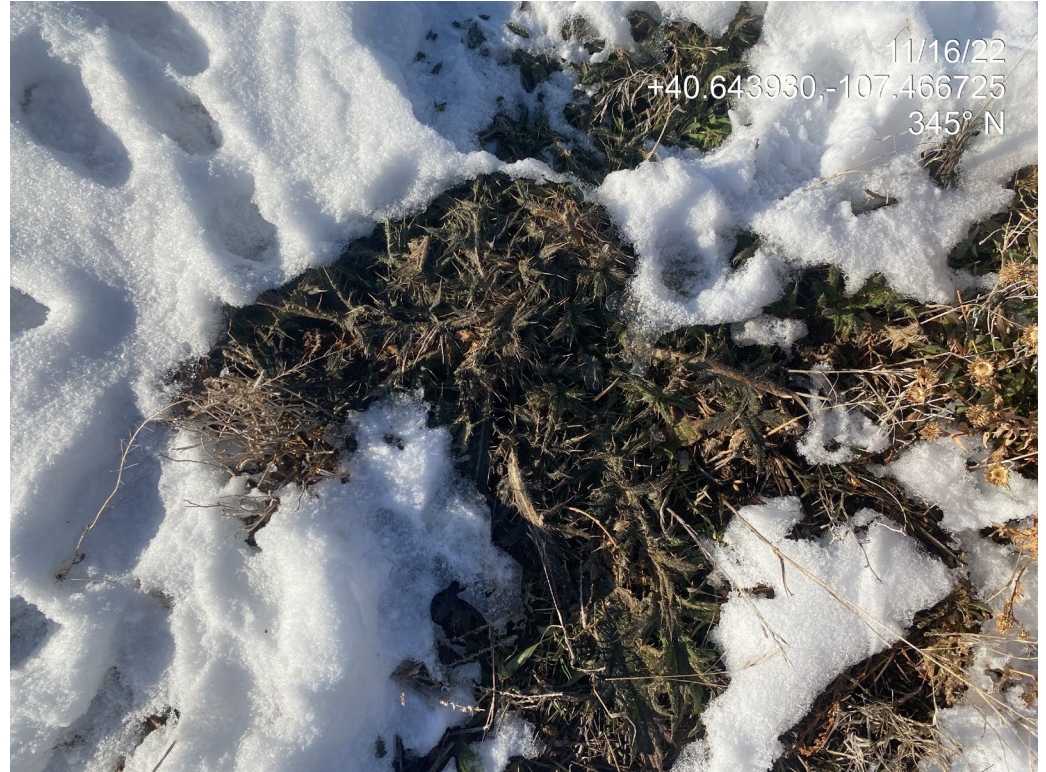
Photo 4. Photo shows bull thistle (List B Noxious Weed) which has gone to seed (left) and a first year rosette (right). There is no evidence that weed management has occurred.

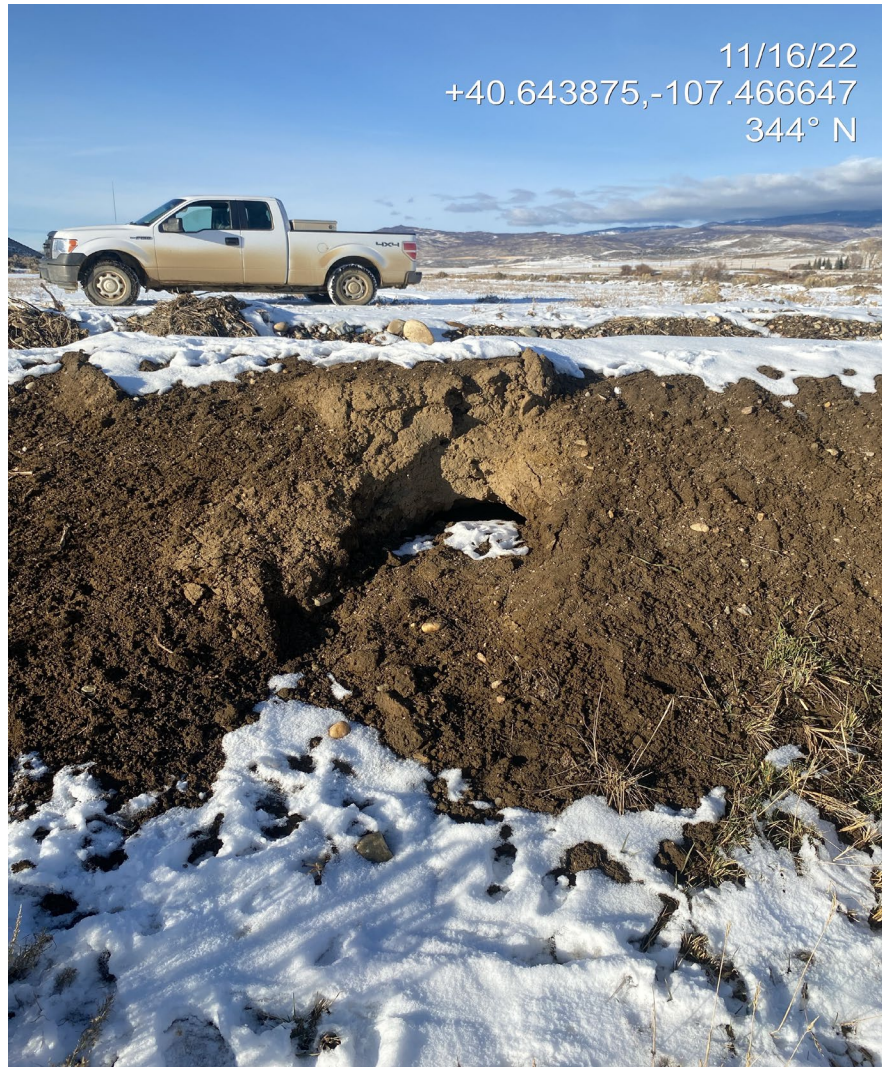
Photo 5. Photo taken from the southeast of the Location shows where the perimeter stormwater berm has been compromised and is not maintained in proper functioning condition.
