Inspection Photos

Operator: Beeman Oil & Gas LLC - #7125

Location Name: Bulldog /5-14H-789

Inspection Document #: 702800953

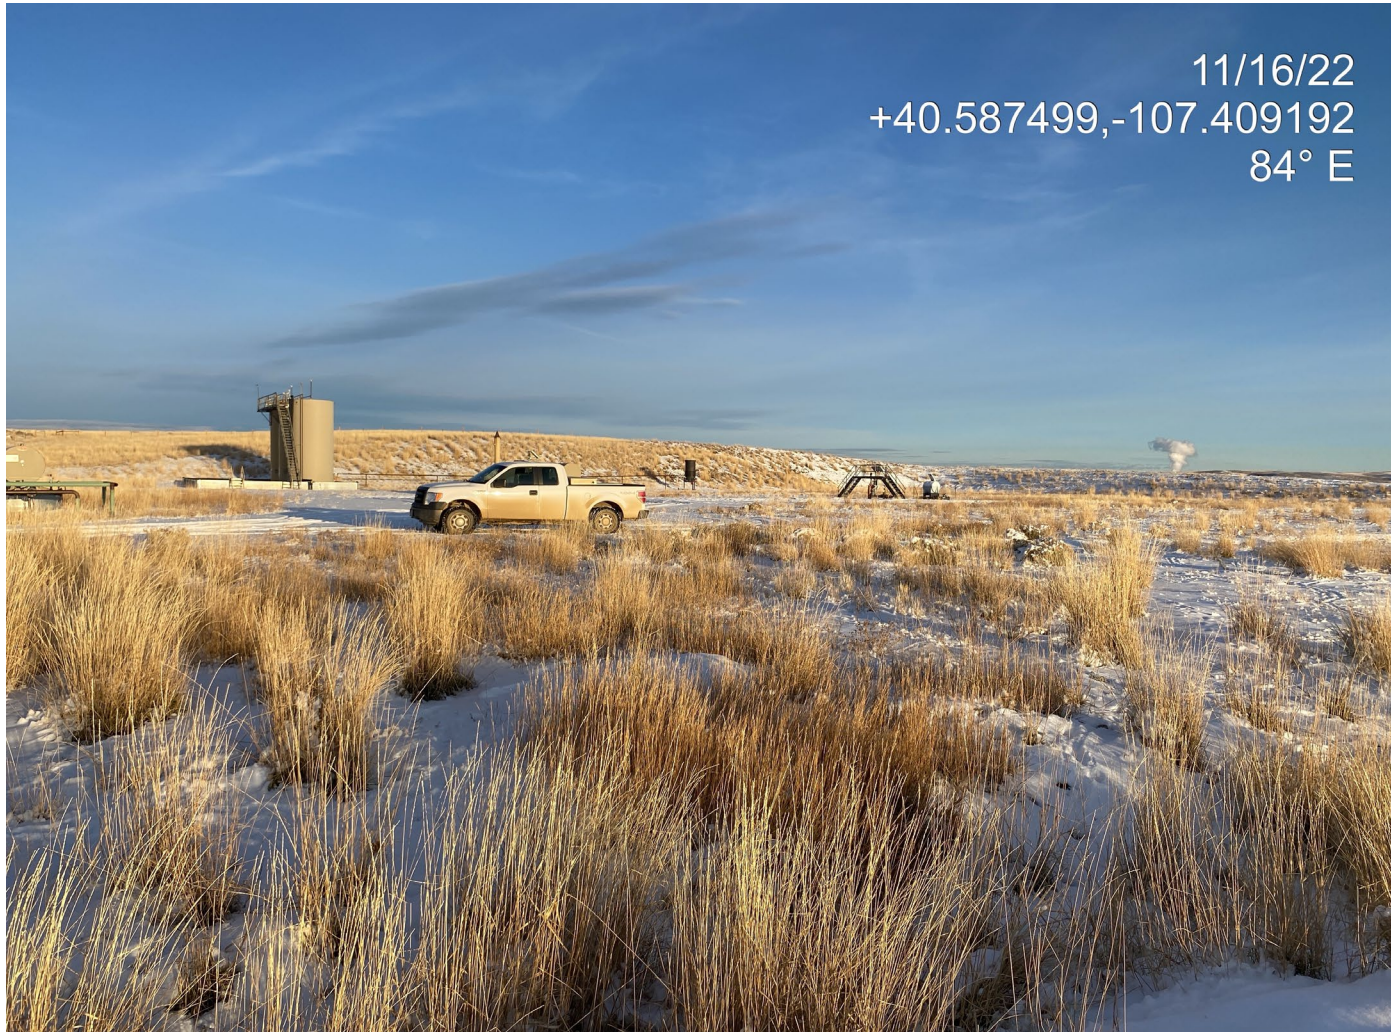
Photo 1. Photo taken from the entrance shows an overview of the location.

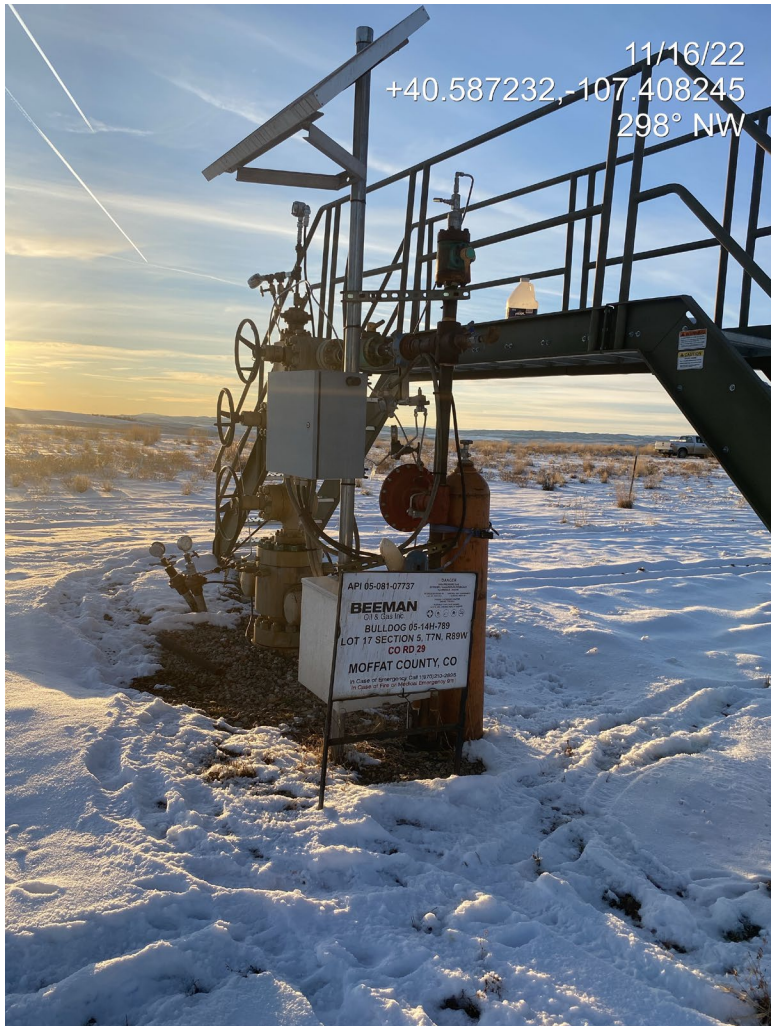
Photo 2. Photo shows the wellhead.

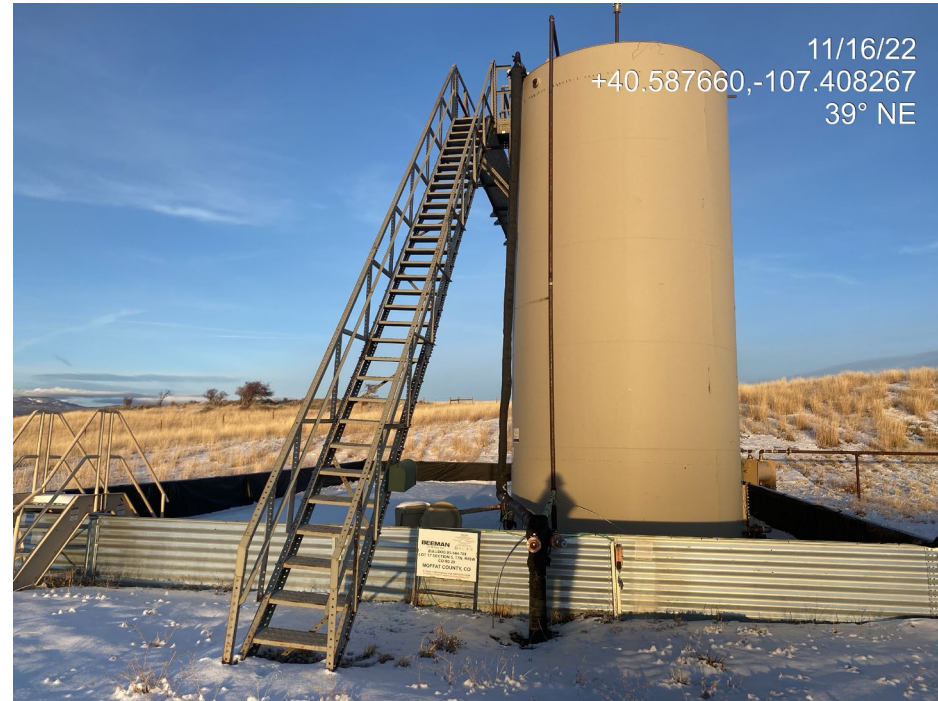
Photo 3. Photo shows a tank battery sign has been installed. Sign does not comply with Rule 605.e; API number absent.

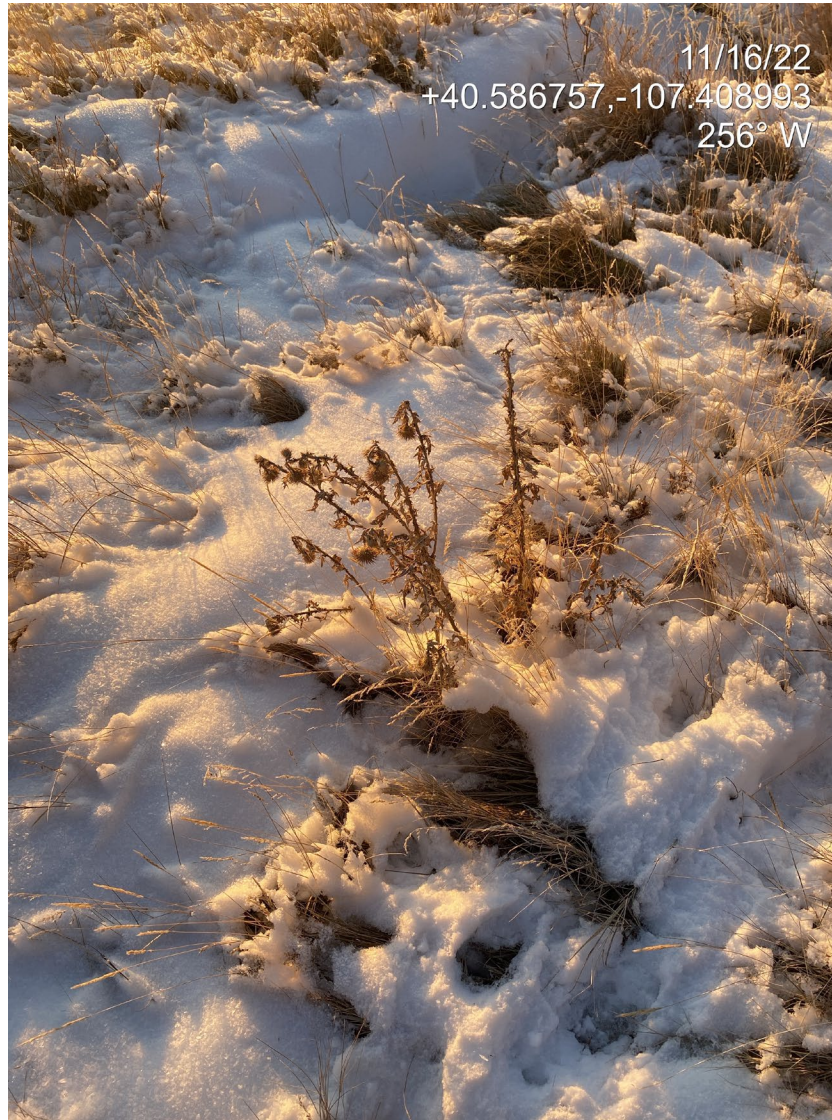
Photo 4. Photo shows an example of bull thistle (List B Noxious) found throughout the location. There is no evidence of weed management.

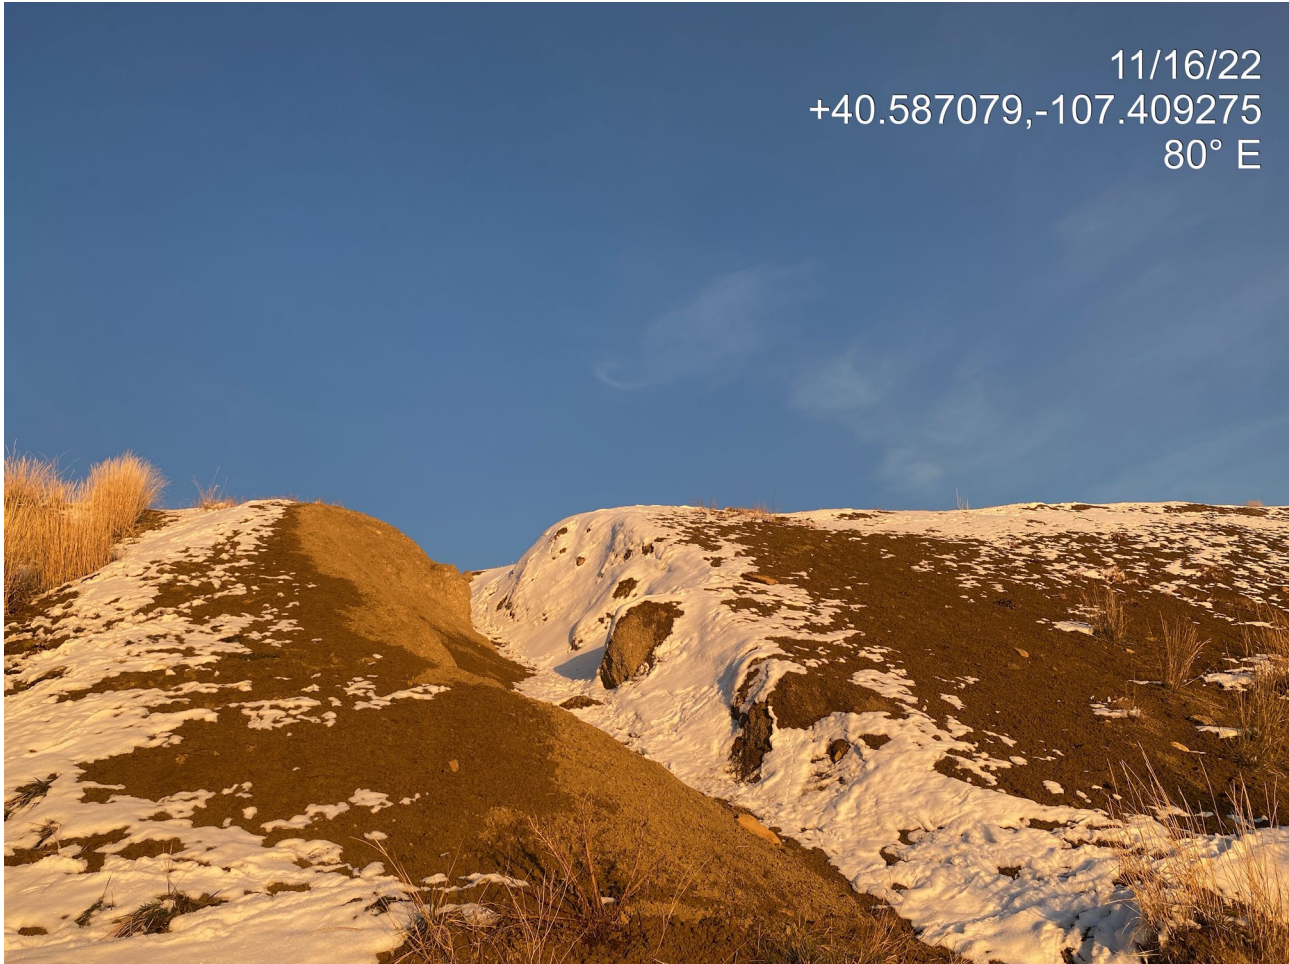
Photo 5. Photo taken from the west of the Location shows where a stormwater berm is not properly designed or maintained in proper functioning condition. Stormwater has incised the berm resulting in a large gully.

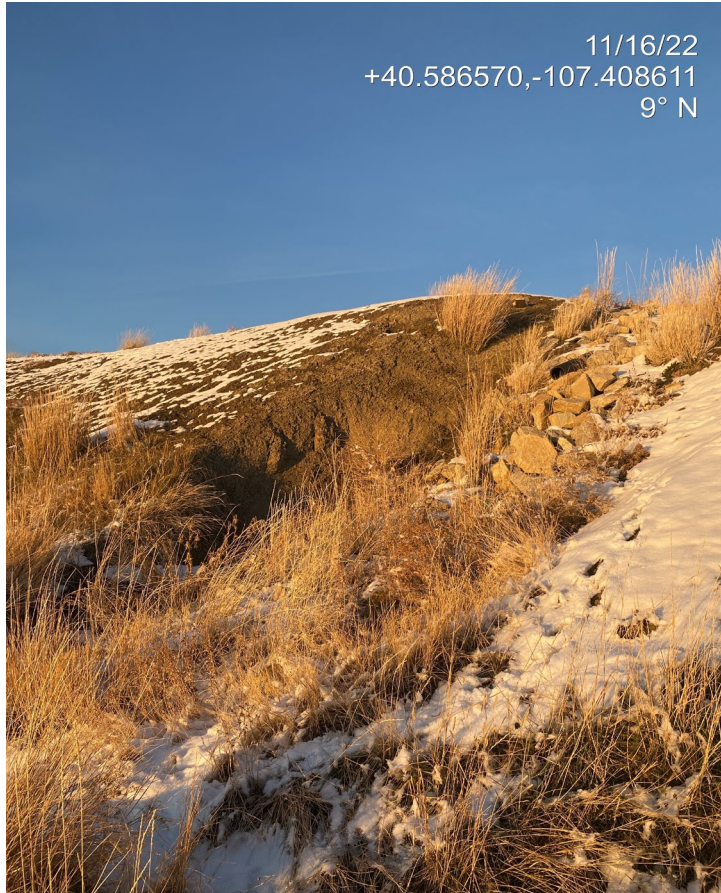
Photo 6. Photo taken from the southwest of the Location shows where stormwater has incised the berm around a drain pipe resulting in a large gully.

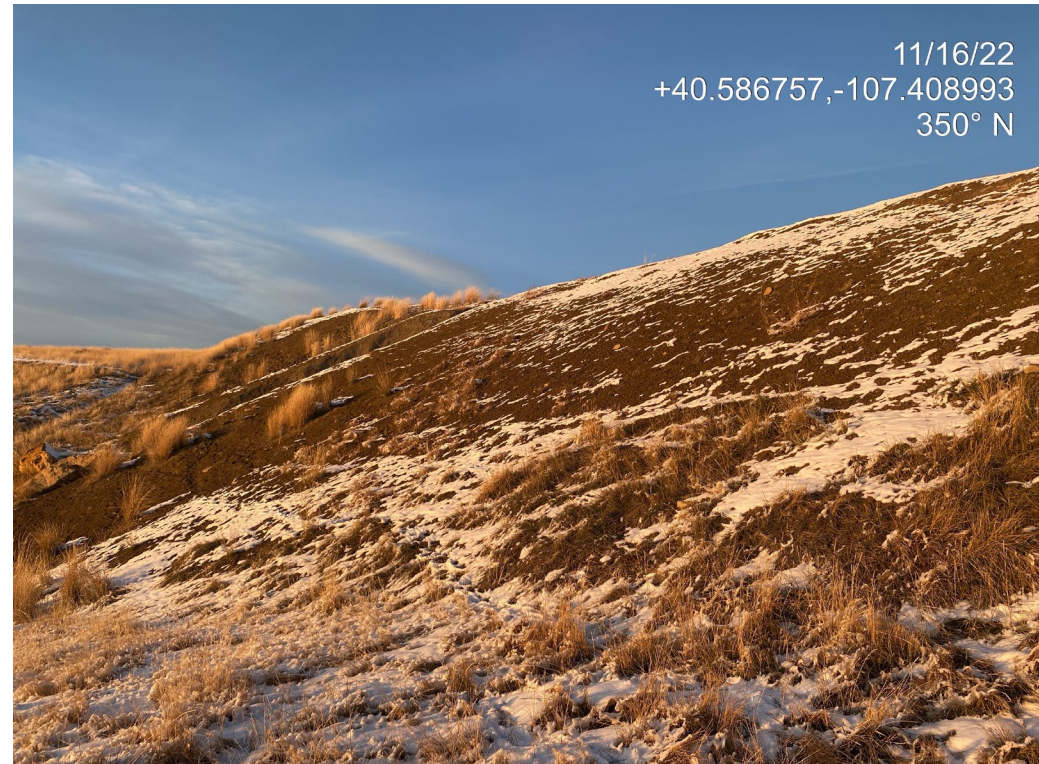
Photo 7. Photo taken from the southwest shows fill slopes of the location are bare and unprotected. Erosion evident throughout.

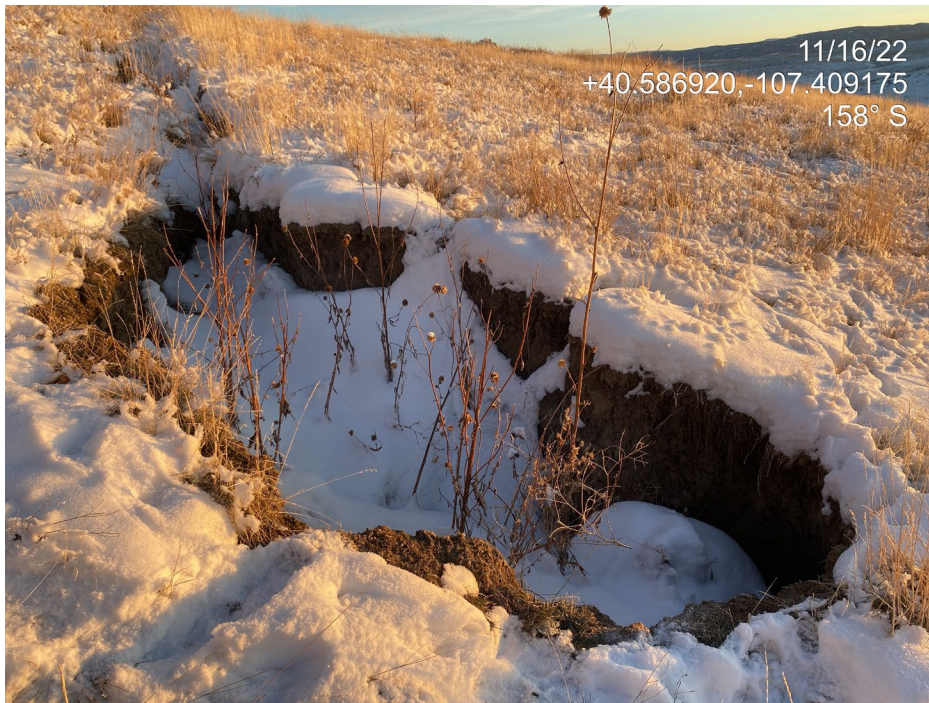
Photo 8. Photo taken from the west of the Location shows where a stormwater ditch is eroding and forming a gully. The gully is expanding and eroding downward, forming a deep hole.

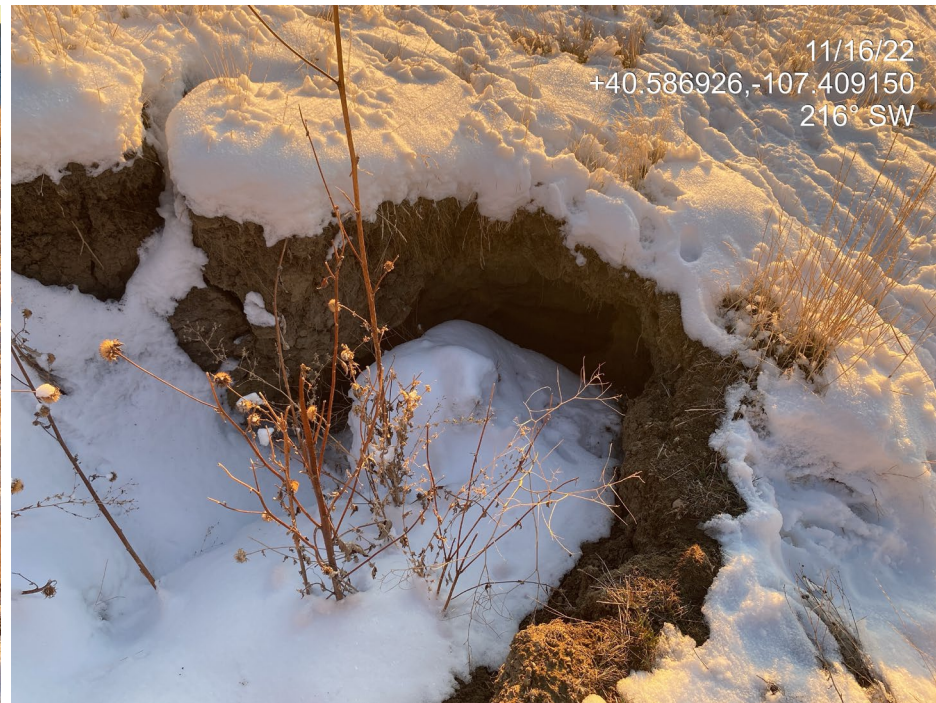
Photo 9. Refer to Photo 8 comment.
