Final Reclamation and Stormwater Inspection

Operator: EXTRACTION OIL & GAS INC - 10459

Location ID: 320606

Inspection Photos
Location Name: Maul 43-26
Location ID: 320606

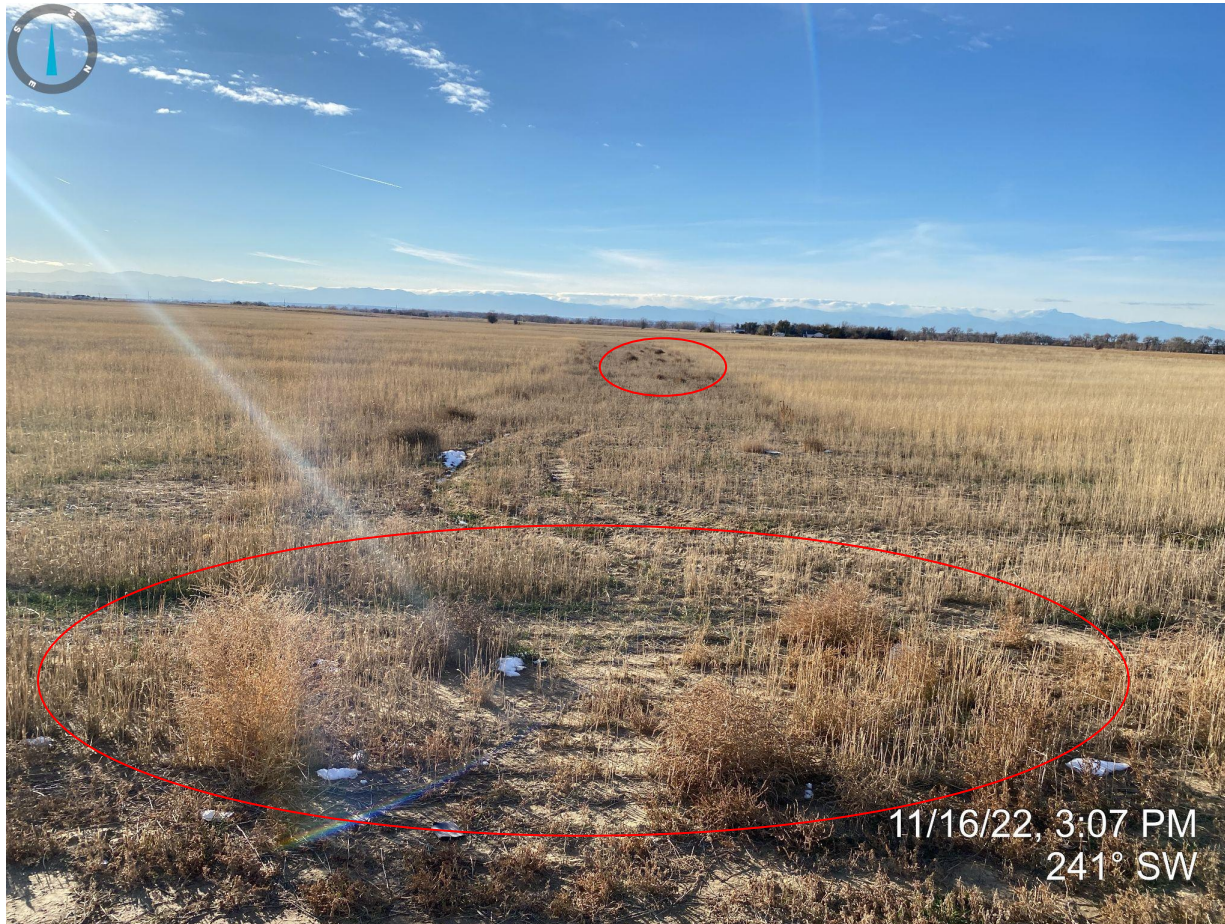
Photo 1. Taken from the entrance to the access road, facing southwest. Photo illustrates the location appears to have been reclaimed with no visible evidence of oil and gas equipment. Undesirable vegetation observed in foreground (e.g. kochia and russian thistle) and throughout portions of the reclaimed areas.

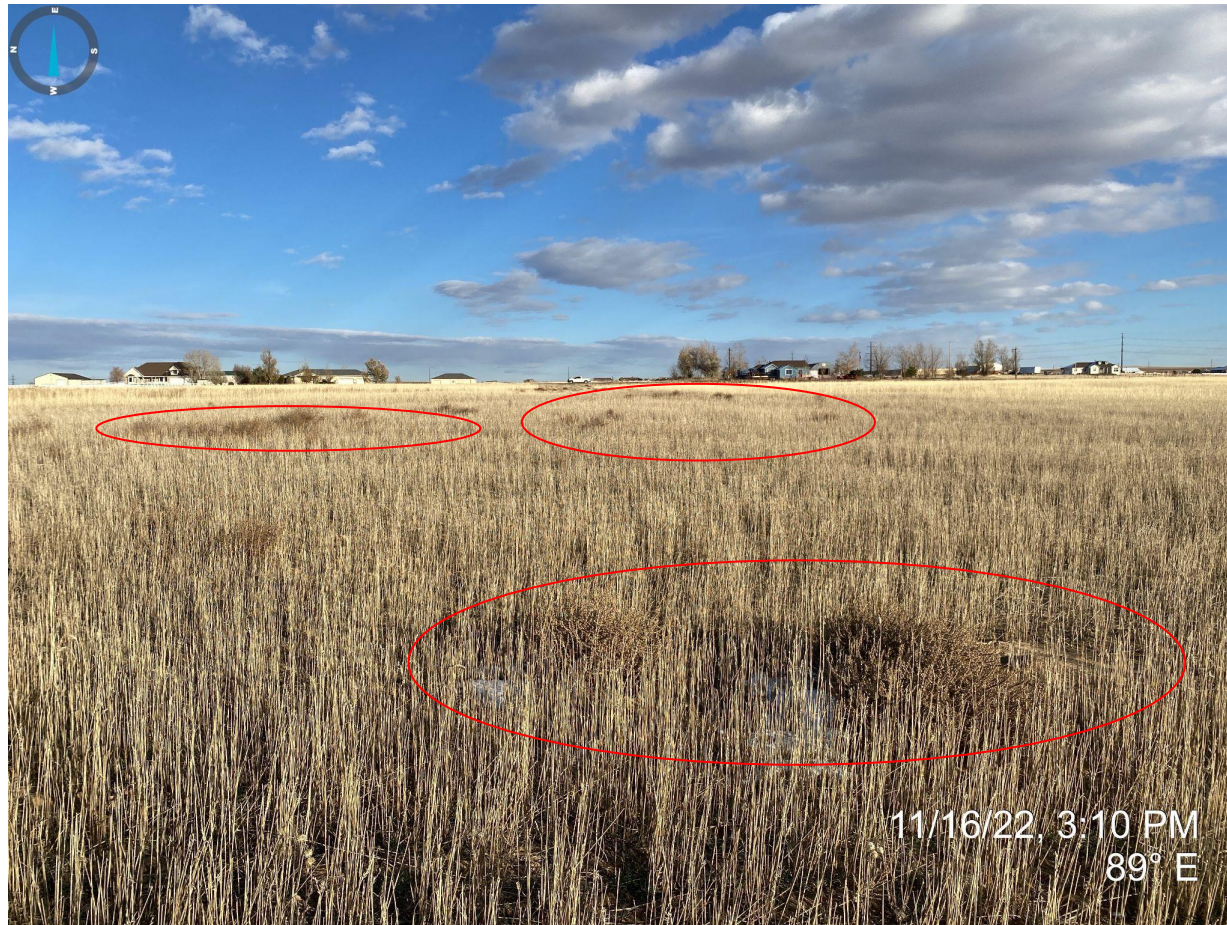
Photo 2. Taken from the western portion of the well location, facing east. See comments in Photo 1.
