# Final Reclamation and Stormwater Inspection

Operator: EXTRACTION OIL & GAS - 10459

Location ID: 320550

Inspection Photos  
Location Name: Leech 24-26  
Location ID: 320550

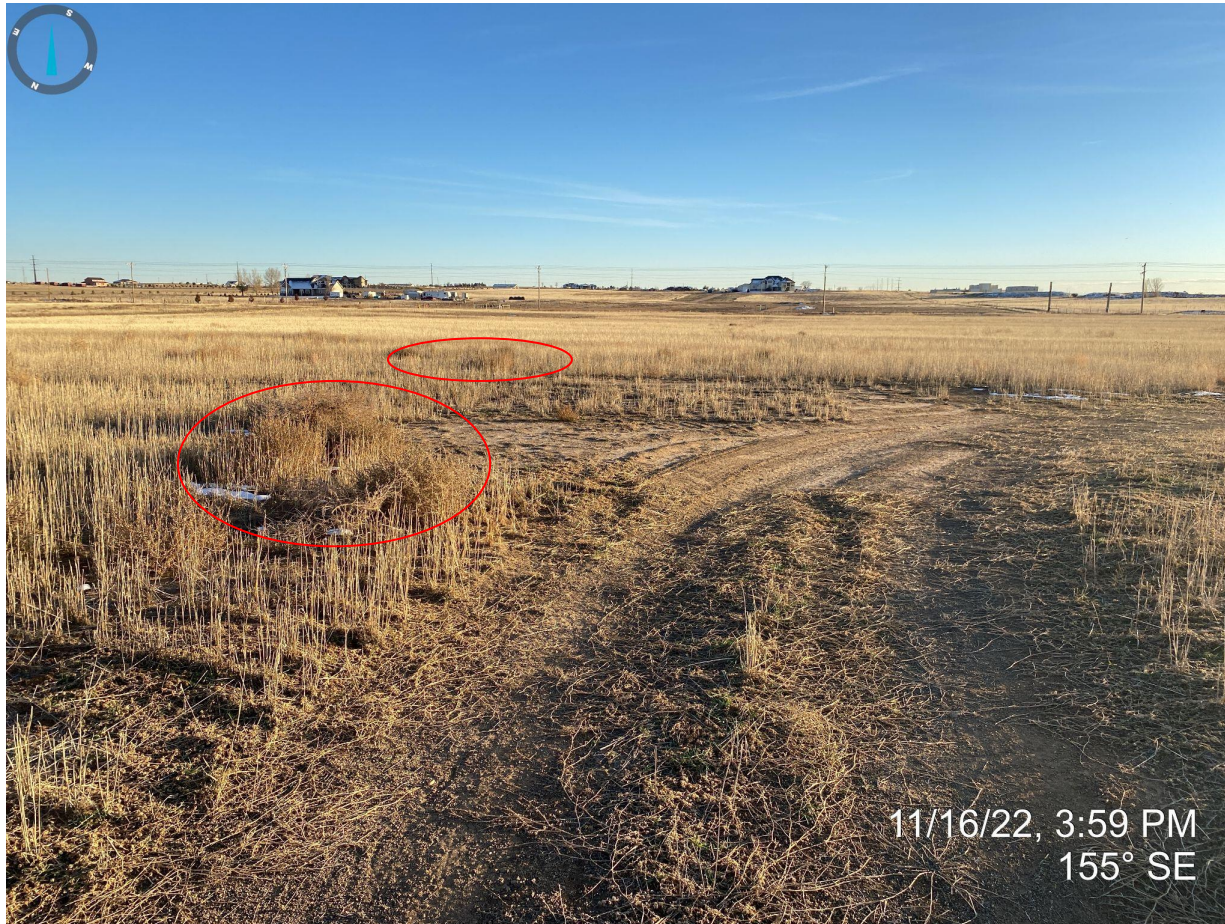
**Photo 1.** Taken from the access road, facing southeast. Photo illustrates evidence of undesirable vegetation (e.g. kochia and russian thistle) near the well location. The access road is currently serving a nearby well (API#001-09652) and will need to be reclaimed upon P&A of that well.

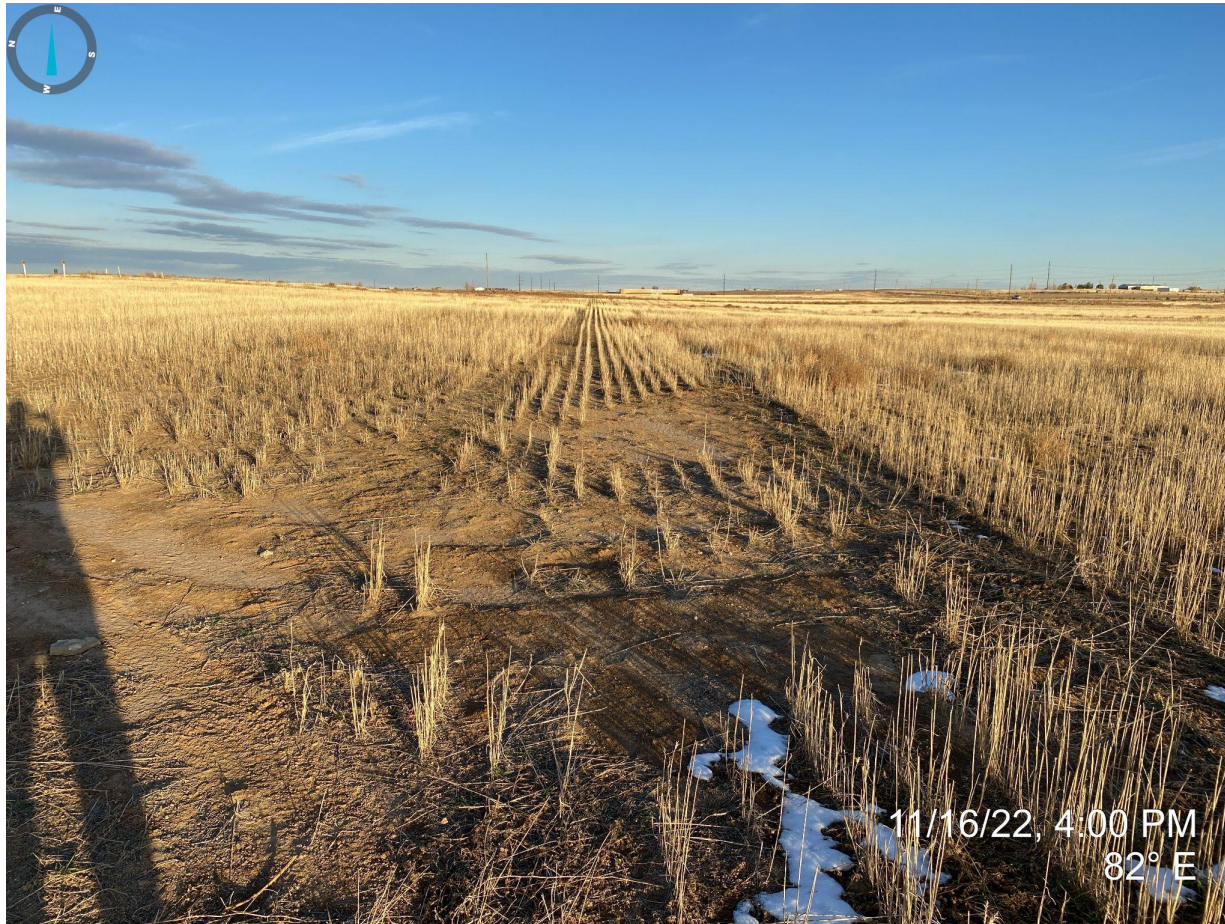
**Photo 2.** Facing east at the well location. Photo illustrates areas non-uniform vegetation cover resulting in bare soil near the former well location; a vegetation assessment will be conducted at a later date to ensure compliance with Rule 1004 standards.

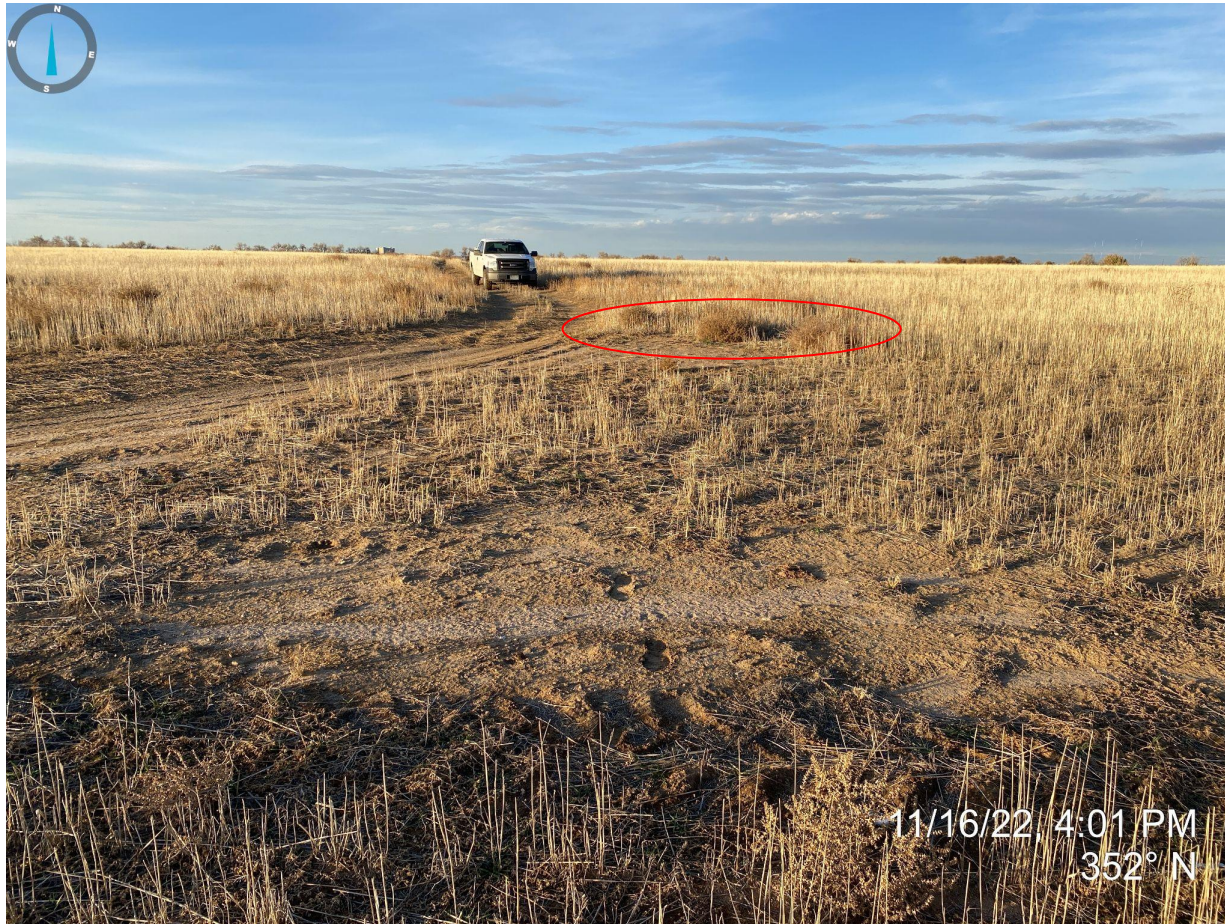
**Photo 3.** Facing north, see comments in Photos 1 & 2.
