# Inspection Photos and Issue Report

Operator: TEP ROCKY MOUNTAIN LLC - 96850

Location #335612

Rio Blanco County, CO

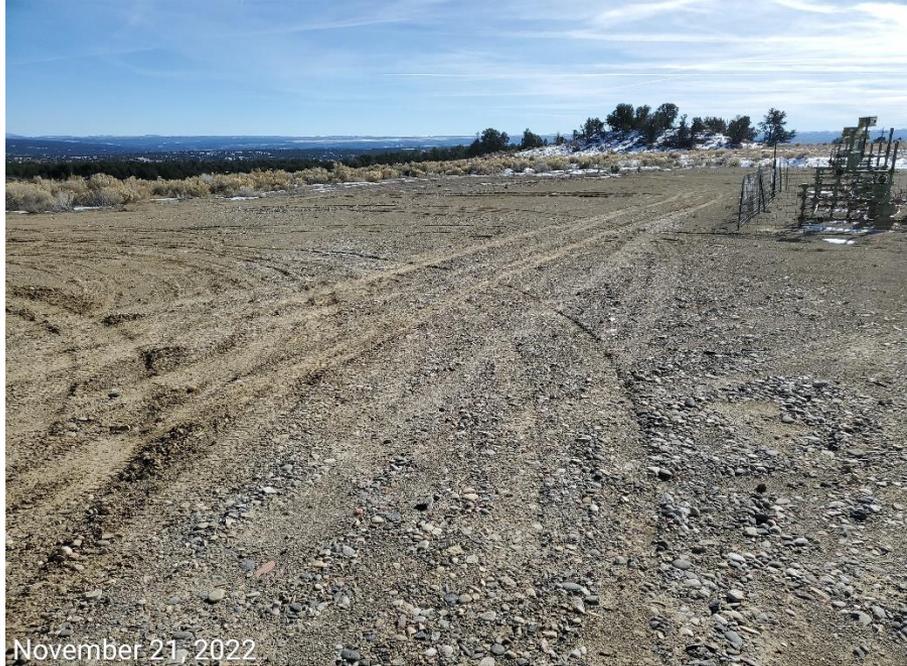
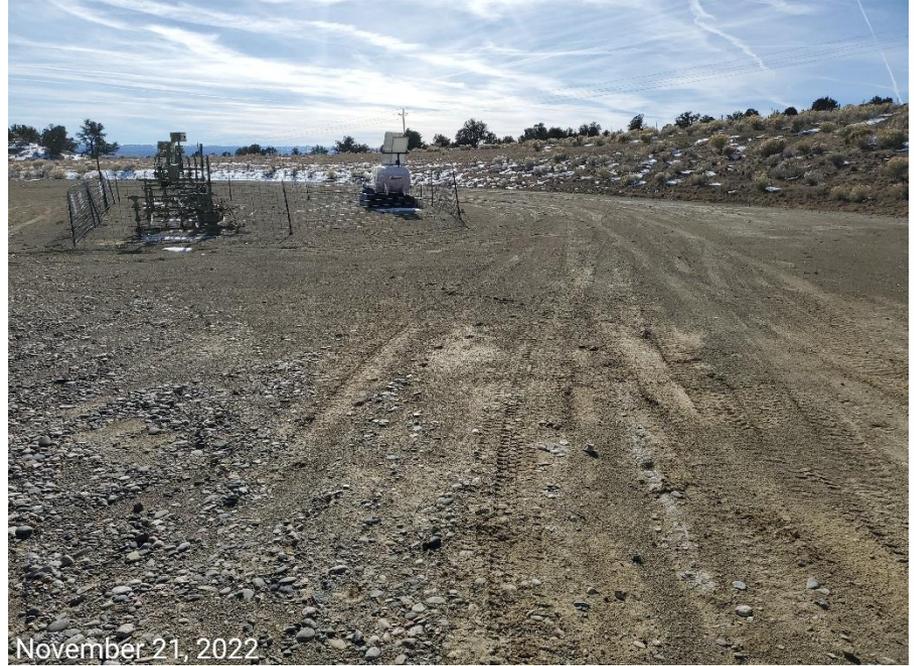
**Photo 1:** Photos show working pad area at the wellheads.

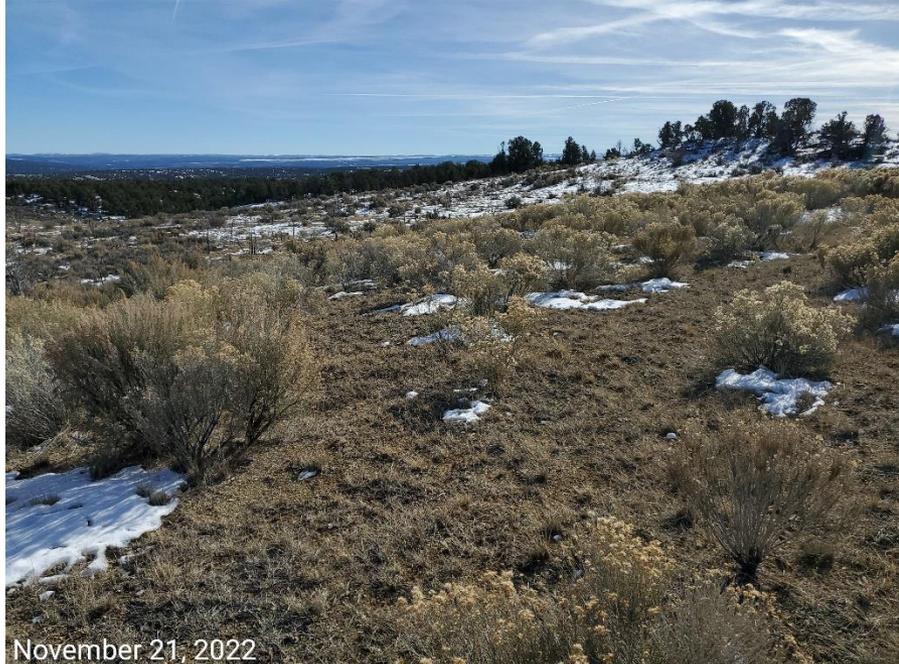
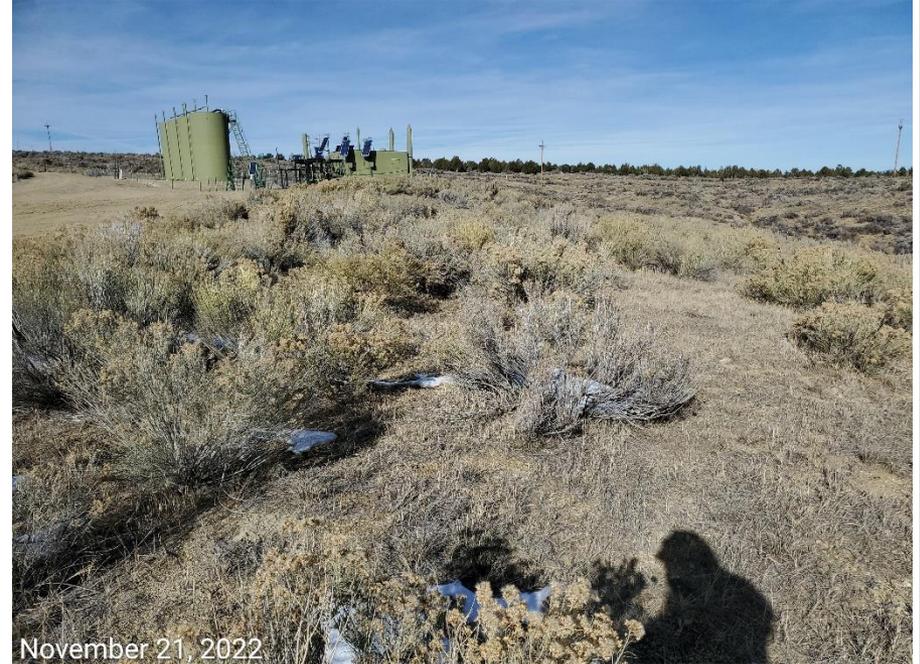
**Photo 2:** Photos examples of the interim areas of the Location.

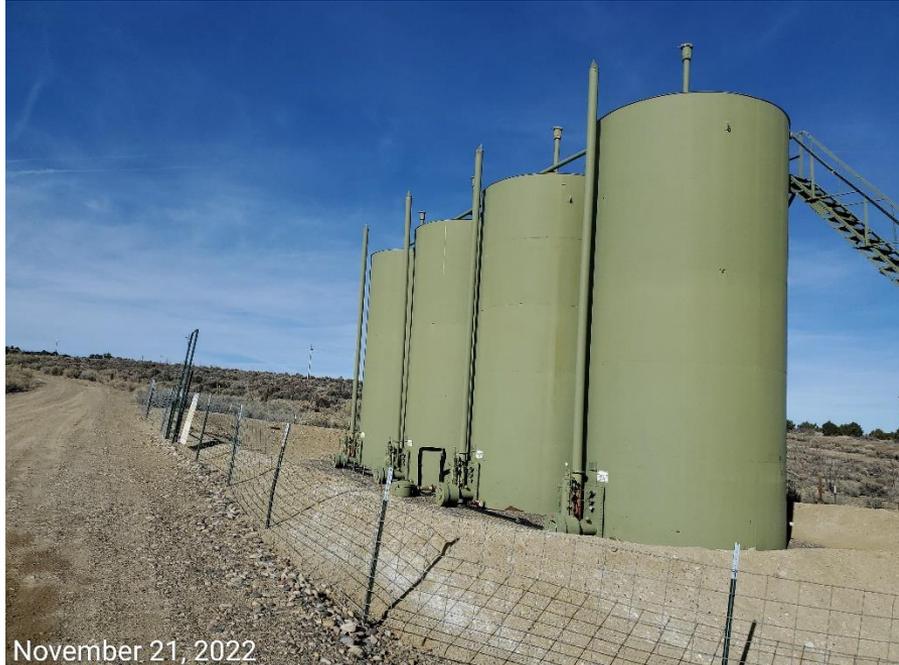
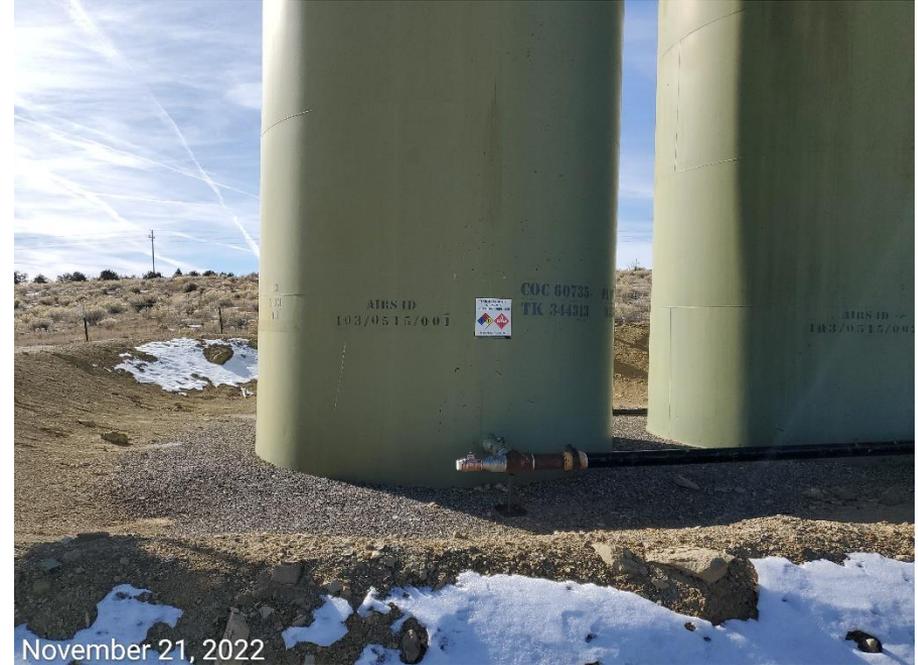
**Photo 3:** Photos show tanks at the battery. Photo left taken from the working pad areas of the Location, photo right taken from behind the battery and Location. Photos show tank labels are not visible from the working pad areas, making it difficult to identify tanks during an emergency.

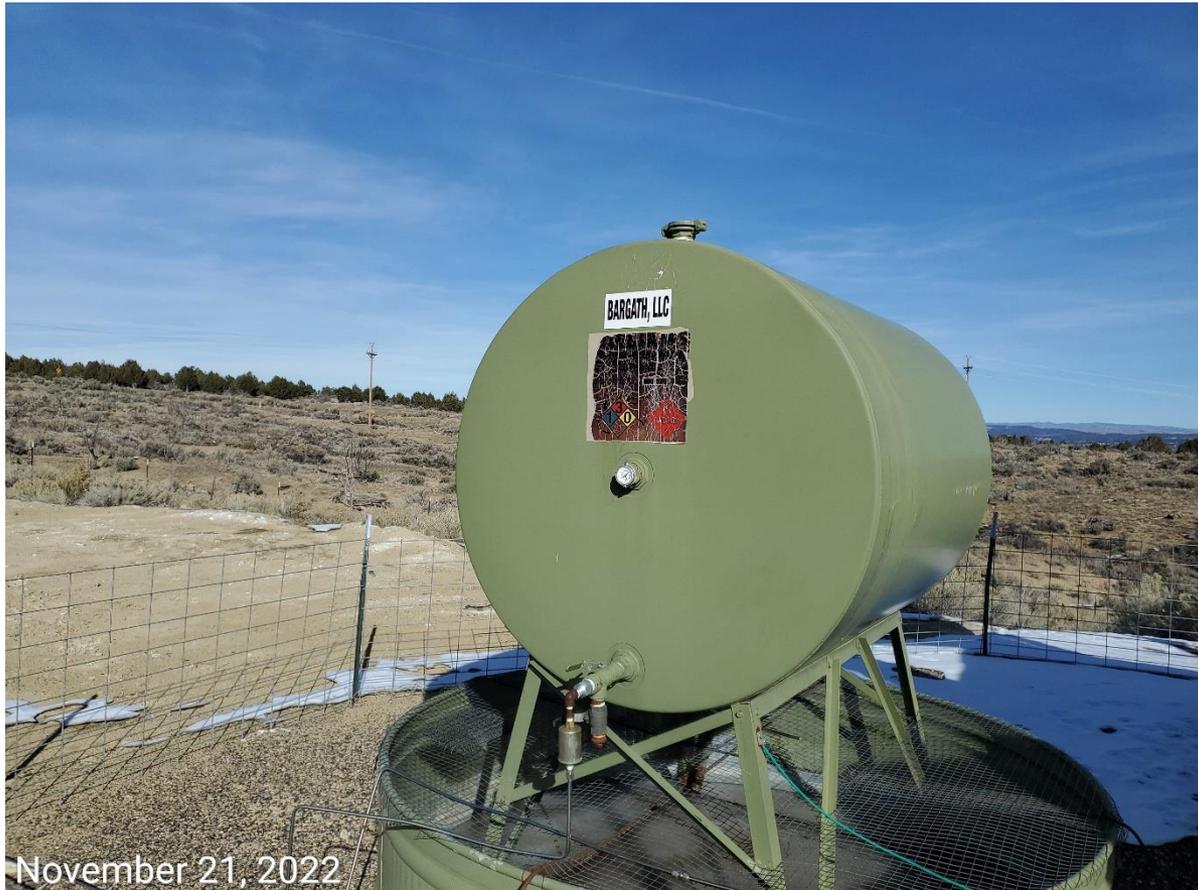
**Photo 4:** Photo of tank adjacent to the separator equipment. Photo shows label information is illegible. Operator information also incorrect.
