# Final Reclamation Inspection

Operator: PDC ENERGY INC - 69175

Location ID: 331203

Inspection Photos  
Location Name: Carlson 14-43  
Location ID: 331203

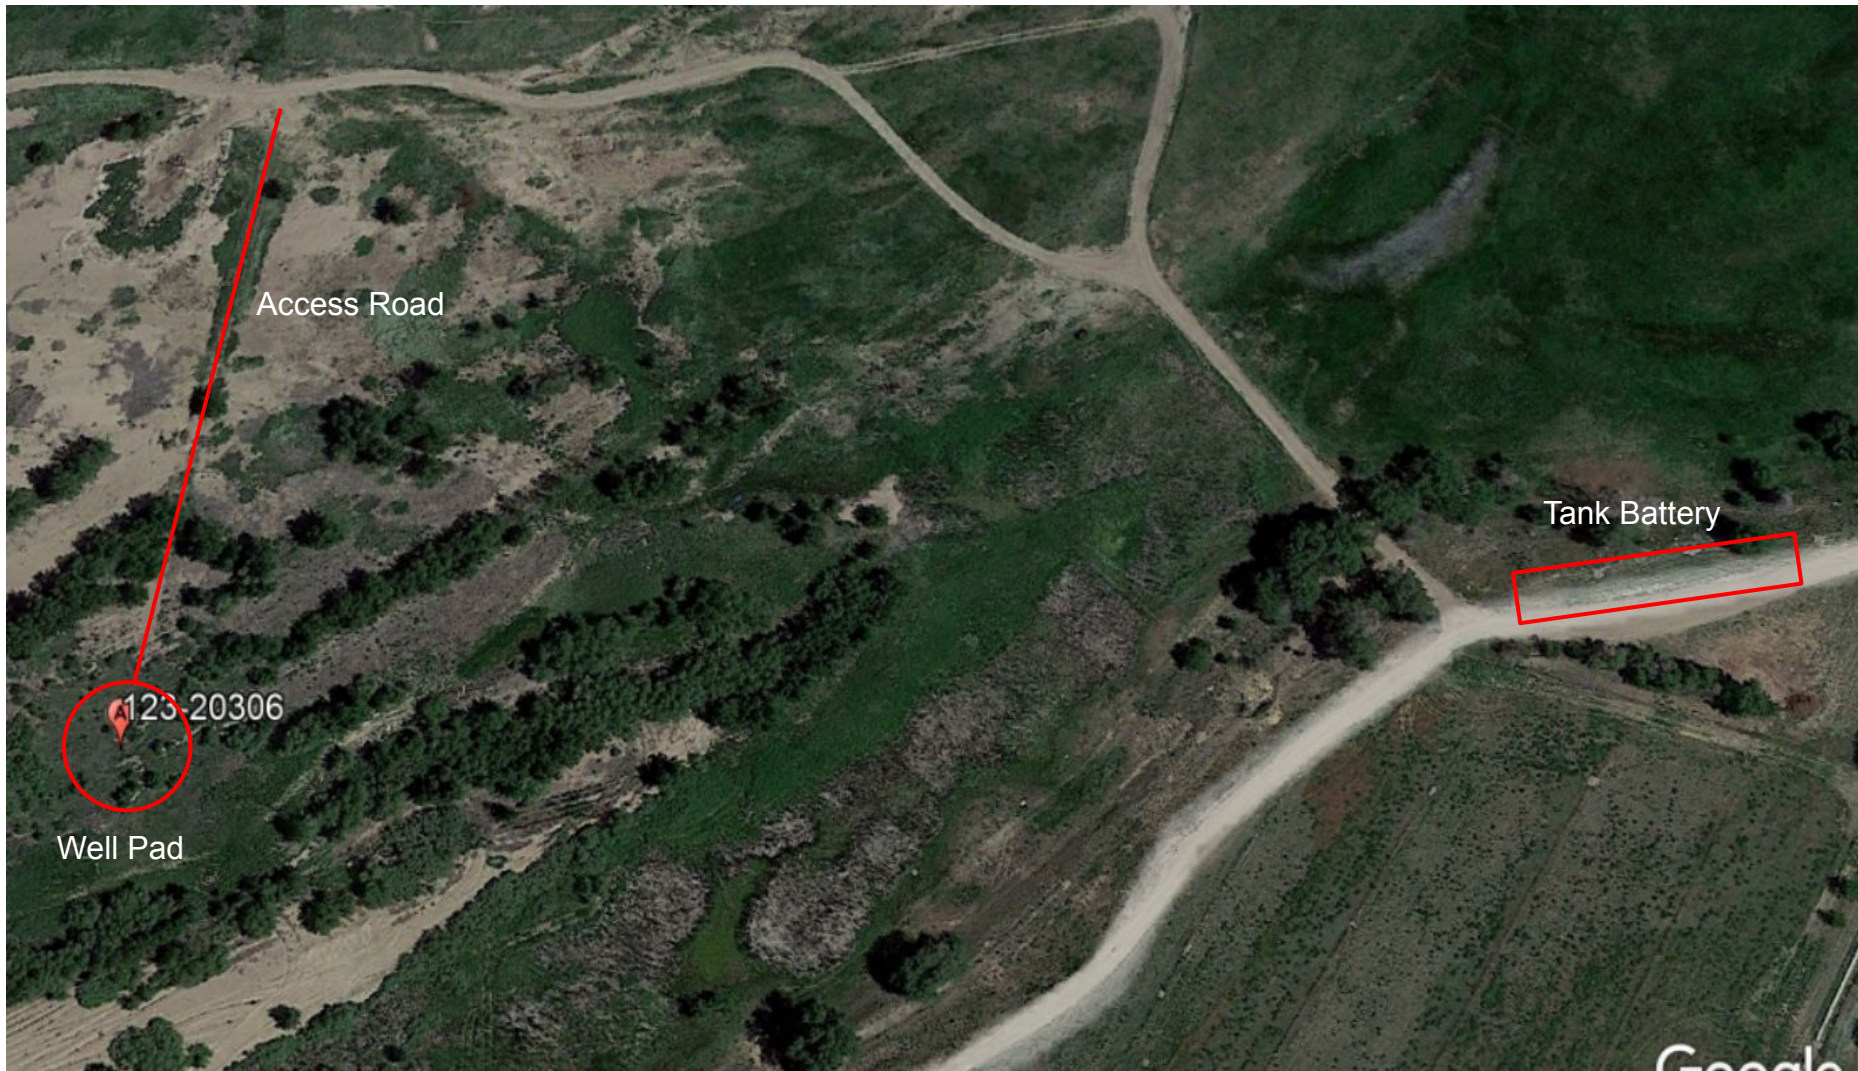
**Photo 1.** 2020 aerial imagery of the well pad, access road and tank battery.

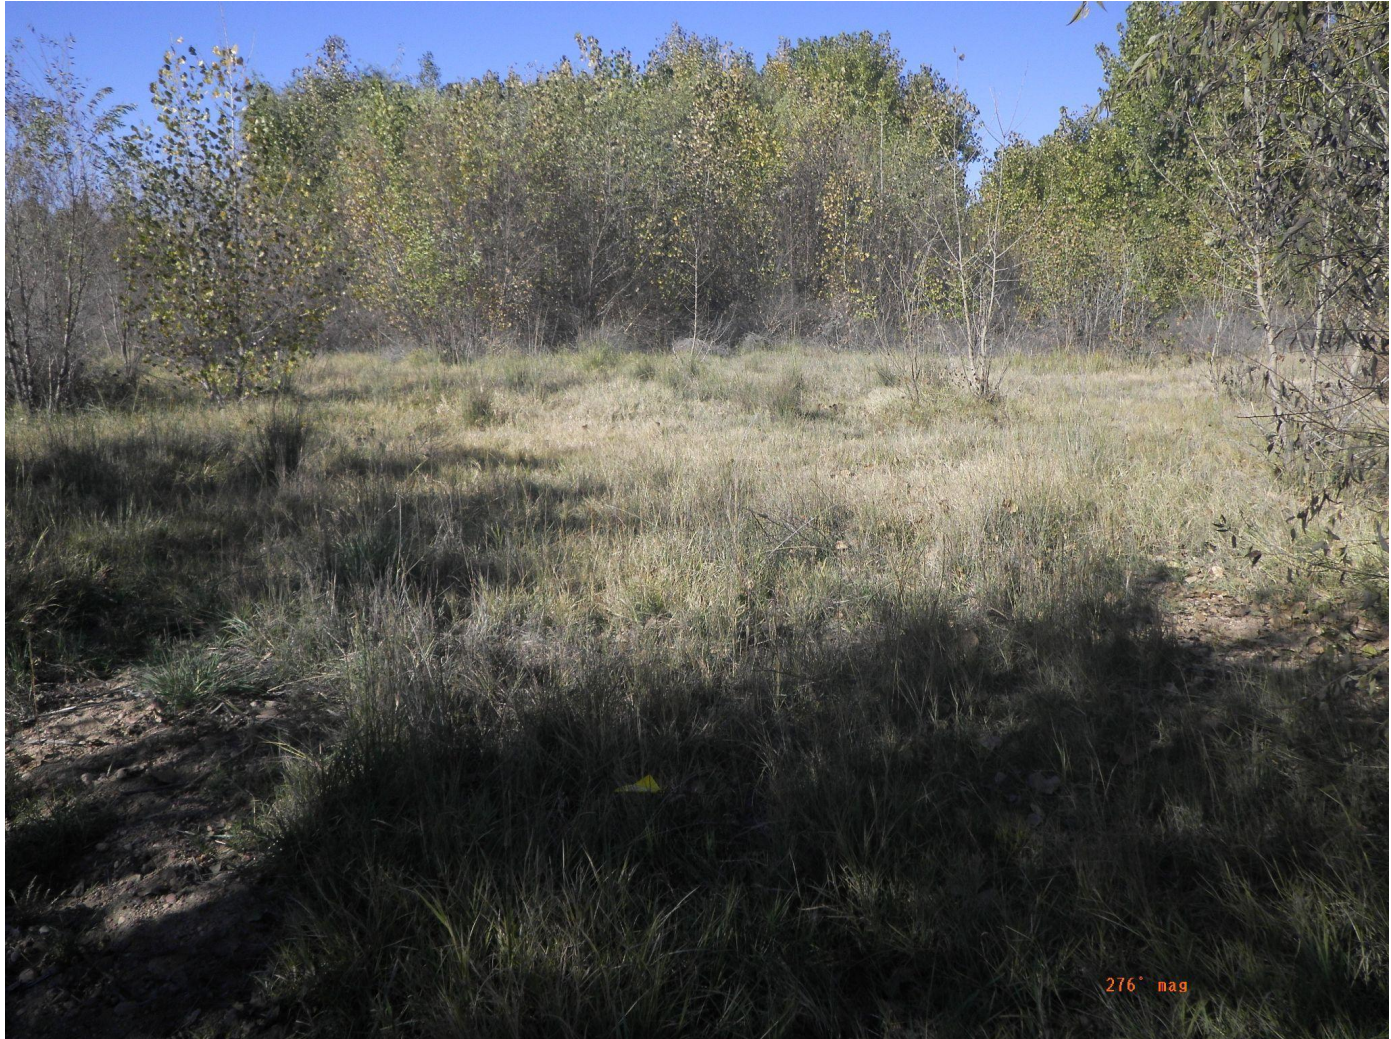
**Photo 2.** Overview photo of the well pad taken at ground level from the northern edge facing south.

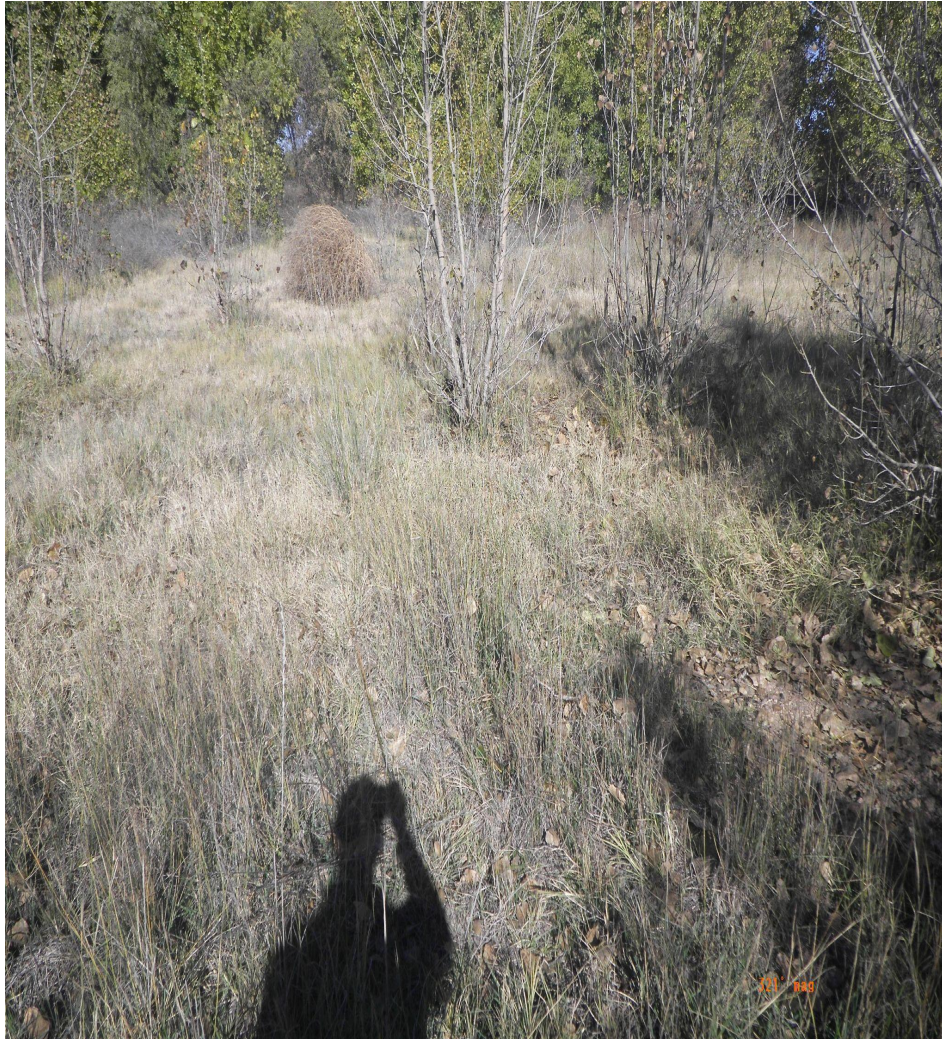
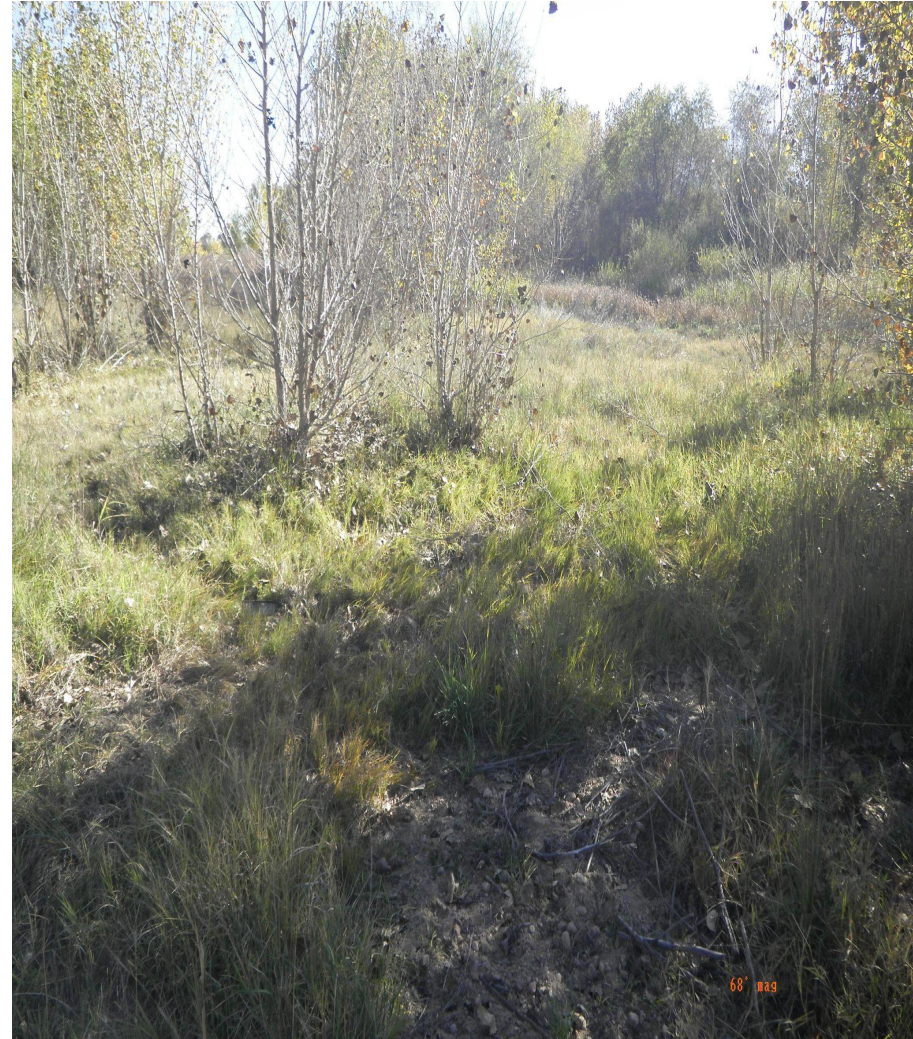
**Photo 3.** Cardinal photos taken from ground level at the middle of the well pad. Left photo facing north, right photo facing east.

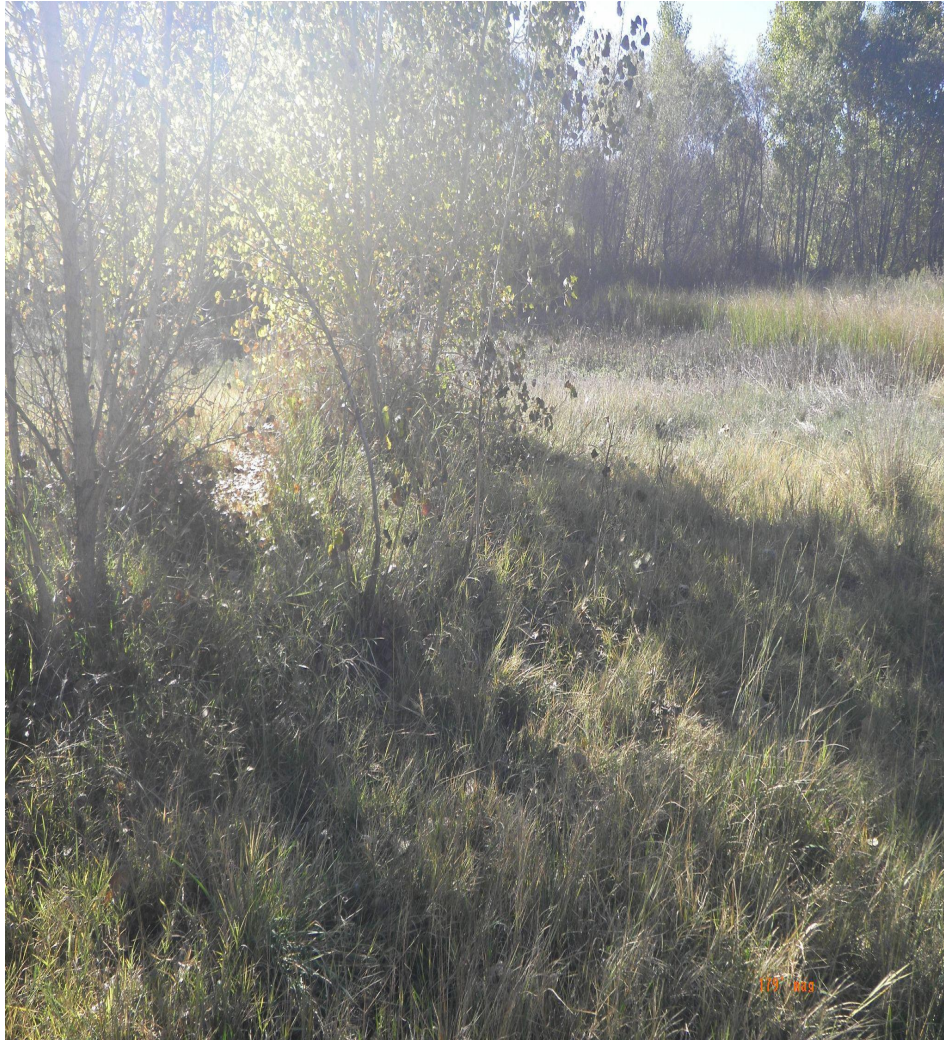
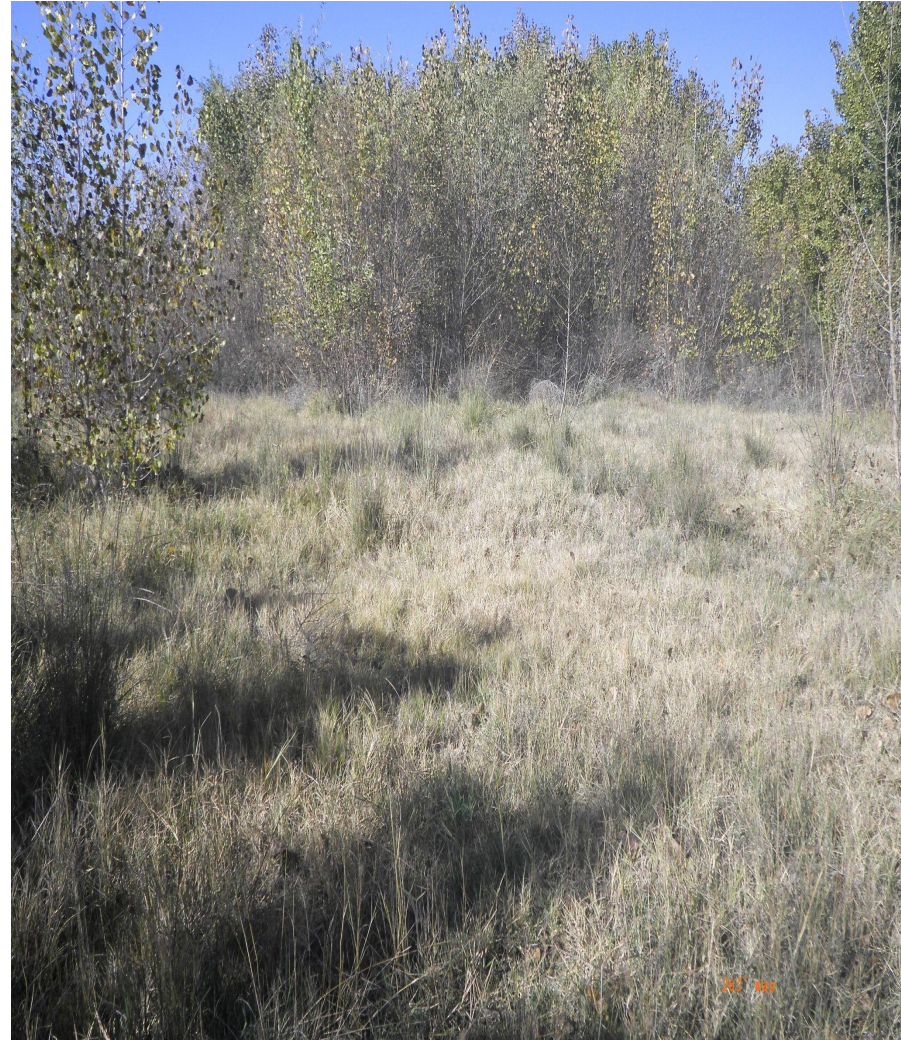
**Photo 4.** Carindal photos taken at ground level from the middle of the well pad. Left photo facing south, right photo facing west. Note: well pad appears consistent with adjacent reference area (see photo 5).

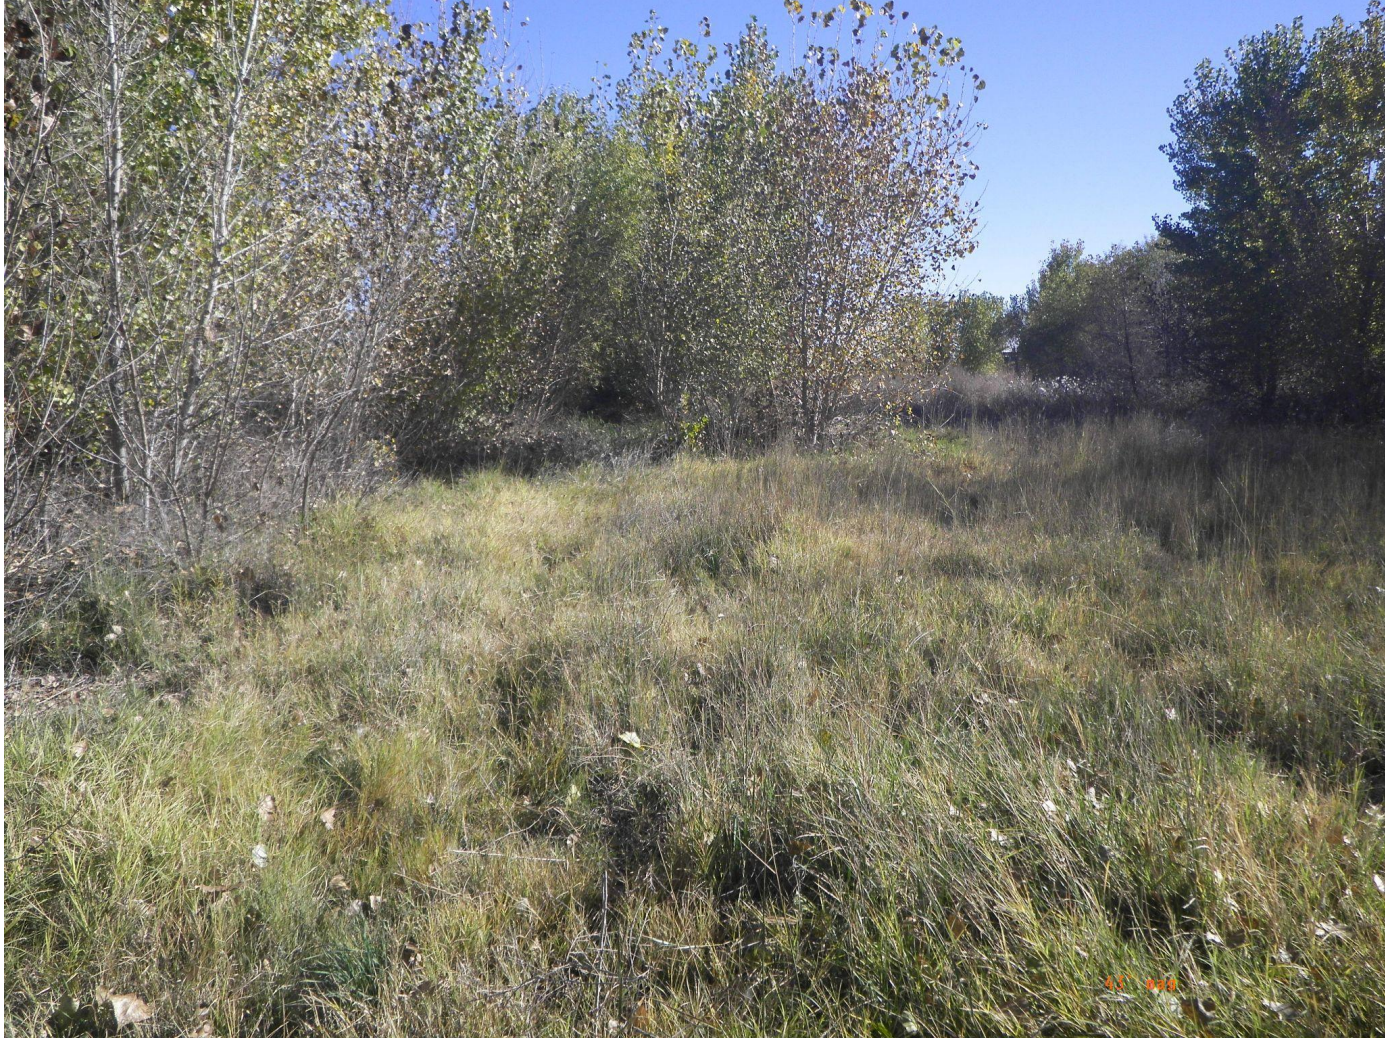
**Photo 5.** Well pad reference area.

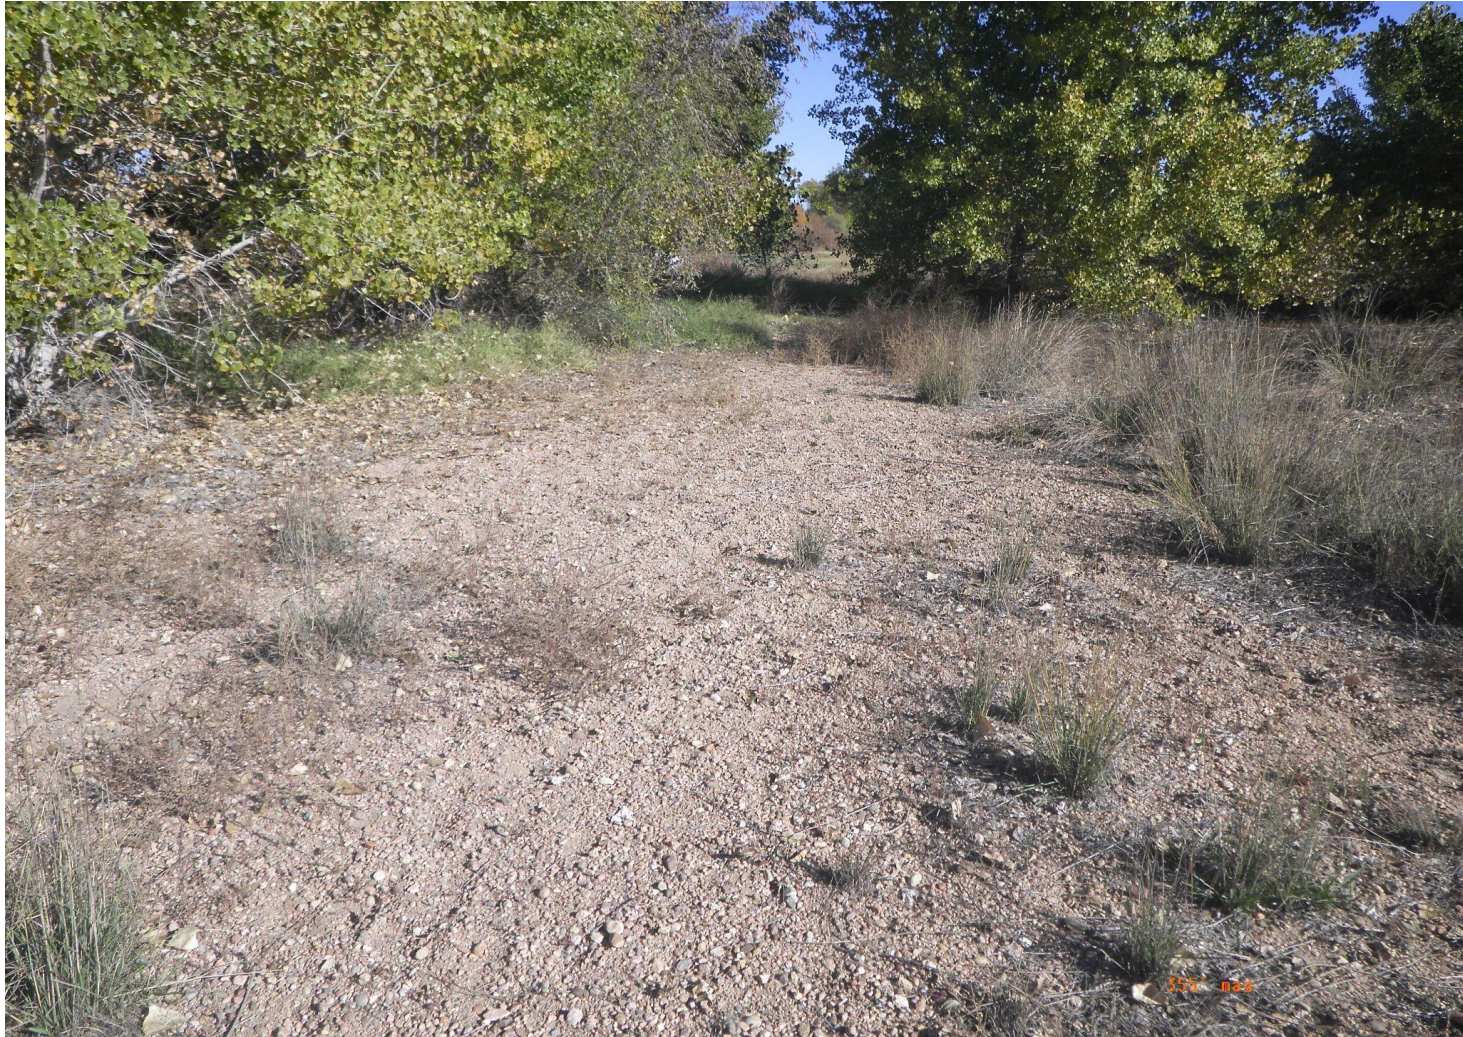
**Photo 6.** Portion of well pad access road remains with gravel and does not appear to have been recontoured.

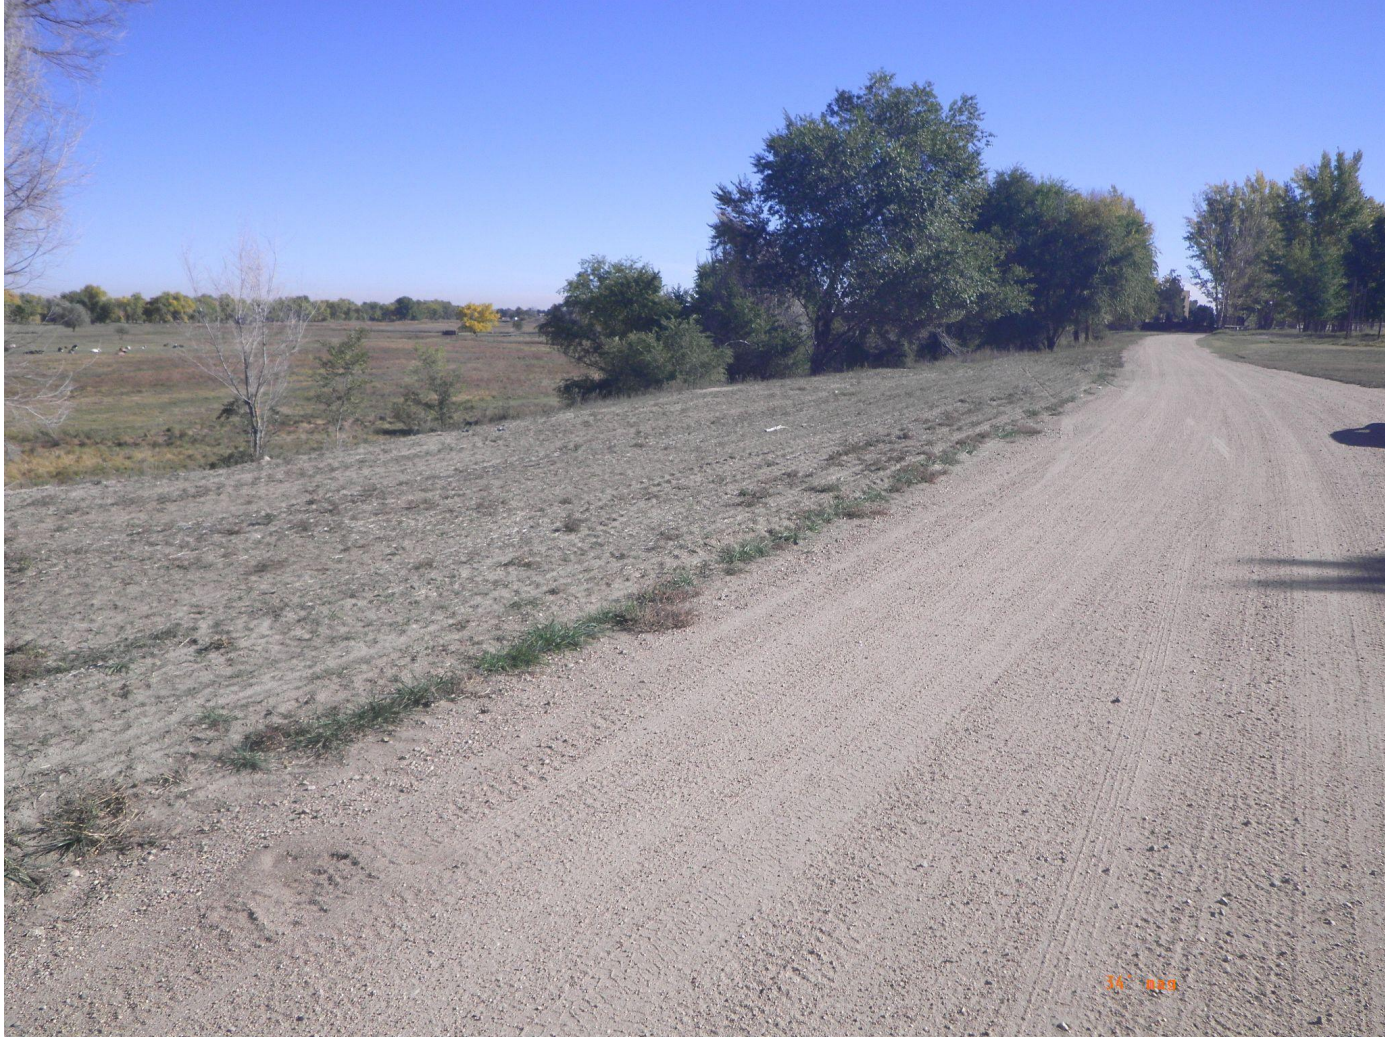
**Photo 7.** Overview photo of the tank battery taken at ground level from the western edge facing east. Note: southern portion of tank battery is a gravel road.

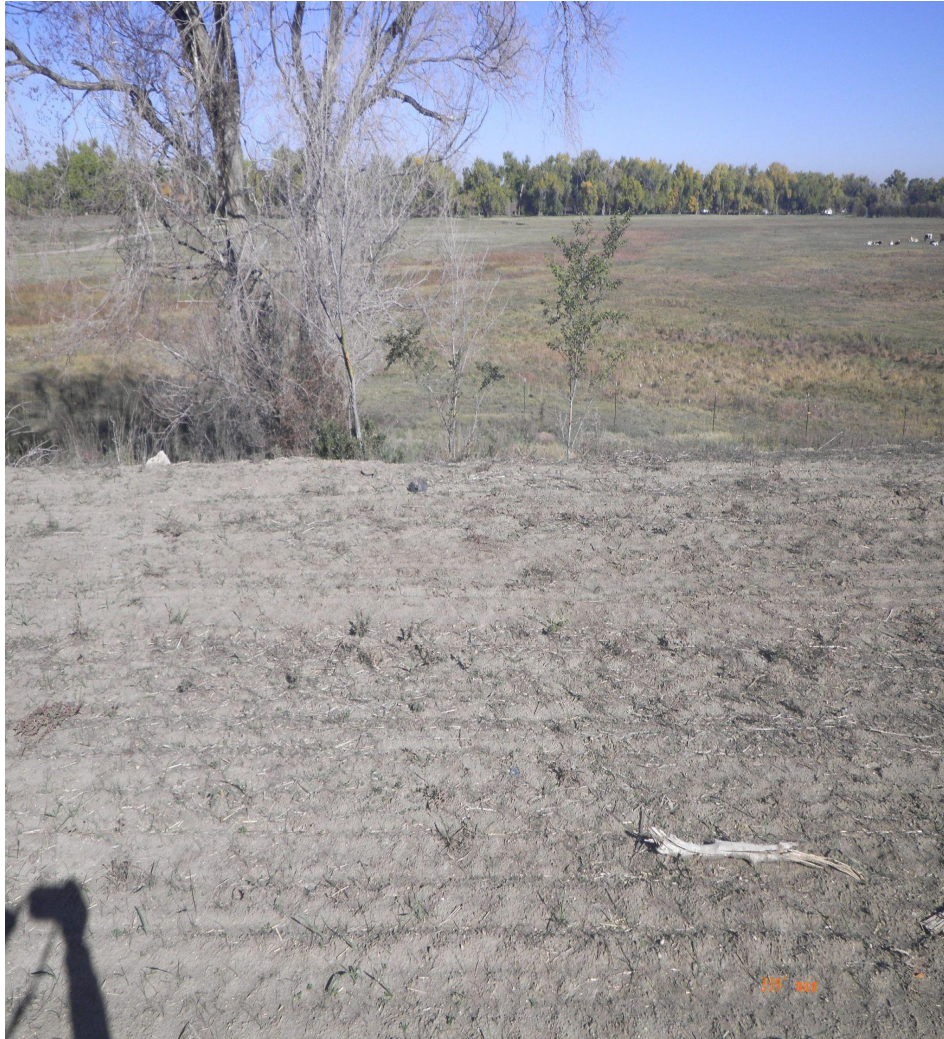
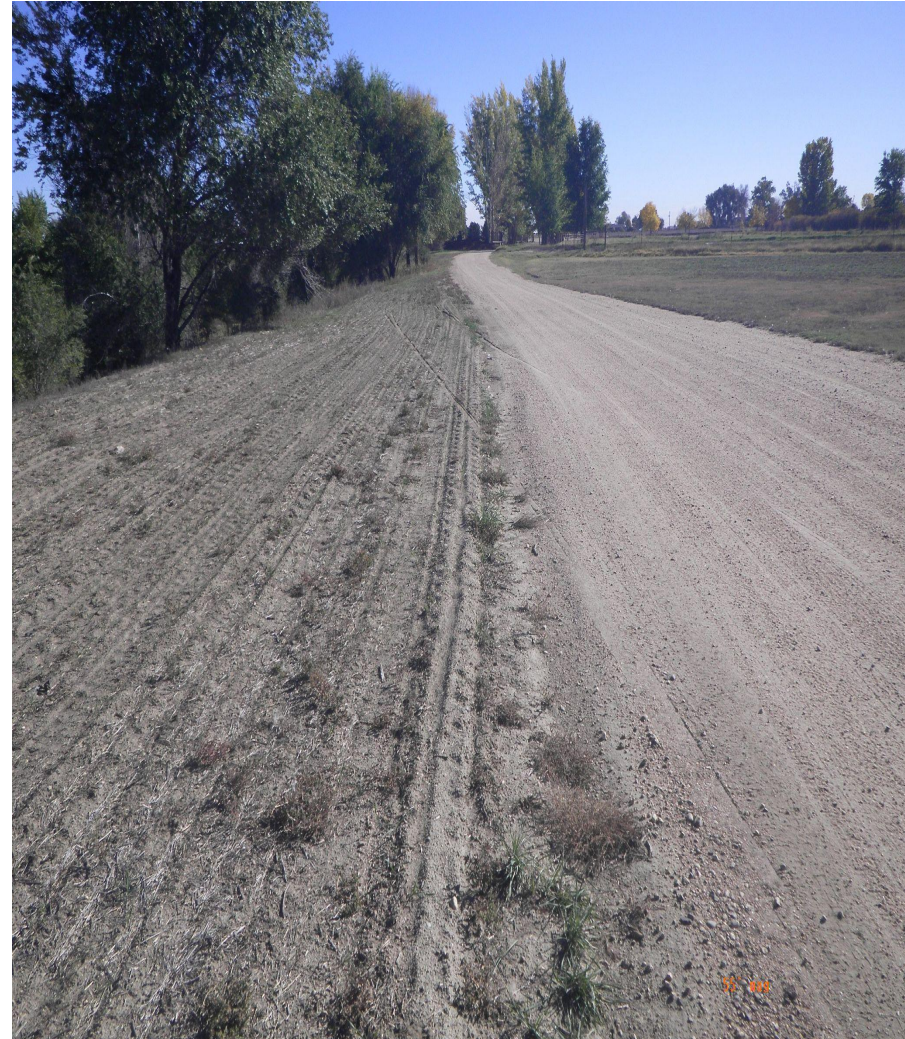
**Photo 8.** Cardinal photos taken at ground level from the middle of the tank battery. Left photo facing north, right photo facing east.

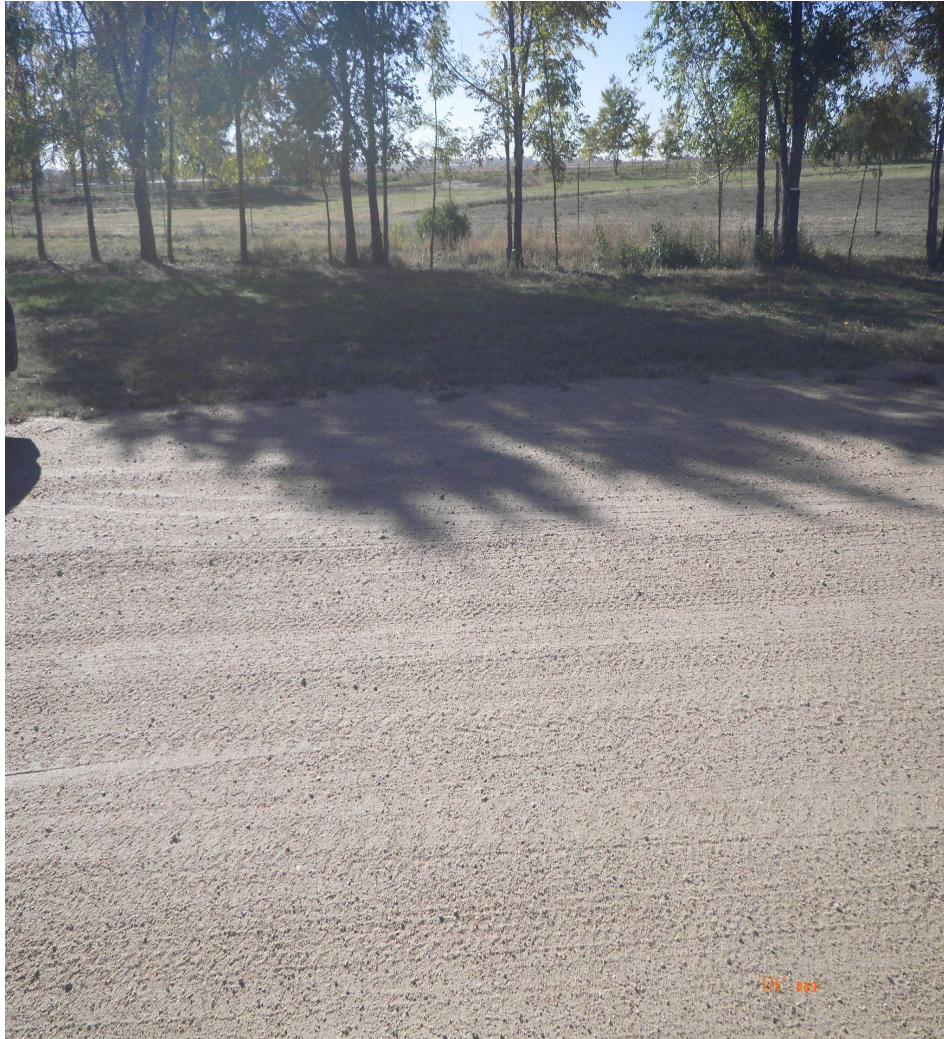
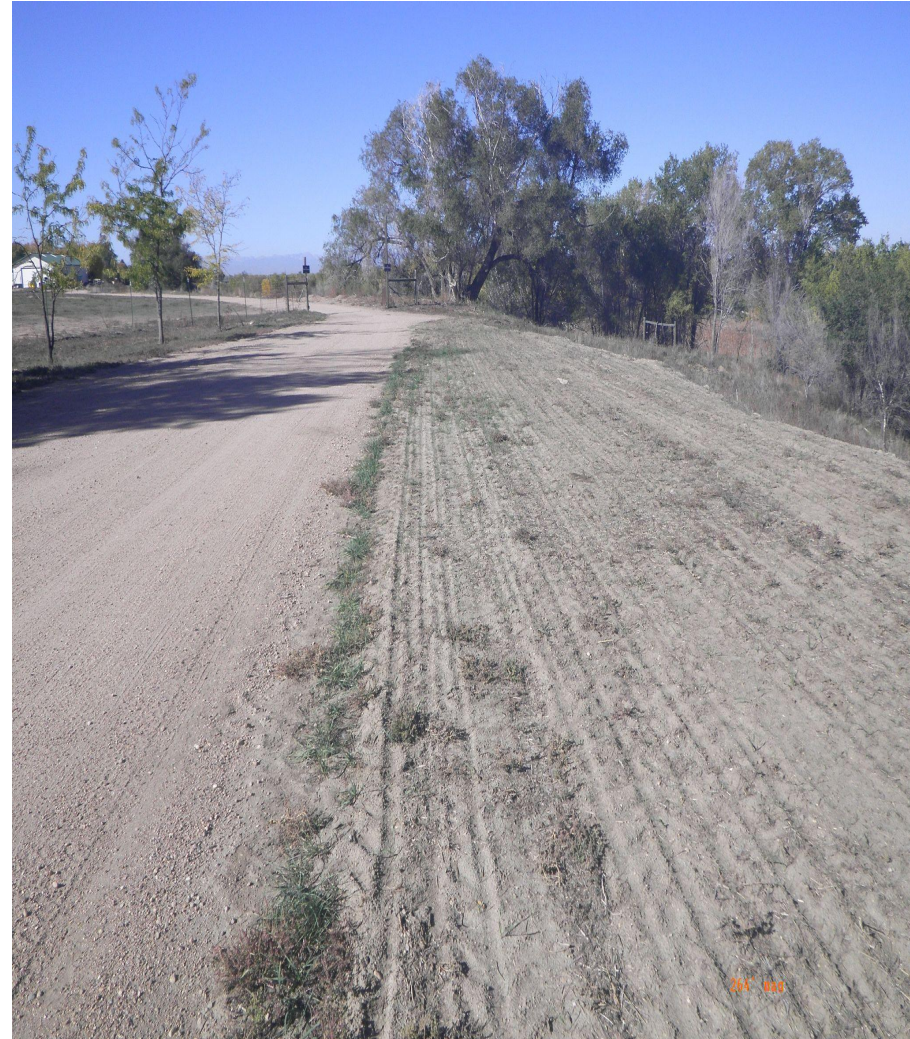
**Photo 9.** Cardinal photos taken at ground level from the middle of the tank battery. Left photo facing south, right photo facing west. Note: Northern portion of the tank battery has been seeded. The area has not reached the 80% threshold so the tank battery will remain in-process until the site can be re-inspected.
