# Inspection Photos

API: 043-06219

Operator: AUSCO PETROLEUM INC

Inspection Date: 12/1/2022

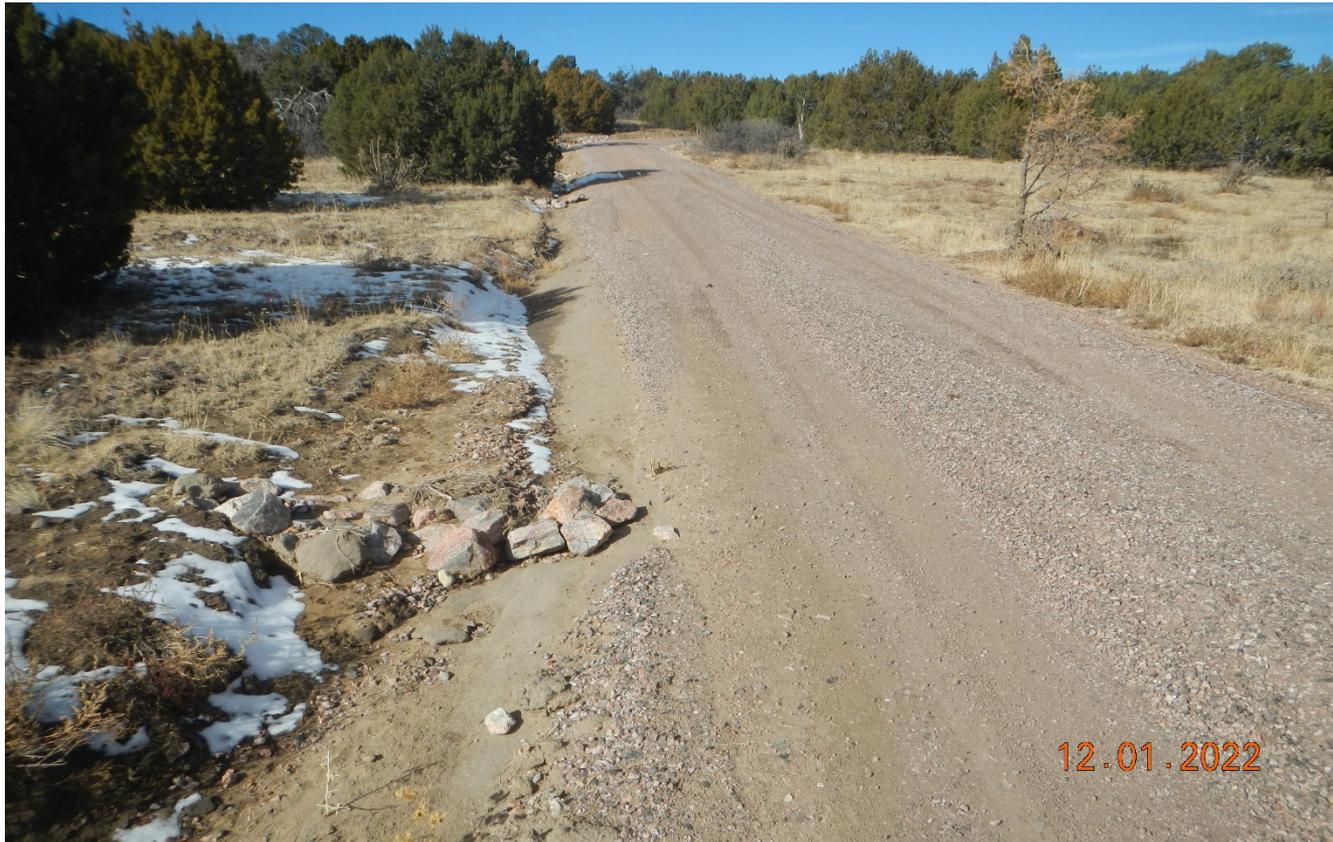
**Photo 1.** Facing northwest along the access road. There are some check dams where stormwater is going around the check dam. BMP maintenance is needed.

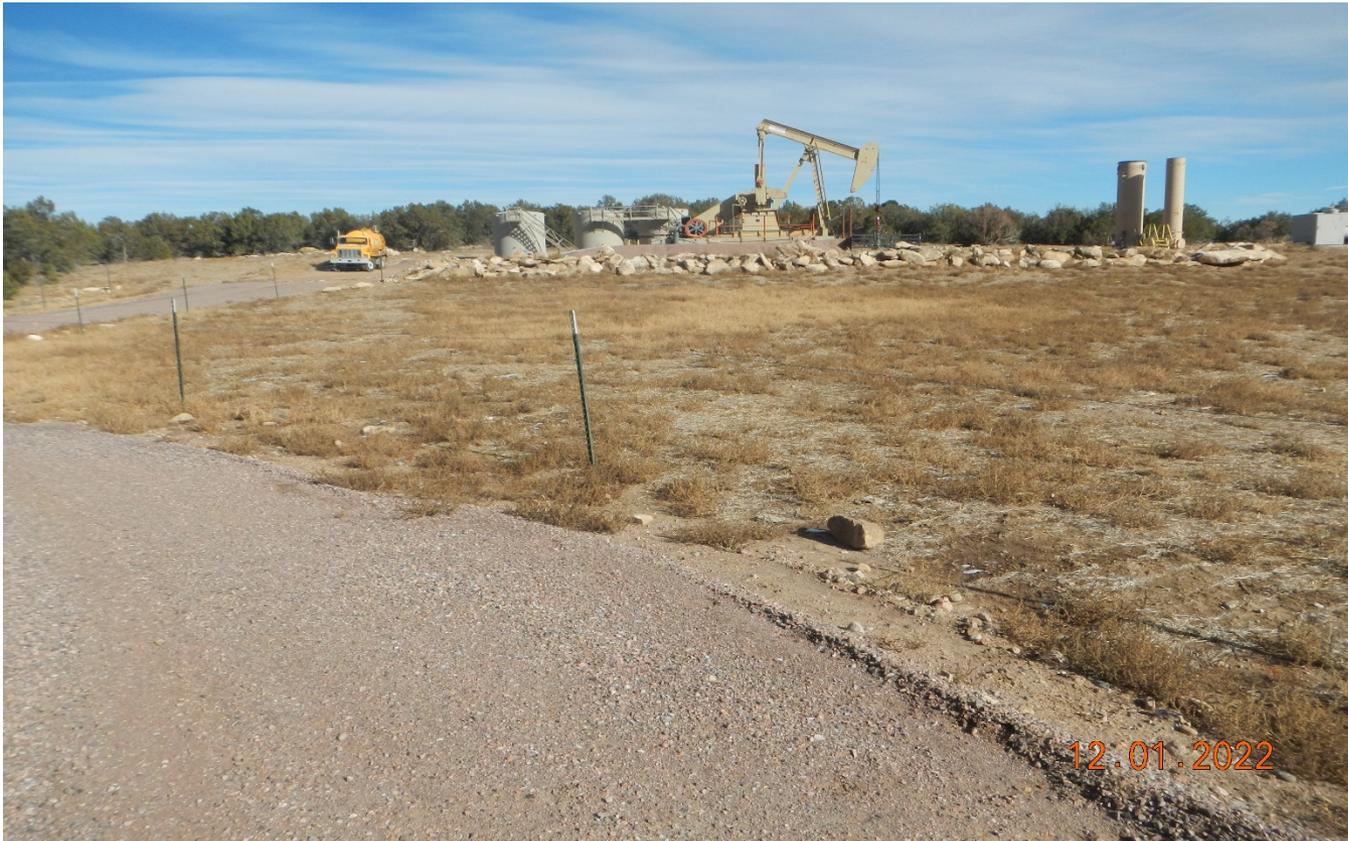
**Photo 2.** Facing north toward the location. Interim reclamation has been performed and the location is reduced in size.

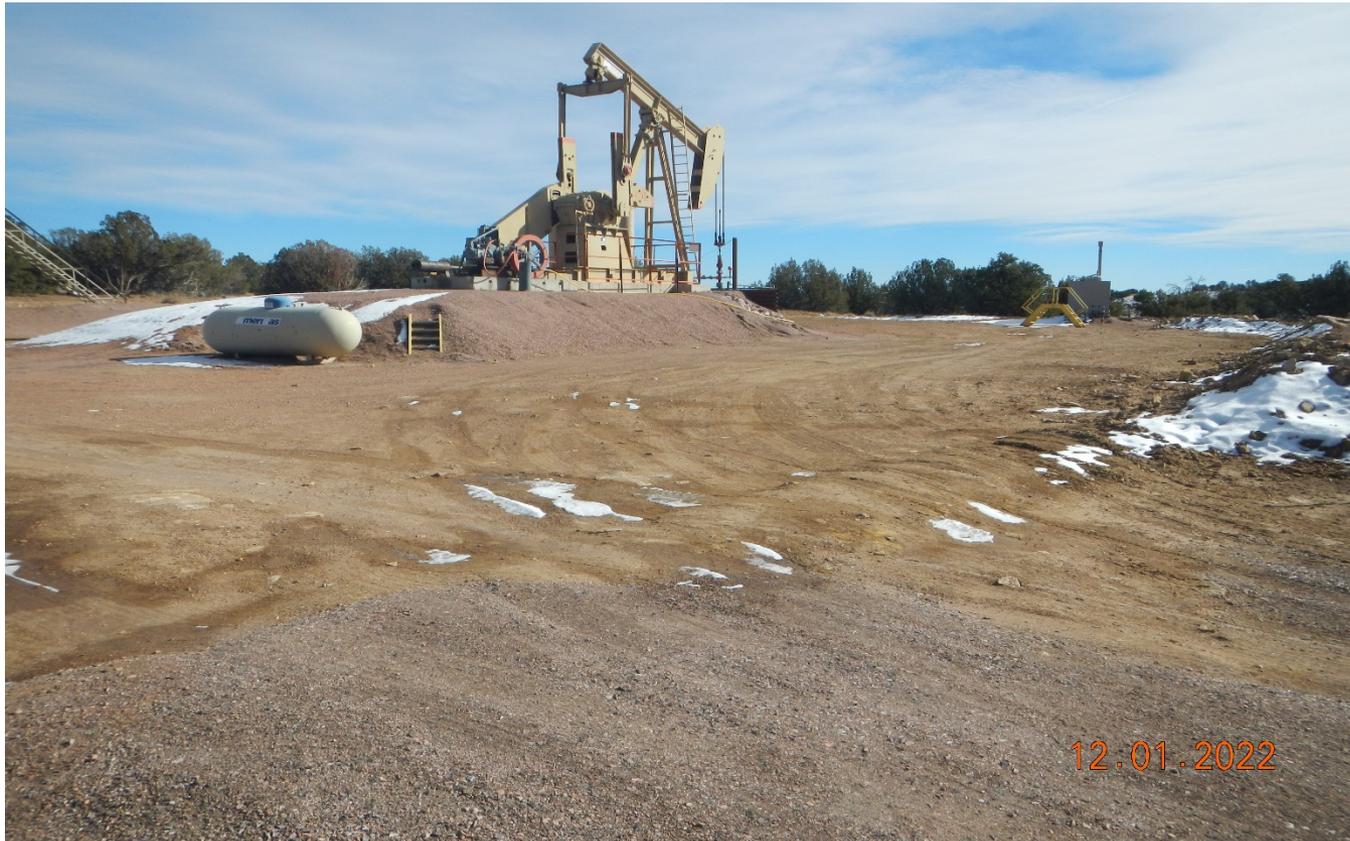
**Photo 3.** Facing northeast toward the wellsite.

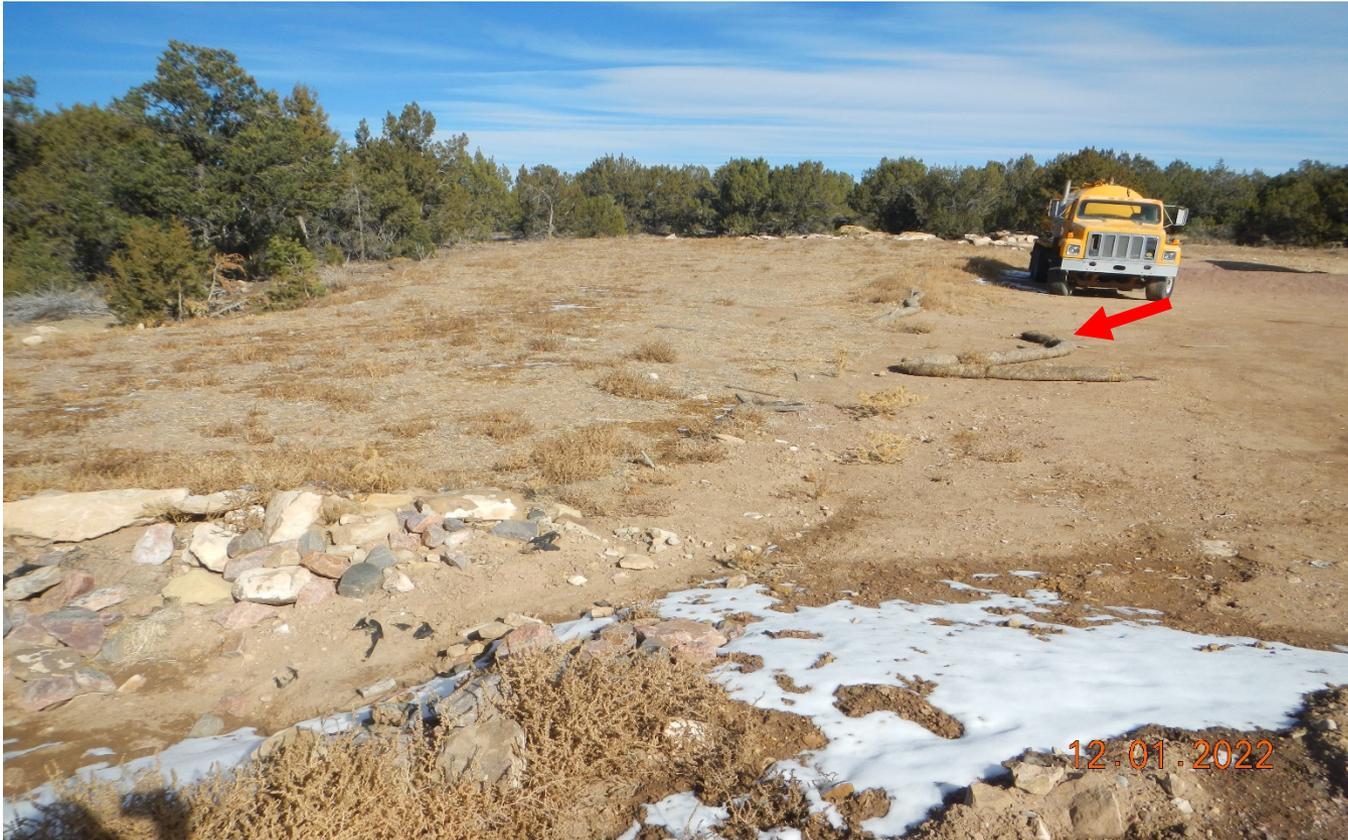
**Photo 4.** The topsoil pile has mostly been used for interim reclamation. This area appears to have been seeded and mulched but vegetation has not yet established. There are displaced wattles that need to be reinstalled.

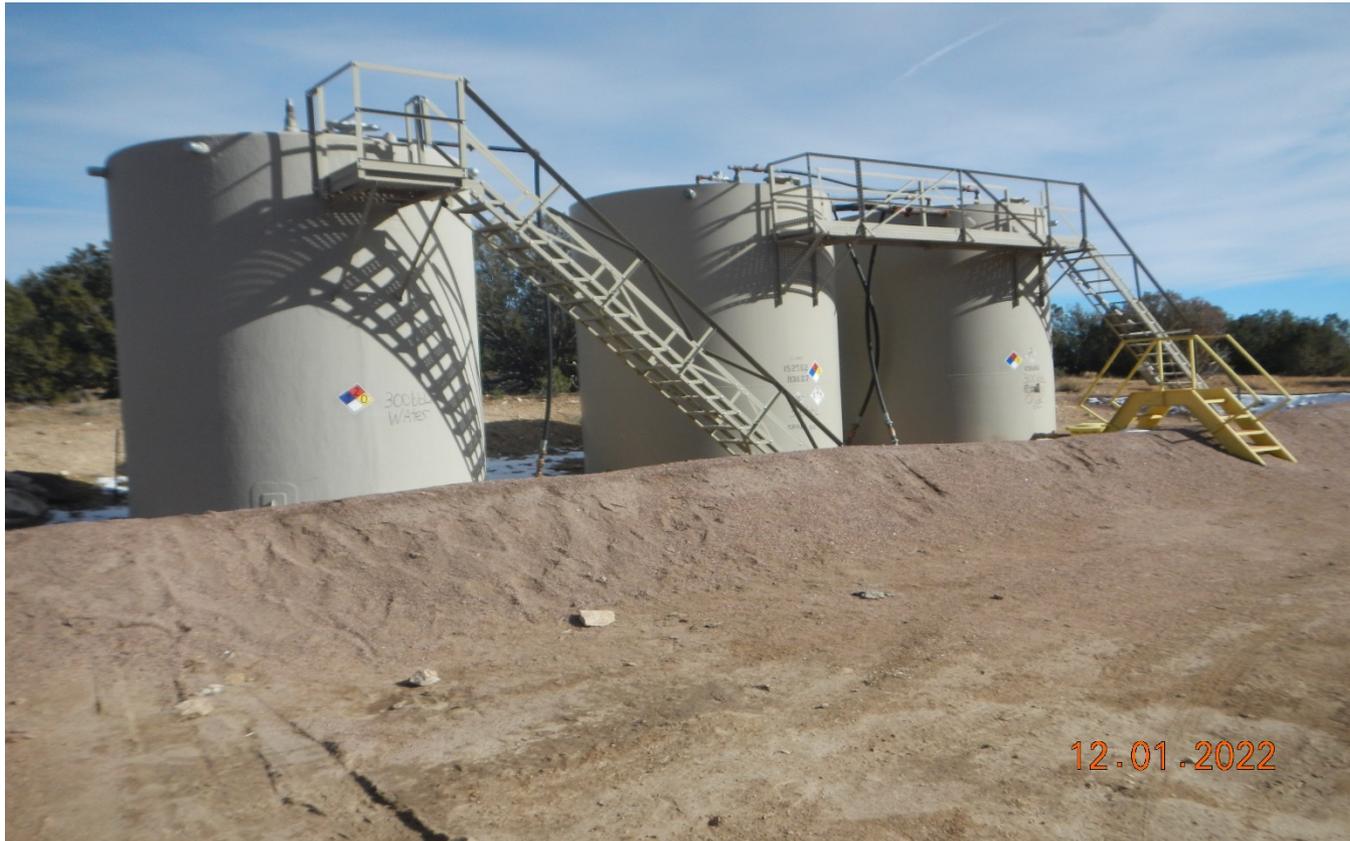
**Photo 5.** Facing toward the tank battery which has been labeled.

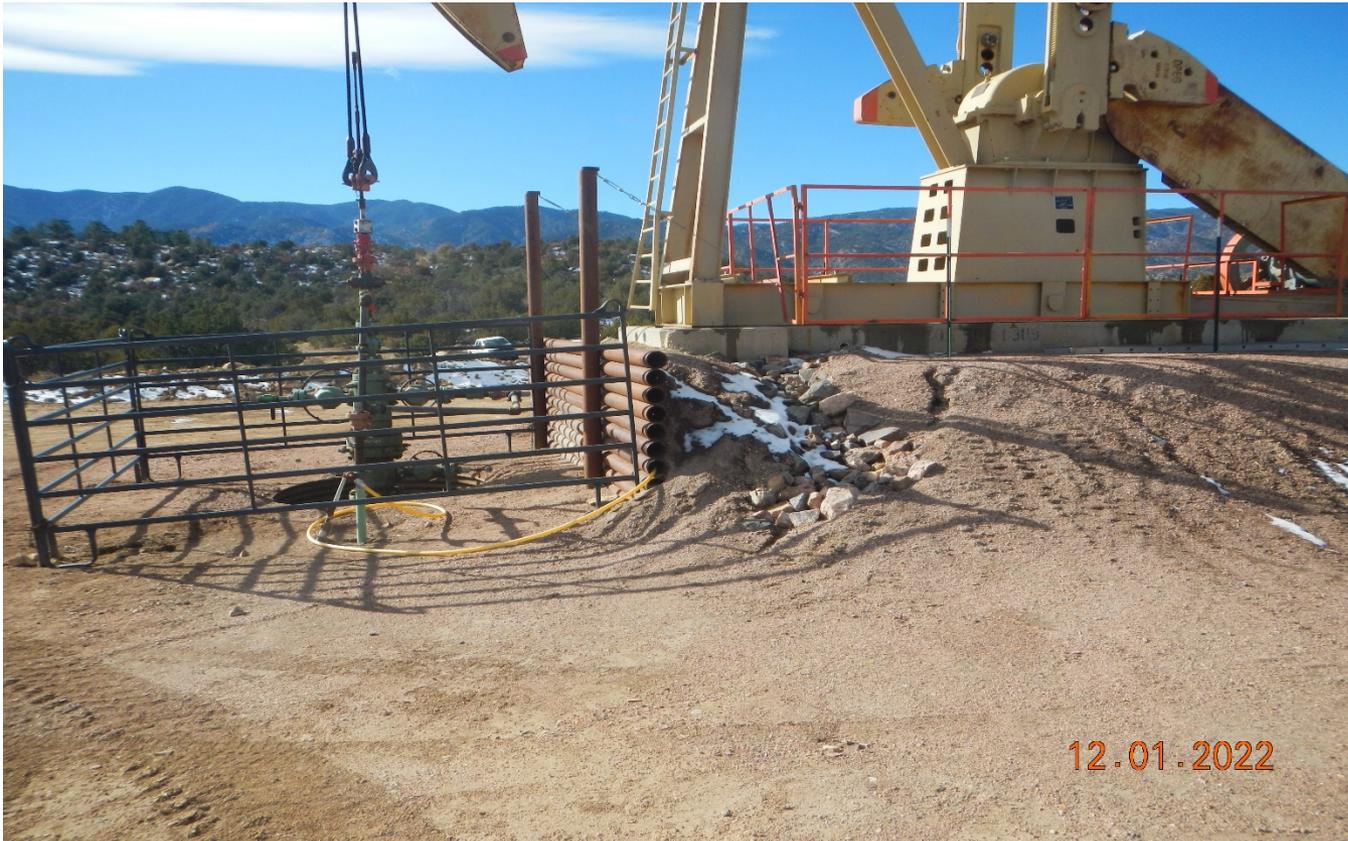
**Photo 6.** Facing toward the pumpjack. Erosion was repaired with rock ri/rap.

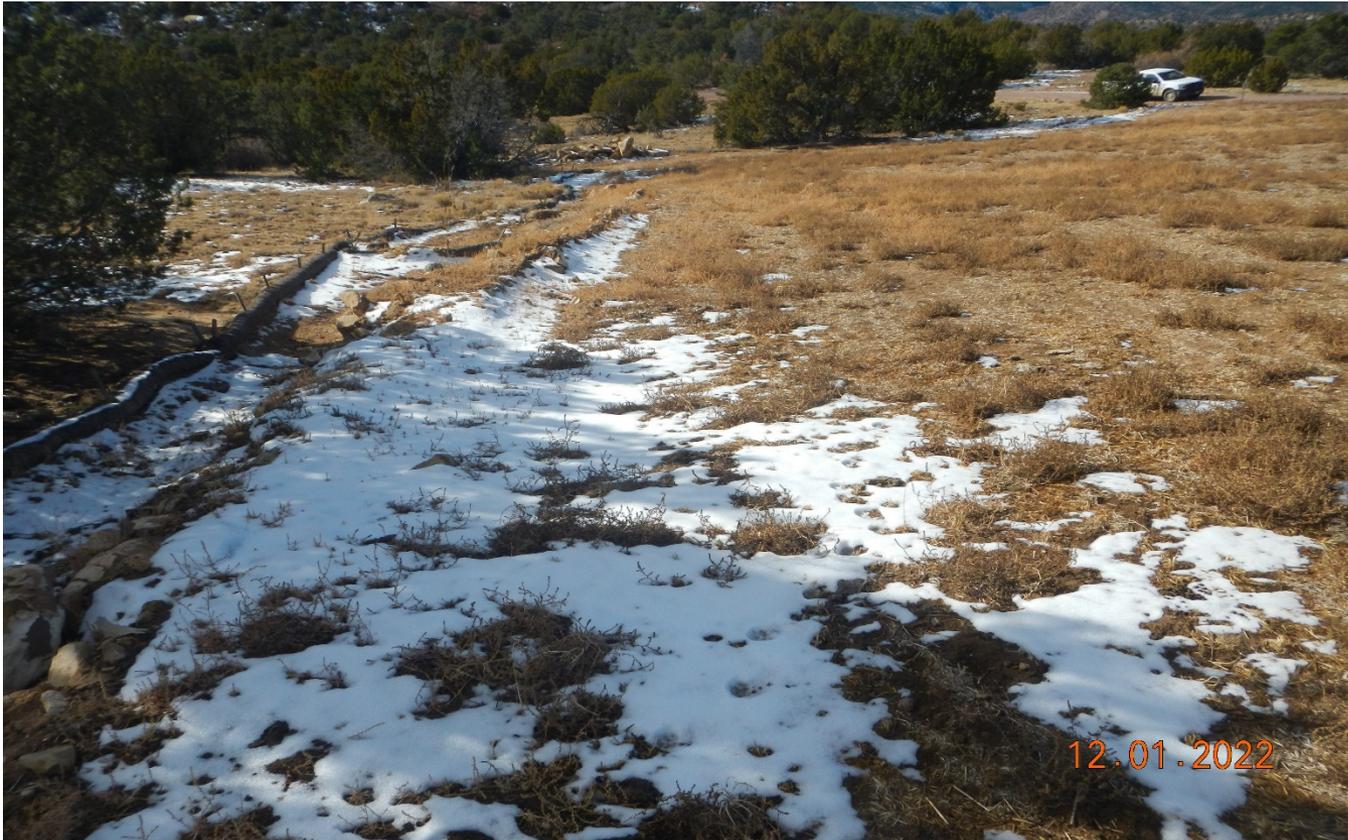
**Photo 7.** Facing south at the east side of the location. There are some wattles in this area that are displaced and need maintenance.

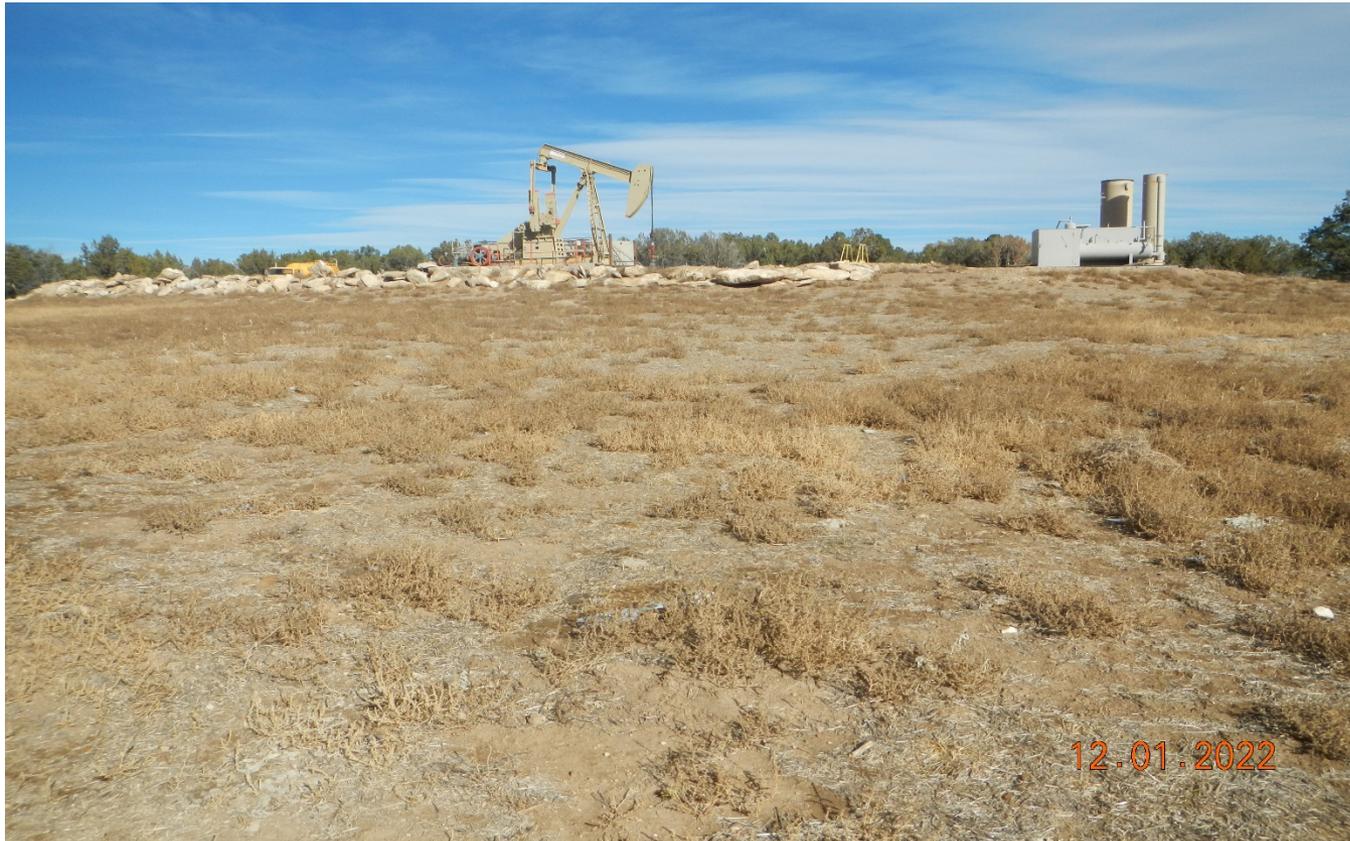
**Photo 8.** Facing northwest toward the location. The interim reclamation area appears to have been seeded and mulched but vegetation has not yet established. There are mostly undesirable weeds which will need to be controlled.
