Inspection Photos

Location Name: CLOUGH-66S93W/7NENW

Inspection Document #: 702800974

Anna O'Malley
Reclamation Specialist, COGCC

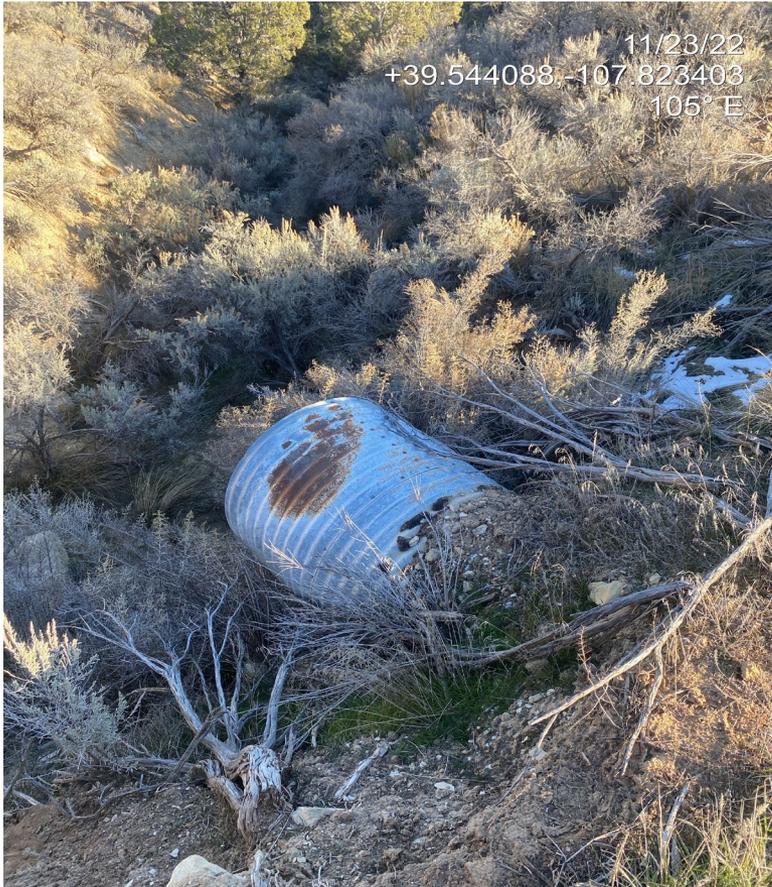
Photo 1. Photo shows the access road culvert remains.

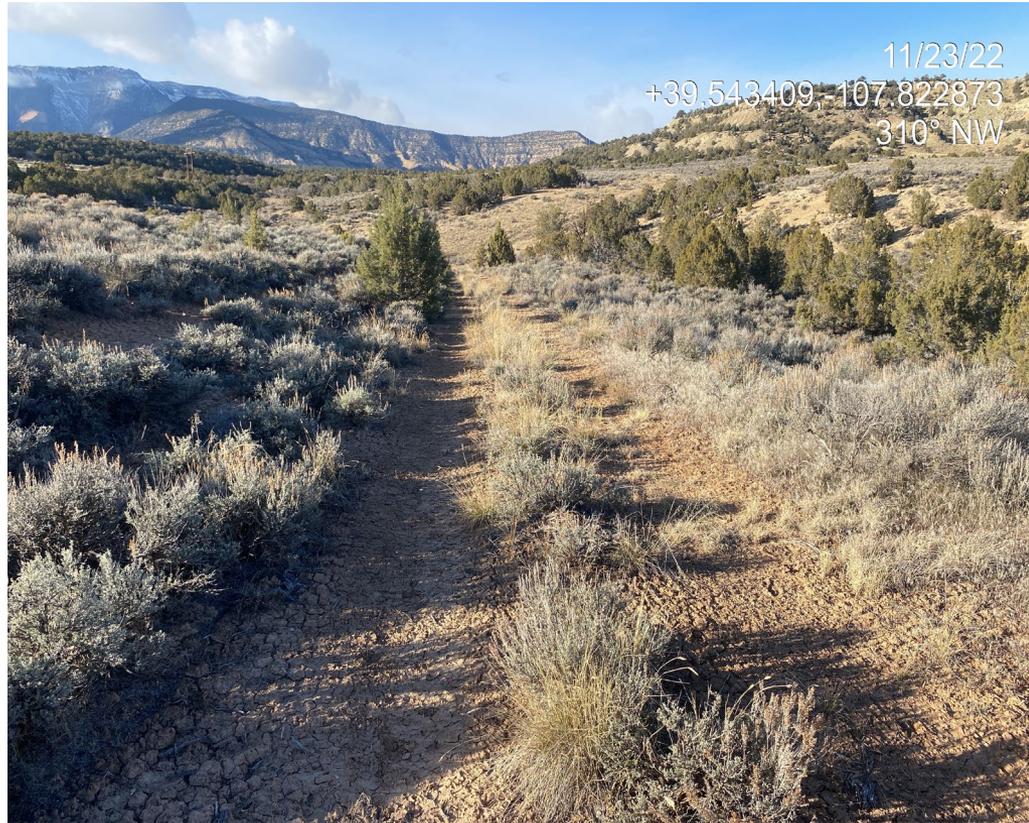
Photo 2. Photo shows the access road remains. Portions of the two-track to the south of the culvert lack vegetation in tracks and require additional reclamation. Note center of road is well vegetated.

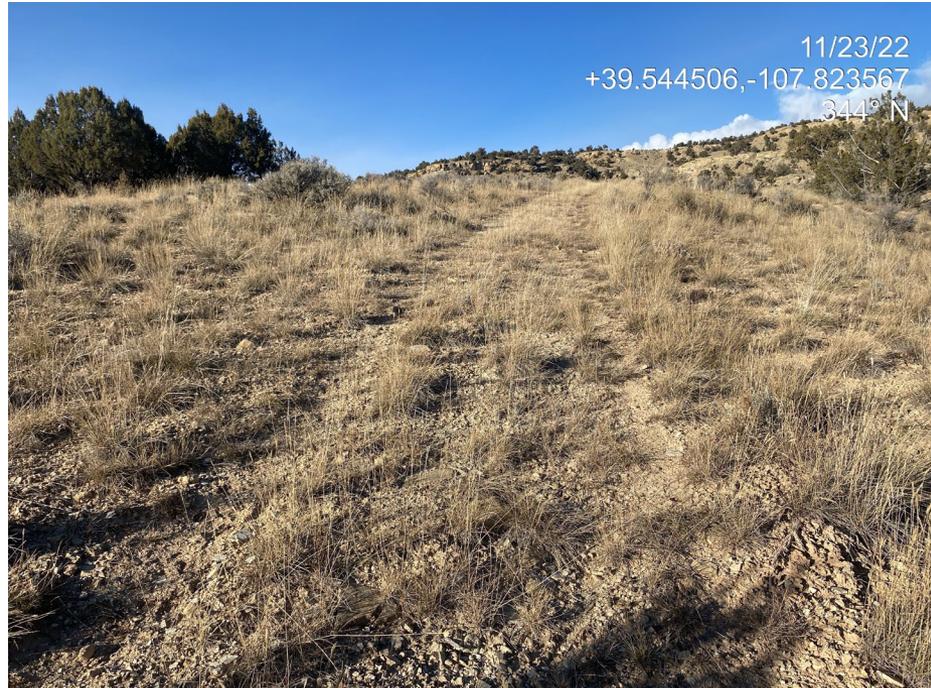
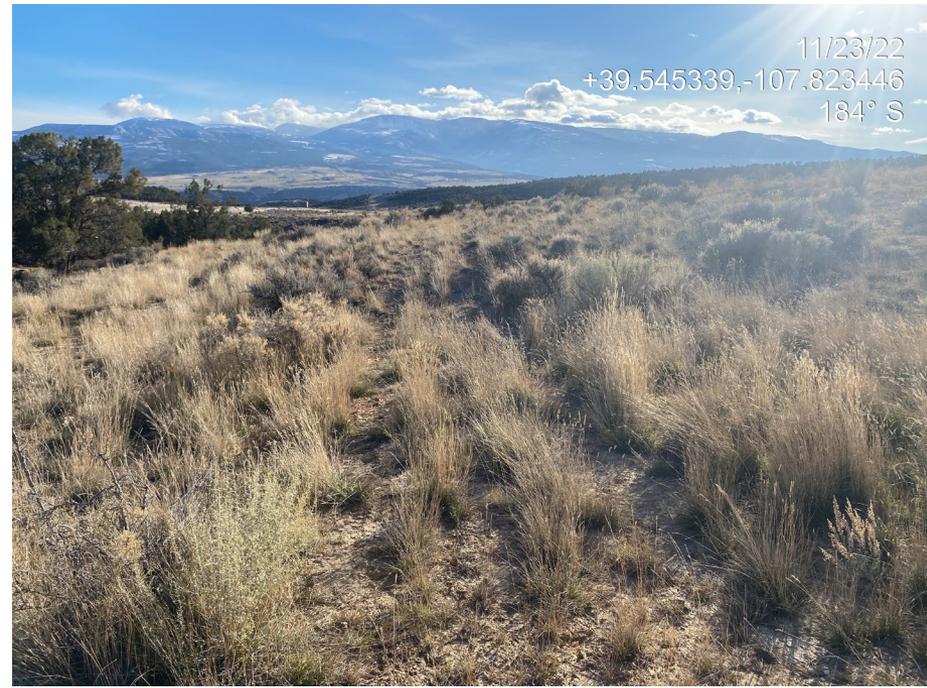
Photo 3. Photos shows the access road to the north of the culvert is well vegetated.

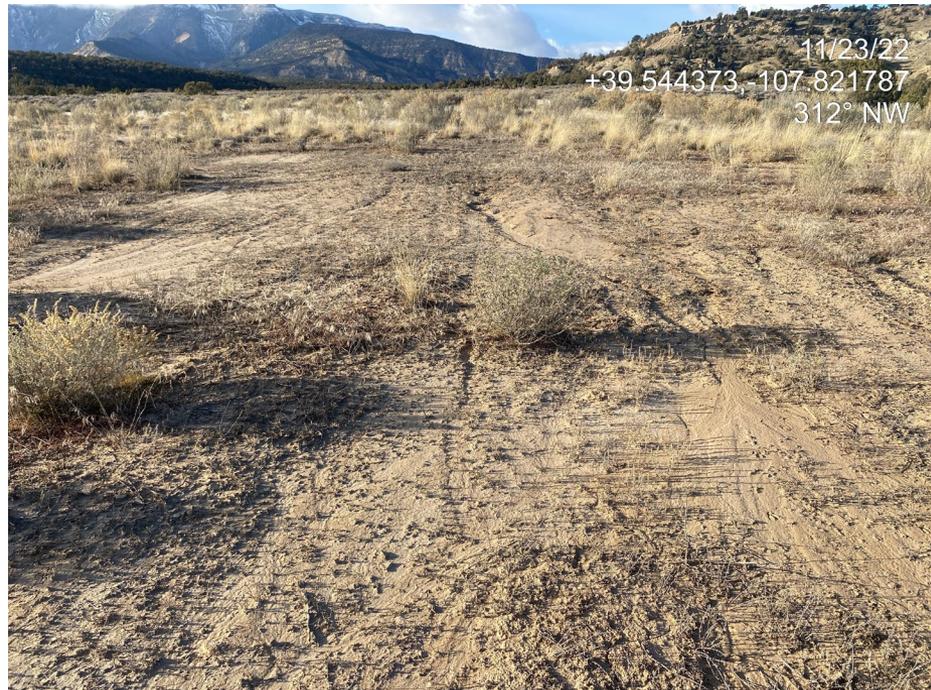
Photo 4. Photo shows seeding has largely failed and erosion is widespread in portions of the location to the south.

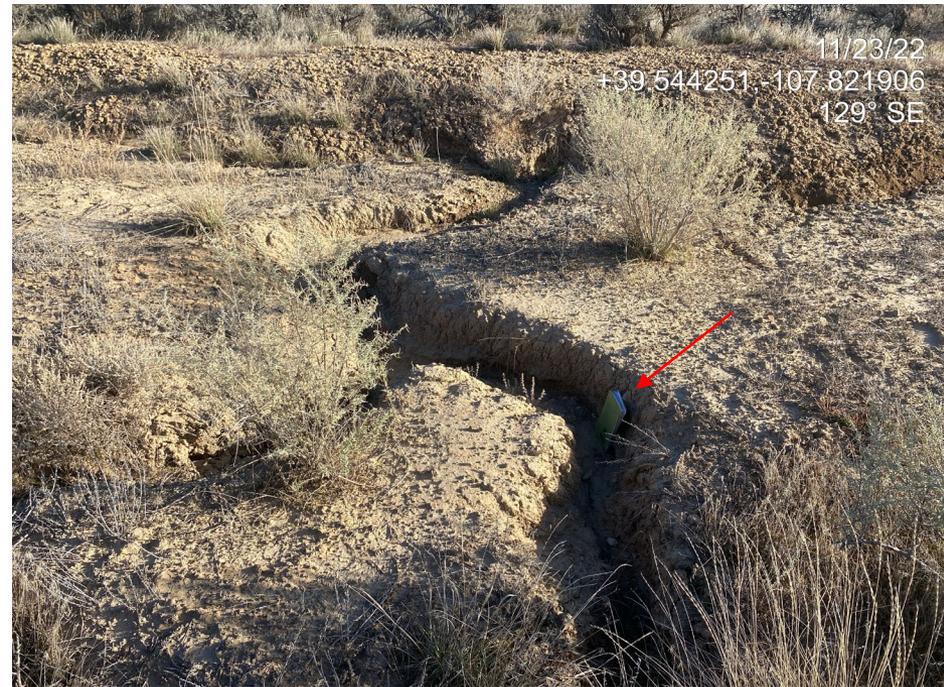
Photo 5. Photo taken from the south of the location shows where erosion pictured in Photo 7 converges to form a network of interconnected gullies. Arrow indicates a scaling device, which is 8 inches.

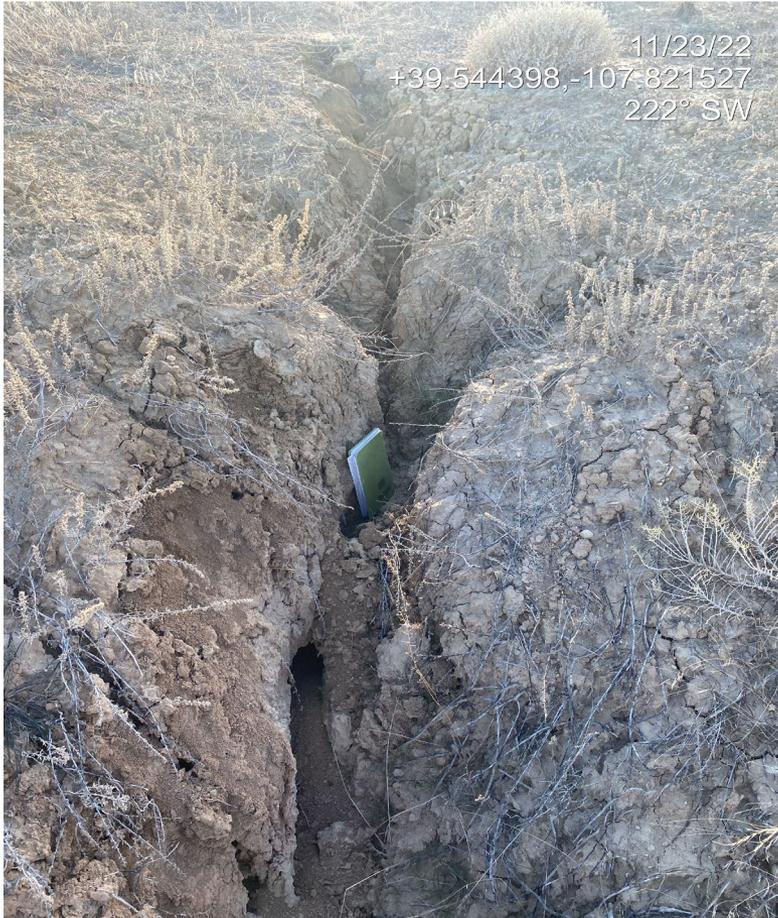
Photo 6. Photo shows gully erosion at the southeast of the location where perennial establishment is poor. Scaling device is 8 inches tall.

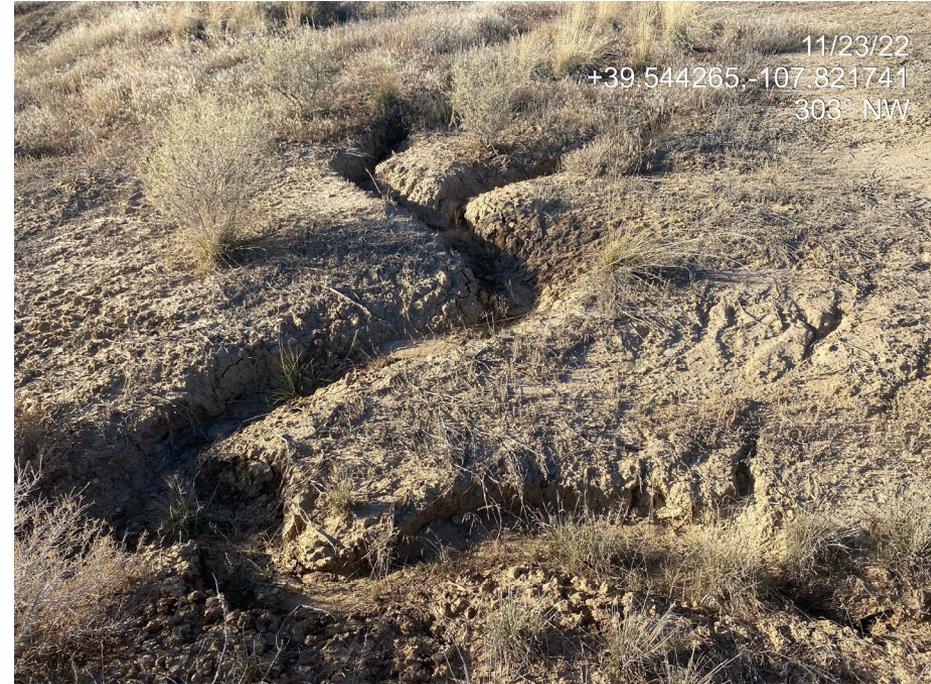
Photo 7. Photo shows gully erosion at the south of the location where perennial establishment is poor.

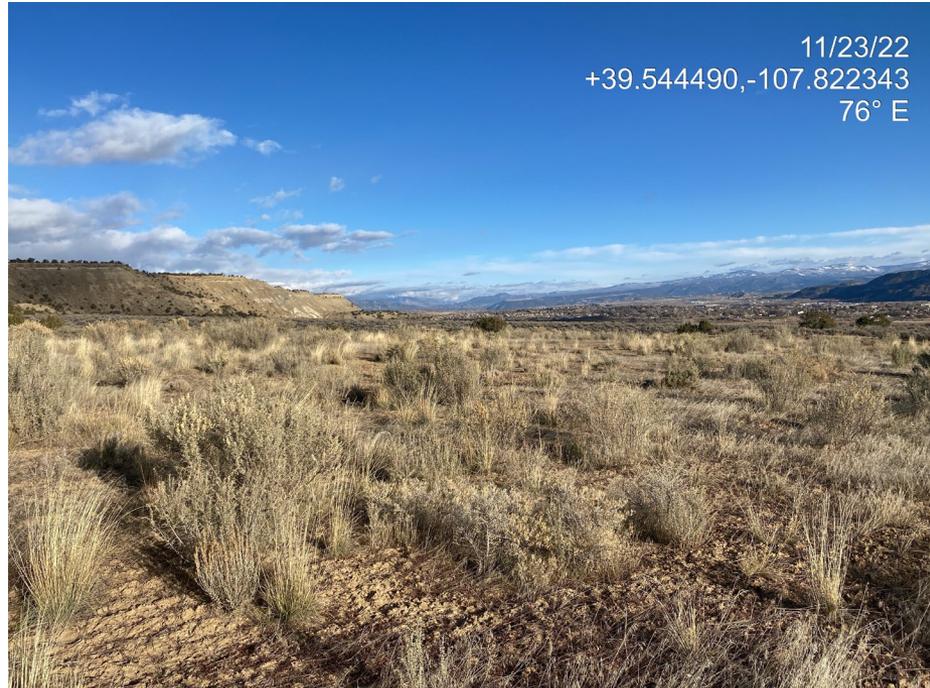
11/23/22
+39.544490,-107.822343
76° E

Photo 8. Photo taken from the west shows an overview of the reclaimed location. Desirable perennial vegetation is well established.

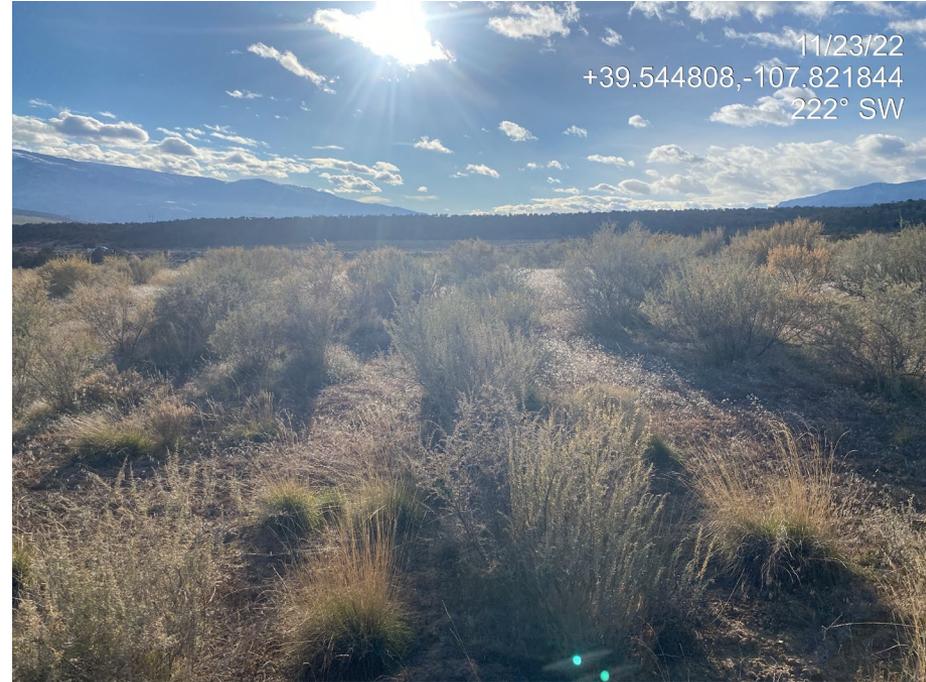
11/23/22
+39.544808,-107.821844
222° SW

Photo 9. Photo taken from the east shows an overview of the reclaimed location. Desirable perennial vegetation is well established.
