# Final Reclamation and Stormwater Inspection

Operator: WHITING OIL & GAS CORP - 96155

Location ID: 441391

Inspection Photos  
Location Name: Razor 29 L Pad  
Location ID: 441391

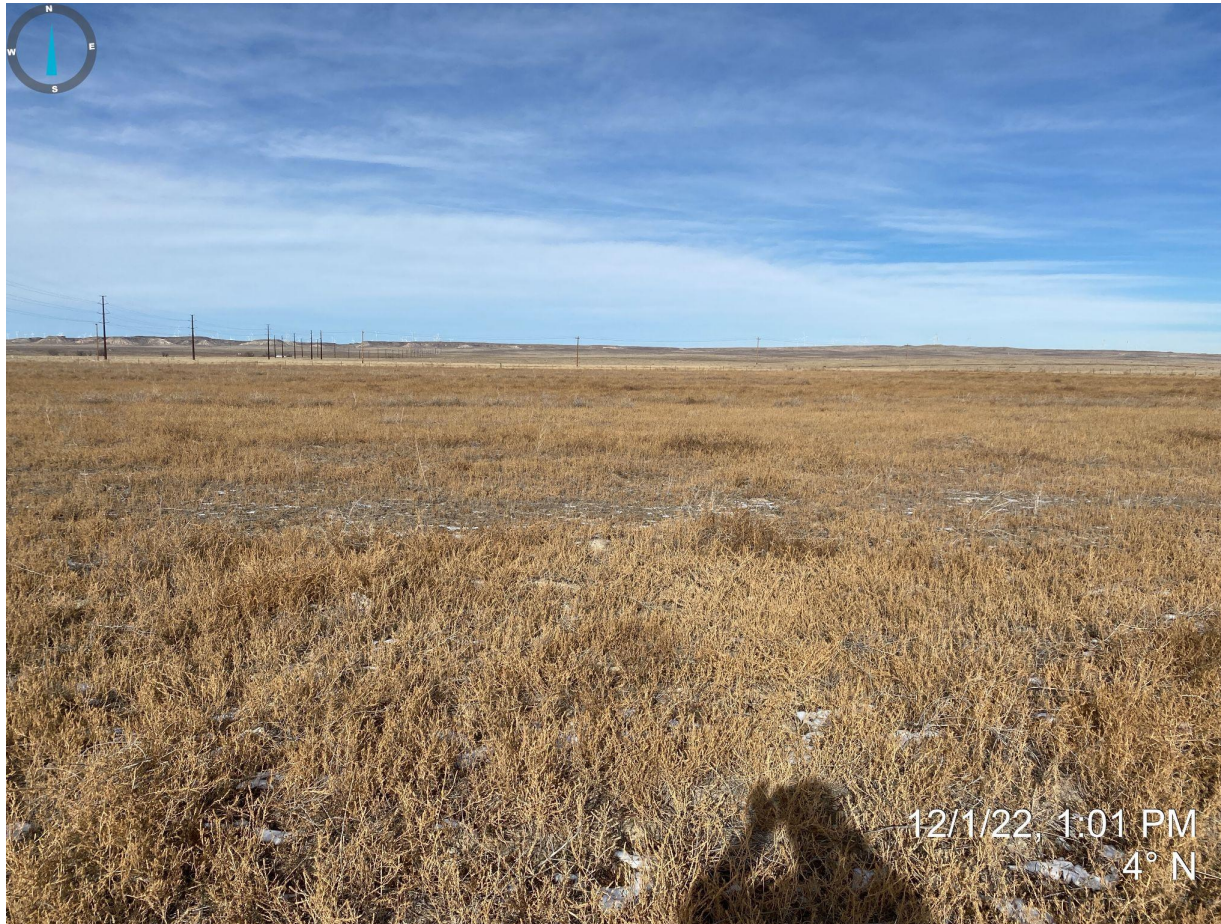
**Photo 1.** Taken from southern portion of location, facing north. Photo illustrates the location is predominantly undesirable vegetation (e.g. russian thistle). Location appears to have been reclaimed as the topsoil stockpiles have been placed to their original contour/position and no evidence of ditch and berm were observed.

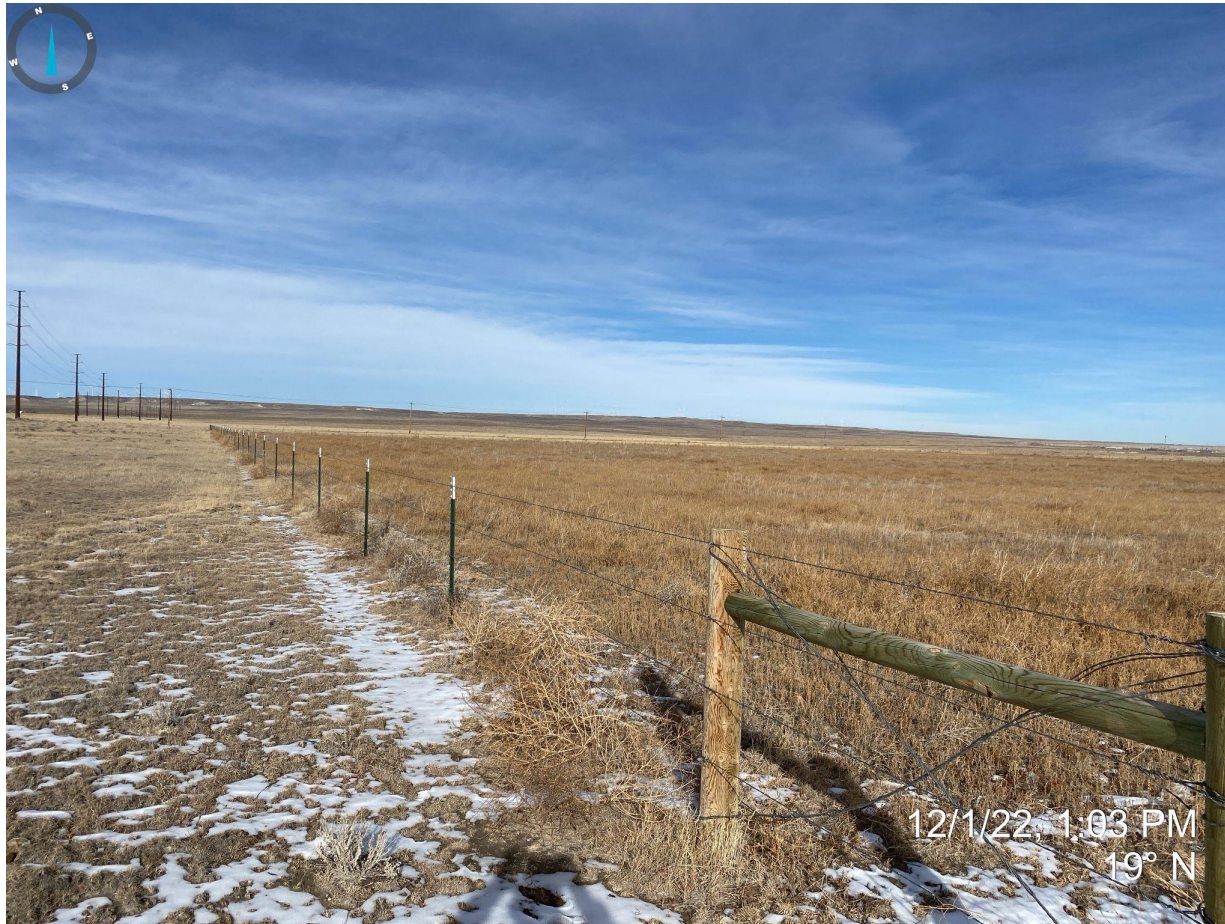
**Photo 2.** Taken from the southwest corner of location, facing north. Photo illustrates the reference area (predominantly buffalo grass) on the outside of the fence, and perimeter fence that remains on location. The fence is now considered debris and needs to be removed.
