# Final Reclamation and Stormwater Inspection

Operator: MAGPIE OPERATING LLC - 52530

Location ID: 312143

Inspection Photos  
Location Name: Warnecke #1  
Location ID: 312143

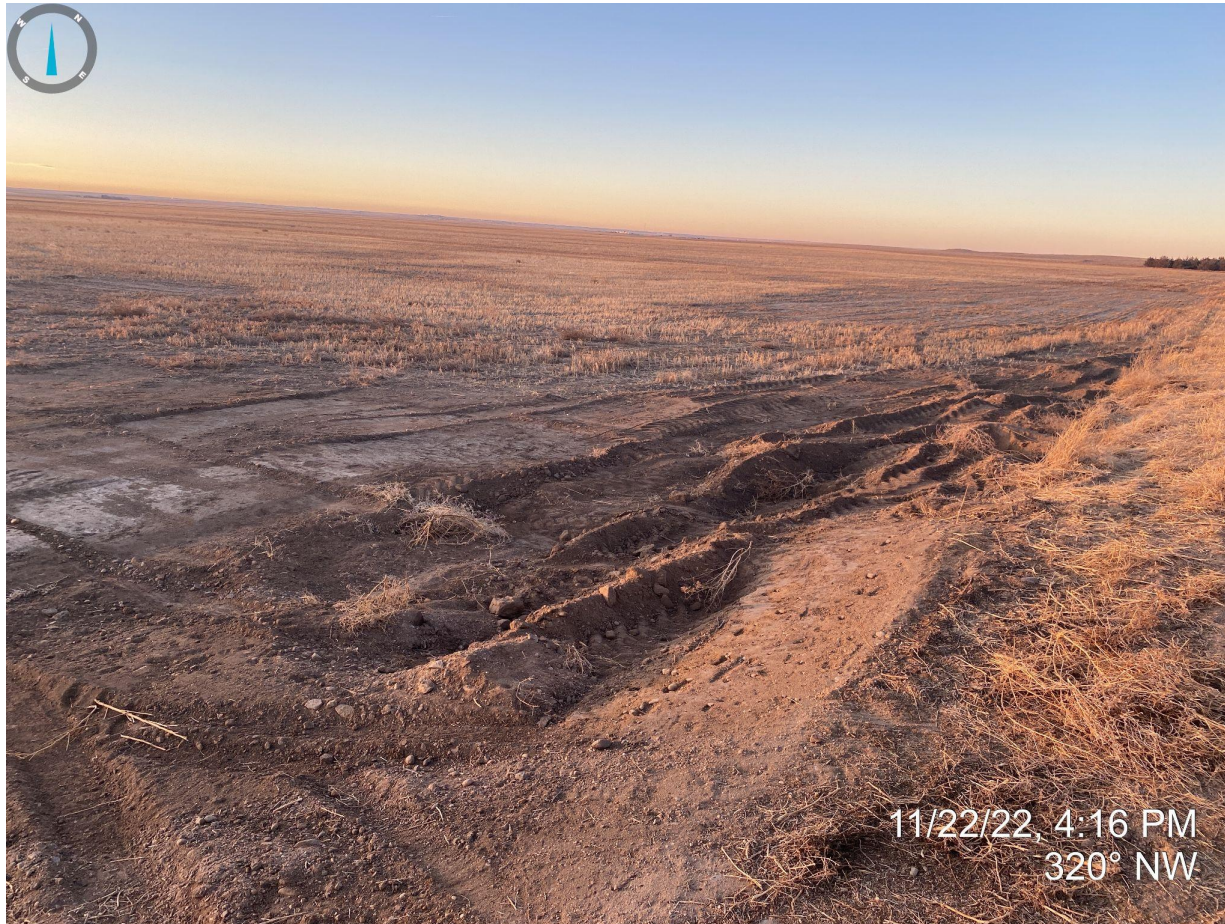
**Photo 1.** Taken near the entrance to the location, facing northwest. Photo illustrates the operator has removed the fence and gate required by previous corrective actions (Doc #696105548). It also appears that the operator has removed some material (likely road base) from the entrance approach.

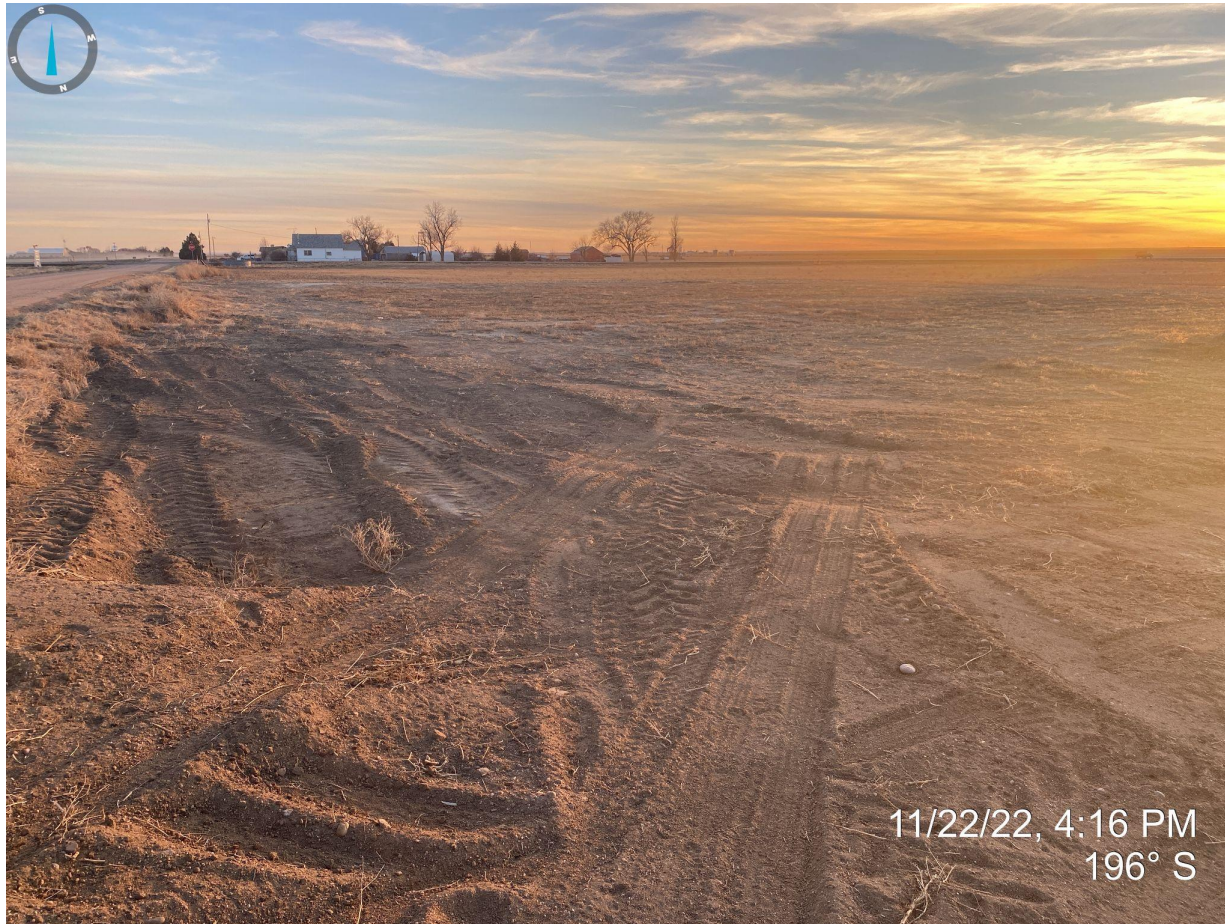
**Photo 2.** Taken near the entrance to the location, facing south. See comments in Photo 1.

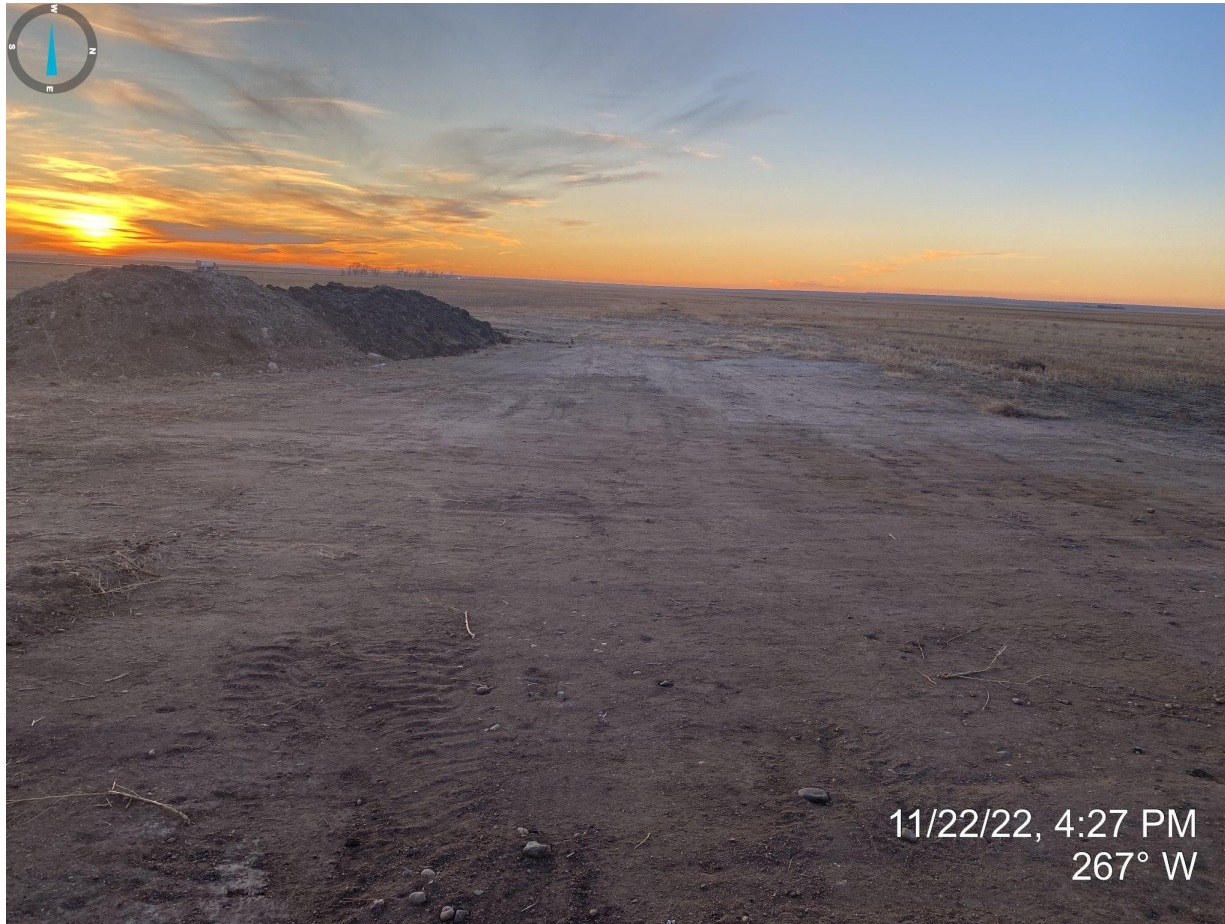
**Photo 3.** Taken from the entrance of the location, facing west. Photo illustrates that the undesirable vegetation has been managed (e.g. mowed) and the manure piles left undisturbed as requested by the surface owner. Photo also shows that it appears no other reclamation work has been performed at the time of this inspection.

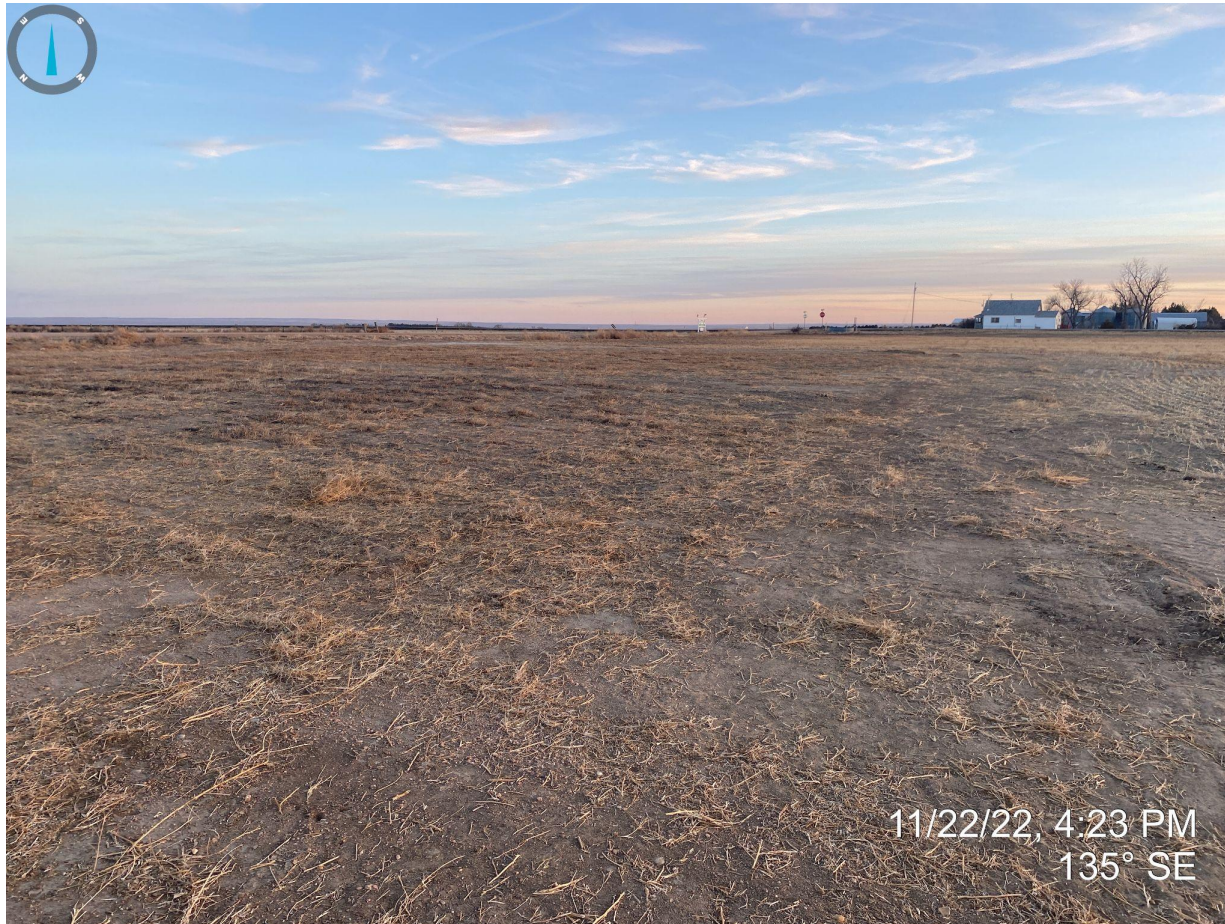
11/22/22, 4:23 PM  
135° SE

**Photo 4.** Taken from the pit location, facing southeast. Photo illustrates that the undesirable vegetation has been mowed and that no other reclamation appears to have been performed at the time of this inspection.

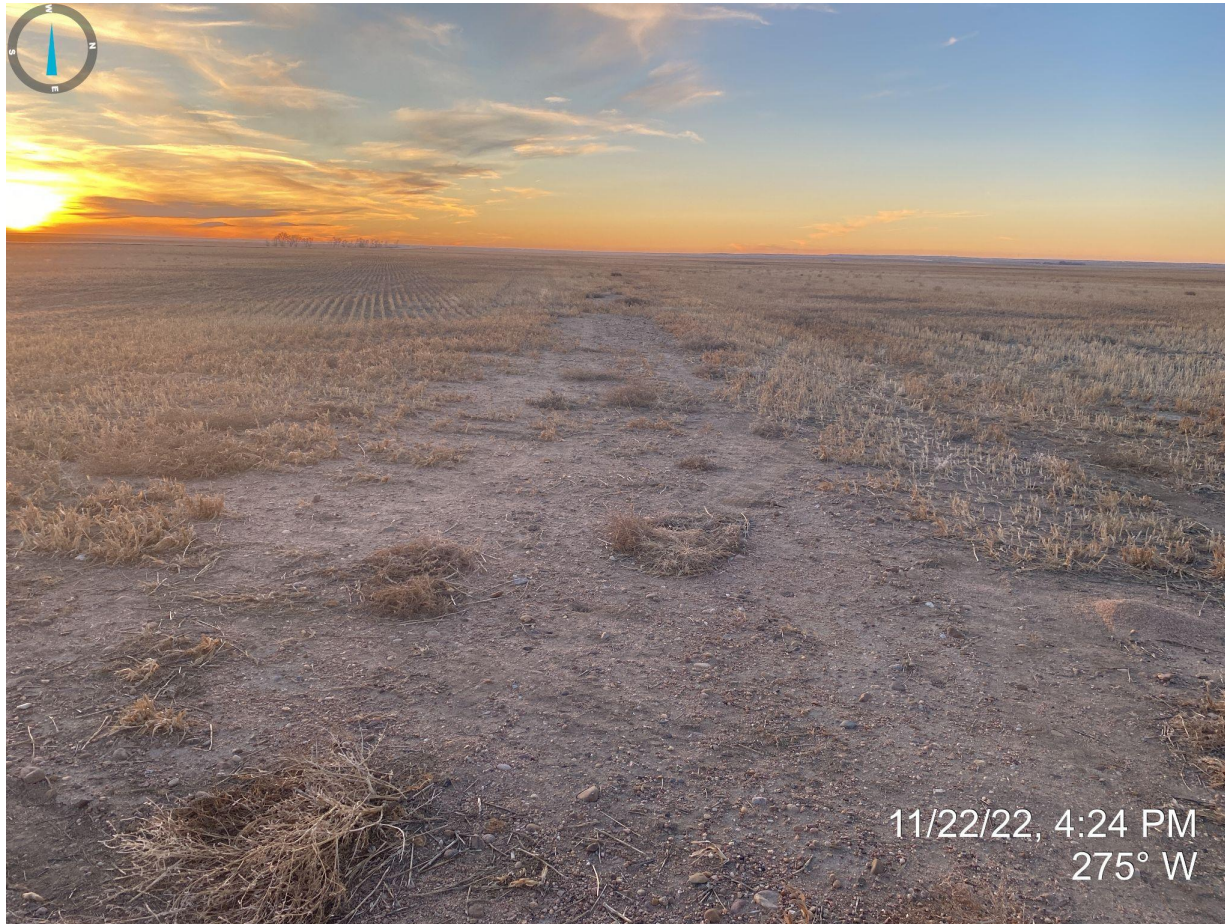
**Photo 5.** Taken from the western portion of the location, facing west. Photo illustrates that the access road leading to the well location has not been reclaimed.
