# Inspection Photos

Operator: TEP ROCKY MOUNTAIN LLC - 96850

Location #324082

Garfield County, CO

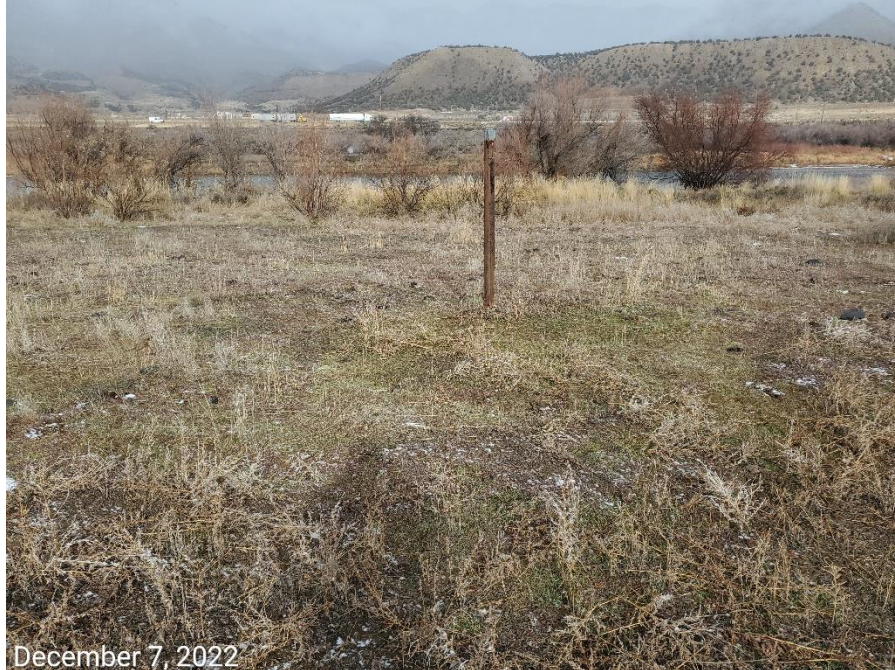
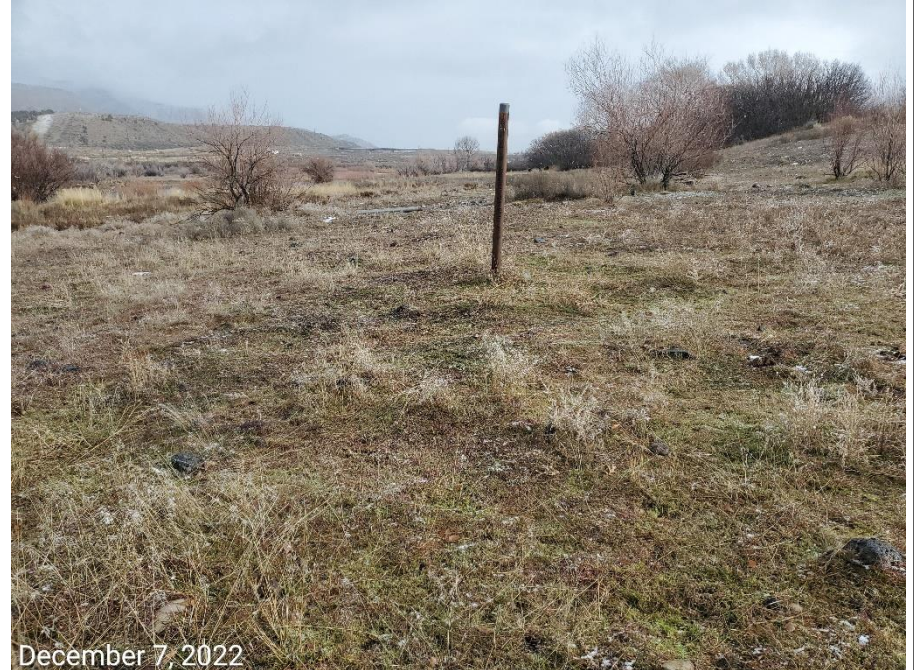
**Photo 1:** Photos 1-2 taken from the central areas of the Location. Photos provide an overview of the location from east, southeast, southwest to west. Photos also show well marker left in place.

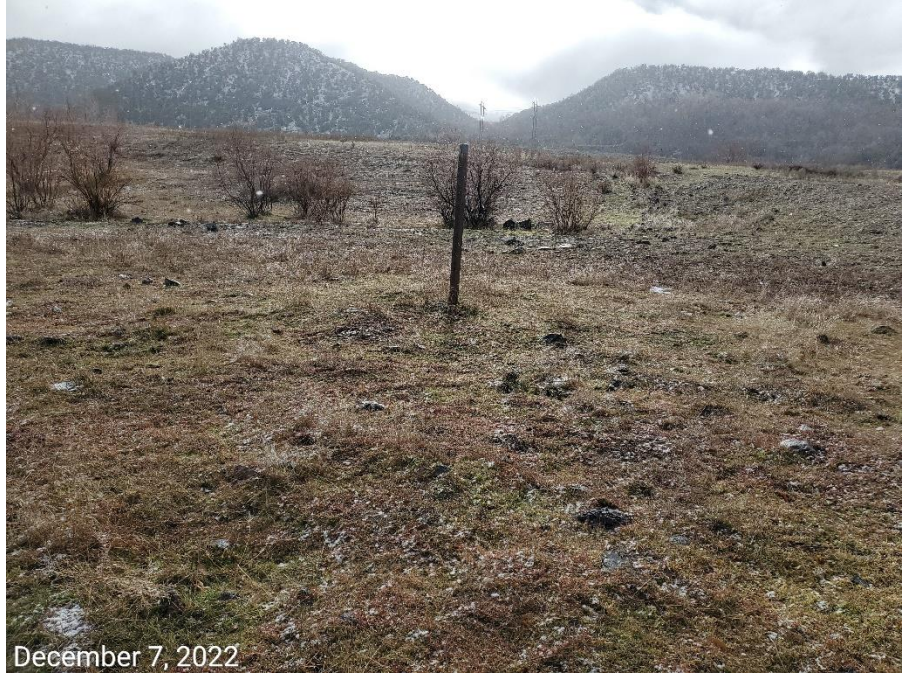
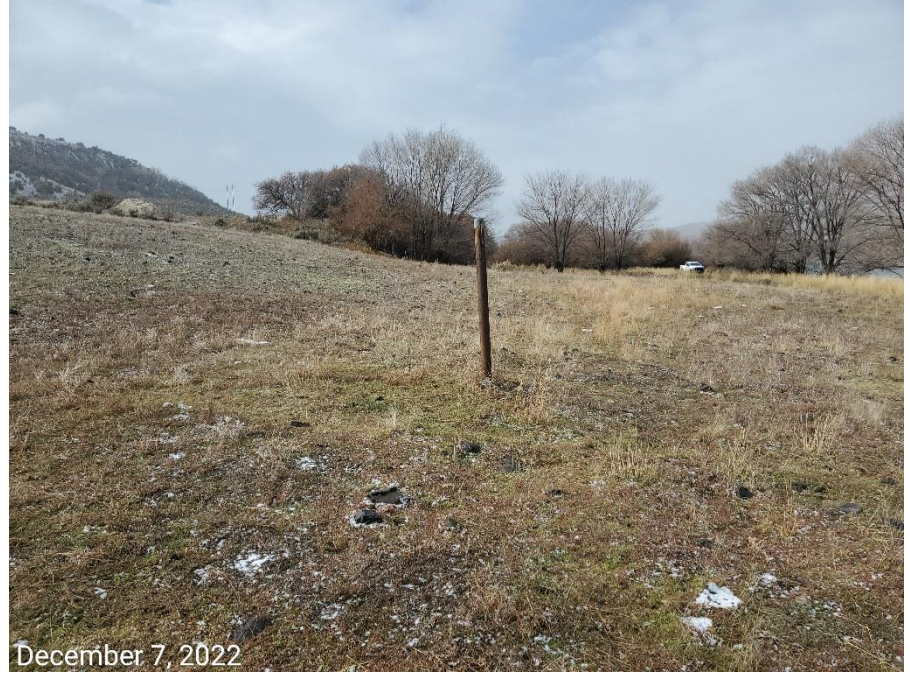
**Photo 2:** See comment under photo 1.

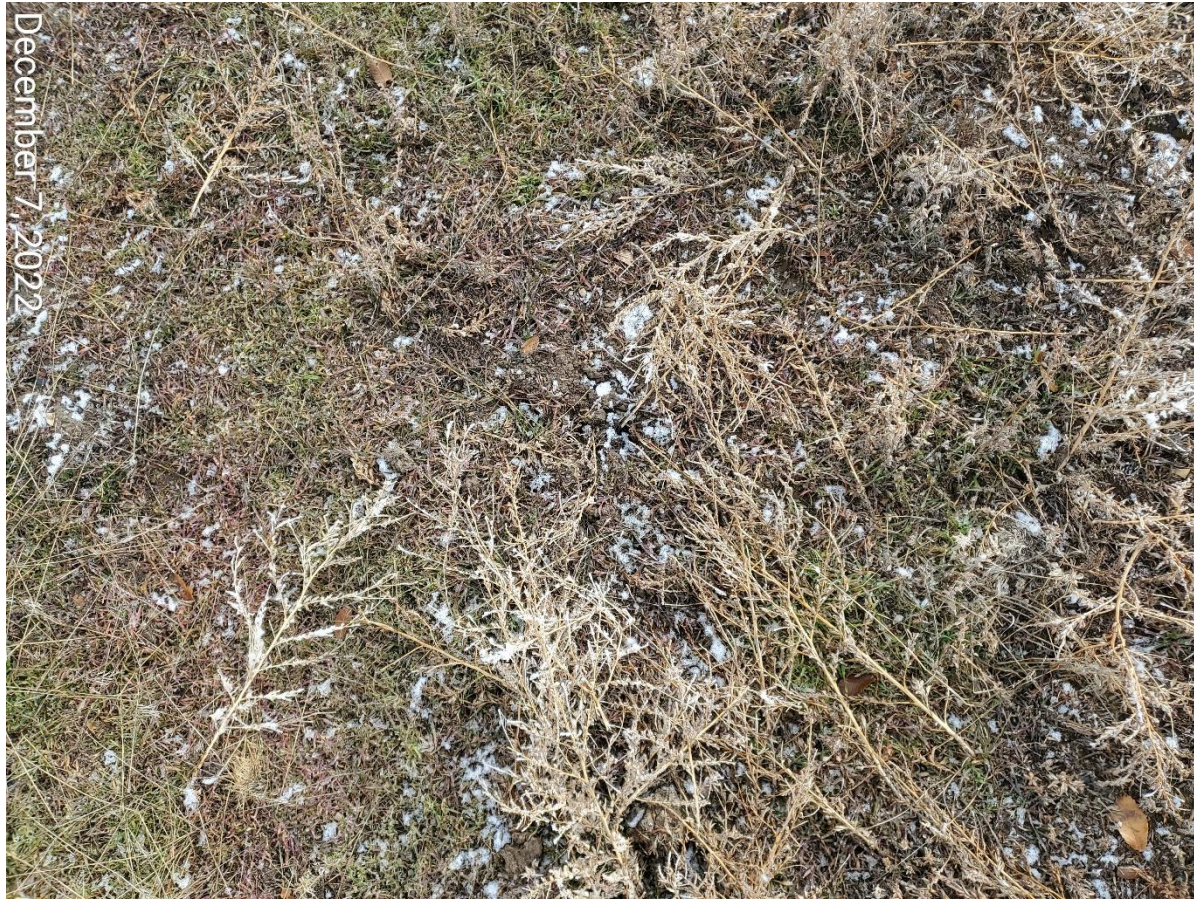
**Photo 3:** Photo an example showing vegetation on the well site; vegetation appears to be predominantly undesirable and annual species. A follow-up inspection will be conducted in a future growing season to assess desirable plant establishment on the Location.

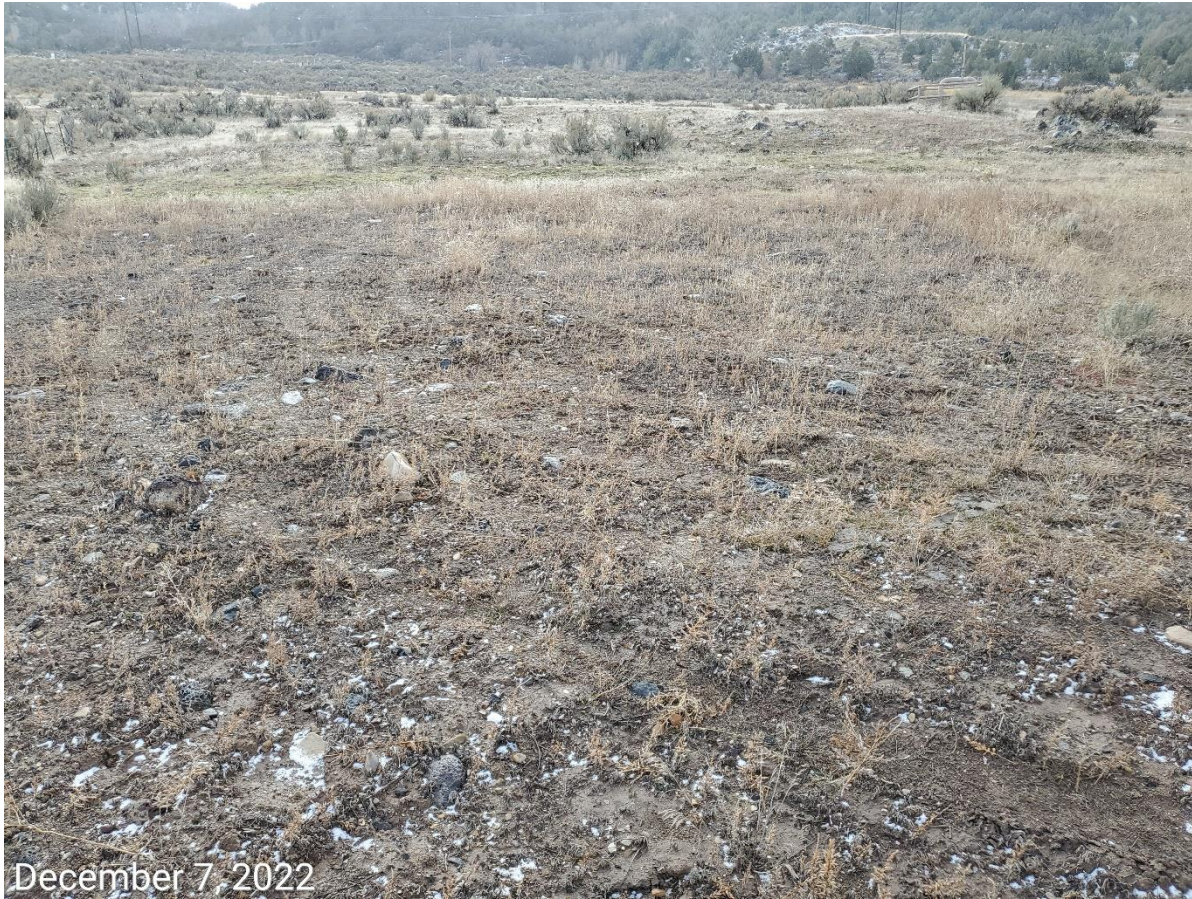
**Photo 4:** Photo taken from the former battery facility north of the Location. Areas do not appear to be progressing towards 1004 standards; vegetation observed predominantly undesirable plant species such as Kochia.

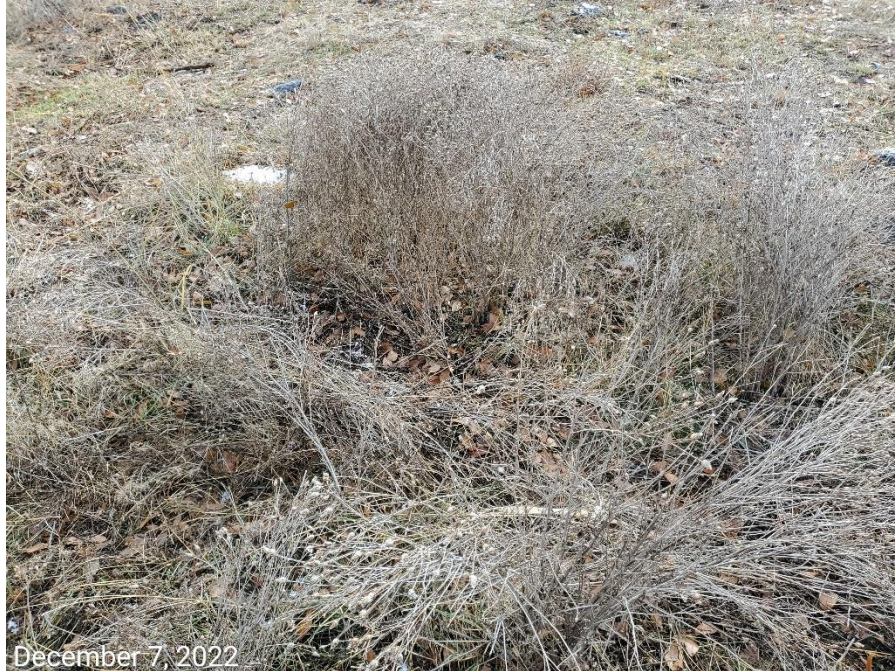
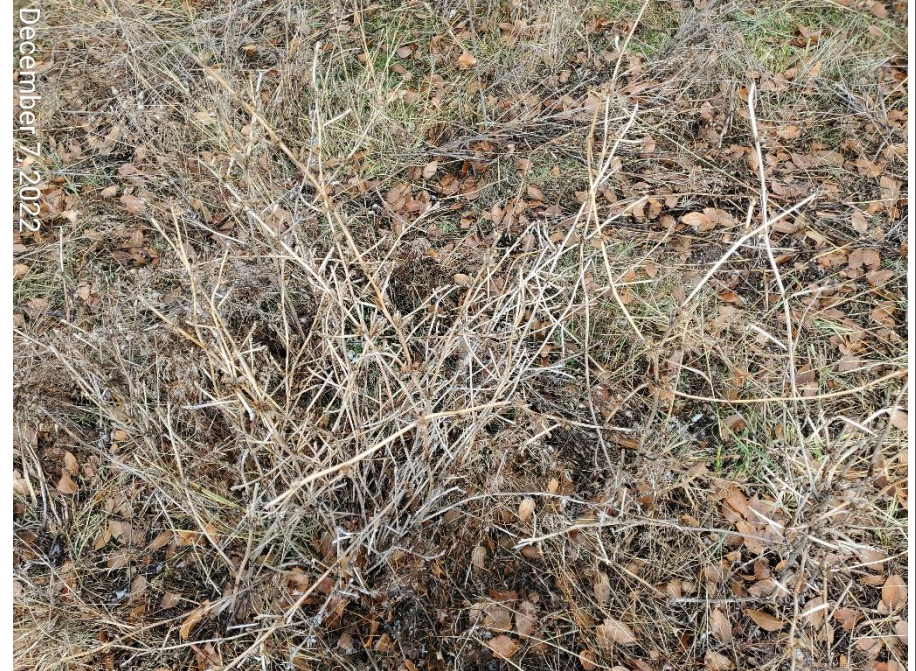
**Photo 5:** Photos examples showing noxious weeds observed throughout the Location; photo left shows knapweed; photo right shows chicory.
