Inspection Photos  
Well 081-07282  
Inspection  
Date:9/14/2022

All Photos taken  
by Kris Neidel

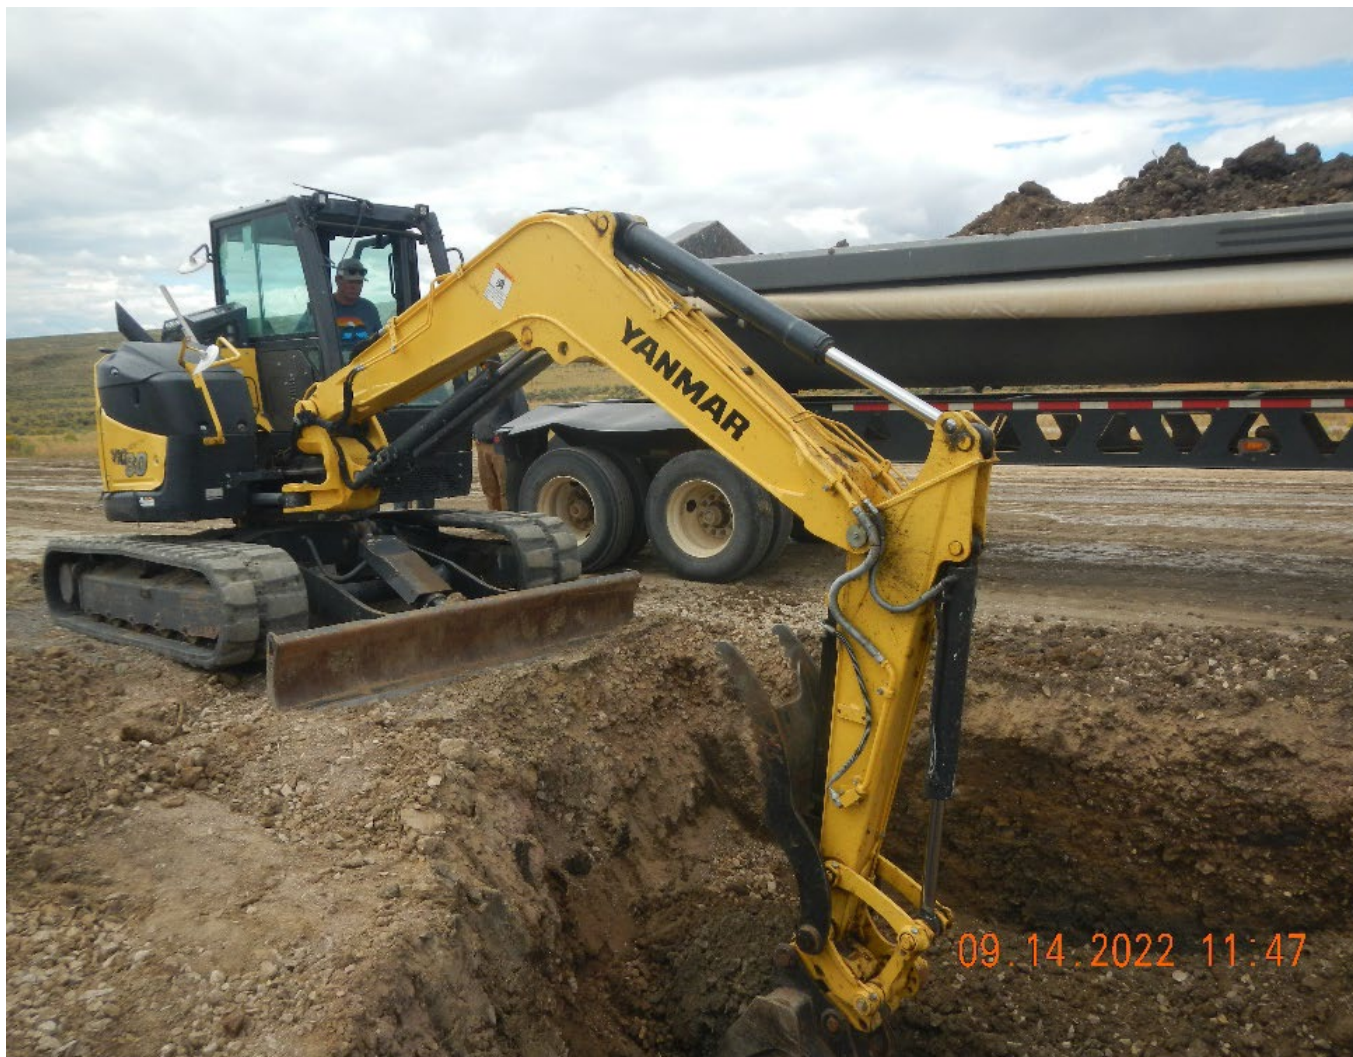
**Photo #1 Approximately 130 tons of soil was removed and hauled for disposal as E&P waste.**

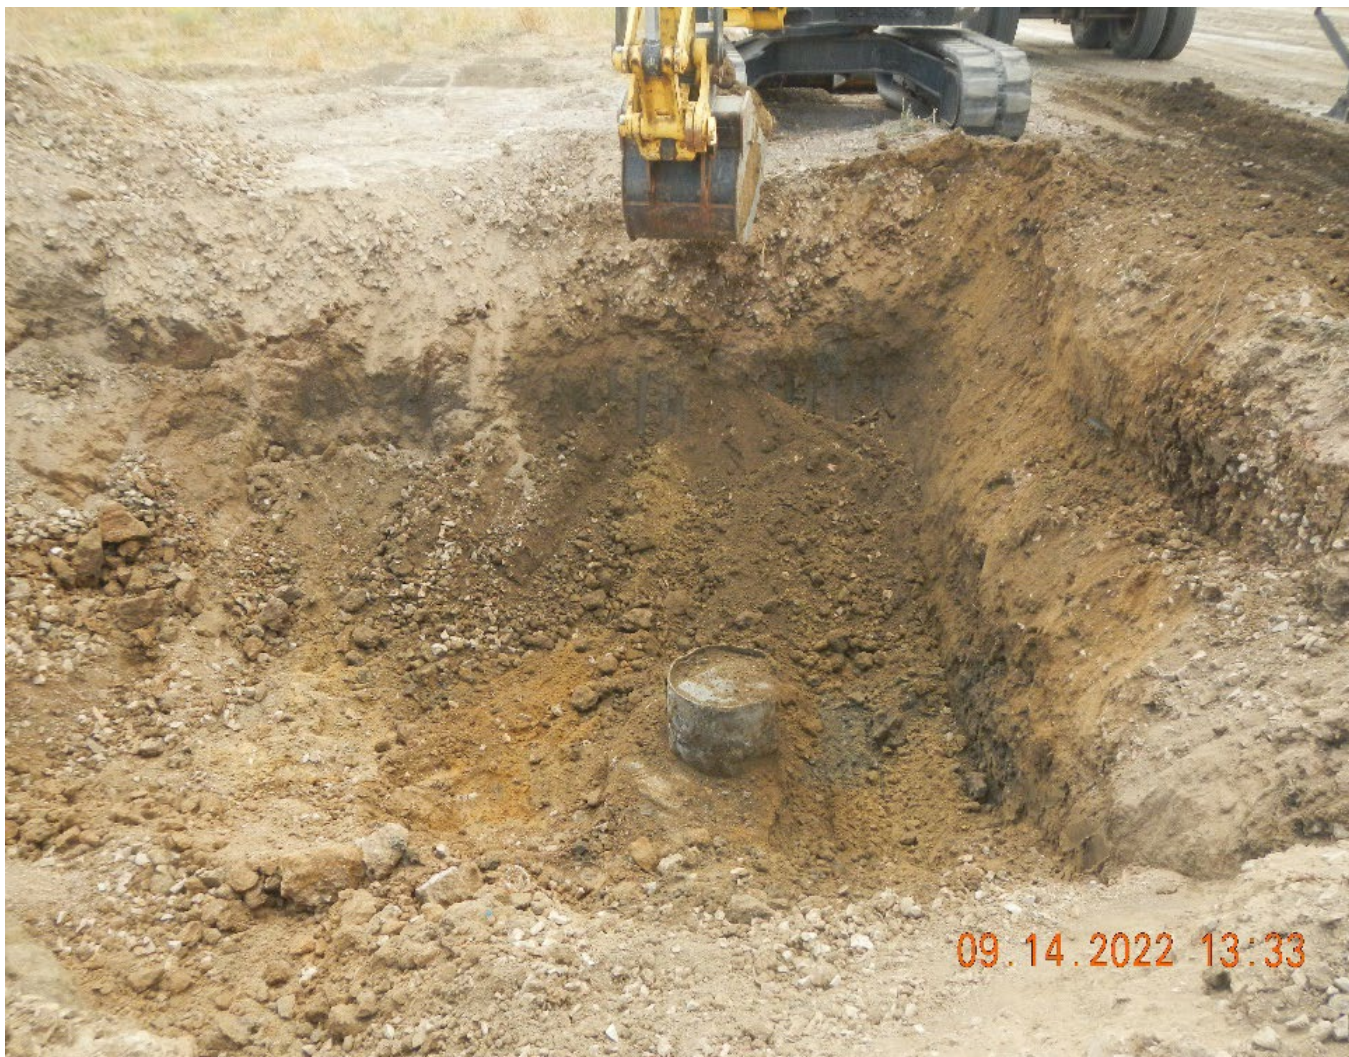
Photo #2 wellhead is visible in excavation. Soil was removed until visible contamination was not obvious. Soil samples were observed by COGCC staff, Kris Neidel.
