Final Reclamation Inspection

Operator: KERR MCGEE OIL & GAS ONSHORE LP #47120

Location ID: 330420

Inspection Photos
Location Name: HSR-KNOX #16-3
Location ID: 330420

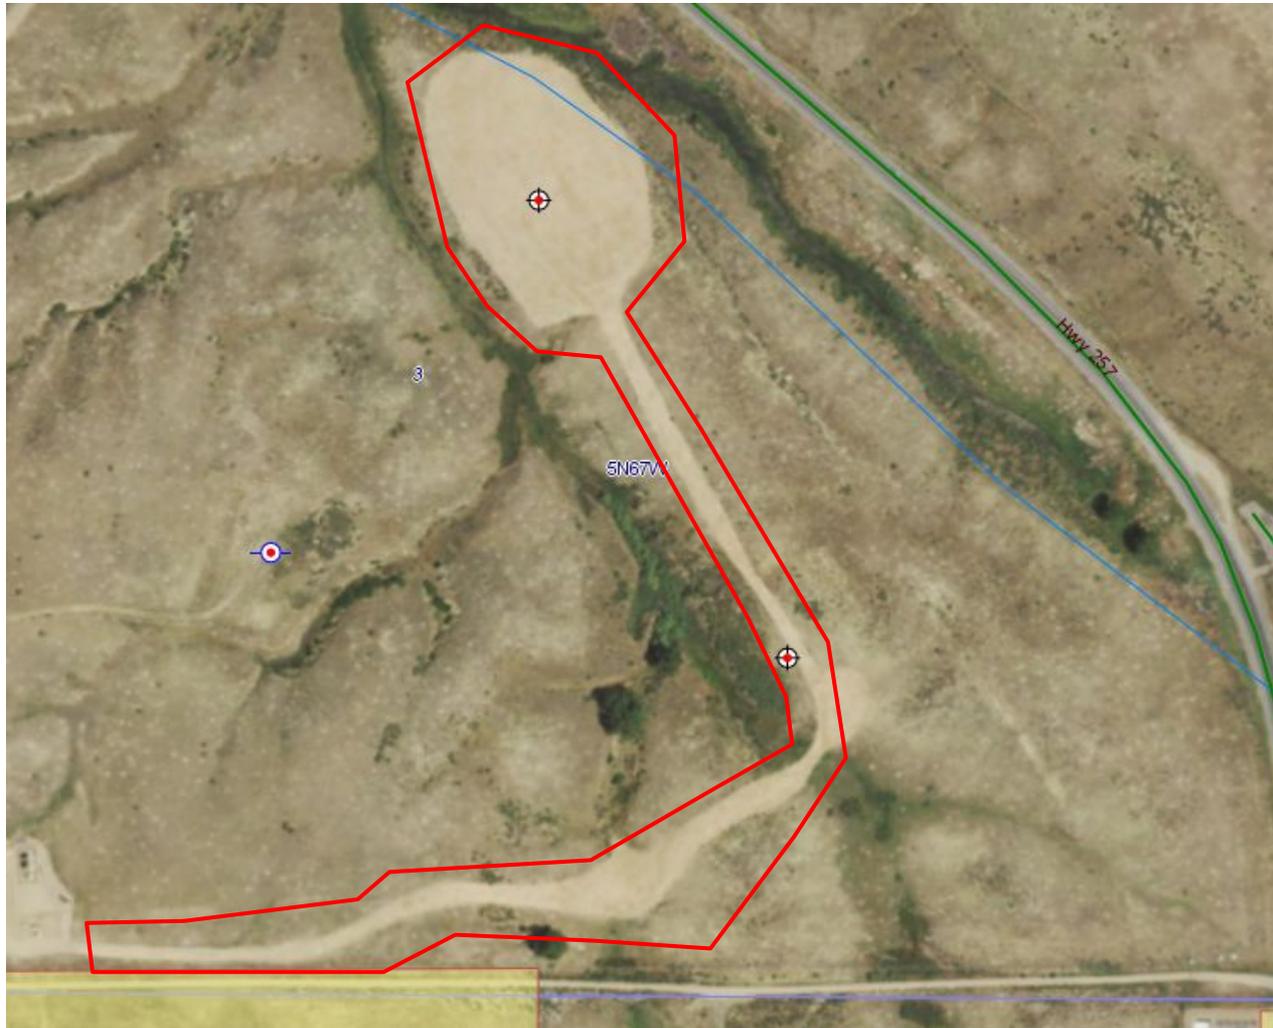
Photo 1. COGCC GISOnline aerial imagery from 2019 illustrates the well location (red circle) and associated access road. The associated tank battery is still active.

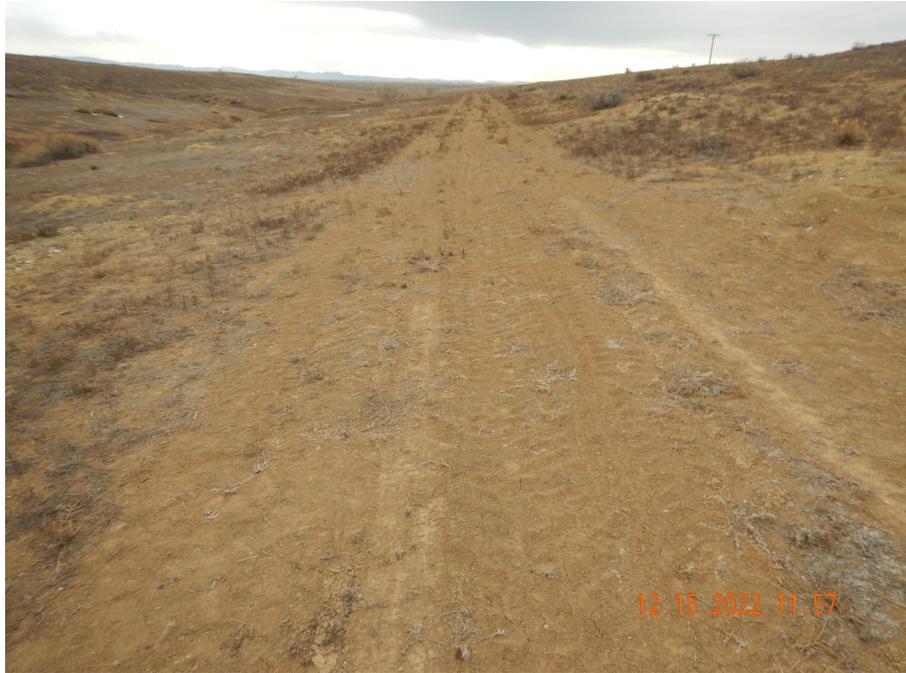
Photo 2. Photo taken from a portion of the well location access road, facing North. Photo illustrates the limited establishment of grass species observed and it is predominately bare ground.

Note- vehicle traffic (not from COGCC) and prairie dog burrows.

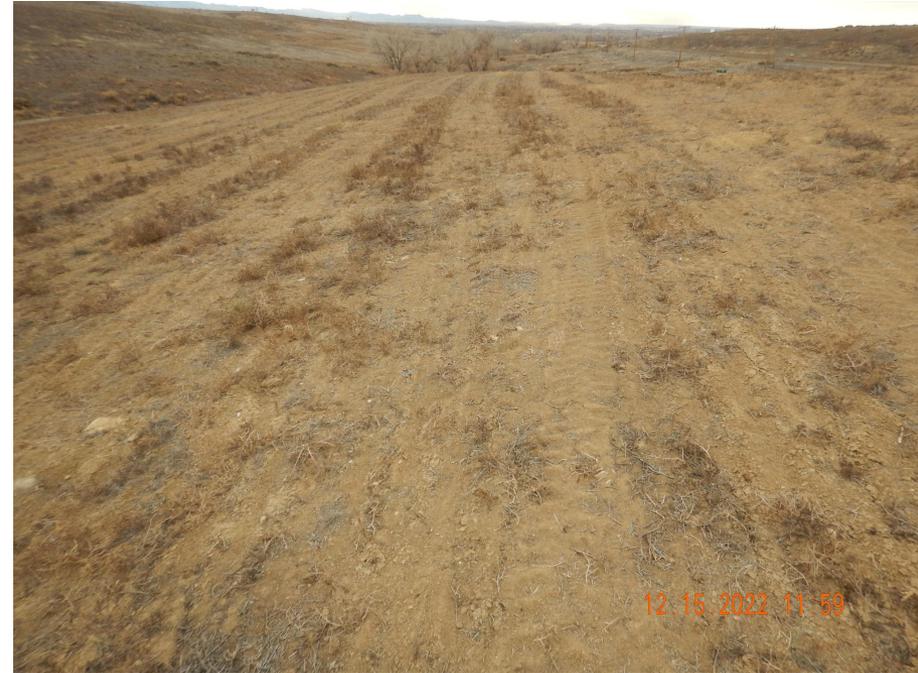
Photo 3. Photo taken from the central well location, facing North. See comments under Photo 2.

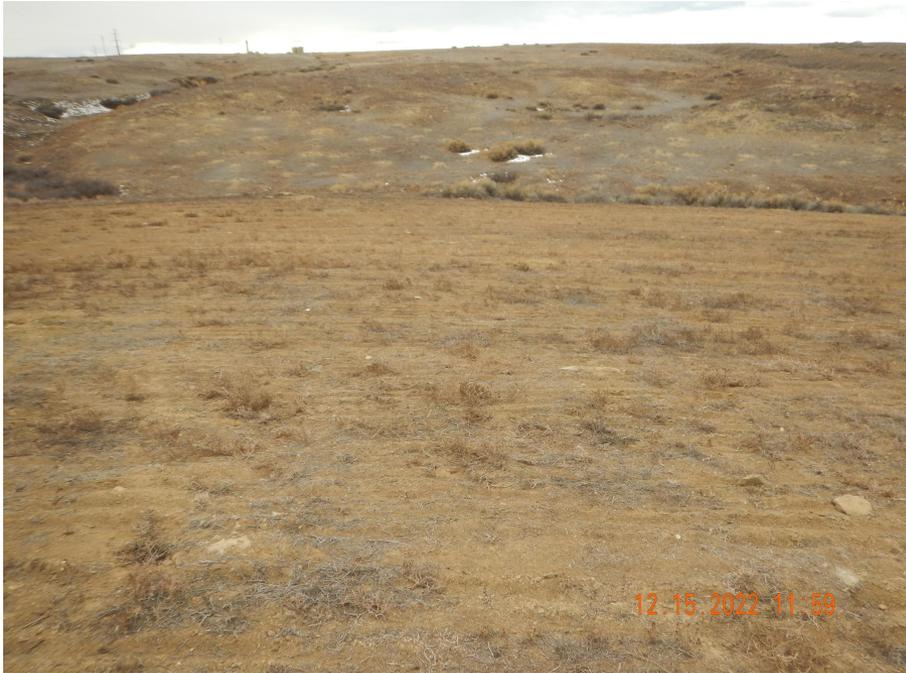
Photo 4. Photo taken from the central well location, facing East. See comments under Photo 2.

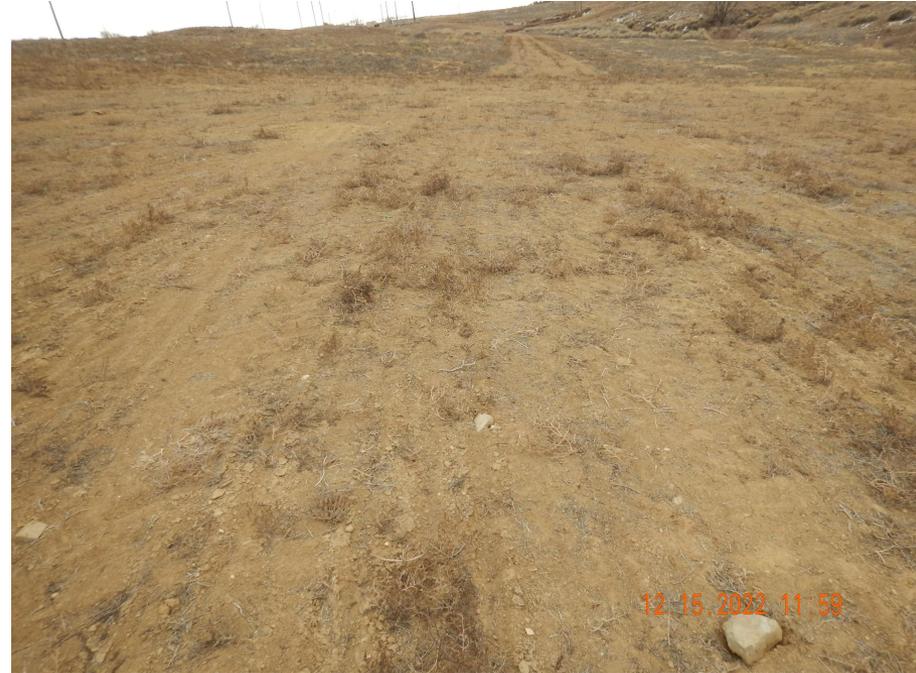
Photo 5. Photo taken from the central well location, facing South. See comments under Photo 2.

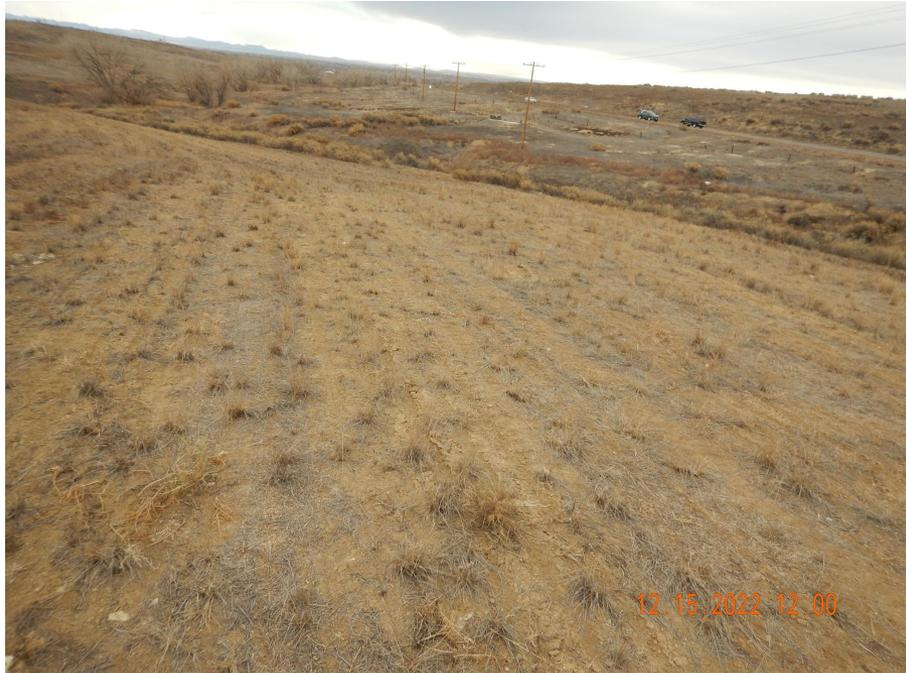
Photo 6. Photo taken from the east central well location, facing North. Photo illustrates the establishment of desirable plant species.

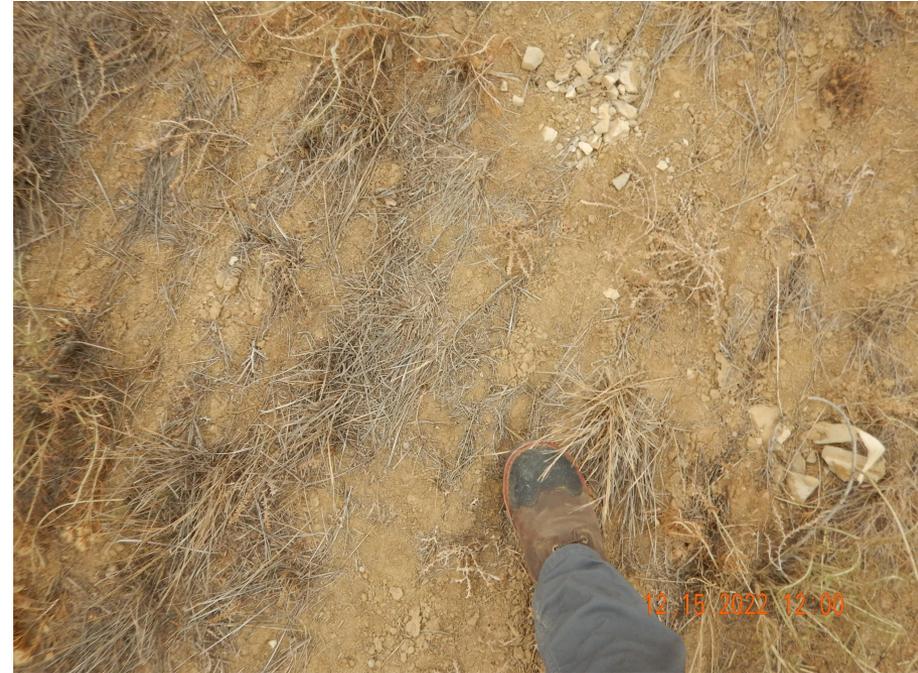
Photo 7. Close up photo taken from the east central well location. See comments under Photo 6.

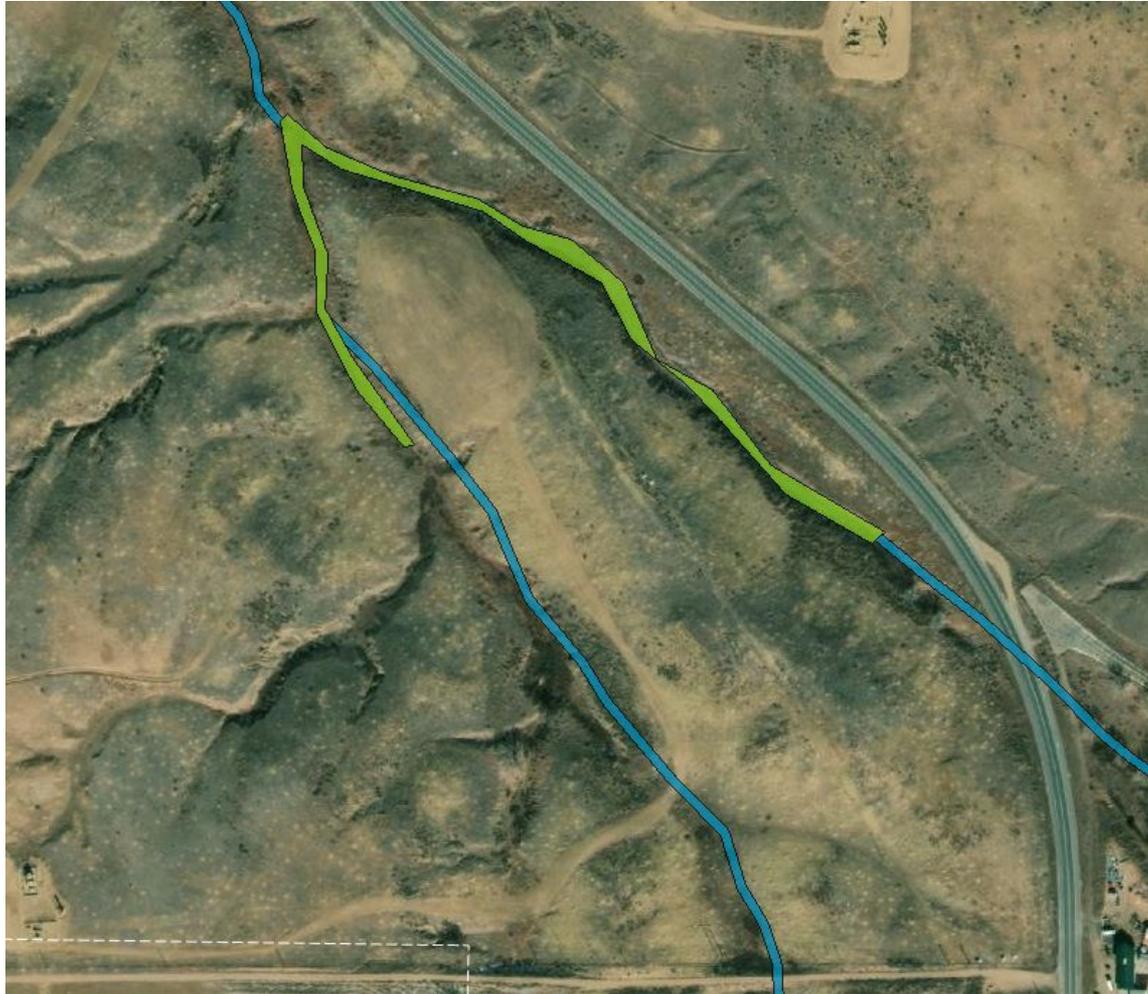
Photo 8. National Wetlands Inventory aerial illustrates Riverine habitat, Freshwater Emergent and Freshwater Forested/Shrub wetland downgradient of location.
