Inspection Photos

12/19/2022

Operator: TEP ROCKY MOUNTAIN LLC - 96850

Location #334431

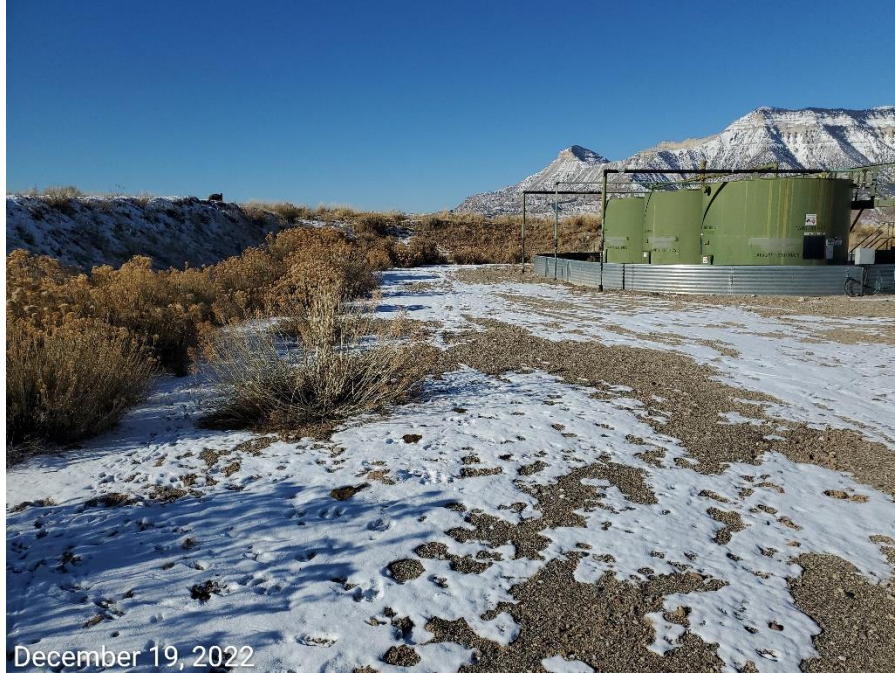
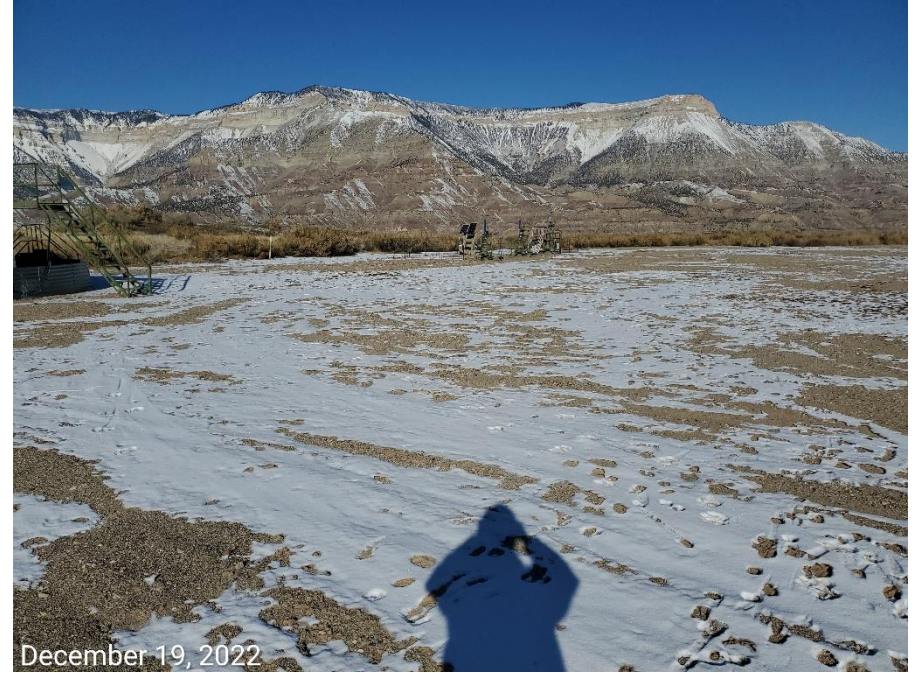
Photo 1: Photos 1-2 taken from the south end of the Location. Photos provide an overview of the location from west, northwest, northeast to east.

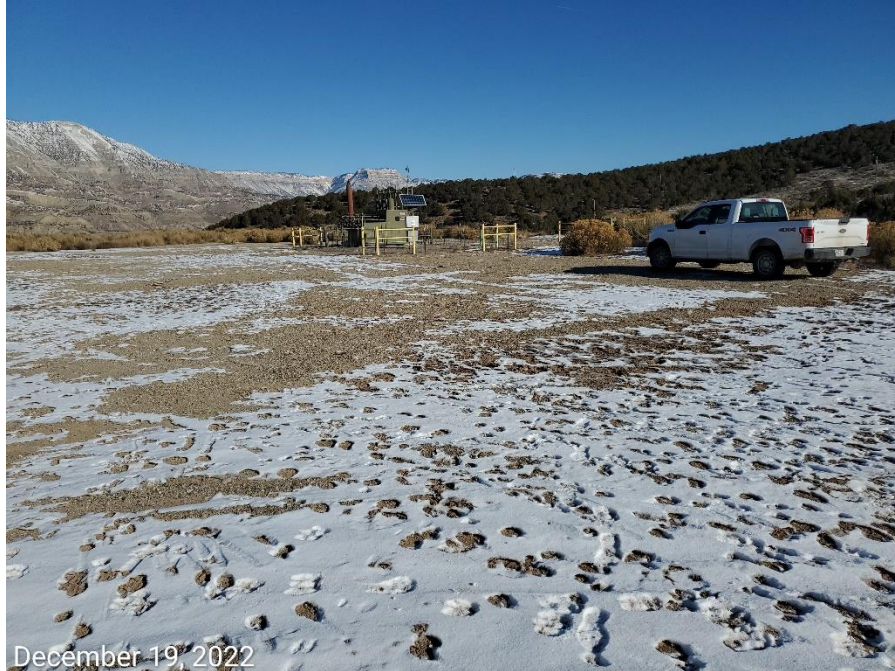
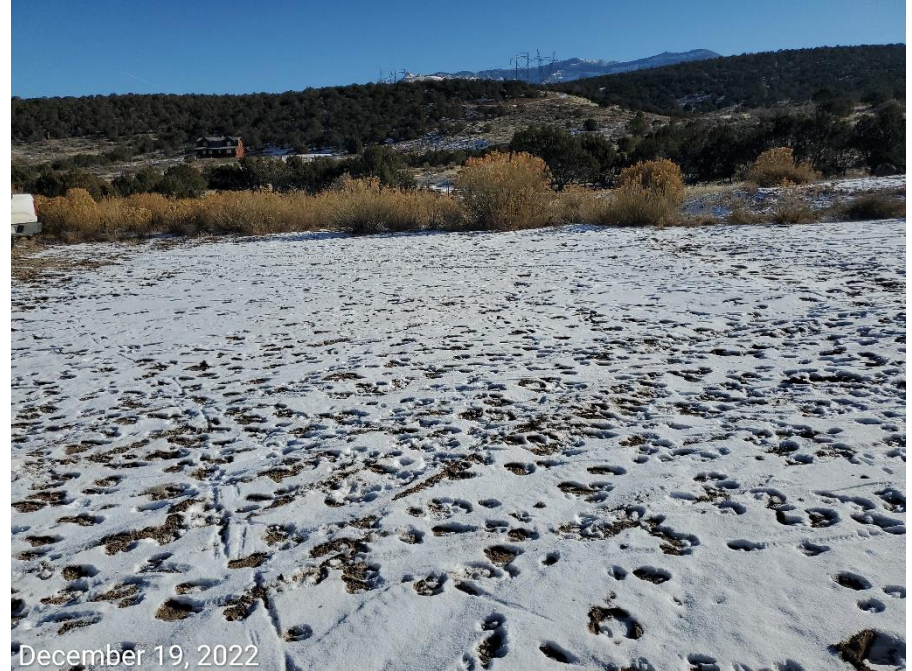
Photo 2: See comment under photo 1.

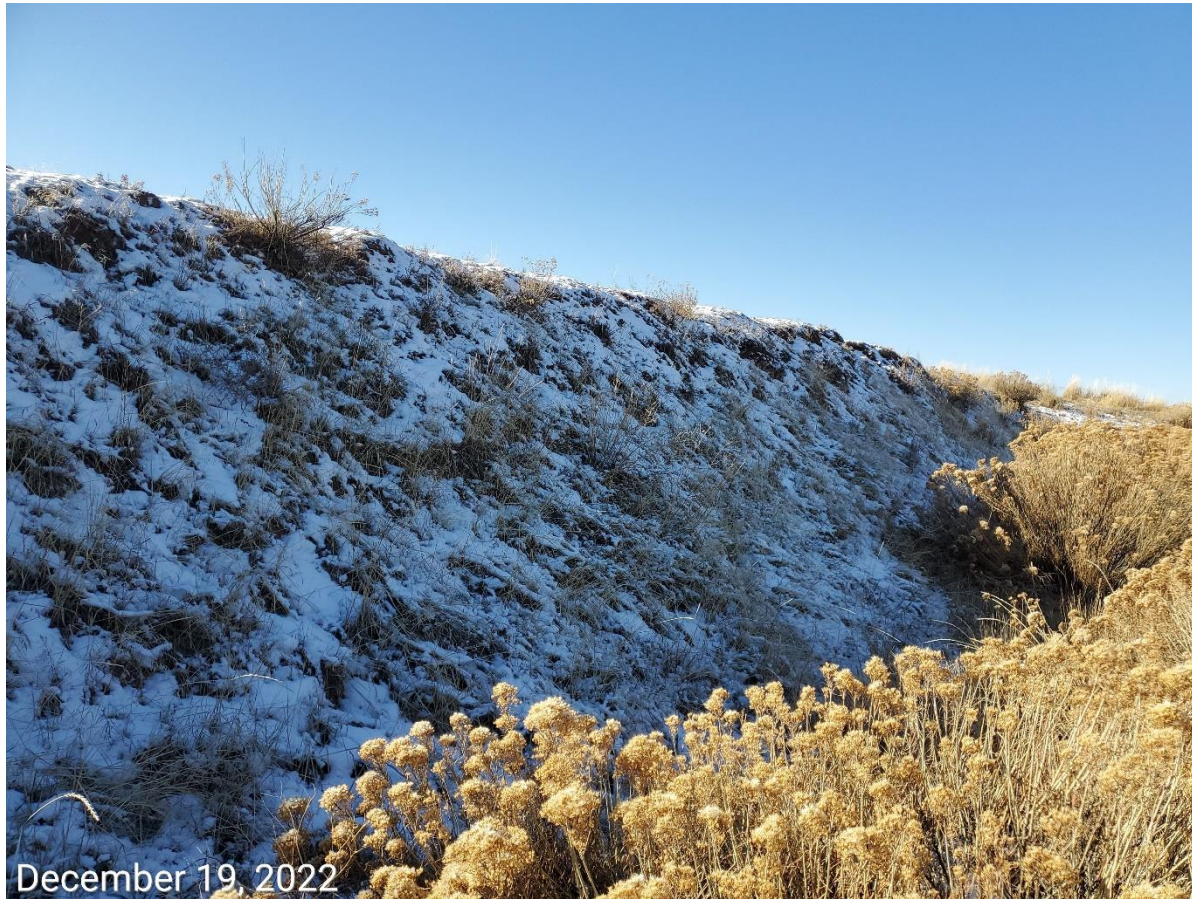
Photo 3: Photo shows cut slopes on the south end of the Location- slopes appear to be vegetated and stabilized.

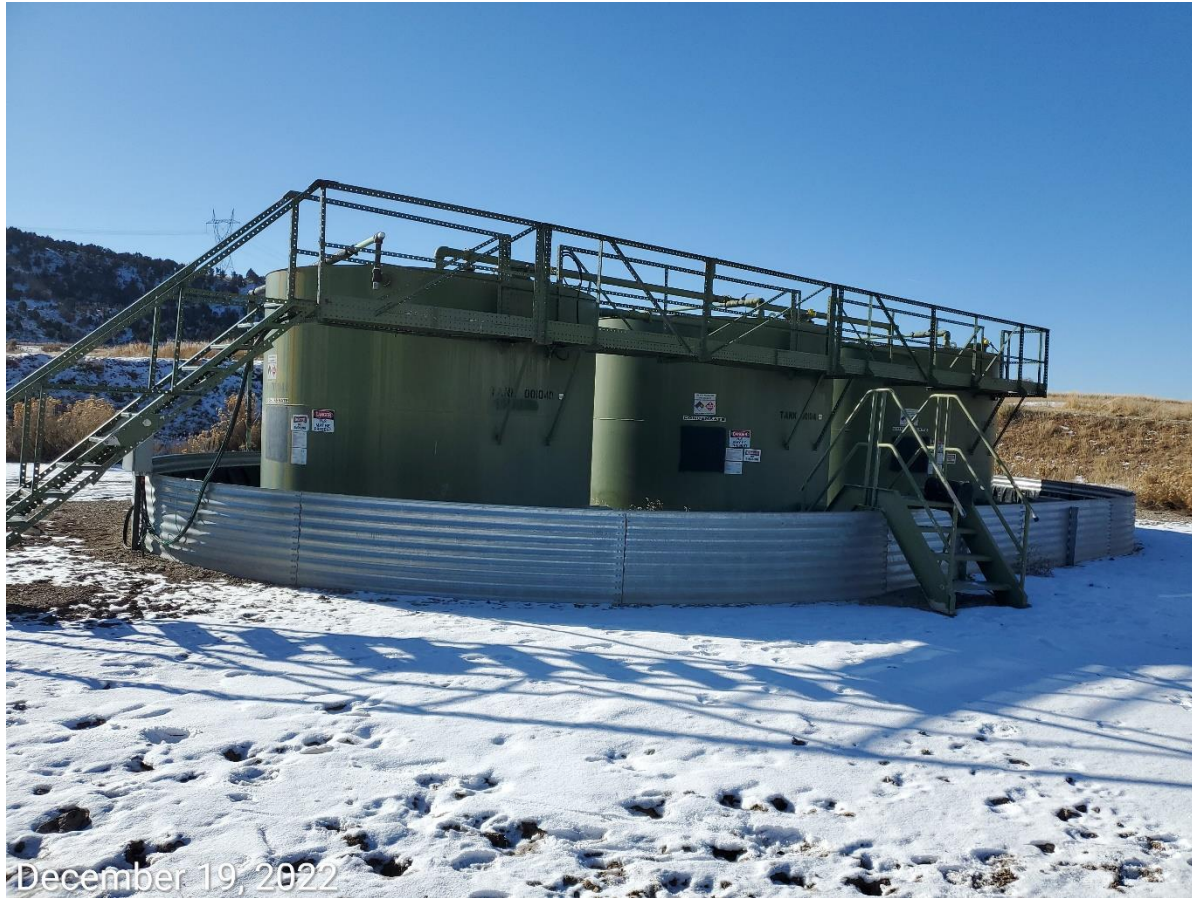
Photo 4: Tank battery facility.

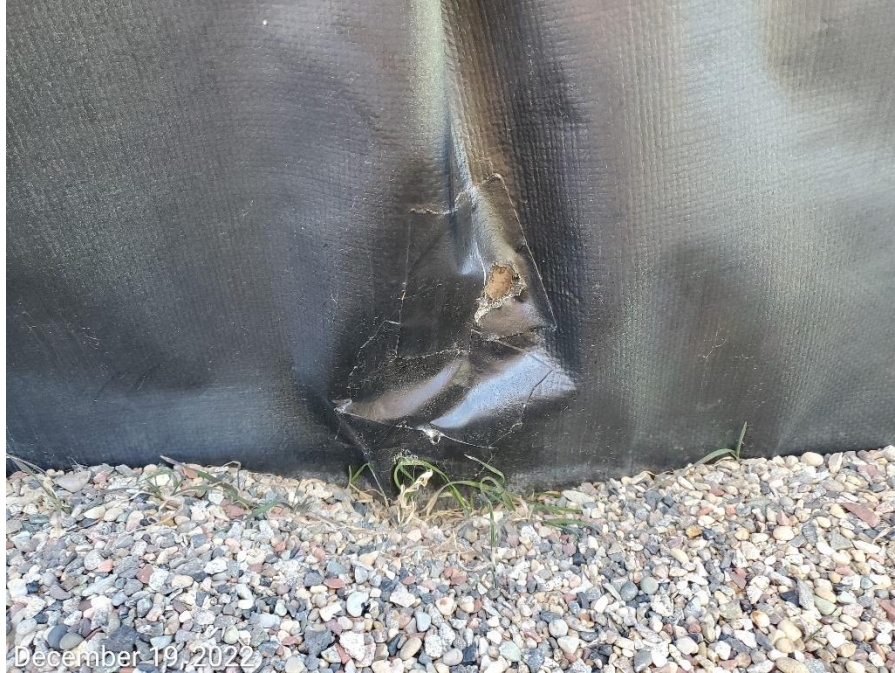
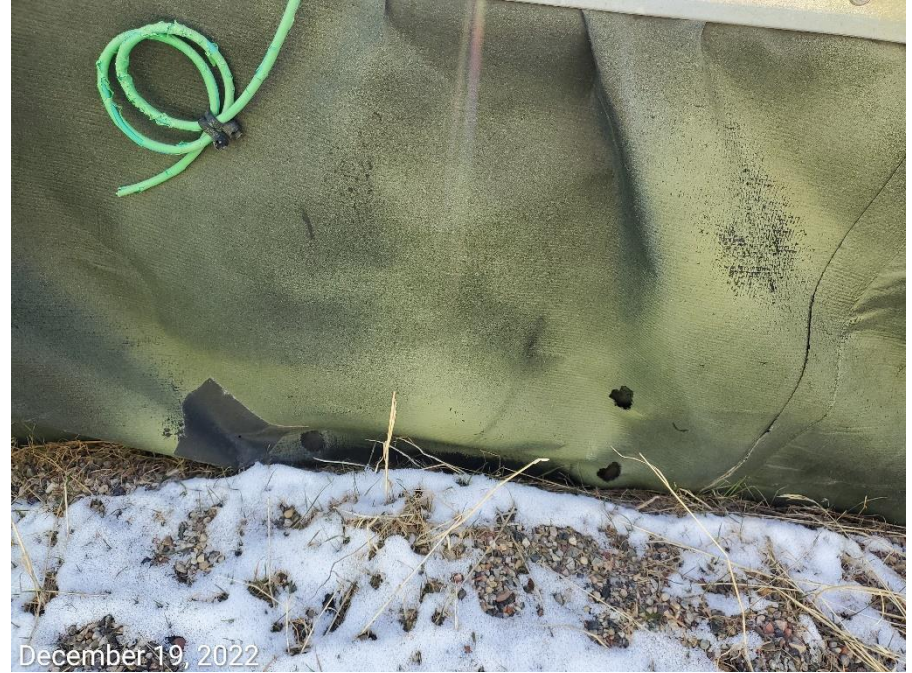
Photo 5: Photos examples showing various holes observed throughout the entire liner at the tank battery.

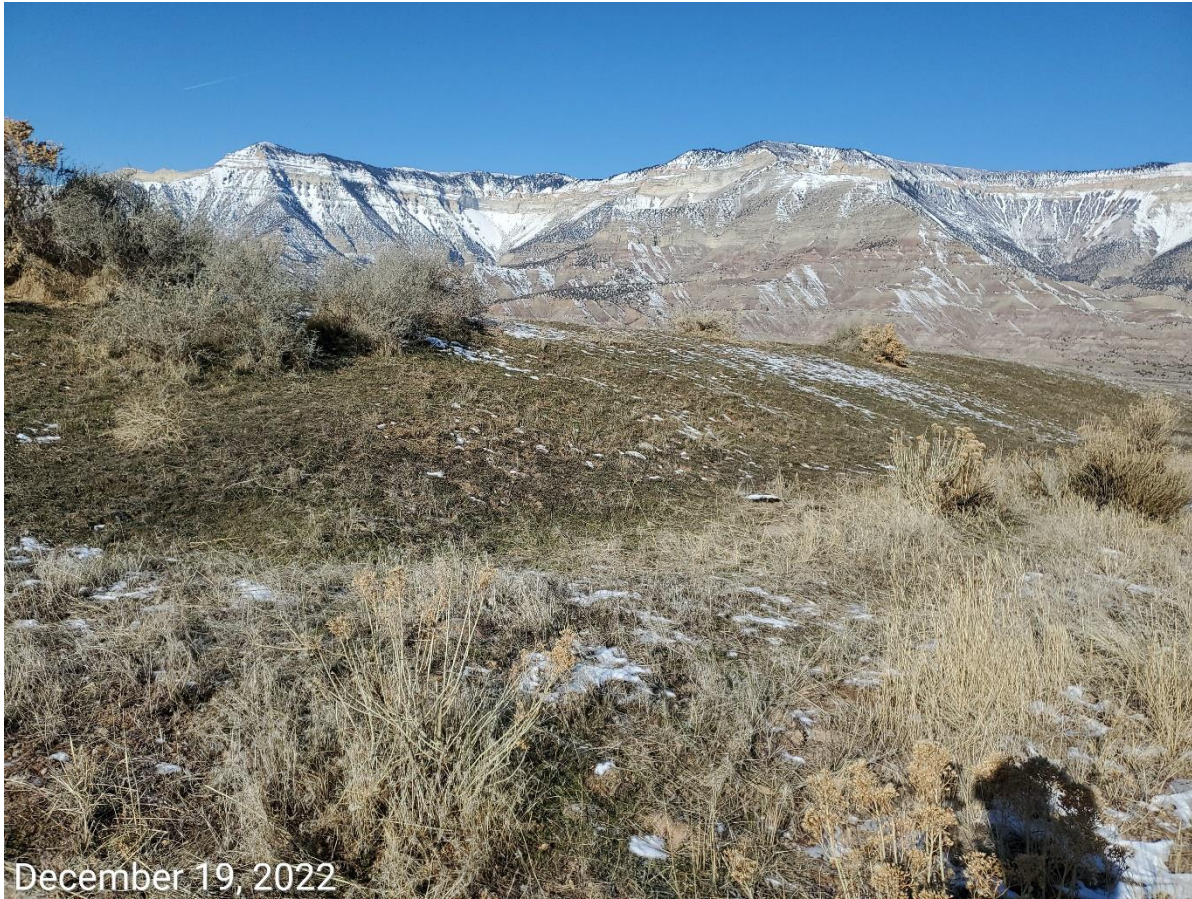
Photo 6: Soil stockpile on the west end of the Location.

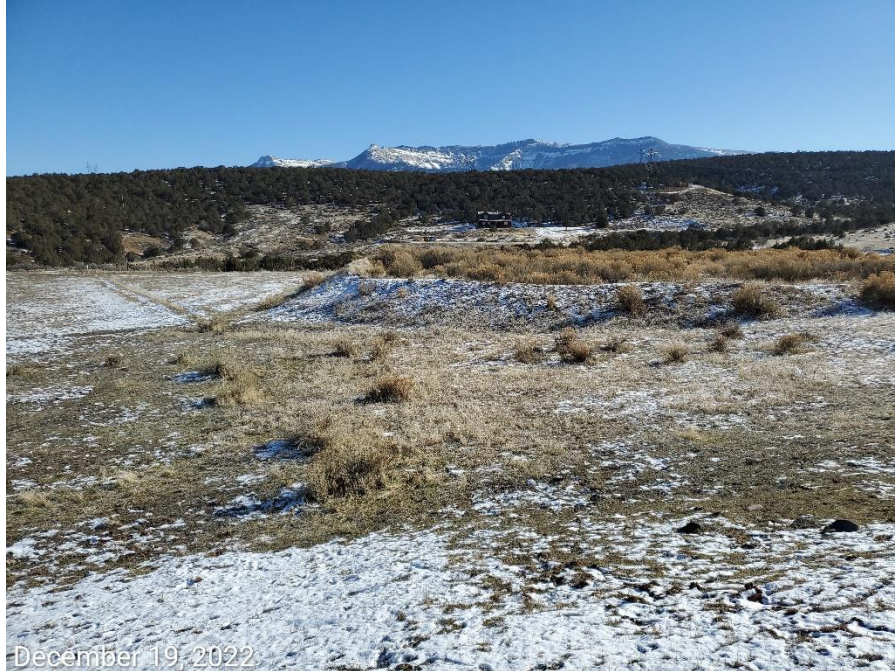
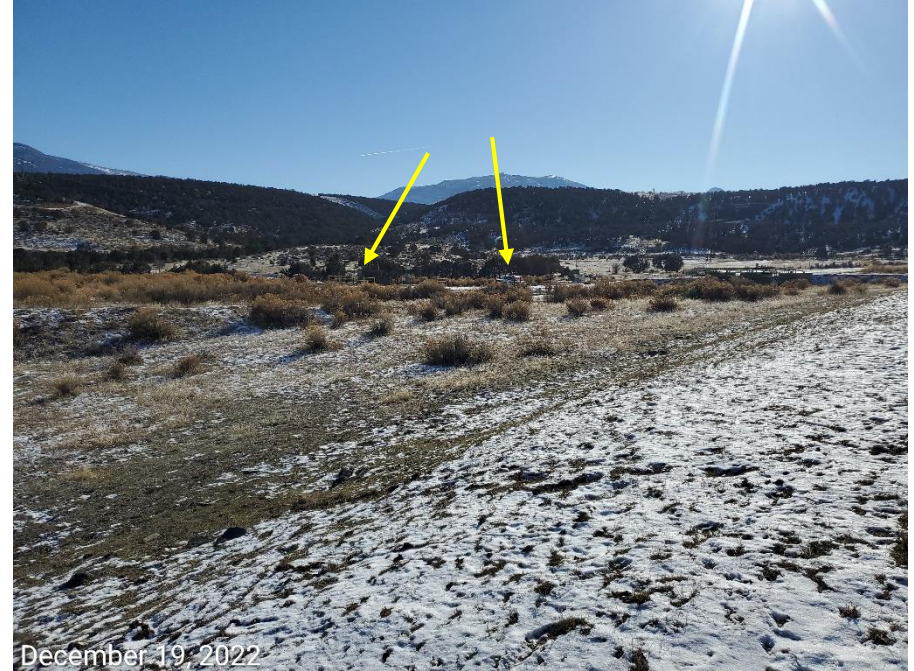
Photo 7: Photo taken from the soil stockpile on the northwest end of the Location, facing east and southeast. Photos show areas on the north end of the Location that have not been reclaimed in accordance with 1003 requirements- fill slopes remain evident, soils are compacted, gravel/road base was not removed and soils replaced. Yellow arrows in photo left shows production equipment (wells, separators).

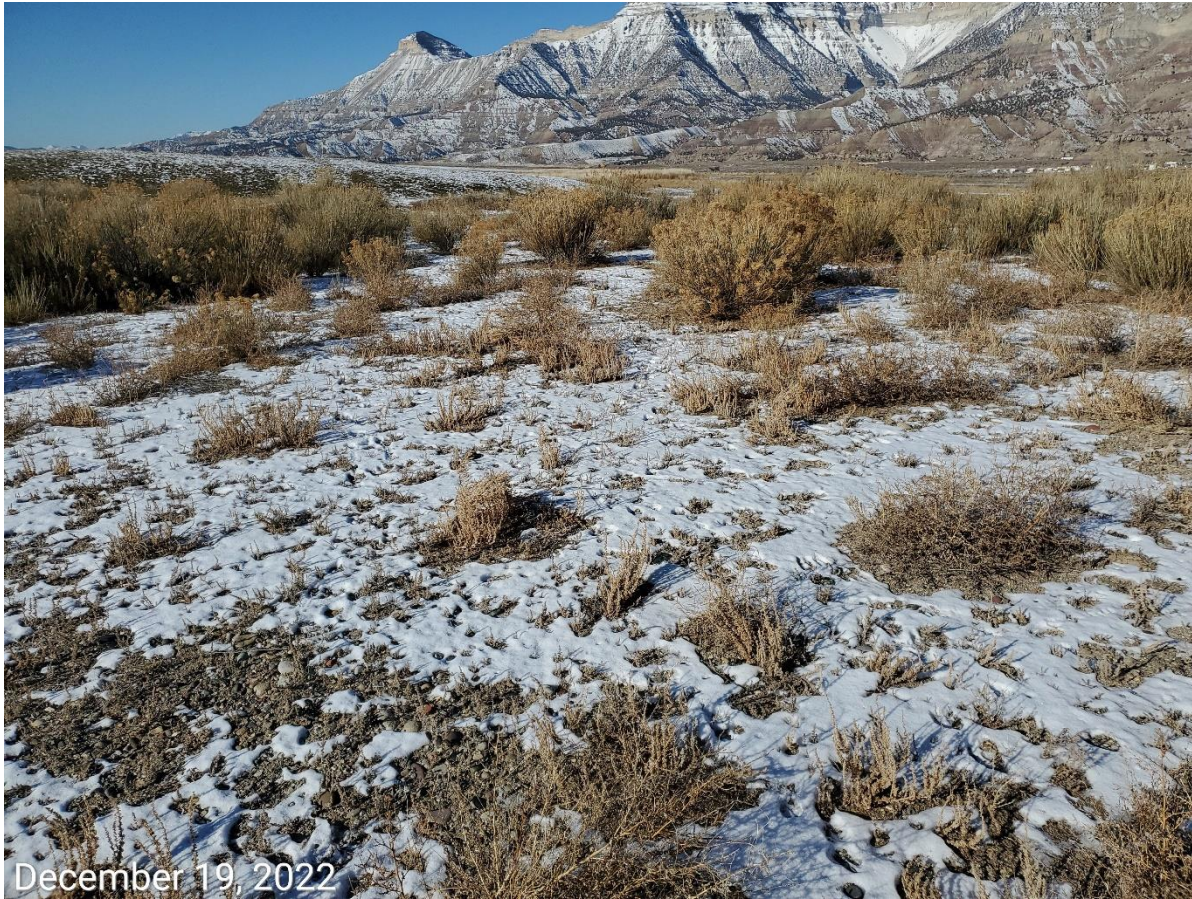
Photo 8: Photo taken from the north end of the Location, facing northwest. Photo shows areas not needed for production have not been reclaimed- gravel/road base remains evident; areas have not been decompacted, recontoured and reclaimed per 1003 rules.

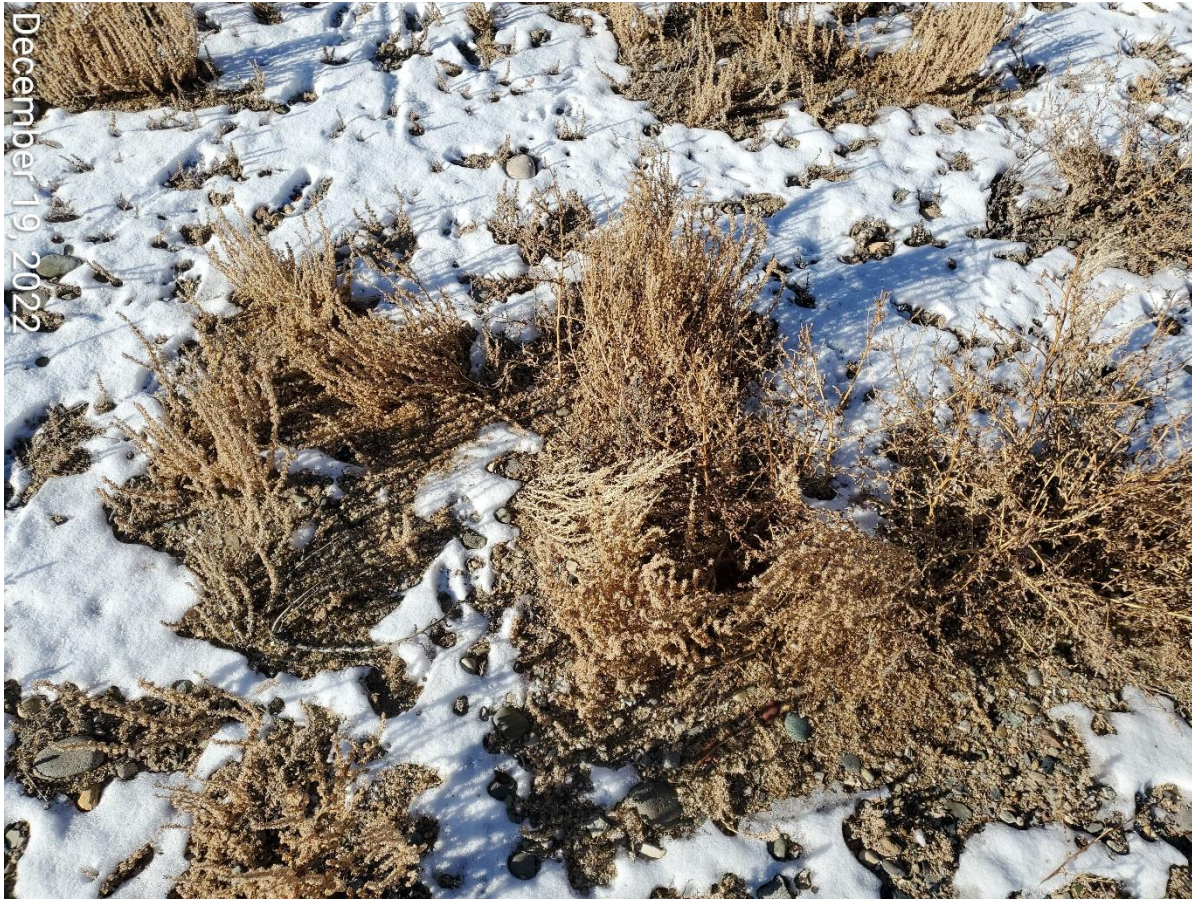
Photo 9: Photo taken from the north end of the Location. Photo shows example of Undesirable Plant Species observed- Species observed include Halogeton, and Russian thistle.

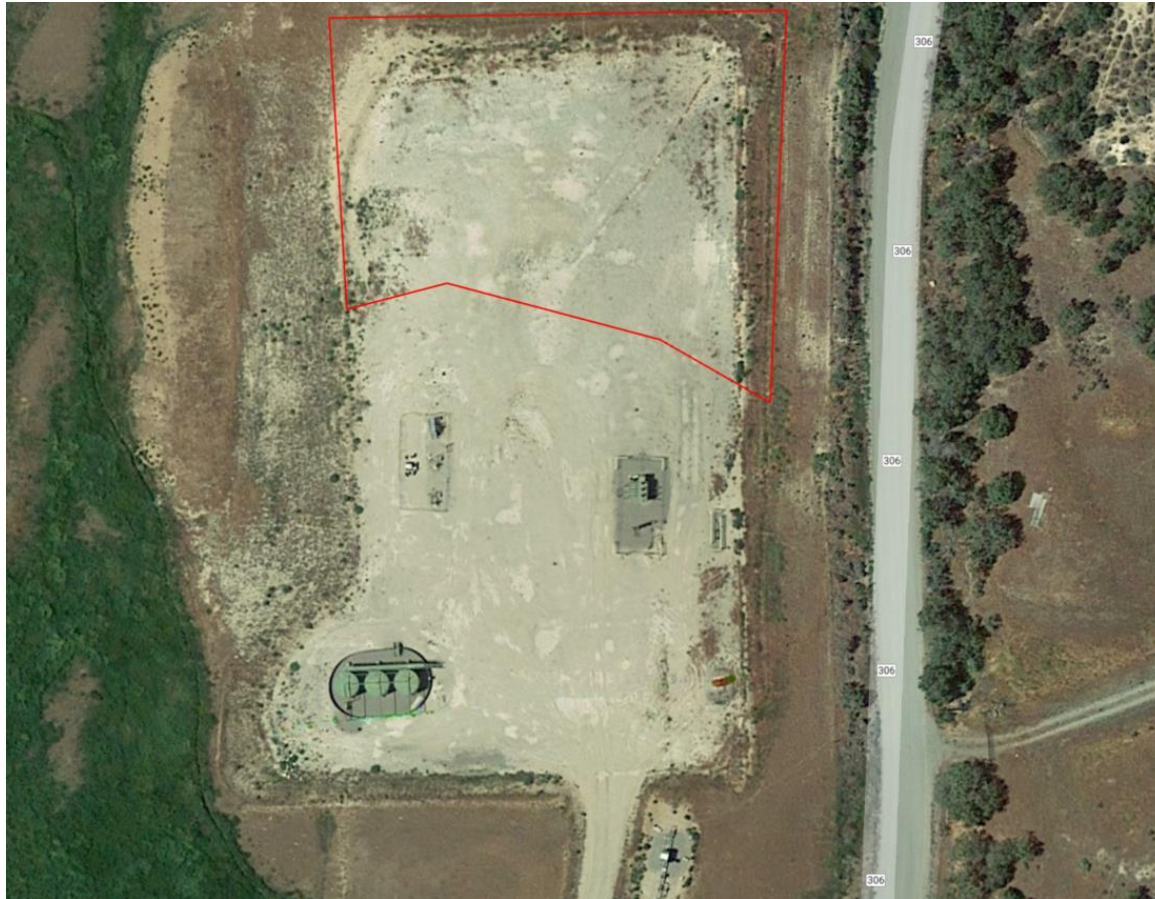
Photo 10: Google earth aerial image of the Location. Red polygon provides examples are areas not needed for production requiring interim reclamation. Areas ~1 acre in size.
