Inspection Photos

API: 061-06023

Operator: WESTERN OPERATING COMPANY

Inspection Date: 12/20/2022

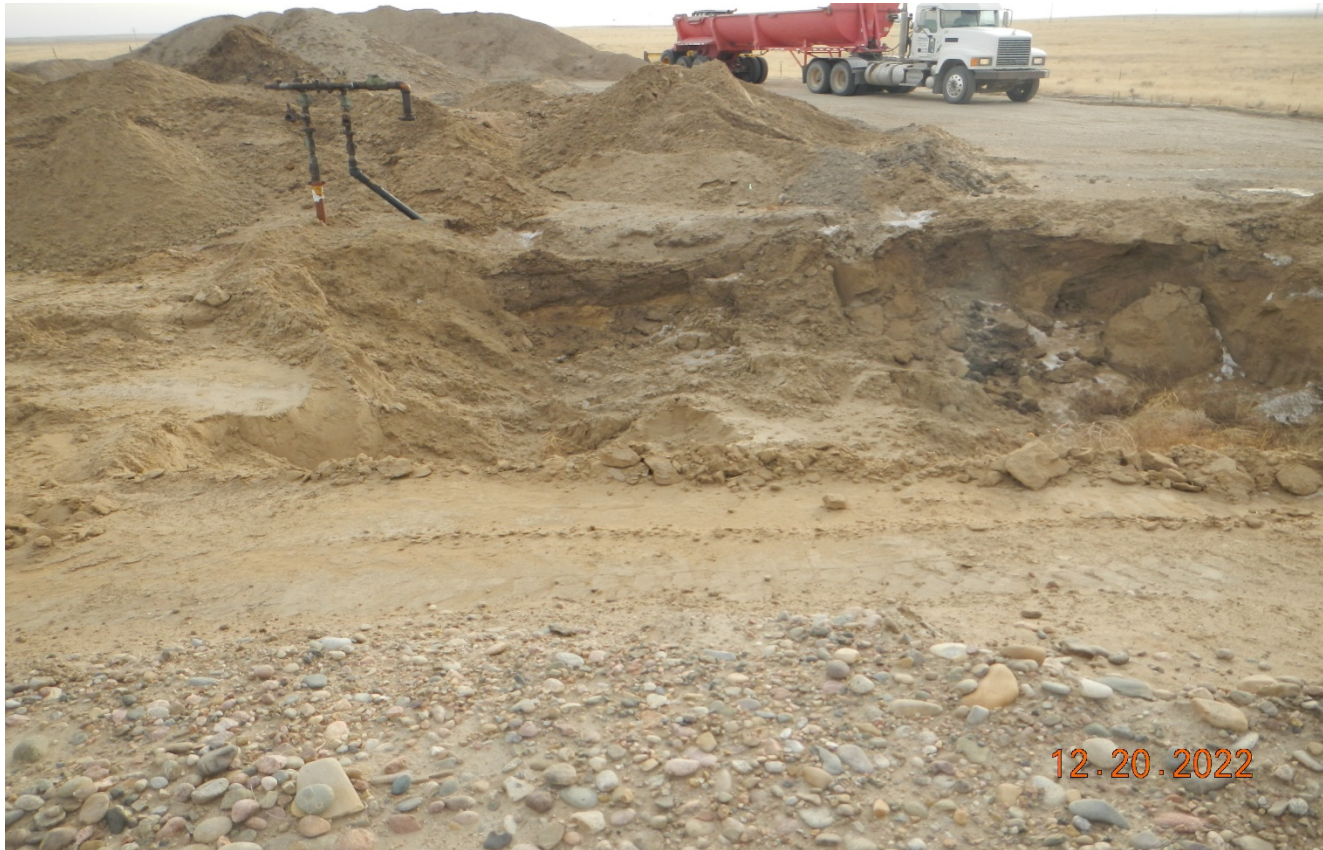
Photo 1. Facing south toward the tank battery facility. The tank was removed and soils have been excavated in this area. Remediation project: 20712

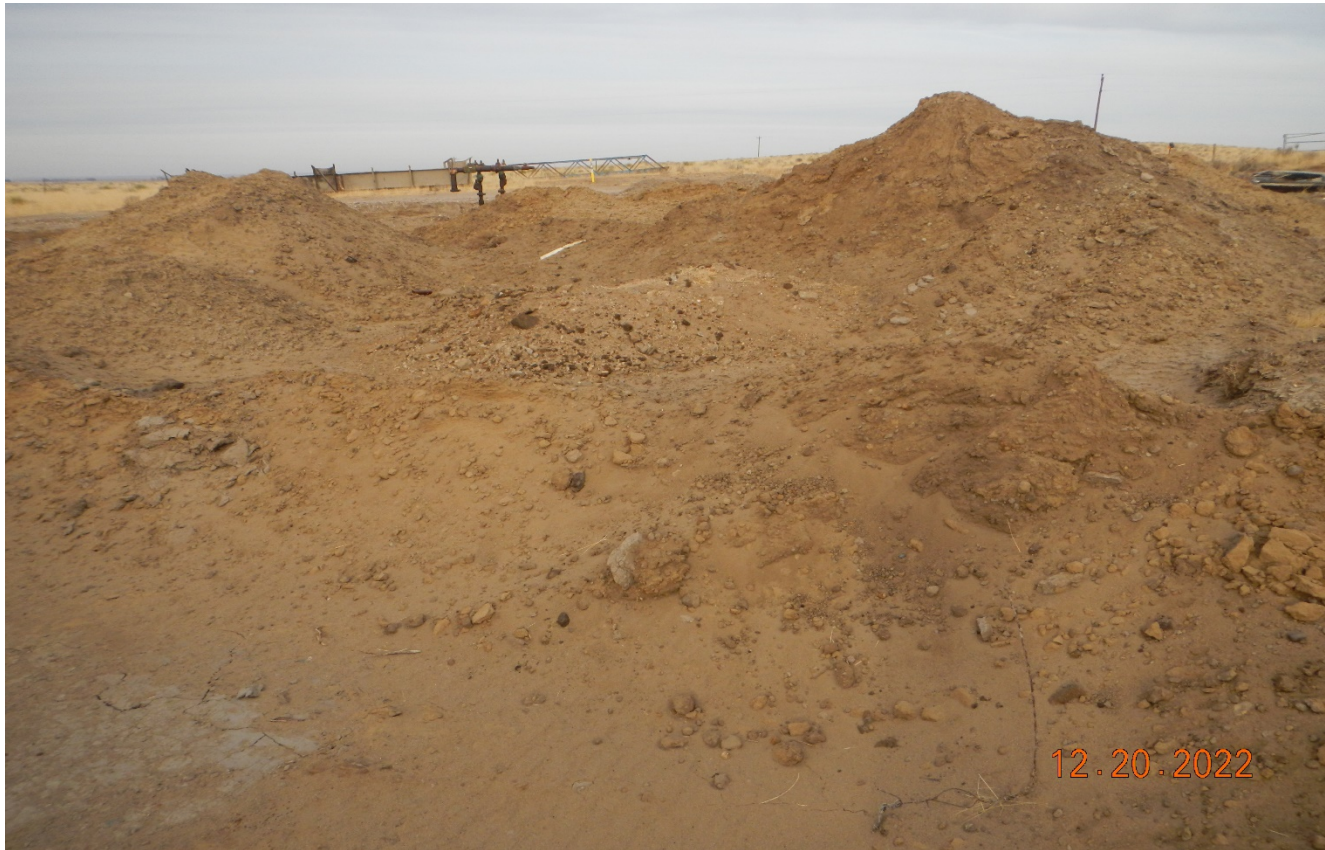
Photo 2. The berms around the soil piles have been constructed larger but were not compacted. Also, no liner was observed under the contaminated soils. Contaminated soils should be removed and properly disposed ASAP.

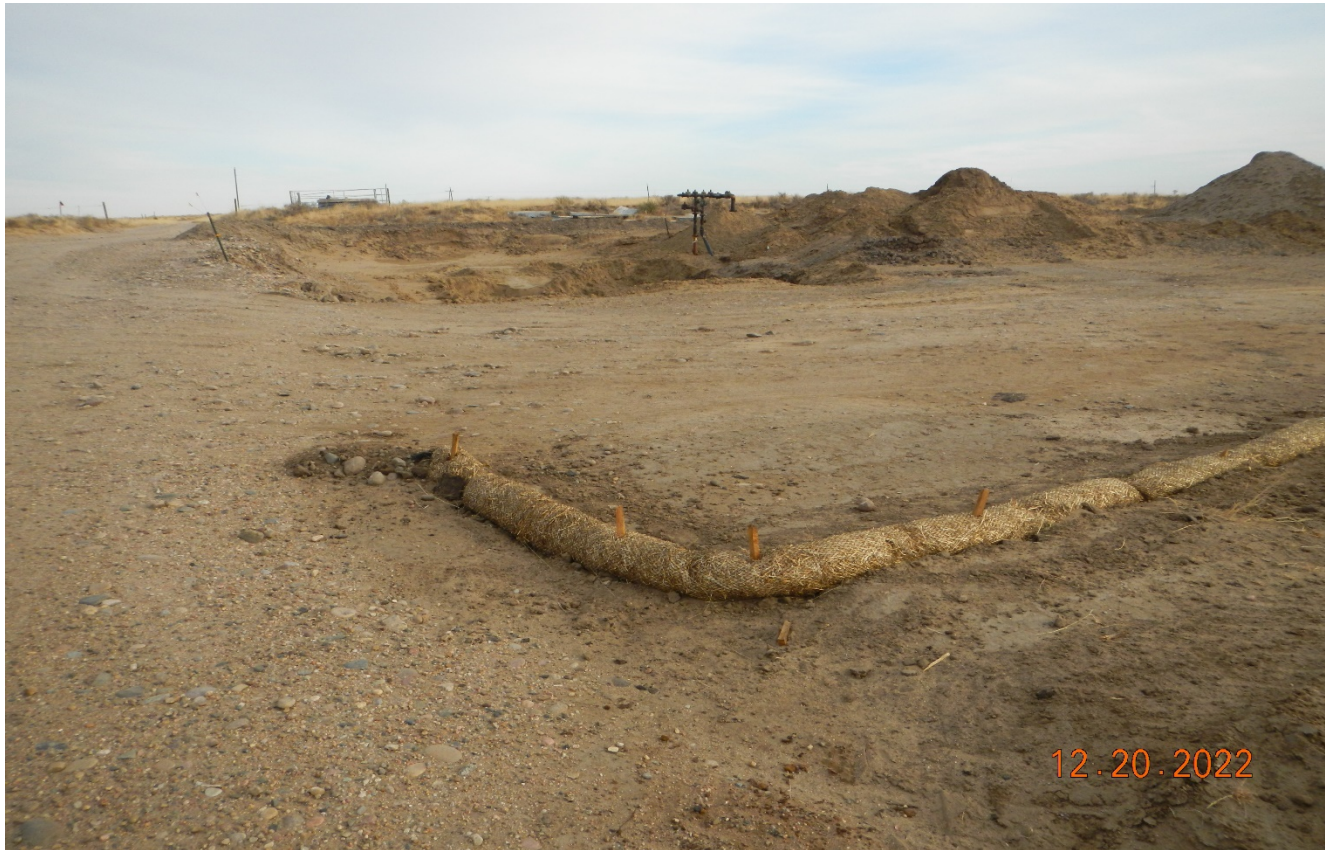
Photo 3. Facing southeast toward the tank battery location. Straw wattles have been installed along the west side of the location.

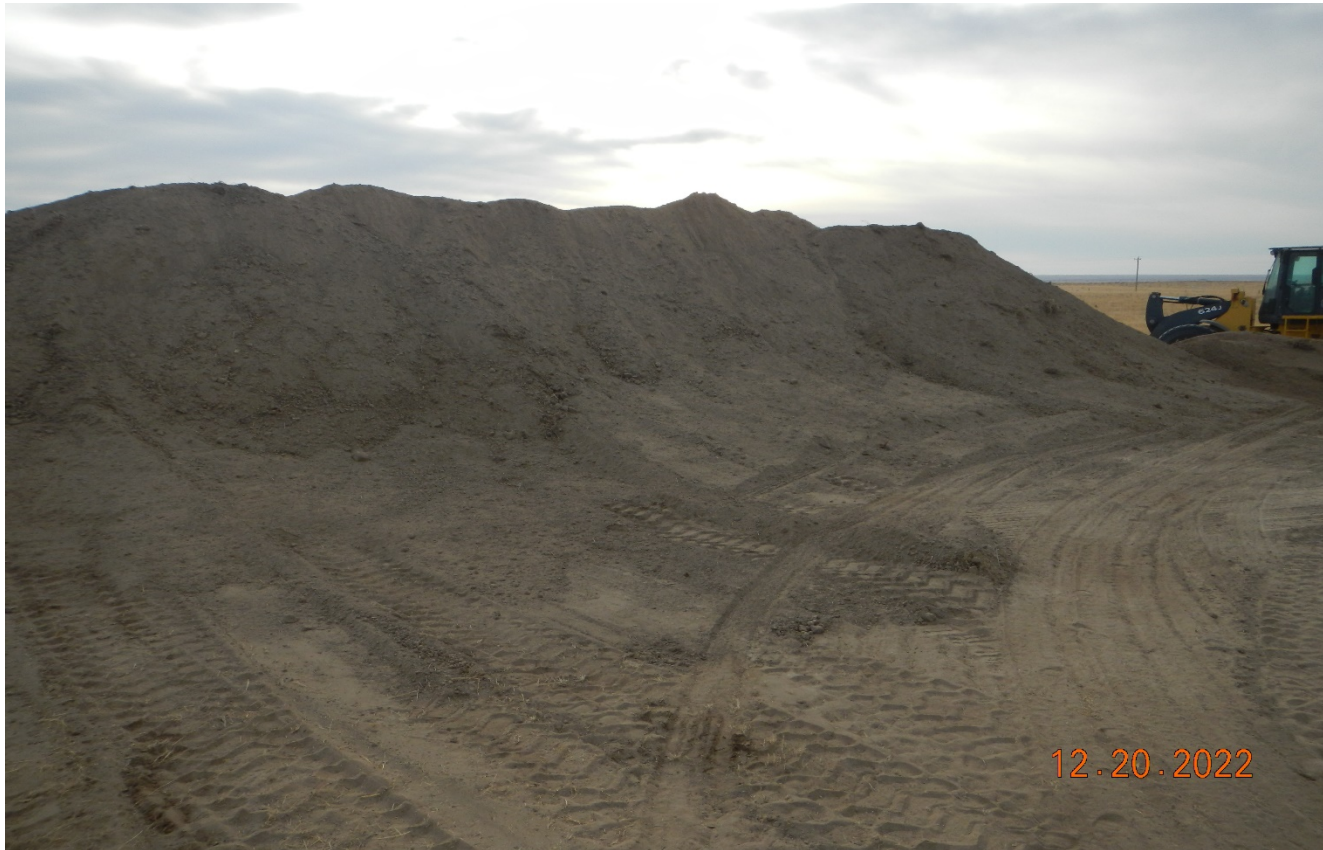
Photo 4. Facing toward the south side of the location. Soil is being hauled in and stored on the location. Temporary erosion controls will be need to prevent erosion of the loose soils.

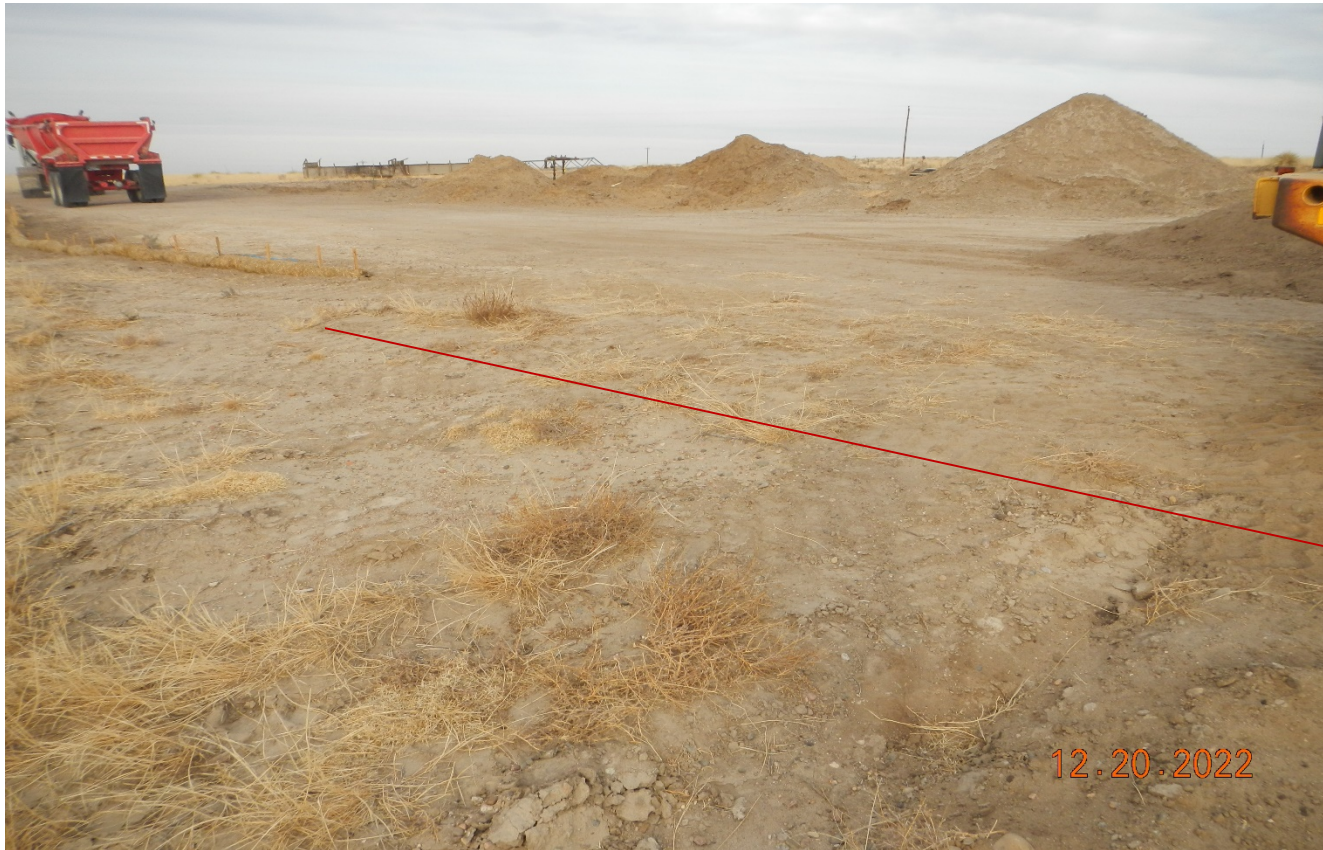
Photo 5. Facing north at the southwest side of the tank battery location. Additional BMP's should be installed on the down gradient side shown at red line down gradient of soil stock pile.

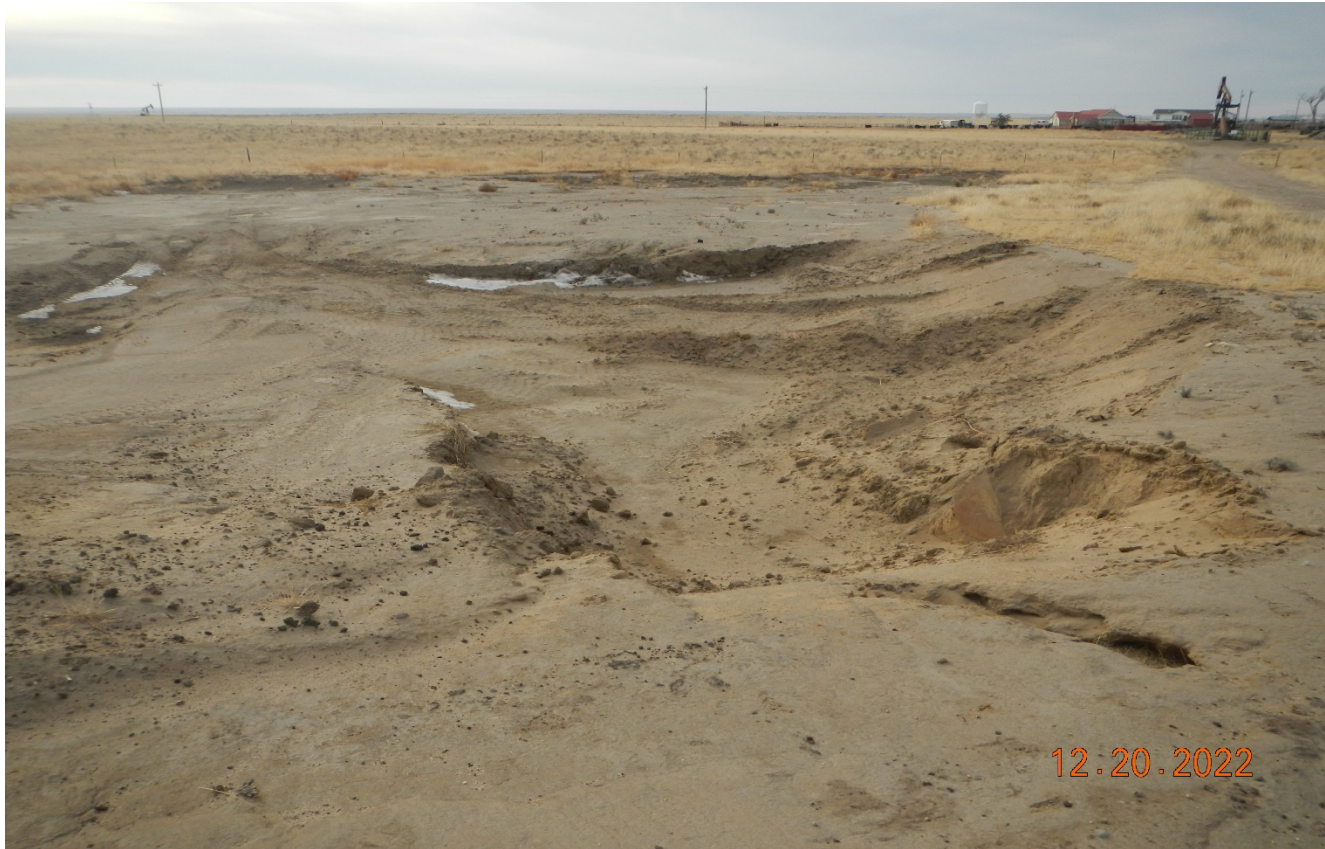
Photo 6. Facing southwest toward the area where the spill occurred. Remediation project: 20712. Some areas have been excavated more than other areas.

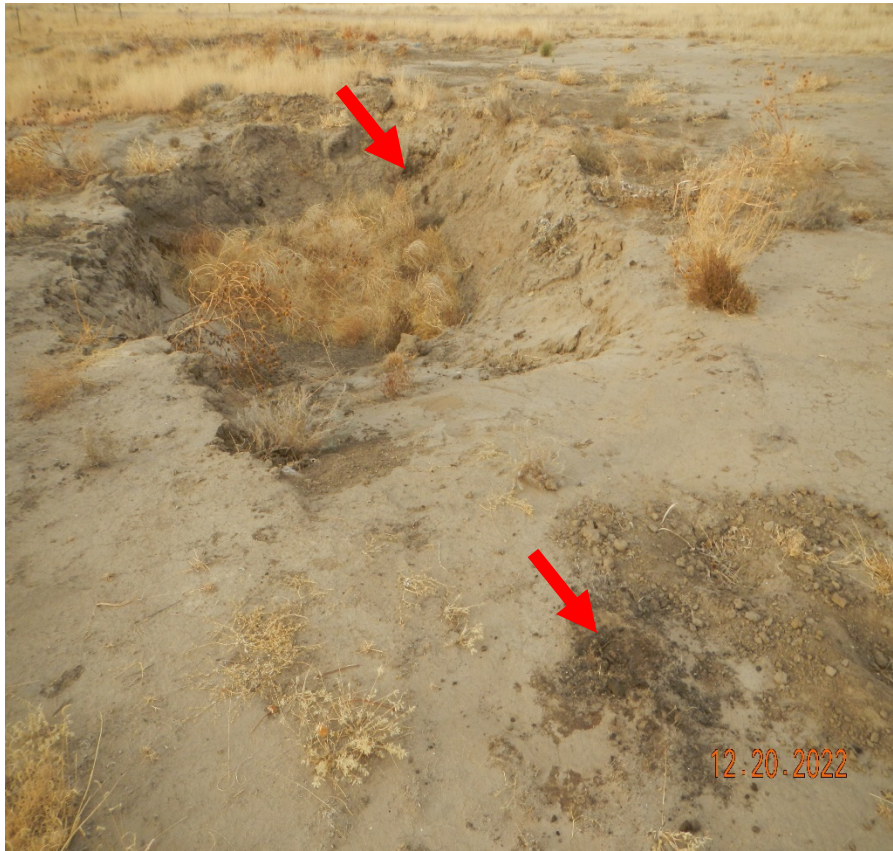
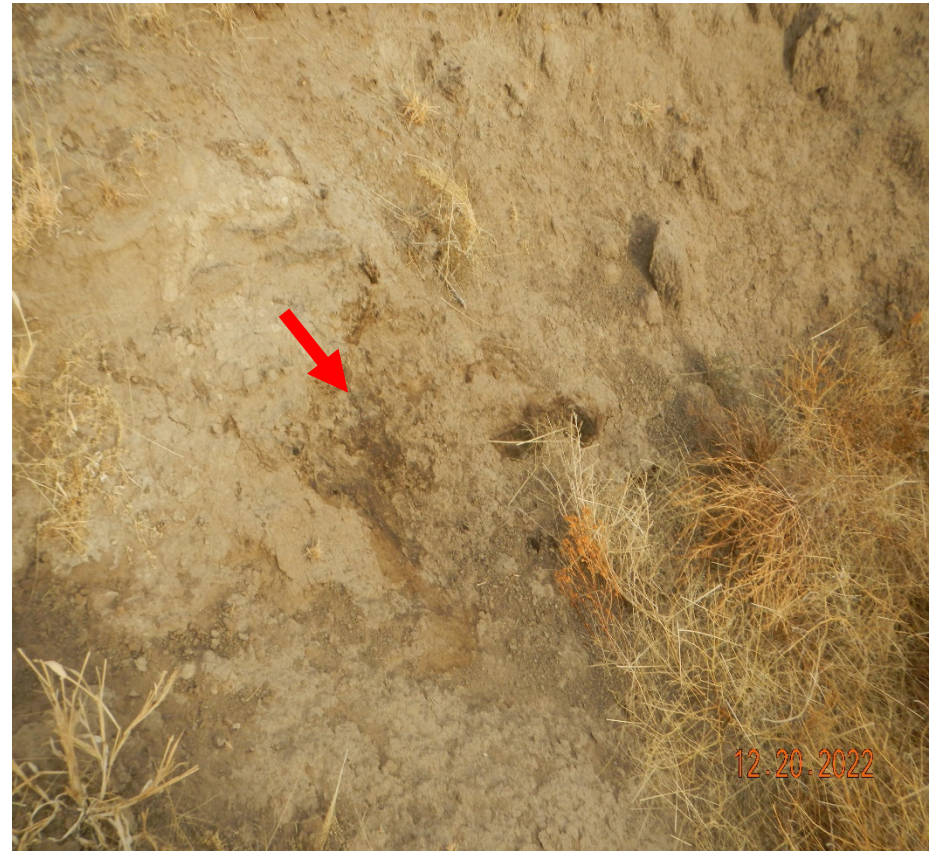
Photo 7. Located at the western side of the spill area. There is an excavated hole at this area approximately 12'x12'6'. There are still areas of oil stained soils at the surface (Bottom left) and 2ft. Down into the excavation area (right photo). Further excavation is needed.
