# REMEDIATION REPORT

## **Santa Fe Natural Resources Ridgeview 32-16-1 Pad**

NESW, Section 16, T6N R91W

Moffat County, Colorado

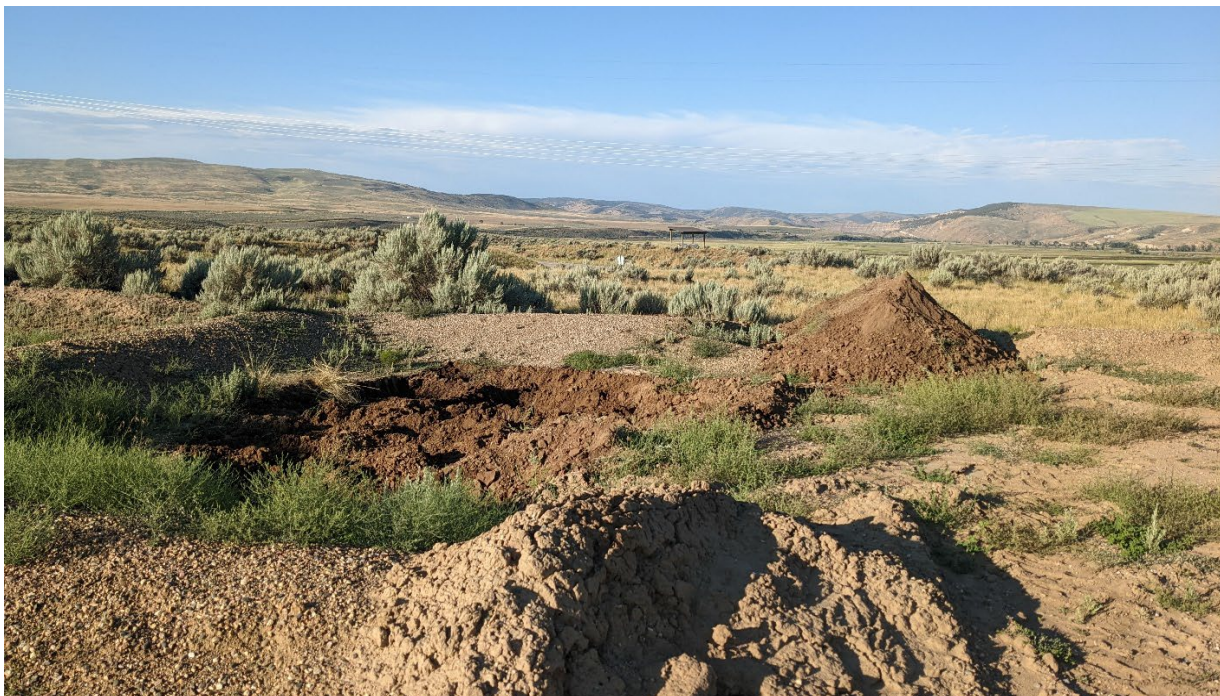
TCO met AE2 personnel on Site with a backhoe and began excavated on the former separator location bottom, throughout the entire secondary containment area to ~ 1.5 feet BGS. The excavated bottom was screened using a PID readings (**Attachment B**) and all samples were < 100 ppm VOCs. A confirmation sample were collected from the excavation bottom (R\_SEP\_1@1.5').

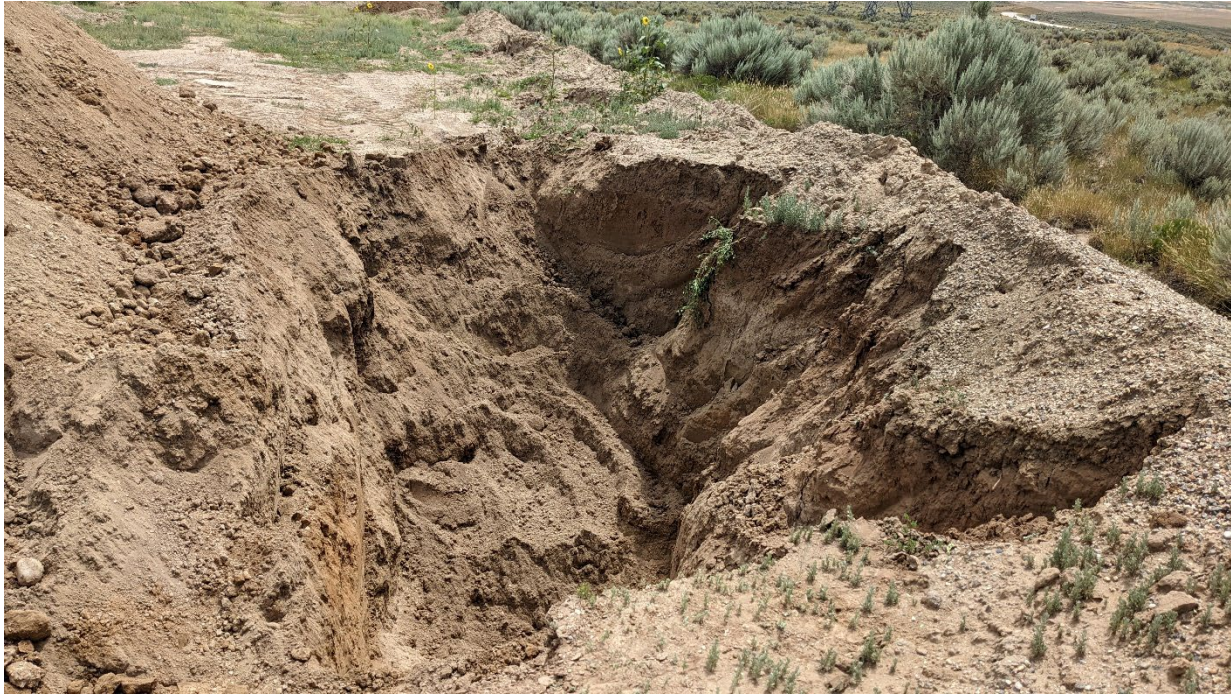
TCO then excavated in the former tank battery working toward the southeast secondary containment. until the excavation was ~9 feet BGS. The excavated bottom and side walls were screened using a PID and all samples were > 100 ppm VOC. Further excavation was postponed until a track hoe could be transported on site. The excavation pit was covered with a tarp to avoid precipitation leaching contamination deeper in soil.

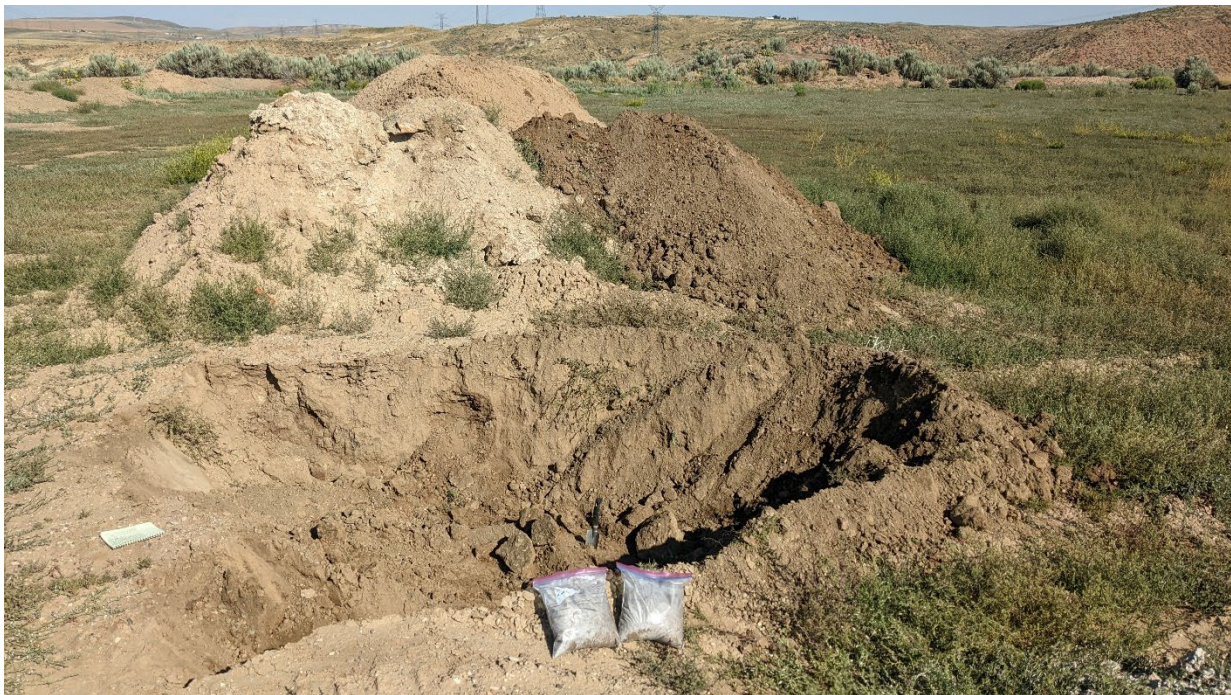
TCO excavated around the former wellhead. Three soil stains were observed on the surface near the wellhead (R\_WH) and soil piles. Each stain location was excavated and the area around the wellhead was excavated too. The excavation bottom and side walls were screened with PID readings < 100 ppm. Four (4) confirmation samples were collected from the excavation bottom and side walls.

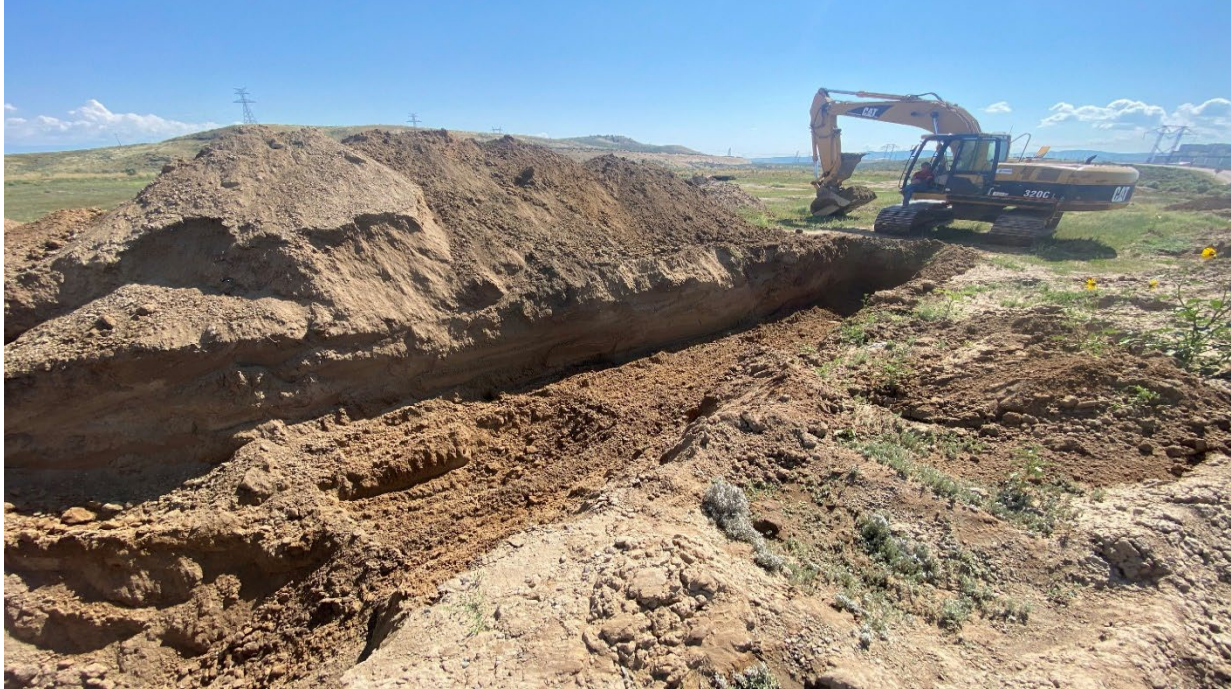
TCO further excavated the former tank battery until the excavated northwest, northeast, and southwest side walls were screened using a PID and all samples were < 100 ppm VOC.

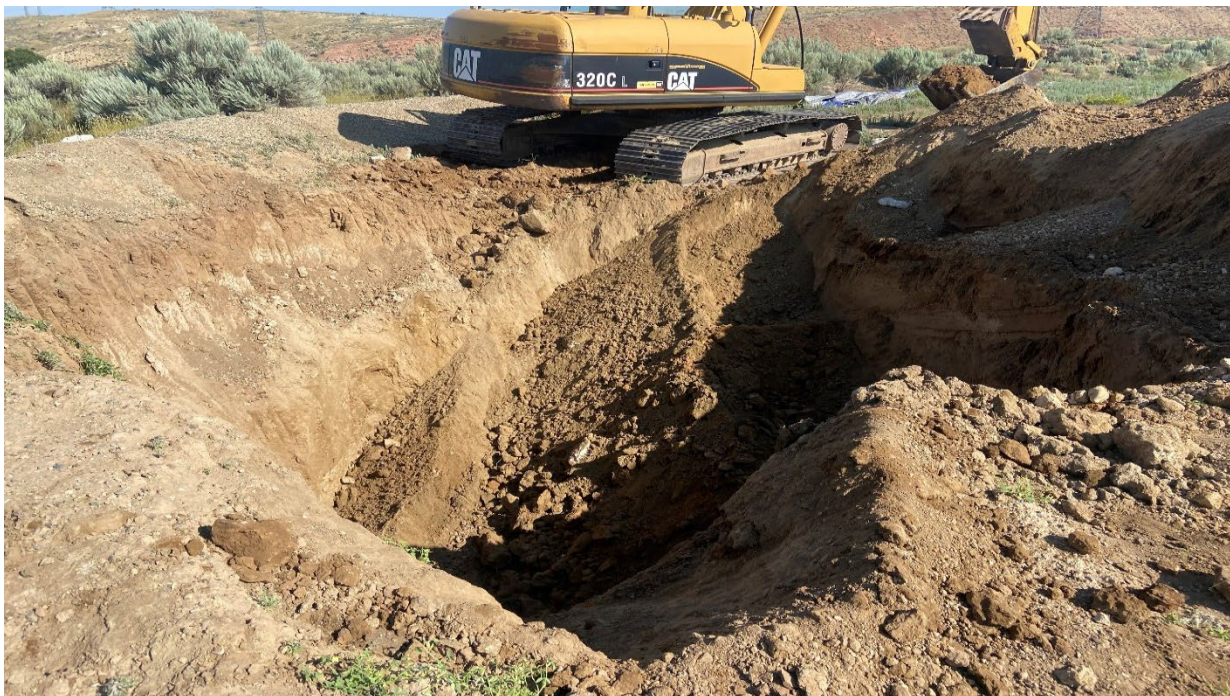
Excavation continued southeast for ~30 feet, from ~9 feet BGS gradually decreasing in depth to ~6' BGS until the south side wall and entire excavation bottom were screened using a PID and all samples were < 100 ppm VOC. Eight (8) confirmation samples were collected from the excavation bottom and side walls.

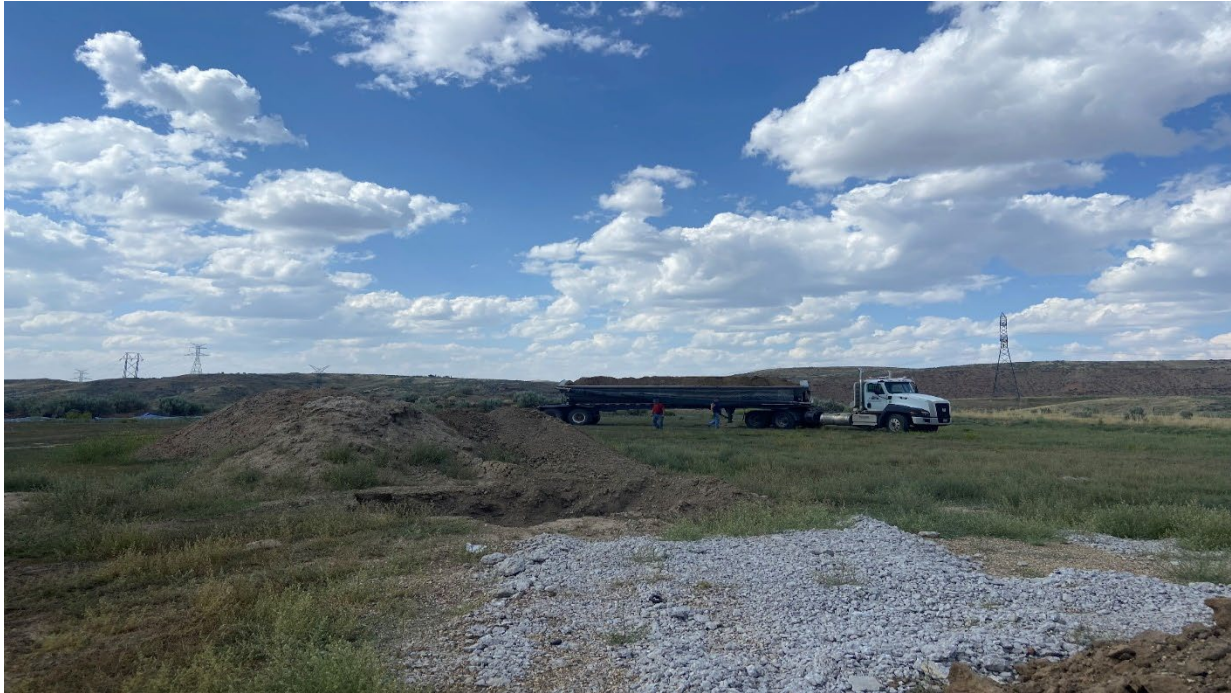
Excavated material was disposed of and hauled offsite to the Moffatt County Landfill located at 1806 C Rd 107, Craig, CO 81625. Waste manifests are provided in with this submittal (**Attachment E**). The excavation was backfilled with clean fill material upon completion.
