Final Reclamation Inspection

Operator: PDC ENERGY INC - 69175

Location ID: 307179

Inspection Photos
Location Name: Laune 44-25
Location ID: 307179

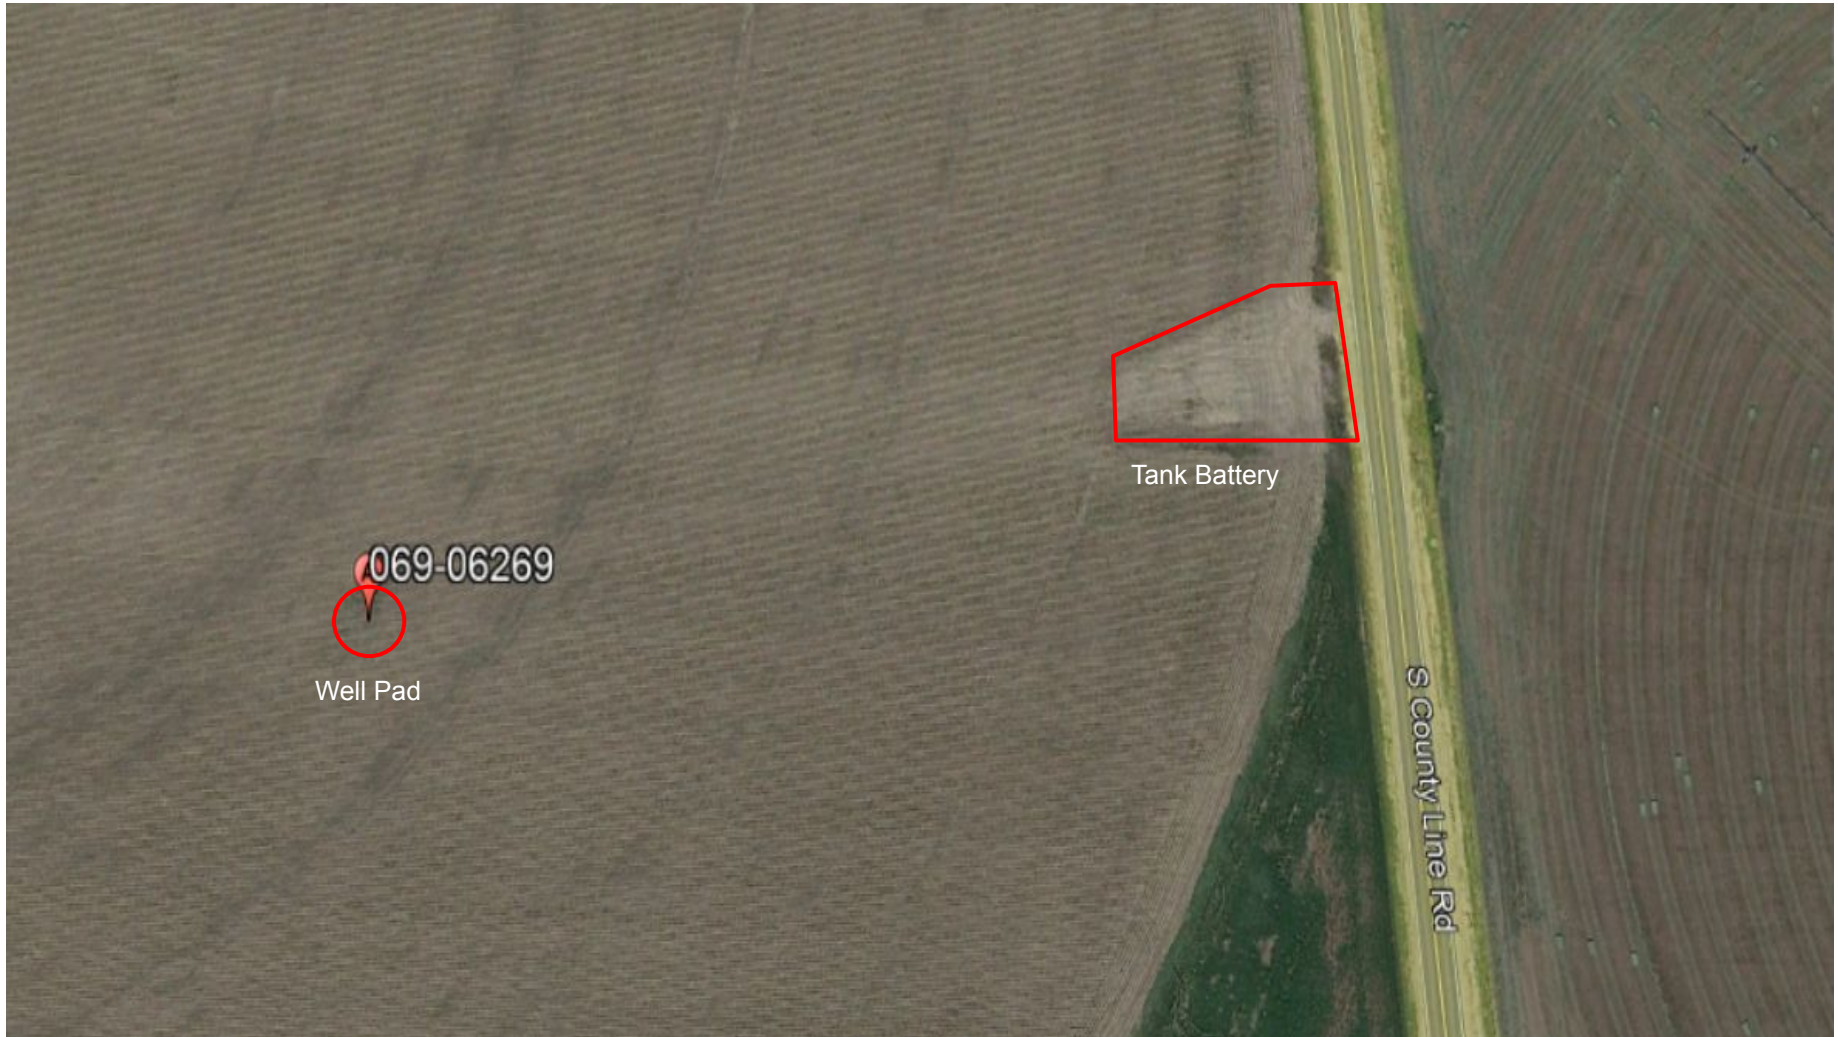
Photo 1. 2021 aerial imagery of the well pad and tank battery.

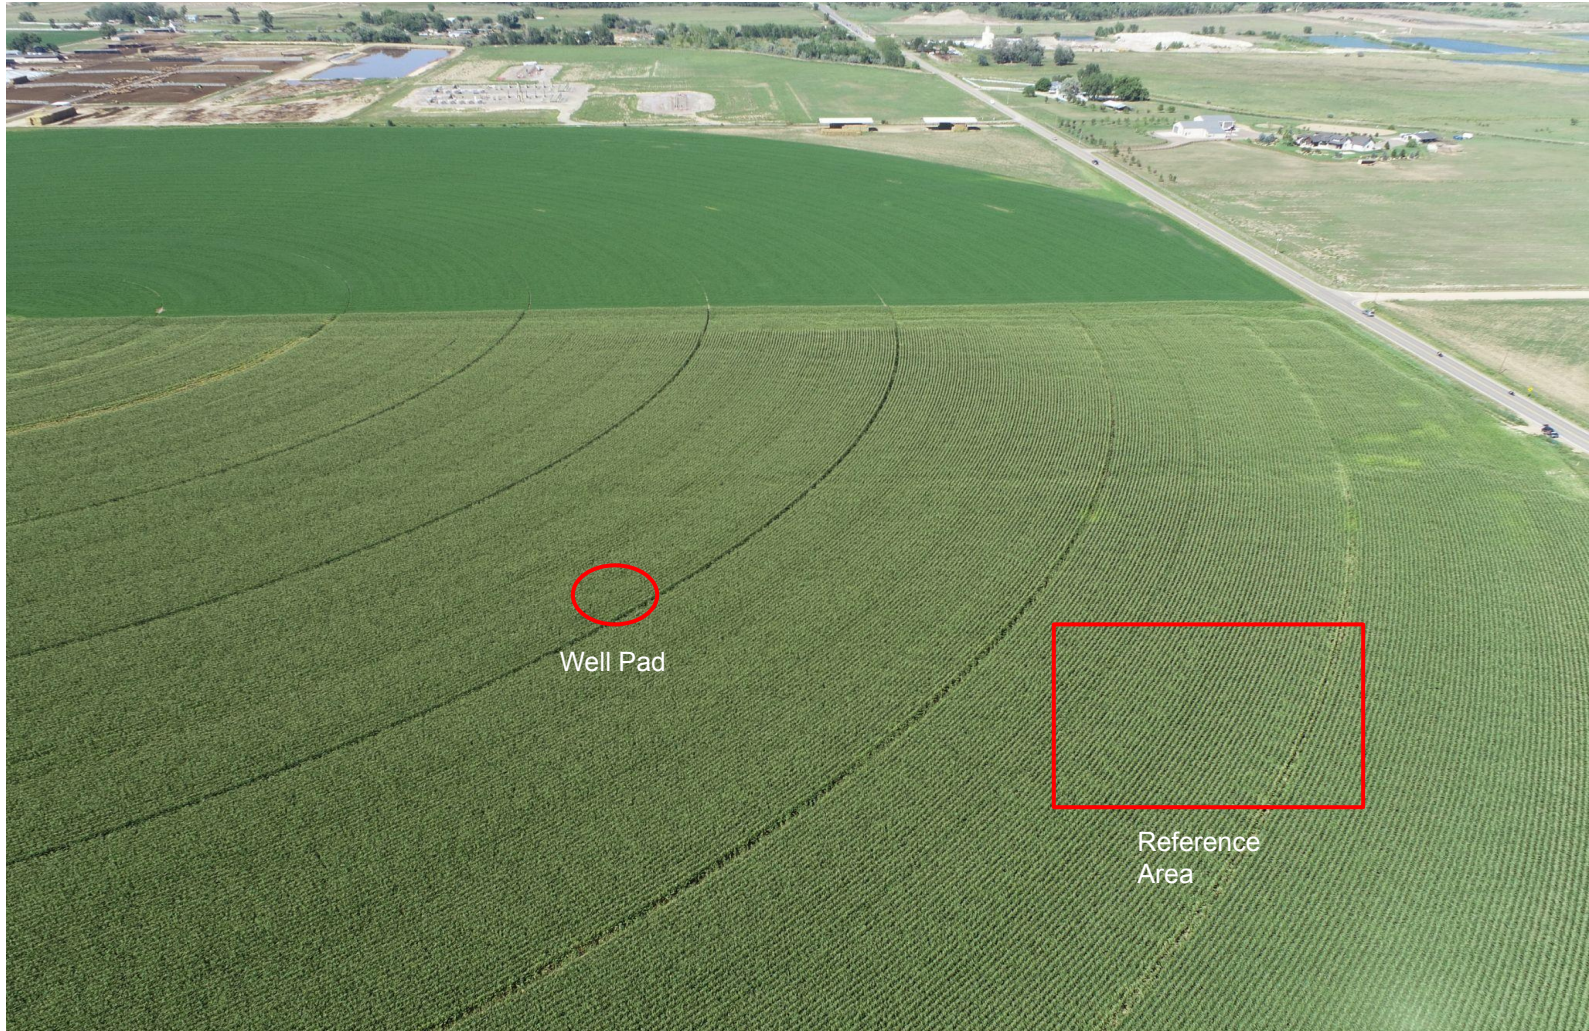
Photo 2. Overview photo of the well pad and reference area taken from the southern edge facing north using a drone. Note: well pad appears consistent with adjacent crop reference area.

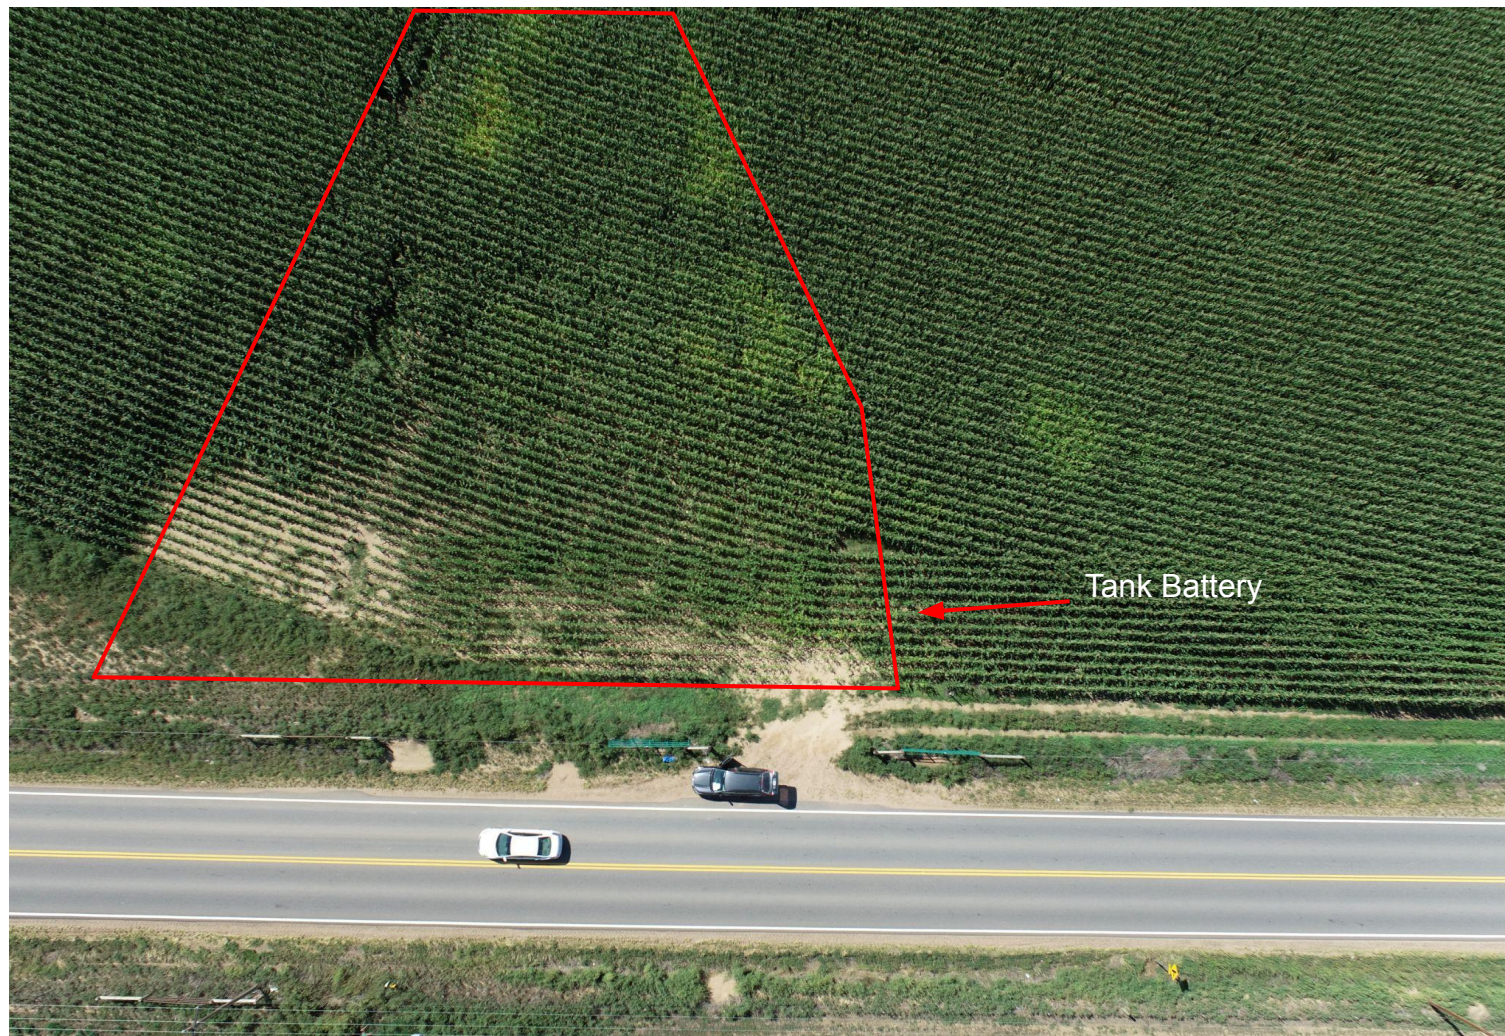
Photo 3. Overview photo of the tank battery taken from directly above the disturbance using a drone. Note: tank battery appears stunted; see elevation model in photo 4.

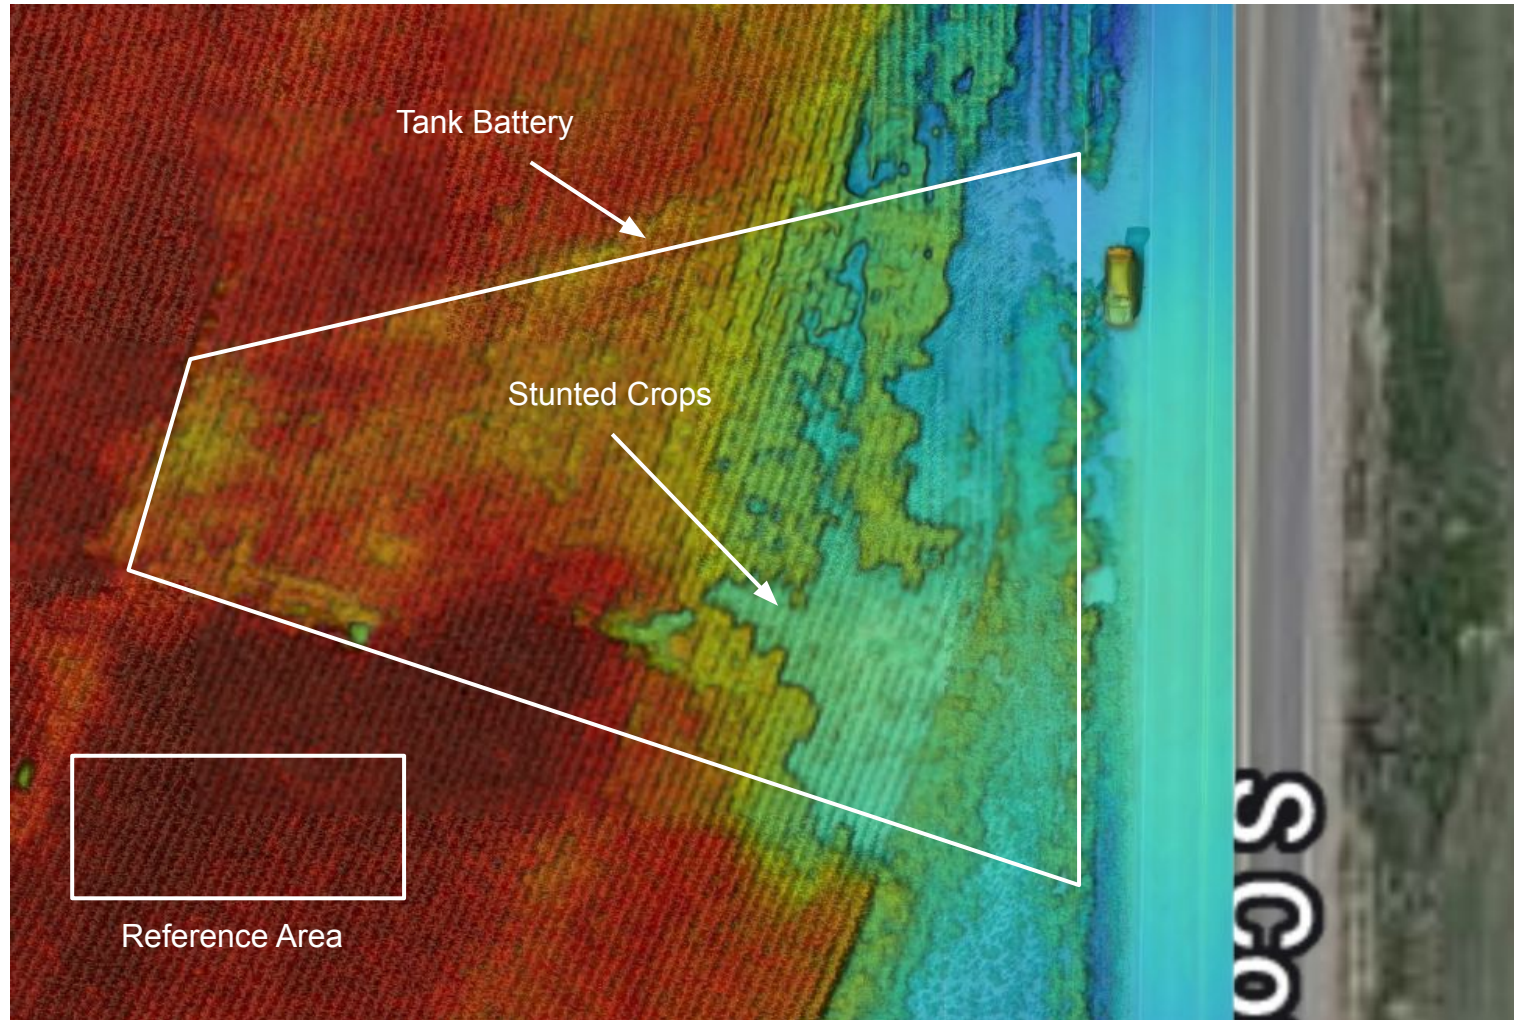
Photo 4. Plant elevation model of the tank battery. Tank battery shows stunted crop growth and does not appear consistent with adjacent crop reference area.
