Final Reclamation Inspection

Operator: PDC ENERGY INC - 69175

Location ID: 327061

Inspection Photos
Location Name: State Lease 81, 42-16
Location ID: 327061

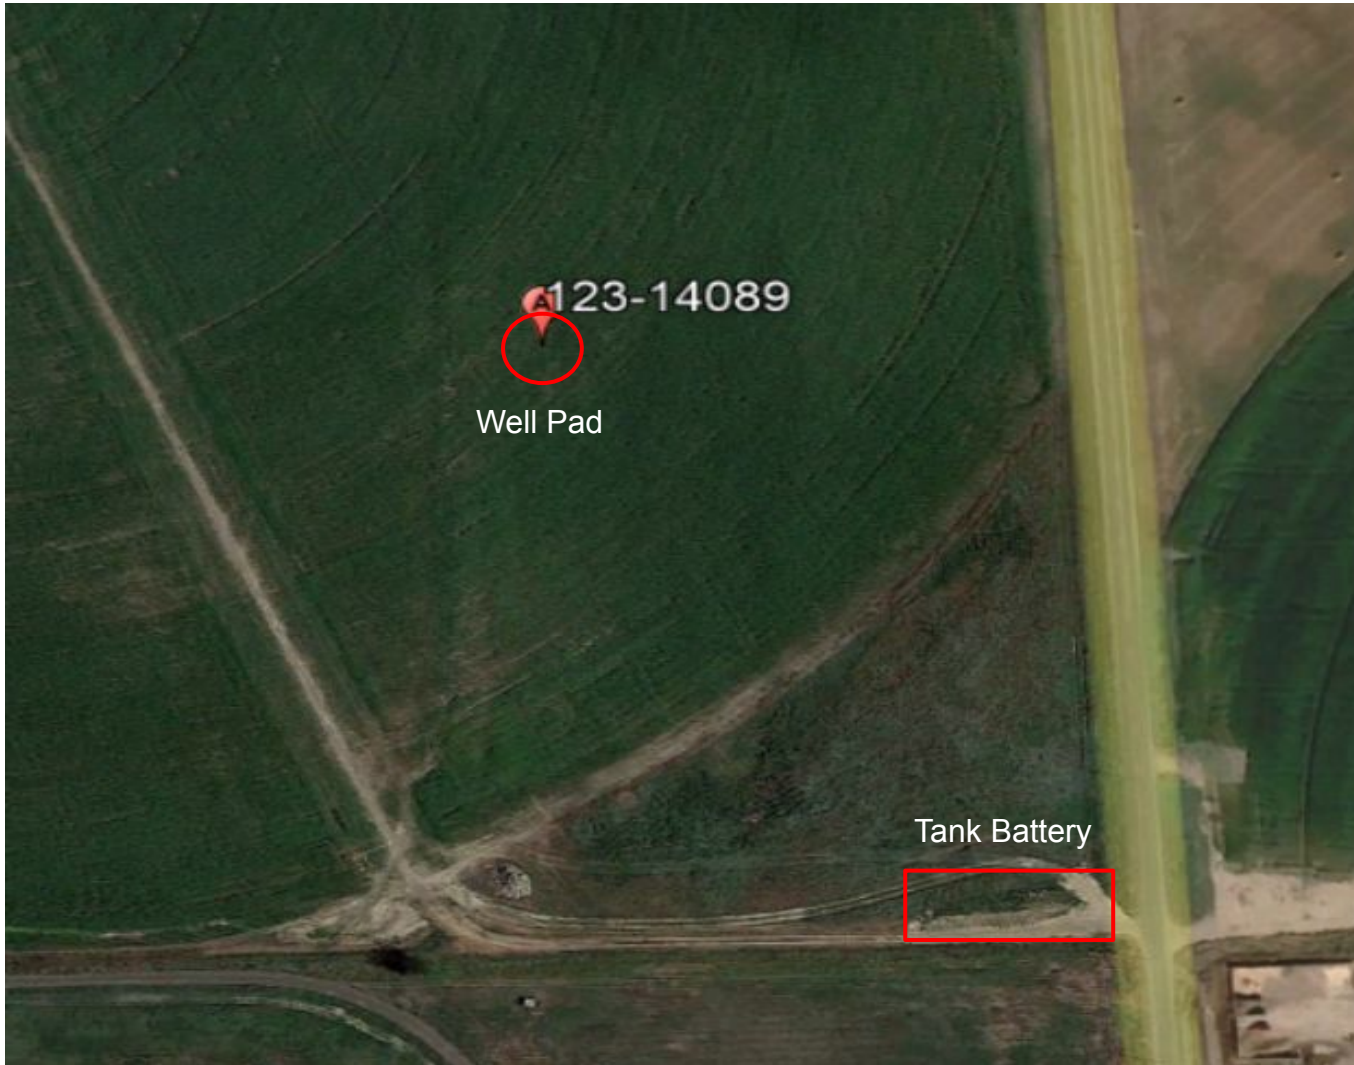
Photo 1. 2020 aerial imagery of the well pad and tank battery. Note: could not identify access road from historical imagery.

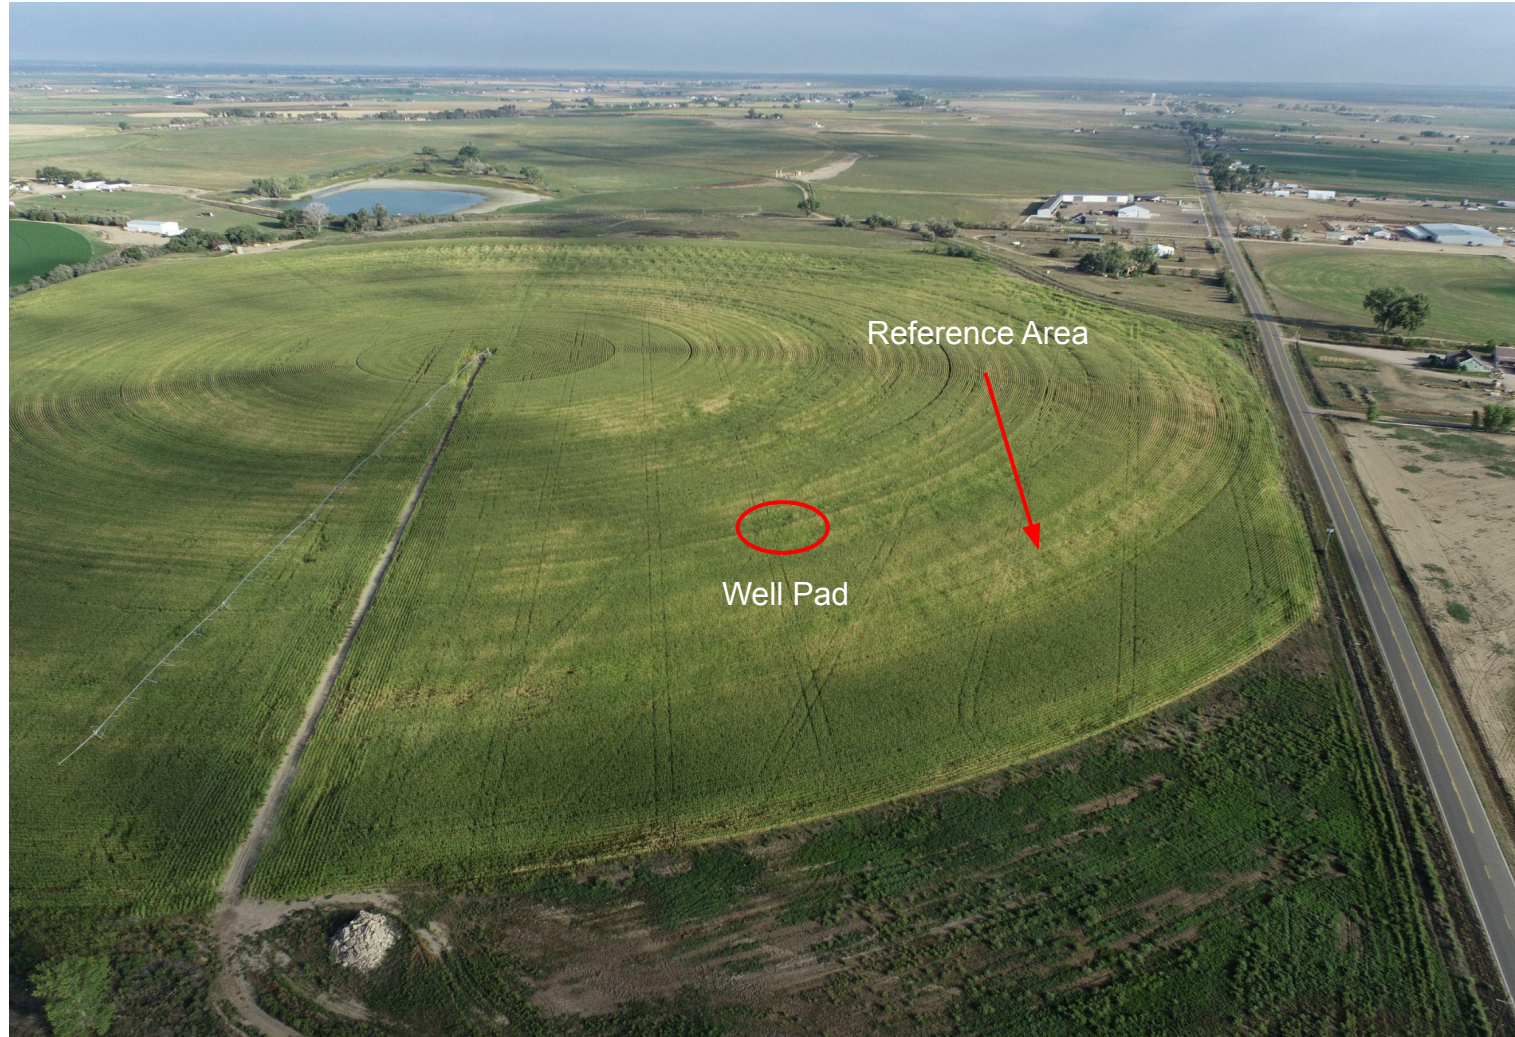
Photo 2. Overview photo of the well pad and reference area taken from the southern edge facing north using a drone. Note: well pad appears consistent with adjacent crop reference area.

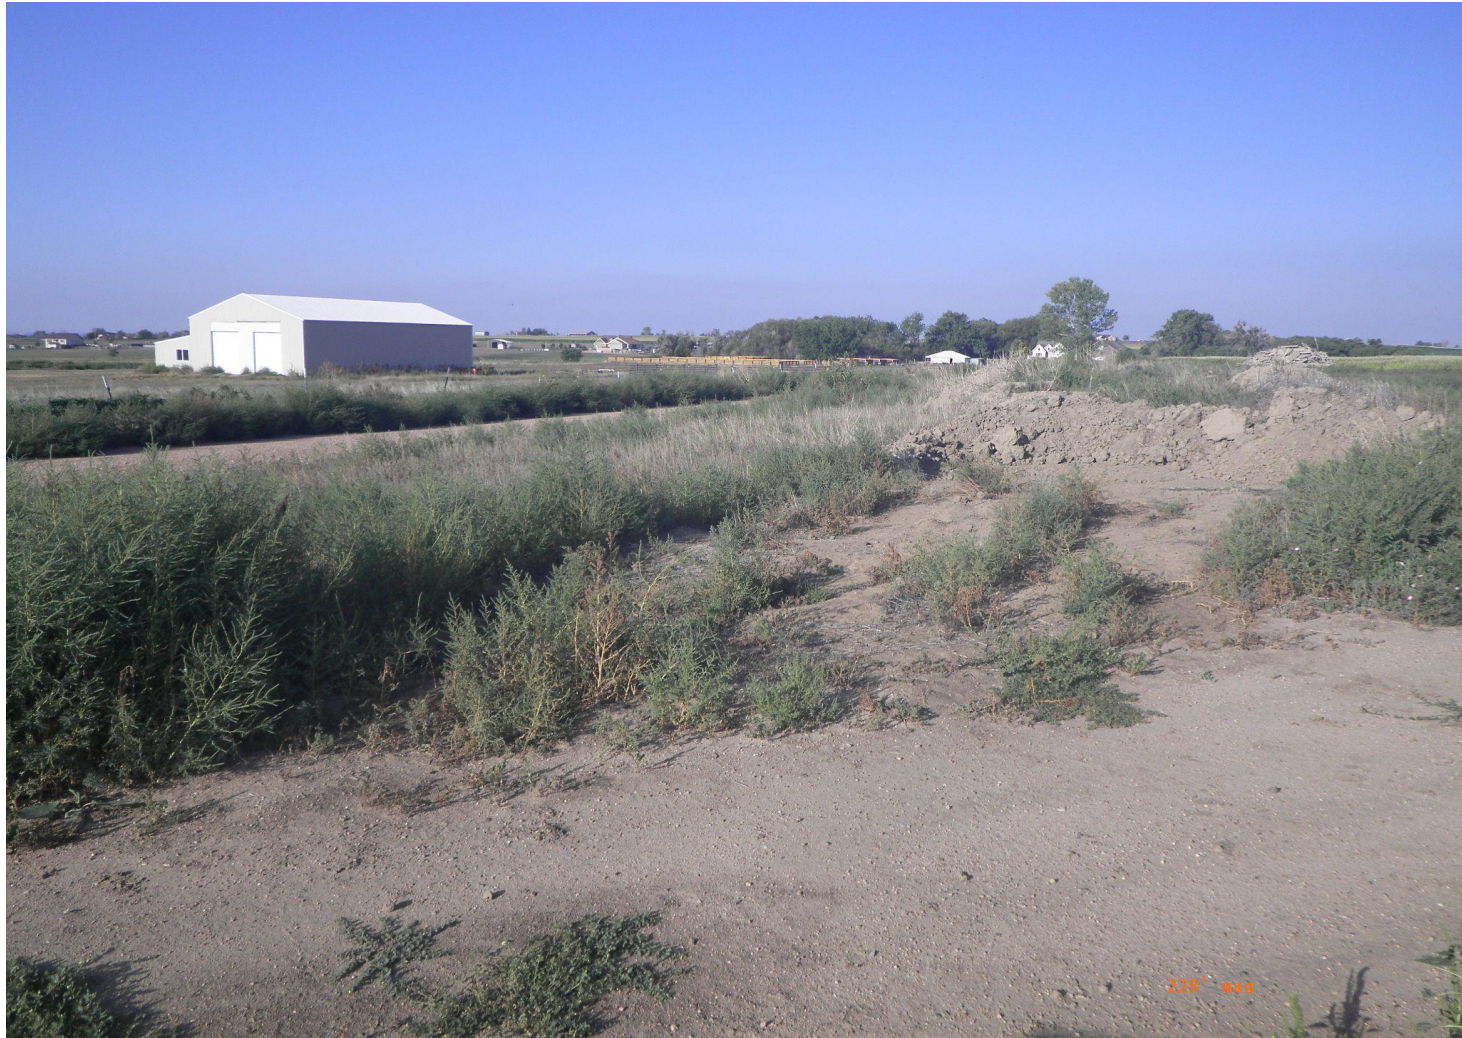
Photo 3. Overview photo of the tank battery taken at ground level from the eastern edge facing west. Note: tank battery falls within a corner crop area.

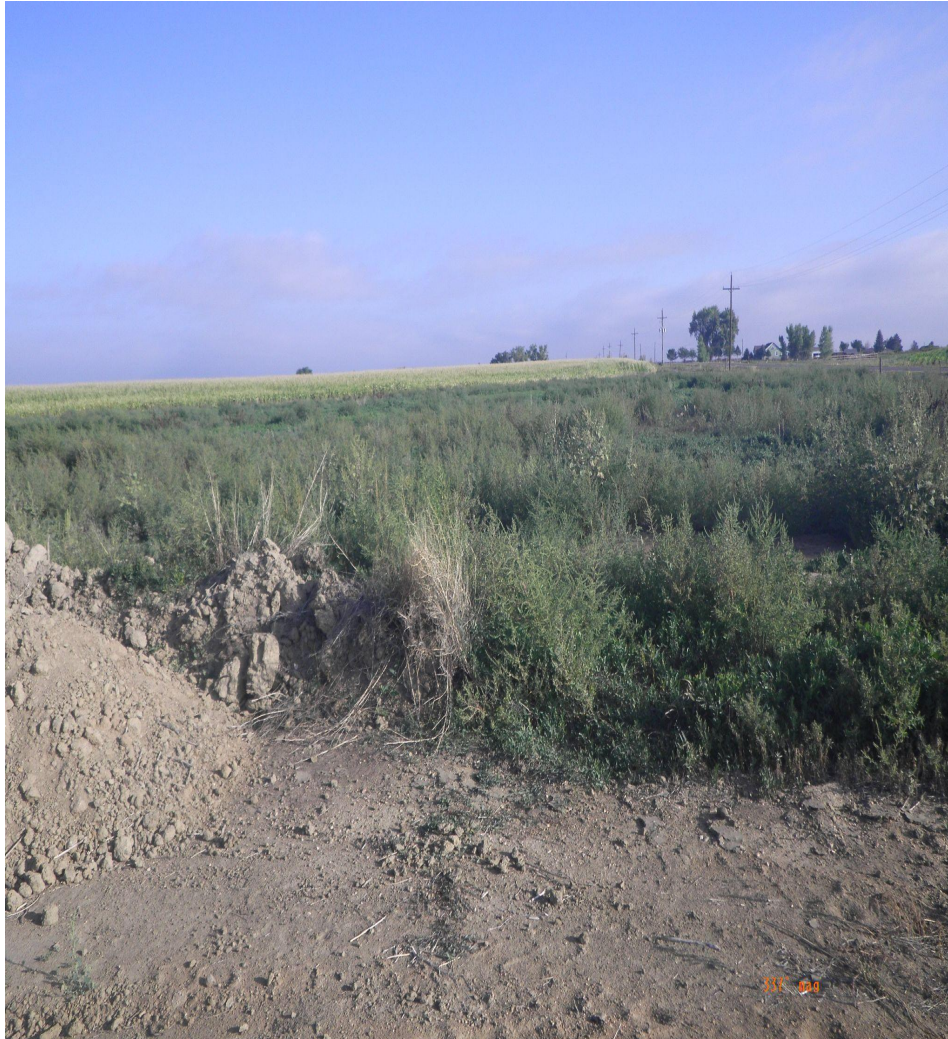
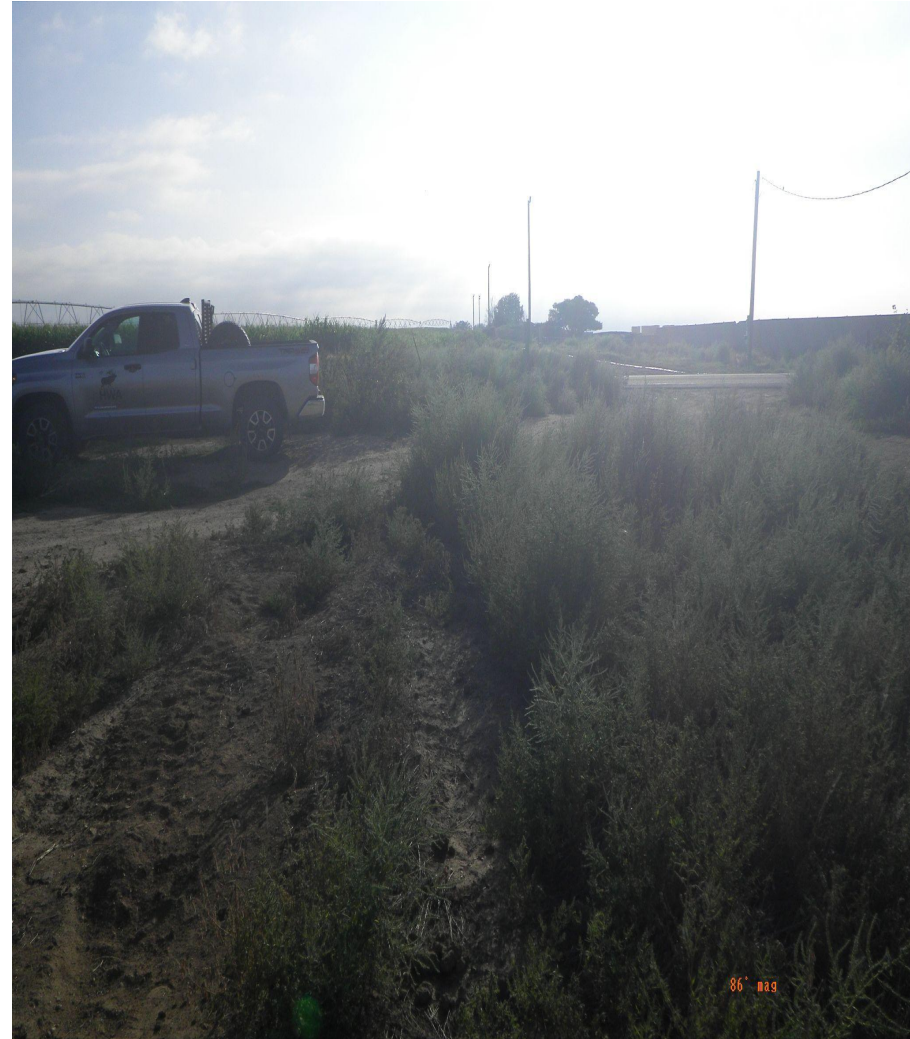
Photo 4. Cardinal photos taken from the middle of the tank battery.
Left photo facing north, right photo facing east.

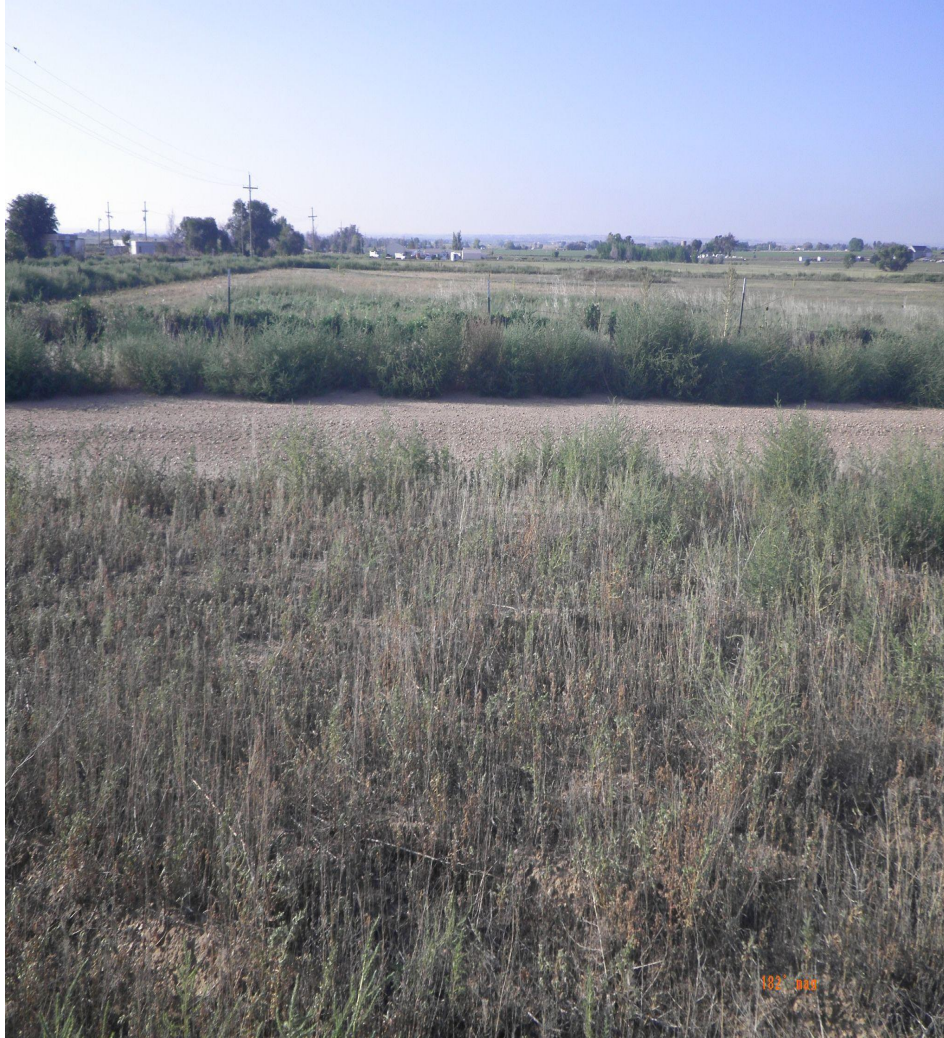
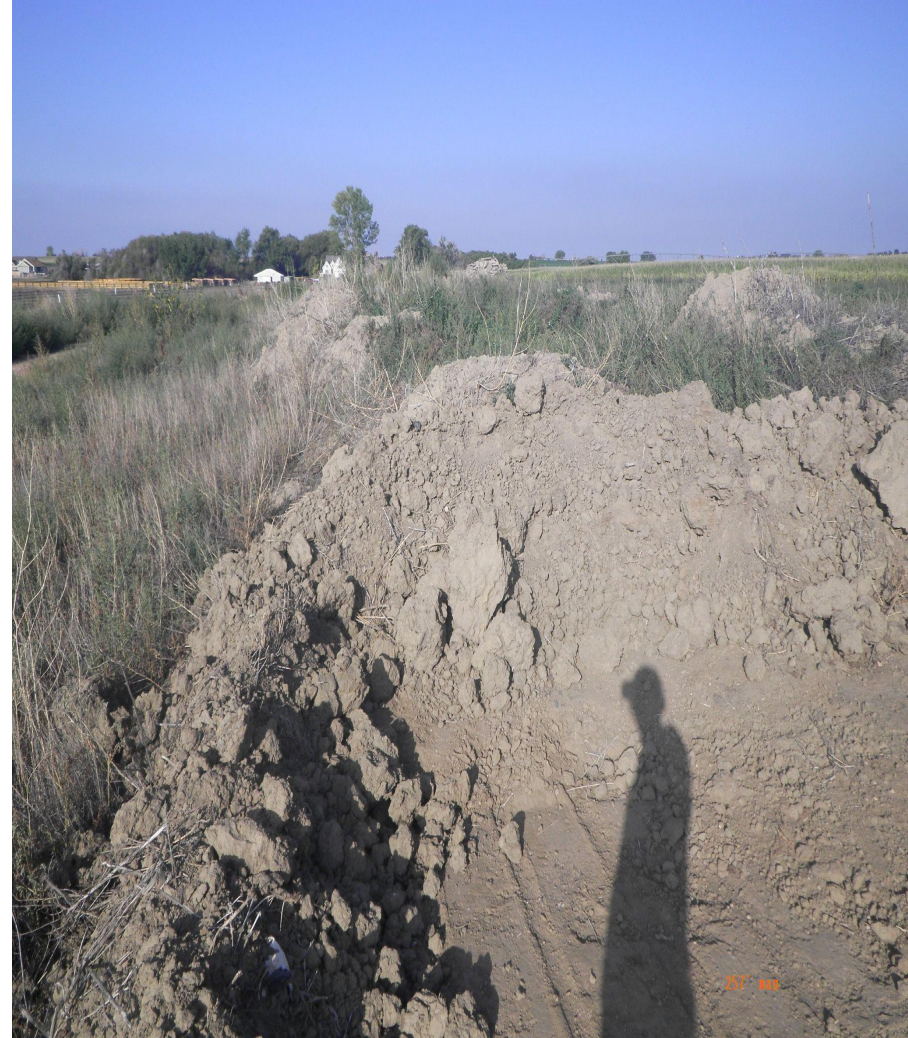
Photo 5. Cardinal photos taken at ground level from the middle of the tank battery. Left photo facing south, right photo facing west. Note: tank battery has a large pile of dirt in the middle of the disturbance and portions of the northern access road remain unreclaimed with gravel.
