Inspection Photos

API: 071-07685

Operator: EVERGREEN NATURAL RESOURCES

Inspection Date: 12/28/2022

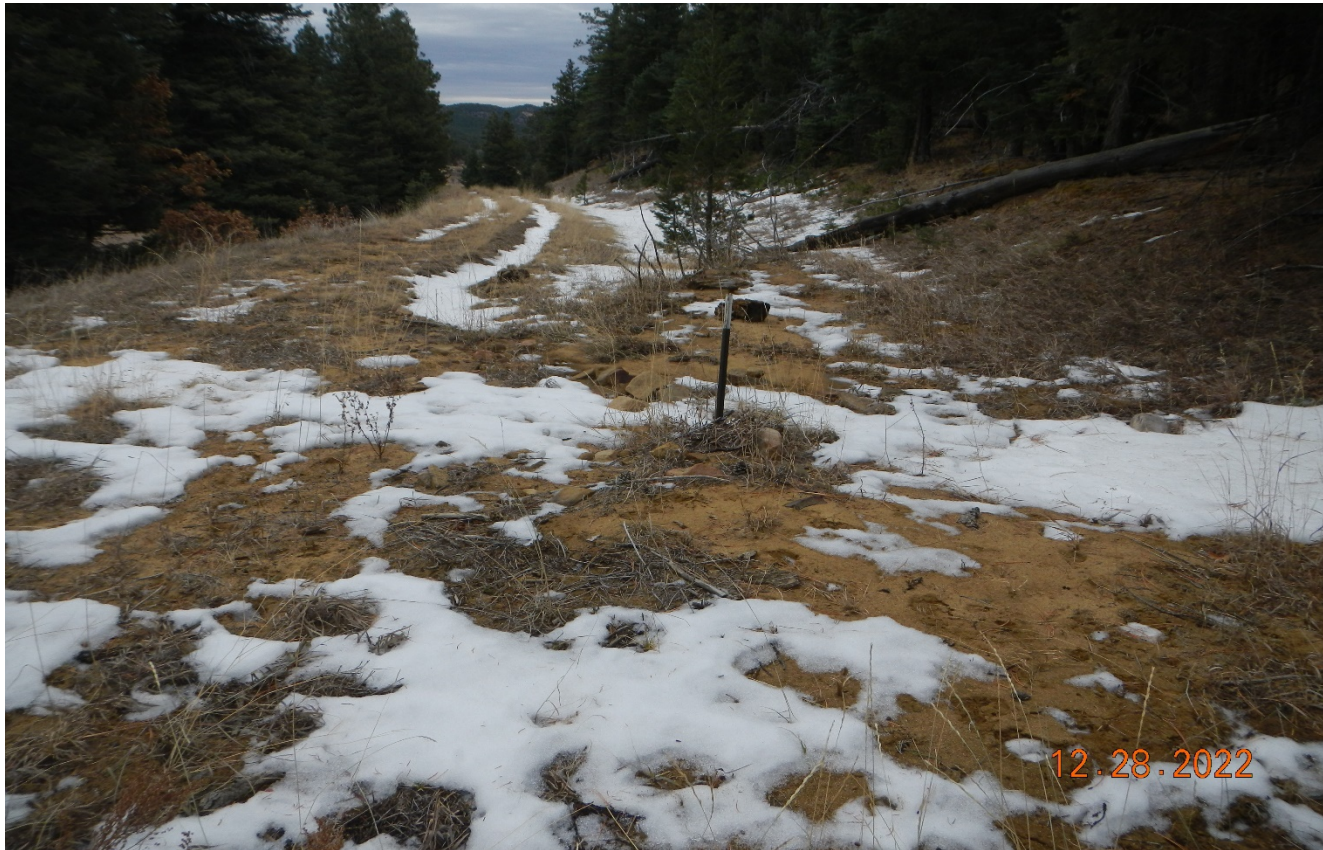
Photo 1. Facing east along the pre-existing access road. This culvert has filled in with sediment causing stormwater to flow down the road causing erosion.

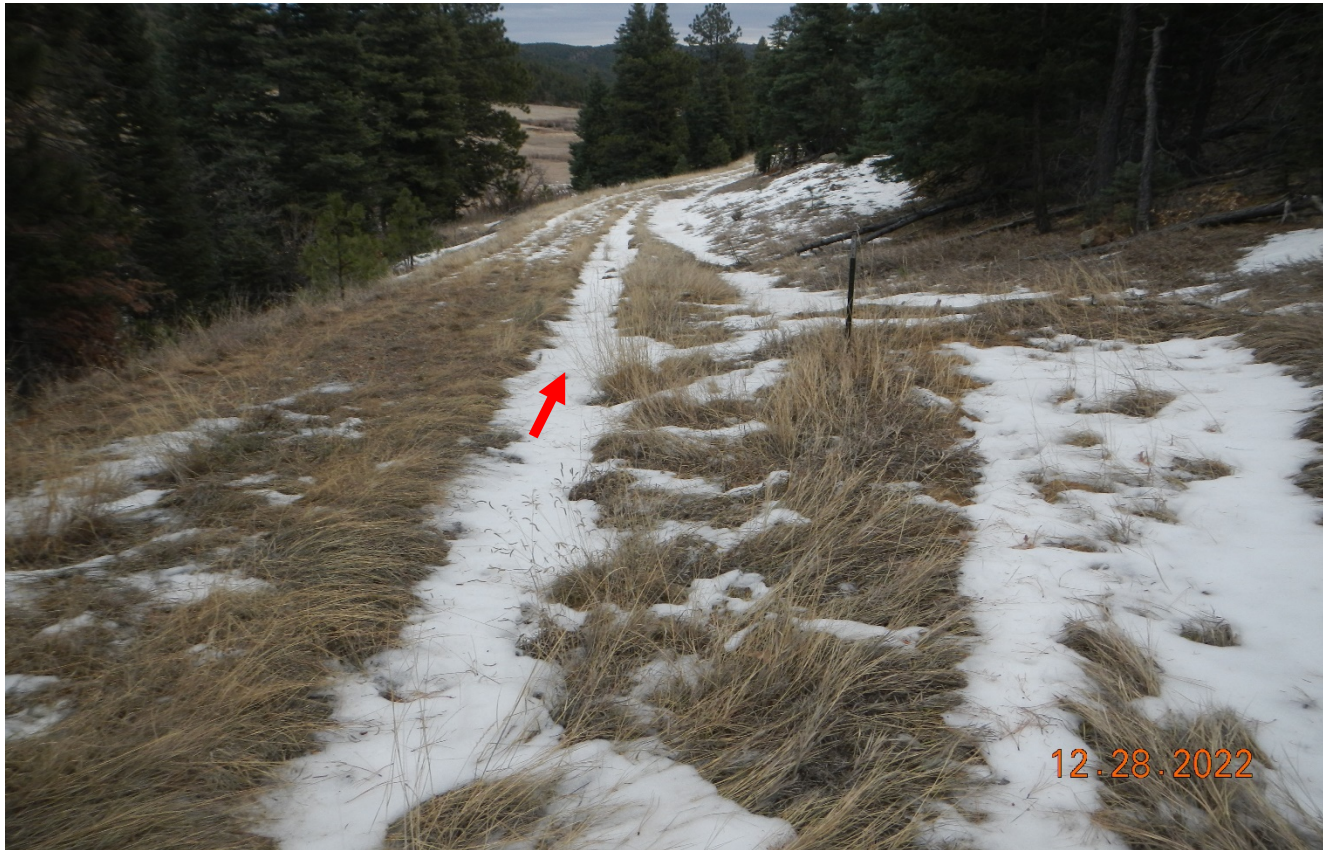
Photo 2. Another culvert further down the road has filled in with sediment. There is erosion along the road shown at red arrow.

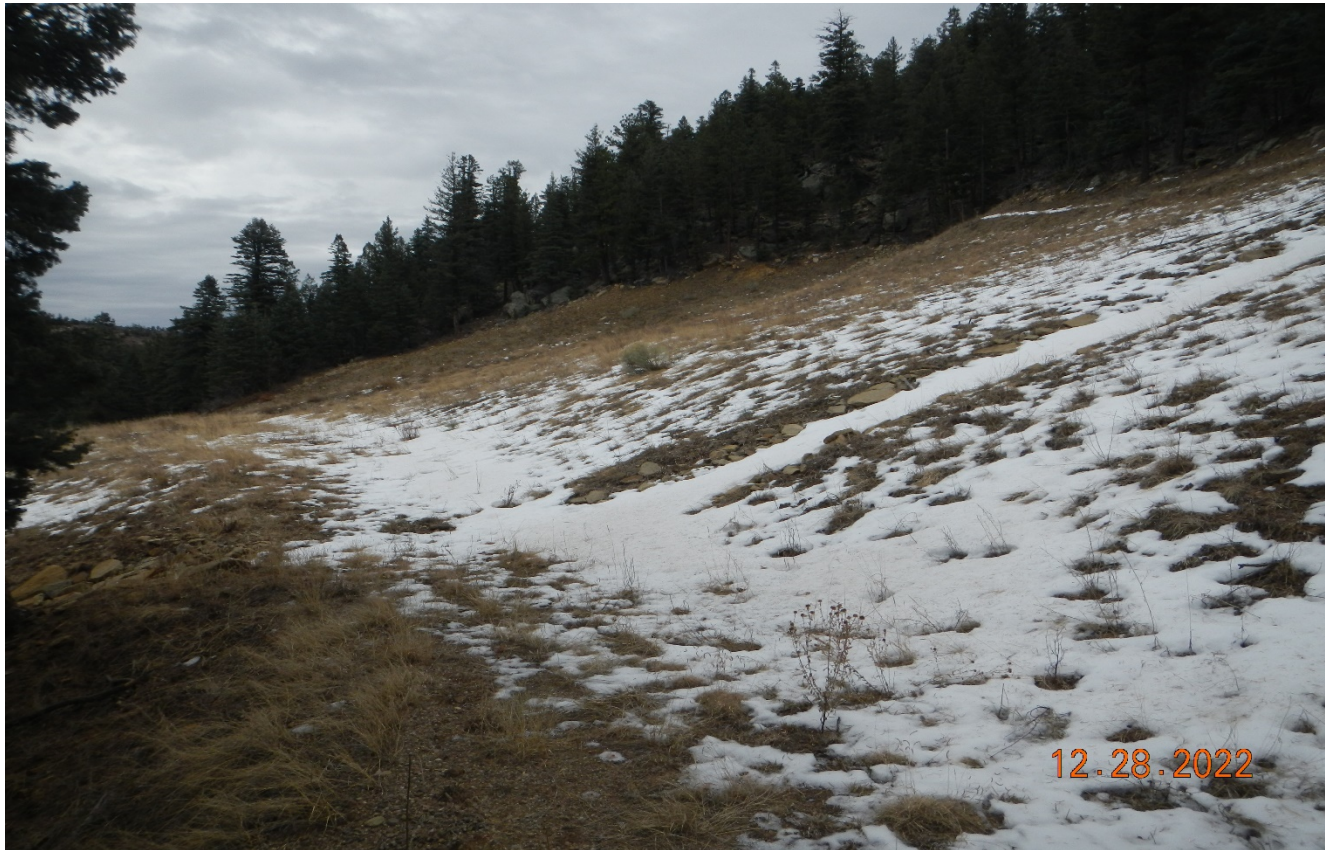
Photo 3. Facing east toward the reclaimed location.
