# Inspection Photos

Operator: LARAMIE ENERGY LLC - 10433

Location #335482

Garfield County, CO

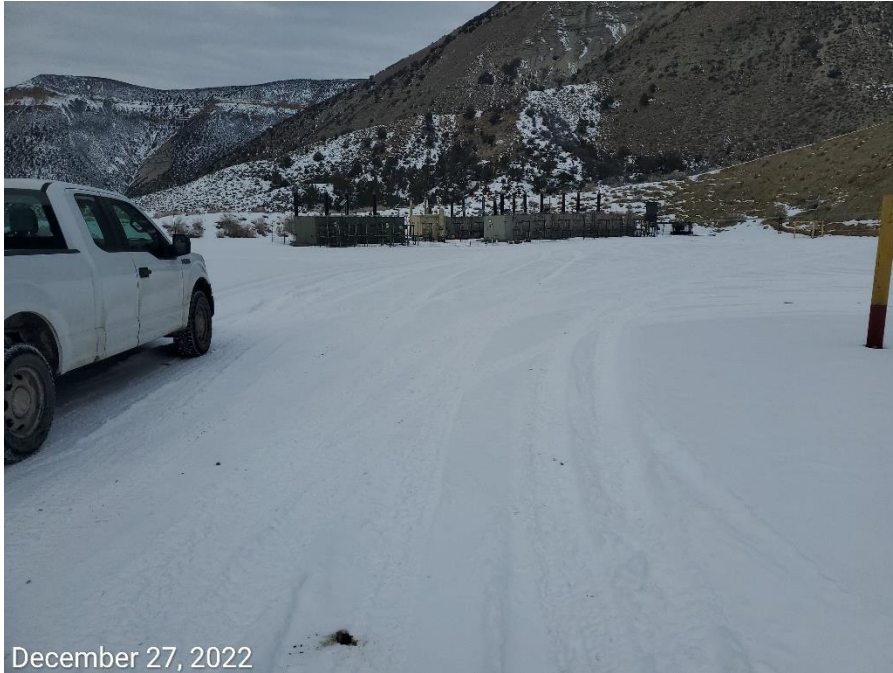
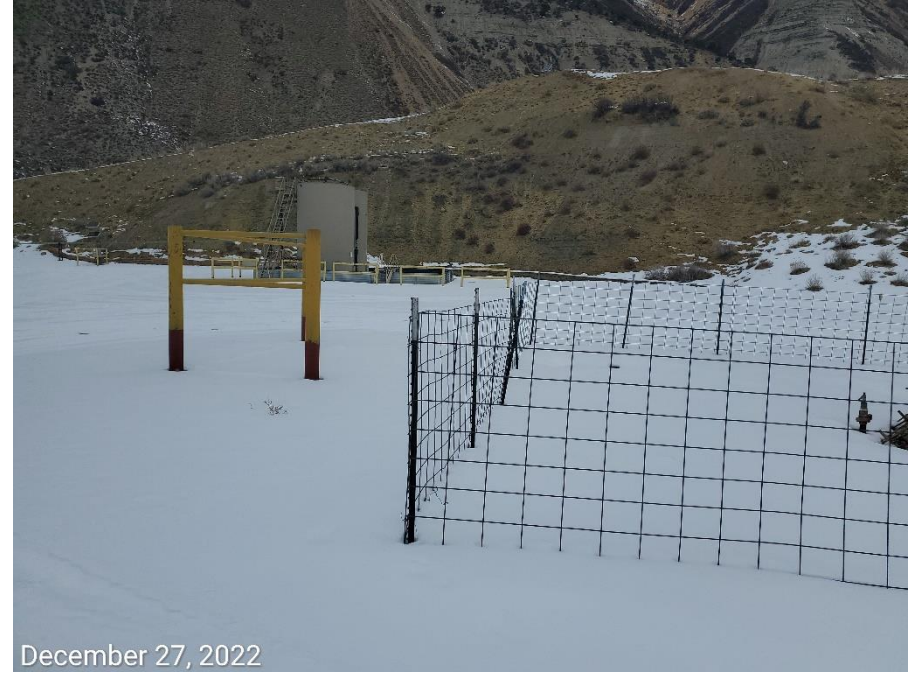
**Photo 1:** Photos 1-2 taken from the south end of the Location. Photos provide an overview of the Location from west, northwest, northeast to east.

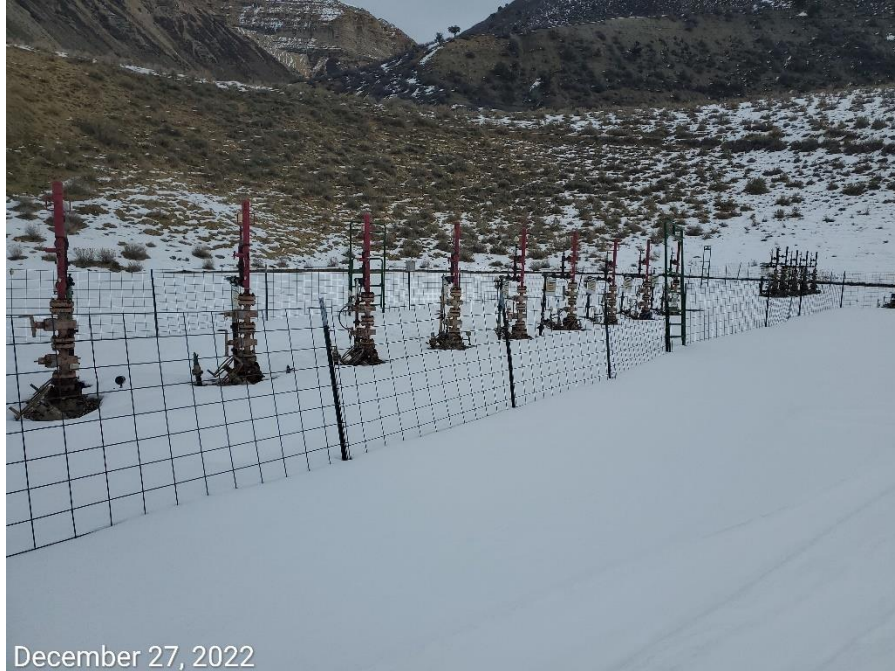
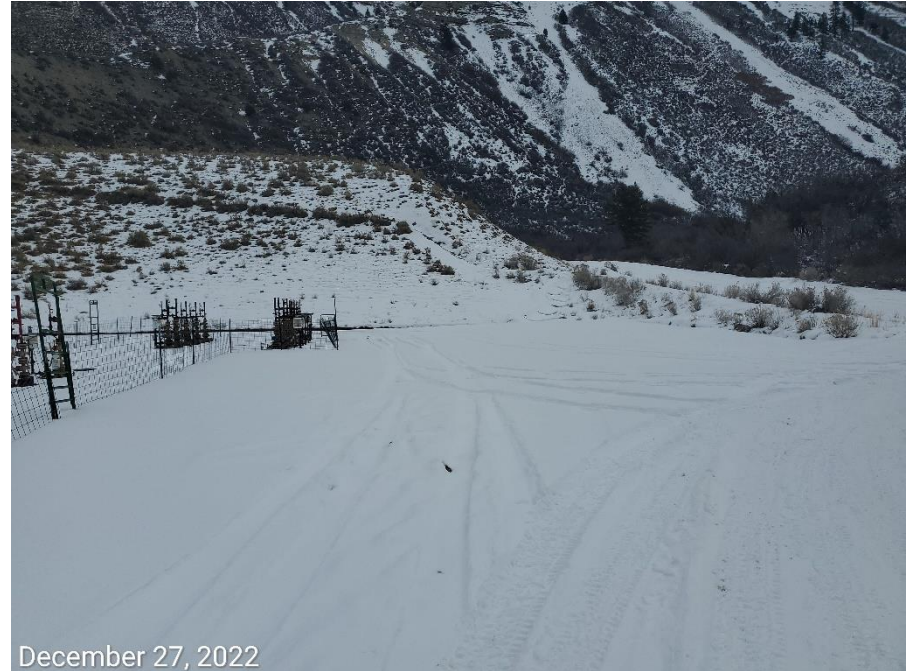
**Photo 2:** See comment under photo 1.

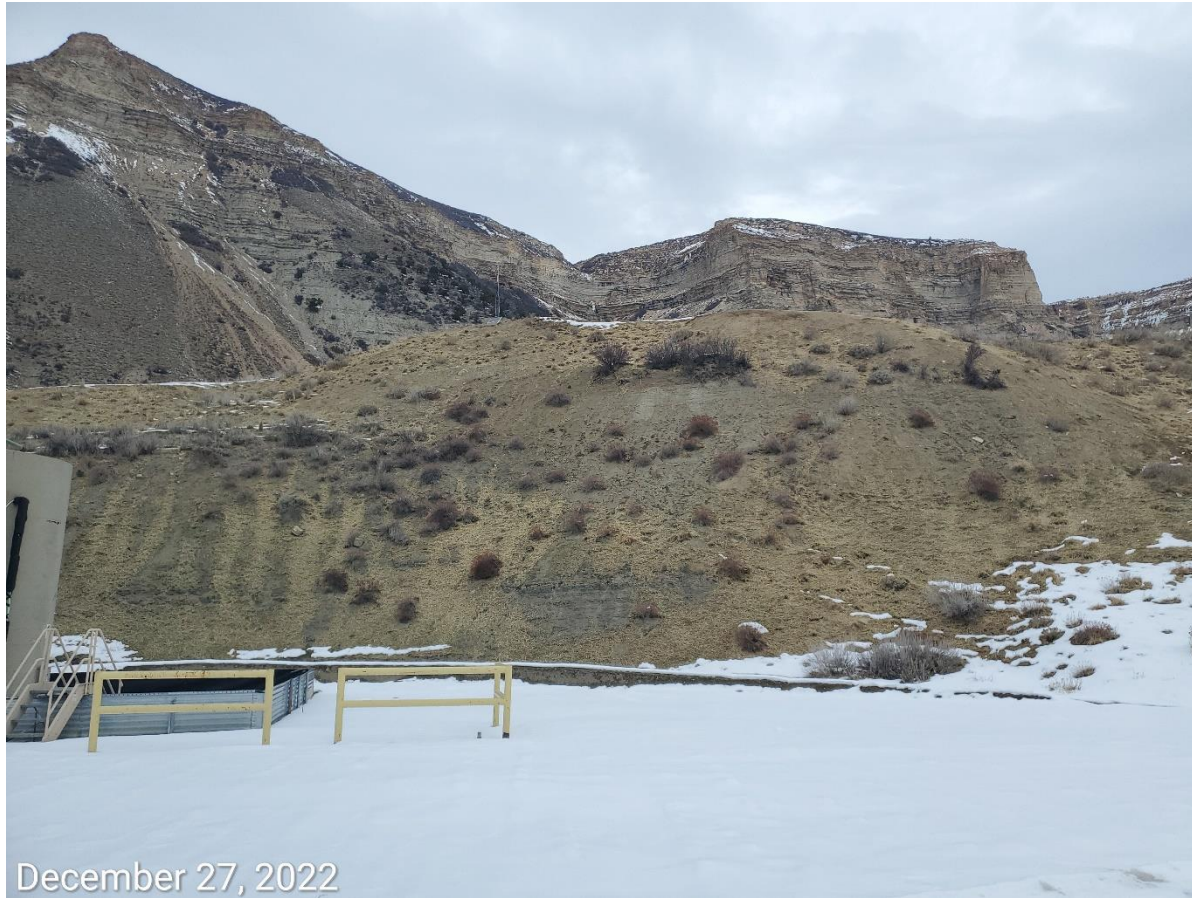
**Photo 3:** Photo taken from the Location, facing north. Photo shows cut-slopes of the Location. Resolution documents submitted by Operator indicate erosion was repaired, followed by an application of straw mulch and hydromulch. Photo shows large areas of the cut slope where BMPs are in disrepair, and erosion degradation is recurring: BMPs implemented have not been maintained, and do not appear to be adequate for the site's conditions

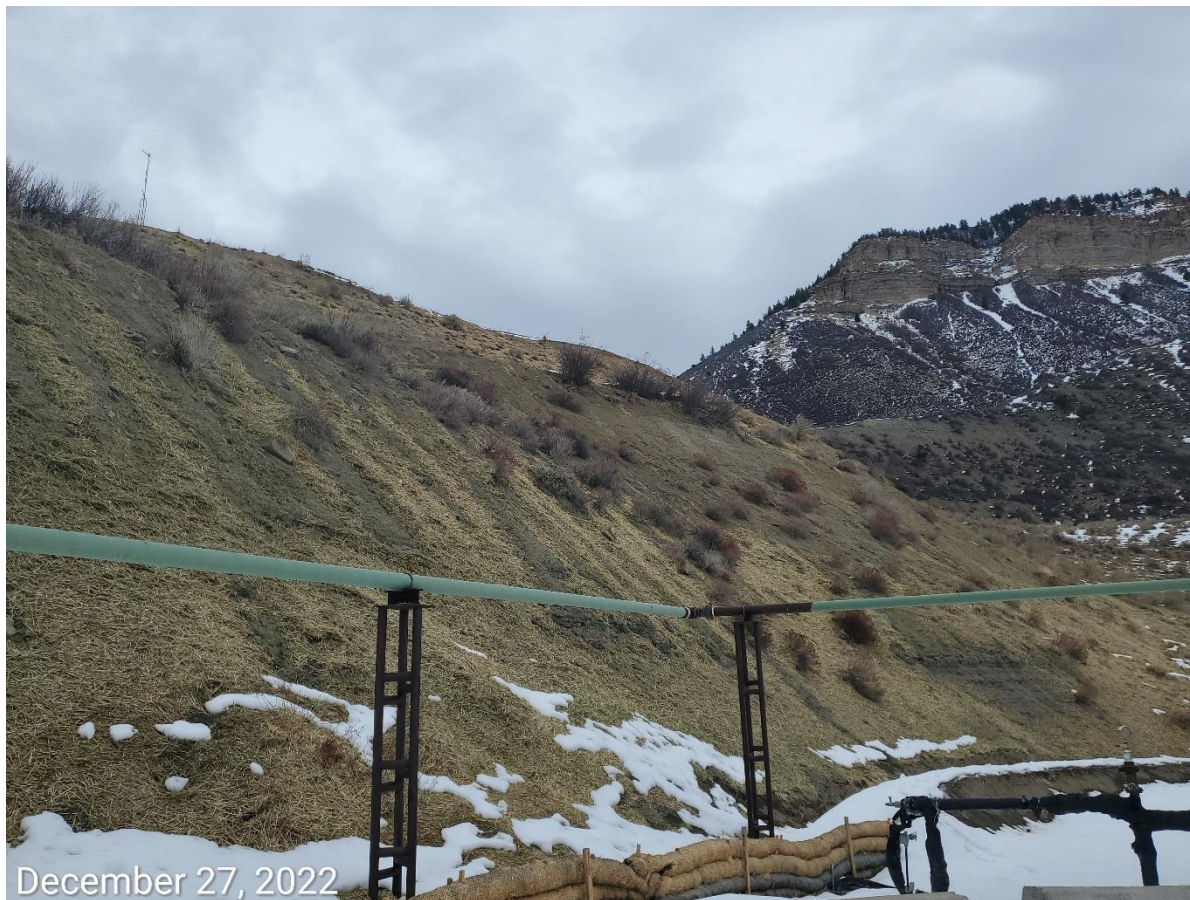
**Photo 4:** See comments under photo 3.

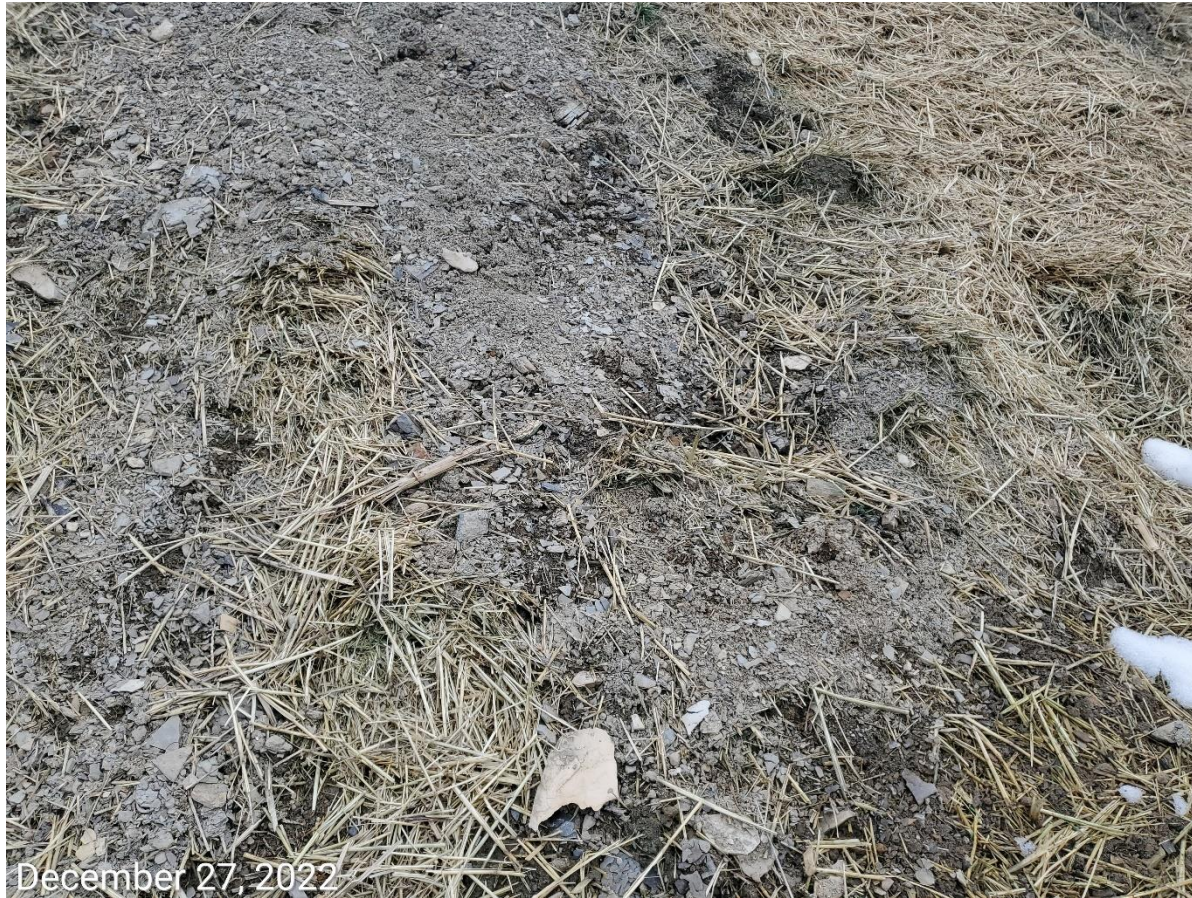
**Photo 5:** Photo taken from the cut slopes of the Location. Photo example showing erosion degradation at the cut slopes; specifically, photo shows sediment covering the mulch; BMPs implemented have not been maintained, and do not appear to be adequate for the site's conditions
