Inspection Photos

API: 071-09604

Operator: OGRIS OPERATING LLC

Inspection Date: 12/30/2022

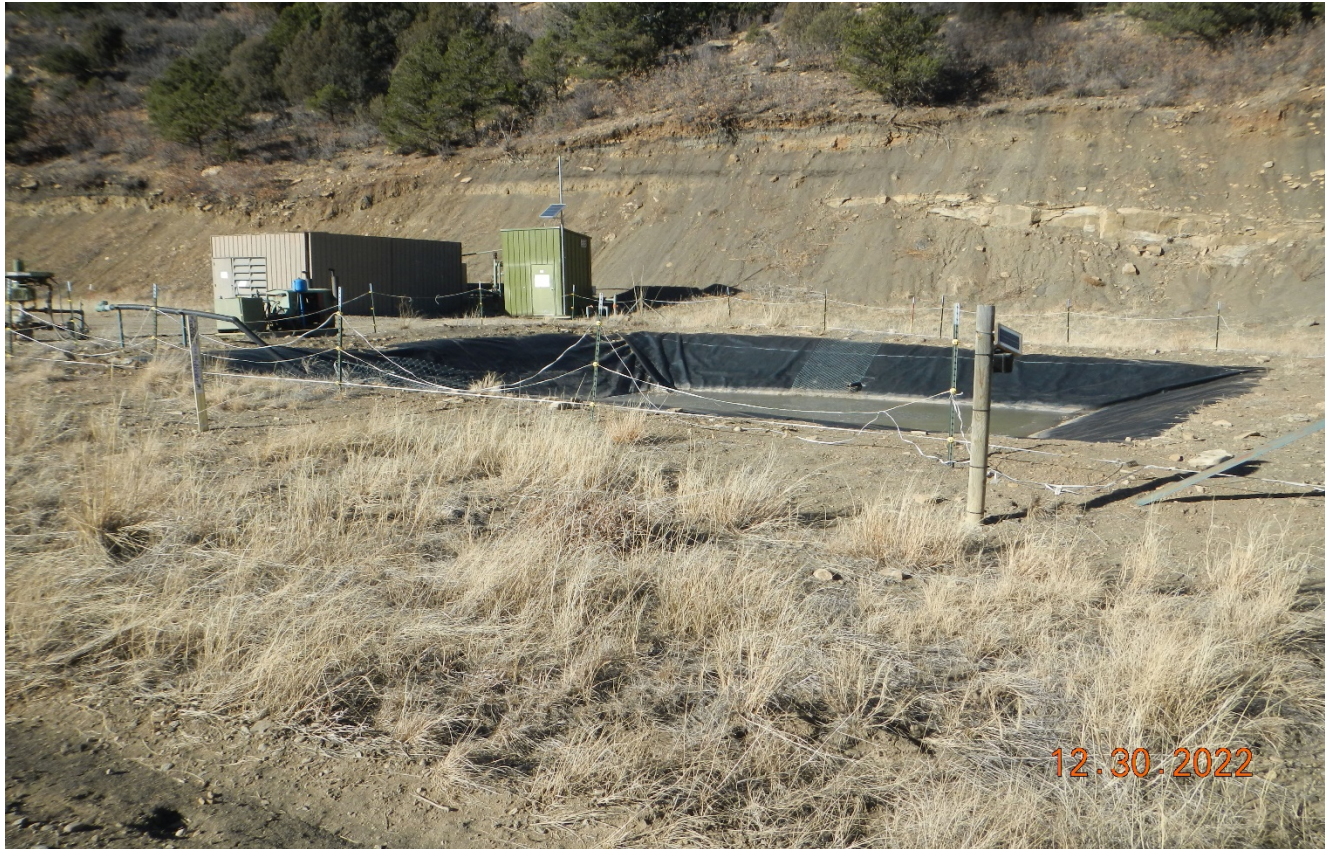
Photo 1. Facing toward the wellsite. The electric fence is in disrepair around the pit. A more robust fencing should be considered.

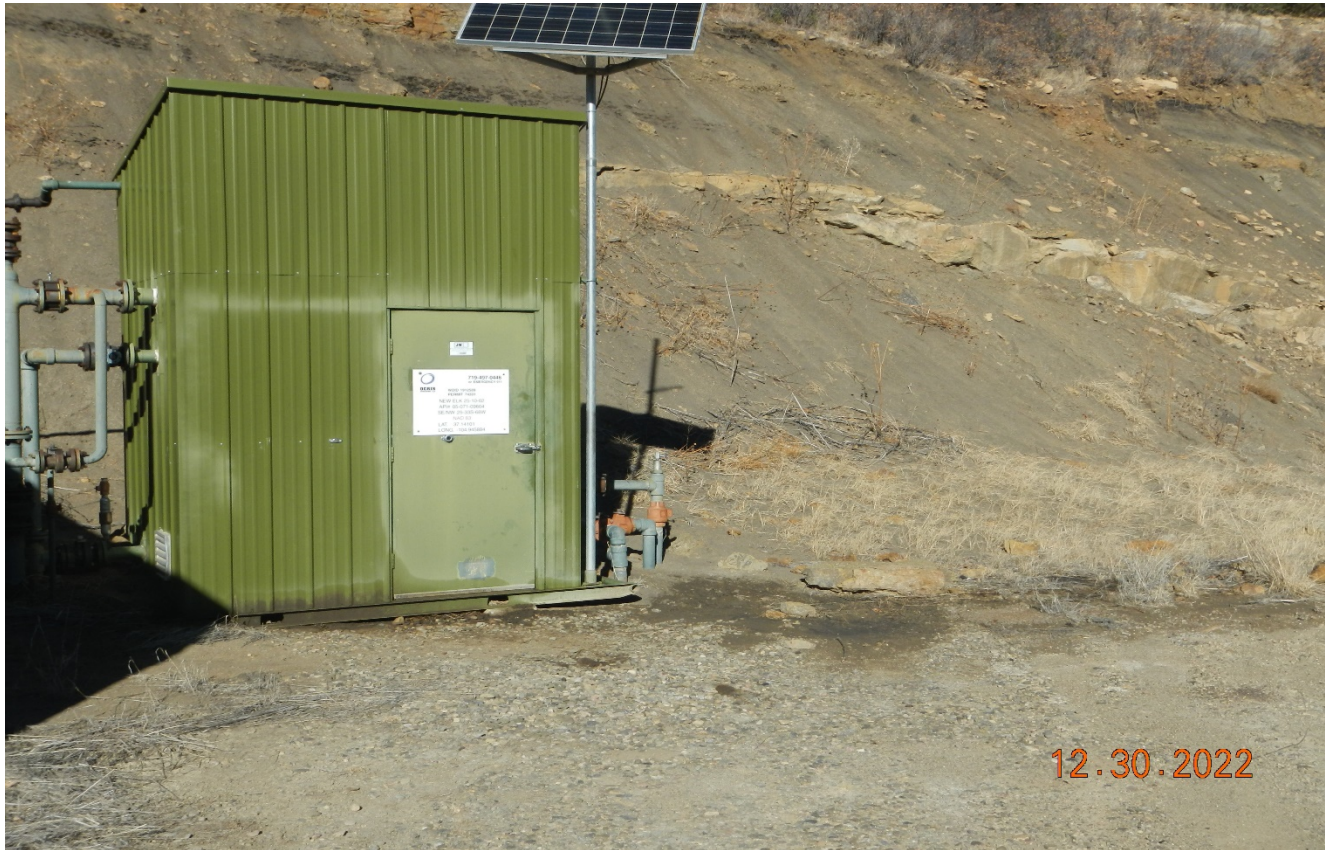
Photo 2. There are stained soils at the meter shed that should be cleaned up and equipment inspected for leaks.
