Final Reclamation and Stormwater Inspection

Operator: KP KAUFFMAN COMPANY - 46290

Location ID: 313843

Inspection Photos
Location Name: Boxer Unit # 25
Location ID: 313843

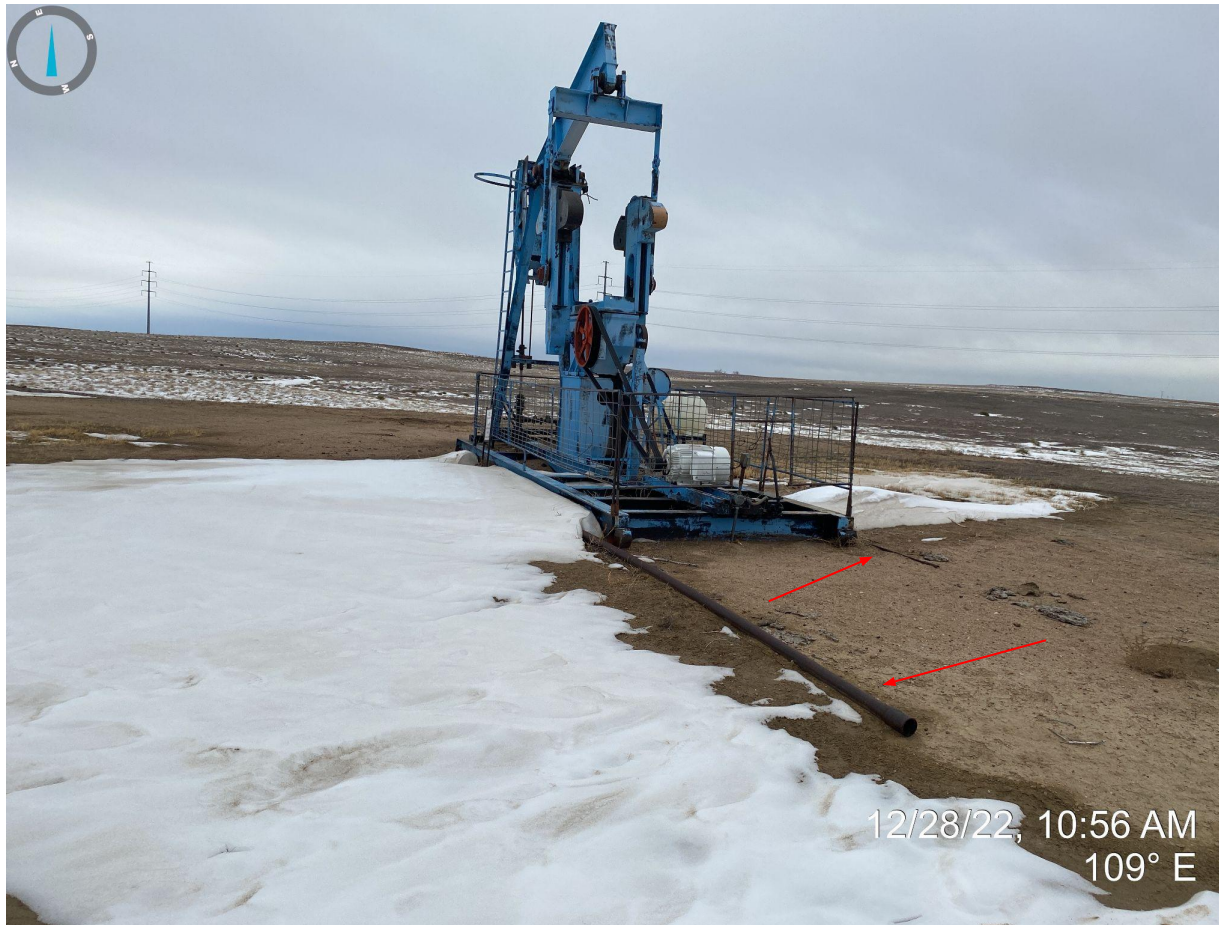
Photo 1. Facing east from western portion of location. Photo shows unused equipment (e.g. pipe and sucker rod) on location. This is considered unused equipment and needs to be removed.

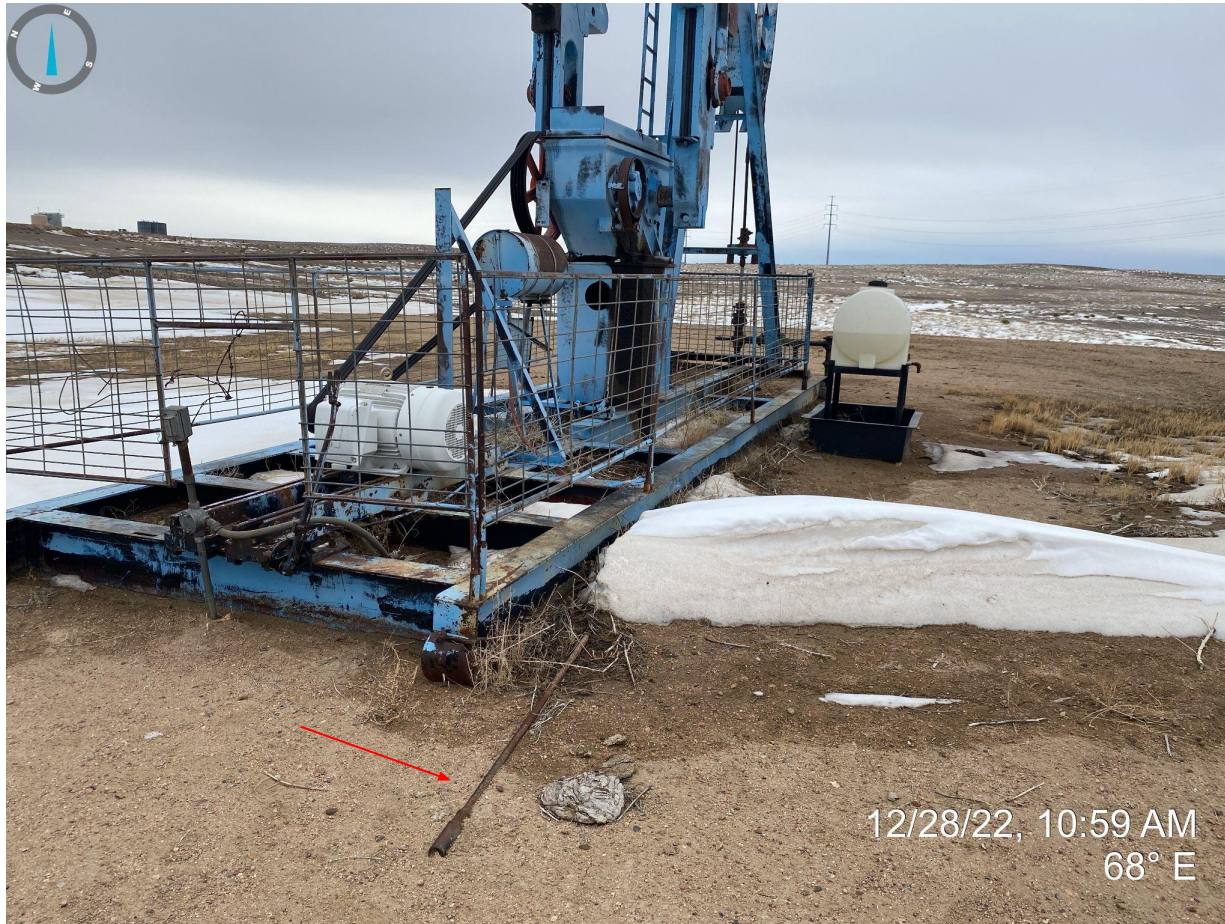
Photo 2. See comments in photo 1.

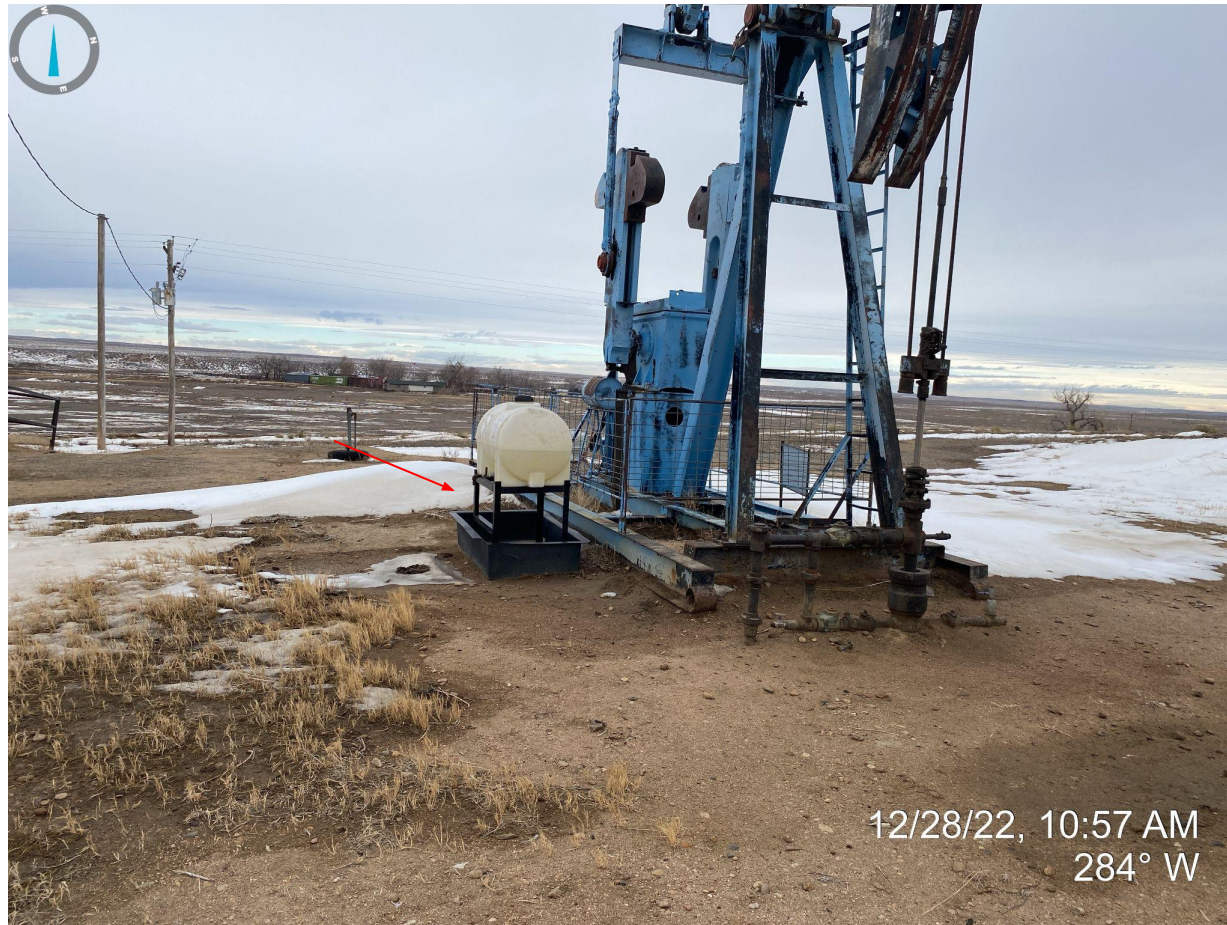
Photo 3. Facing west from the eastern portion of the well location. Red arrow illustrates no visible netting/wildlife protection around open tank.

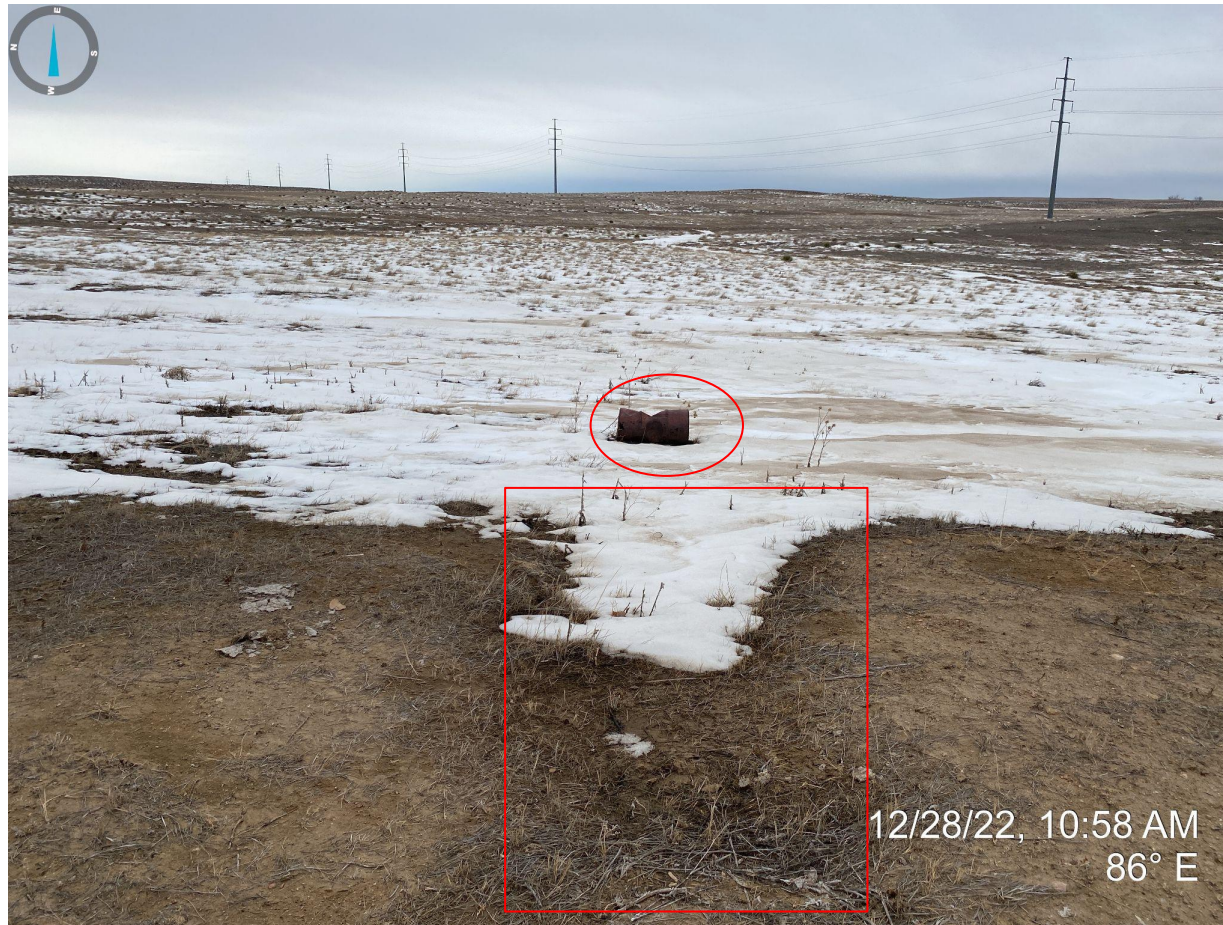
Photo 4. Facing east from the eastern portion of the well location. Photo illustrates debris (e.g. barrel) highlighted in red; and evidence of soil degradation/erosion due to apparent stormwater runoff. Location will be re-inspected at a later date to assess soil conditions as snow cover blocked view of adjacent lands.
