Construction and Stormwater Inspection

Operator: ENERPLUS RESOURCES (USA) CORPORATION - #10177

Location ID: 478120

Inspection Photos
Location Name: Calgary Streets/
Location ID: 478120

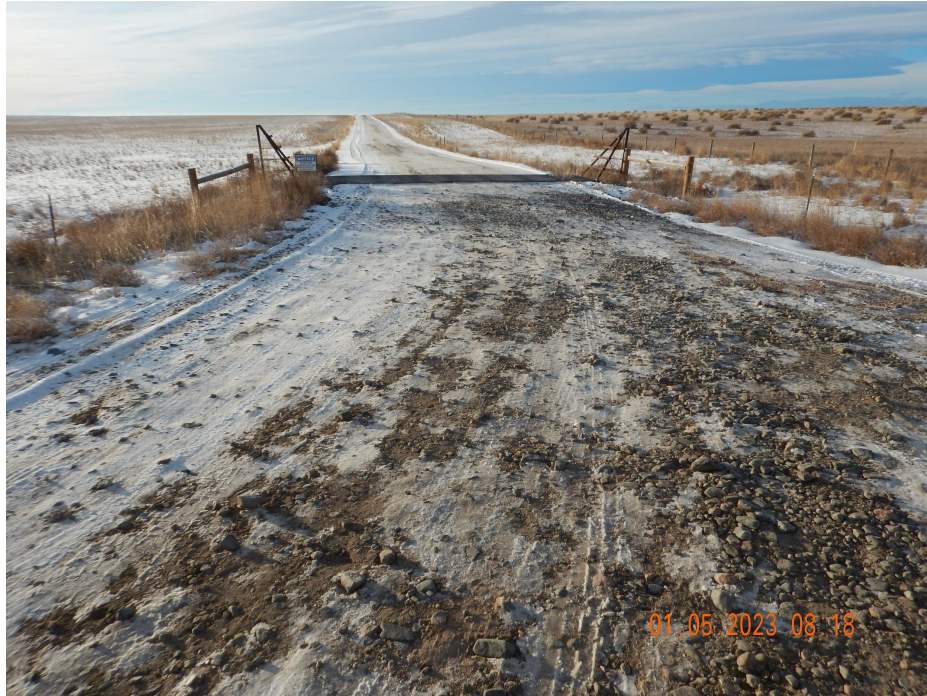
Photo 1. Photo taken from the entrance of location, facing South. Photo illustrates the entrance of location which will be shared with the Irish pad.

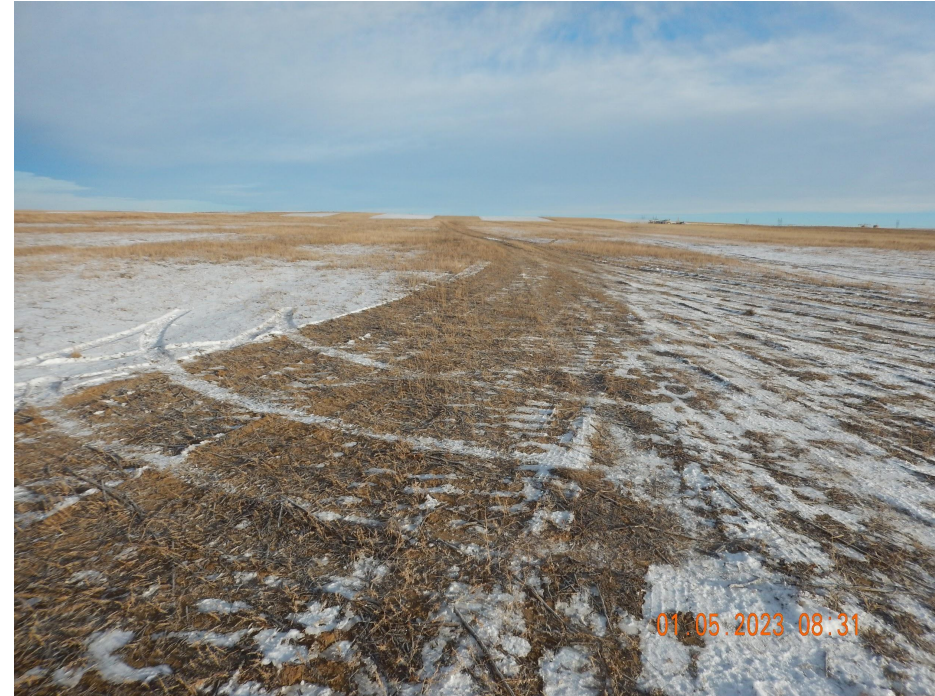
Photo 2. Photo taken from the northeastern location, facing North. Photo illustrates a temporary access road. Operator shall comply with Rule 1004 after its use.

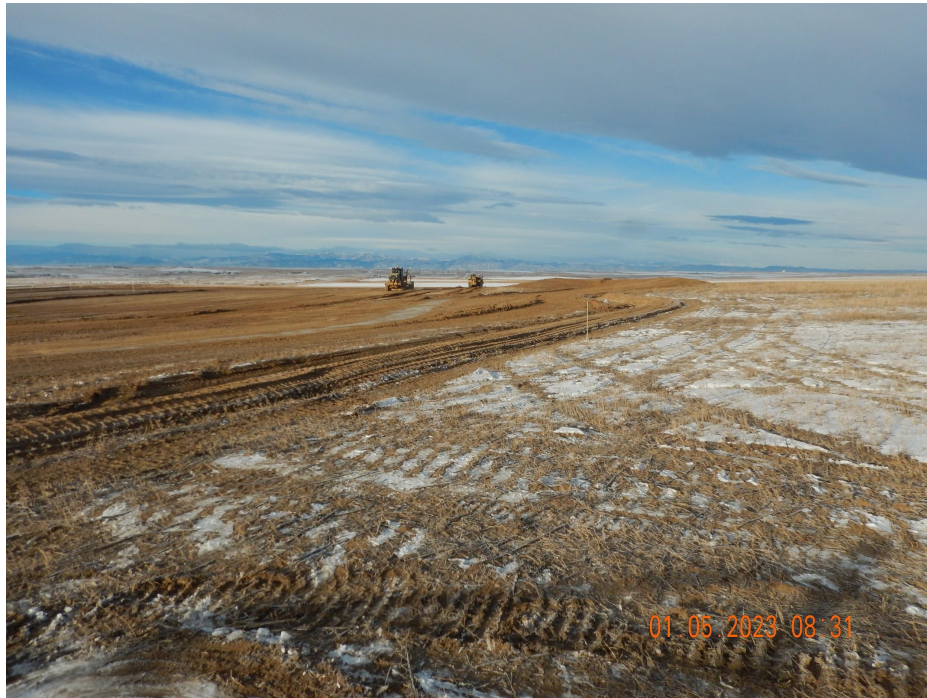
Photo 3. Photo taken from the northeastern location, facing West. Photo illustrates Operator is conducting topsoil salvage operations.

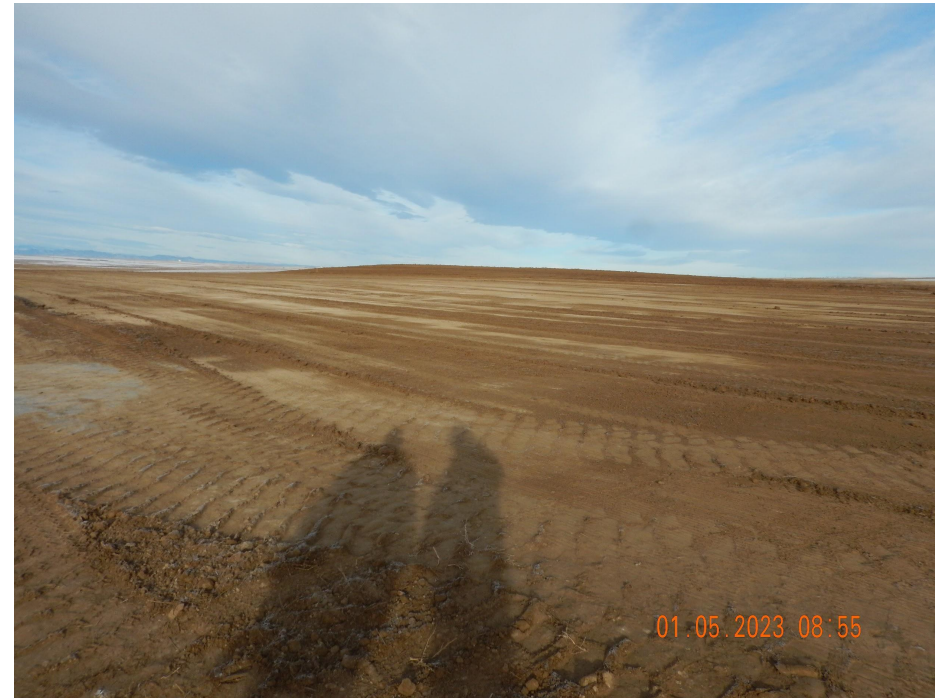
Photo 4. Photo taken from the central location, facing Northwest. Photo illustrates the color change of what appears to be topsoil (dark color) and subsoil (lighter color).

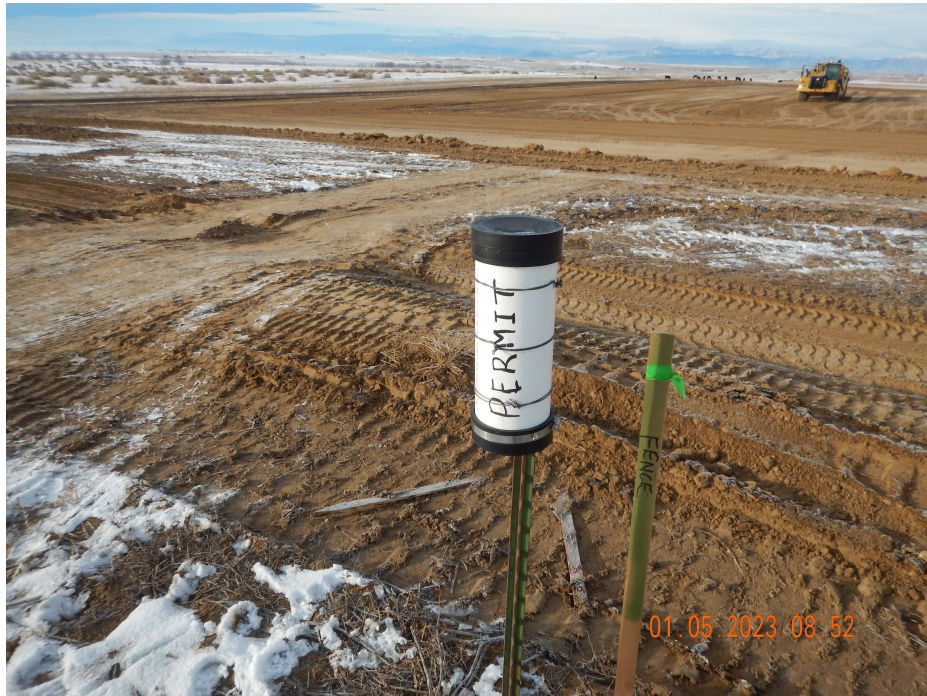
Photo 5. Photo taken from the eastern location, facing West. Photo illustrates the required permits per Rule 406.

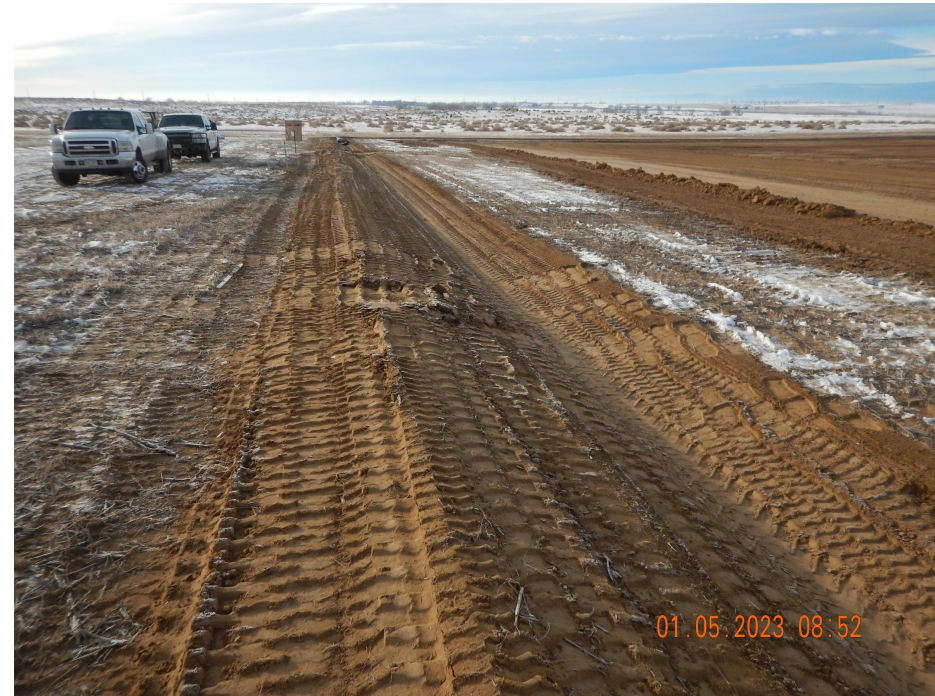
Photo 6. Photo taken from the eastern location, facing South. Photo illustrates a ditch and berm BMP installed around the entire perimeter of location during construction Operations.
