Interim Reclamation and Stormwater Inspection

Operator: SUMMIT OIL AND GAS LLC - 10774

Location ID: 465272

Inspection Photos
Location Name: Castor 7-59/12
Location ID: 465272

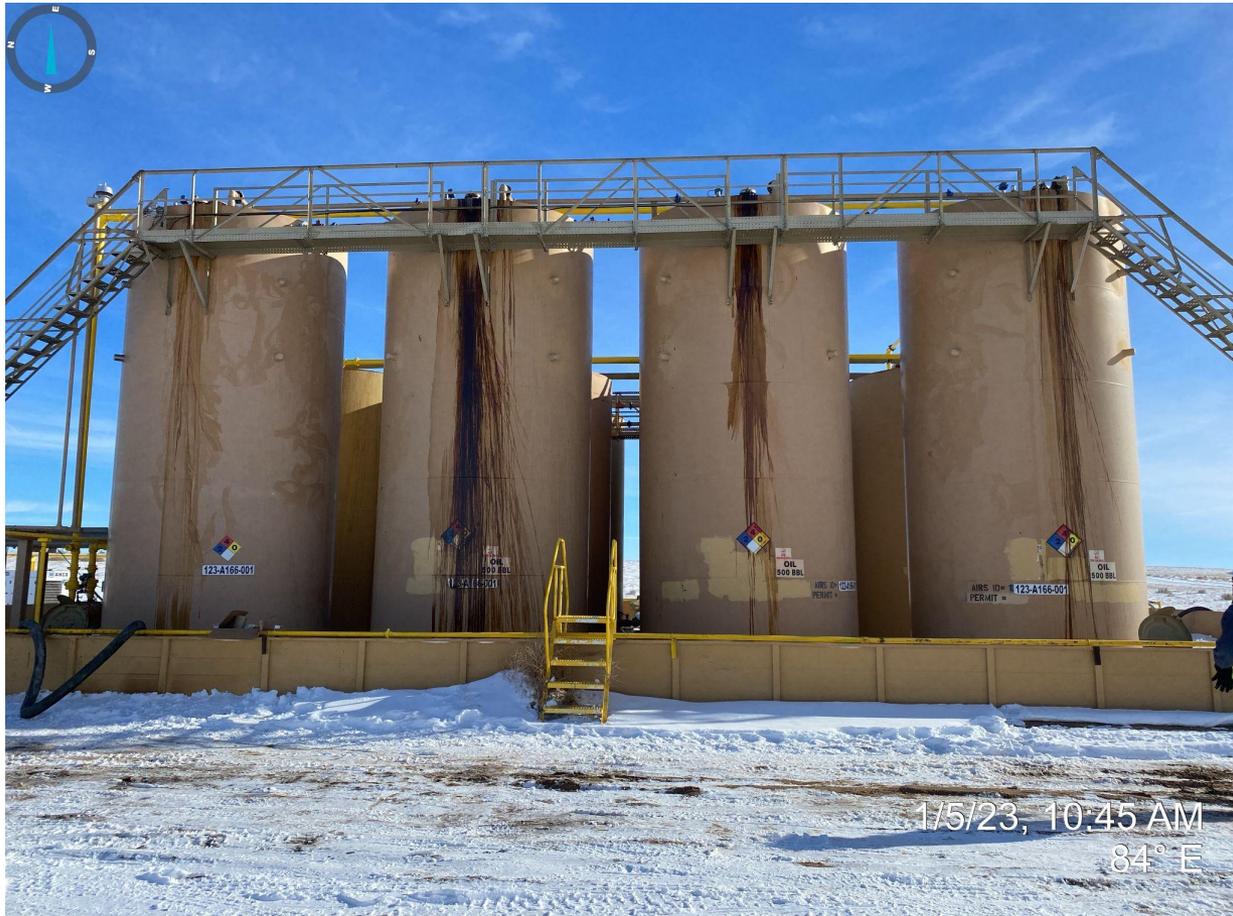
Photo 1. Facing east towards tank batteries. Photo illustrates crude released from thief hatches and dripping down the sides of the batteries.

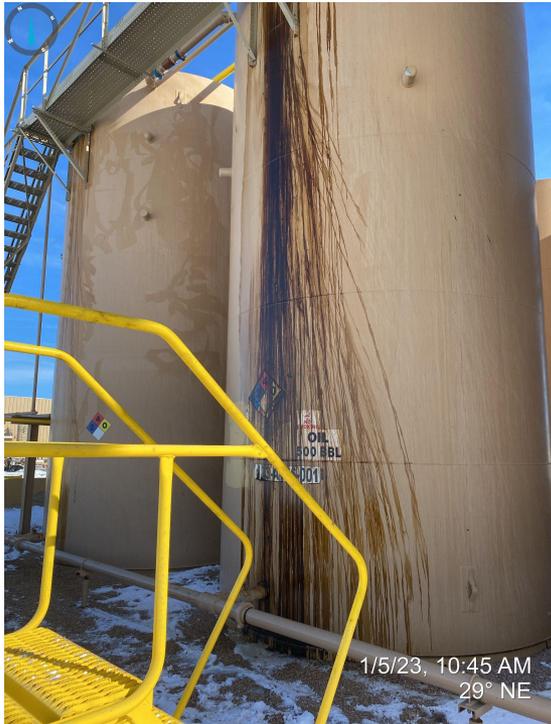
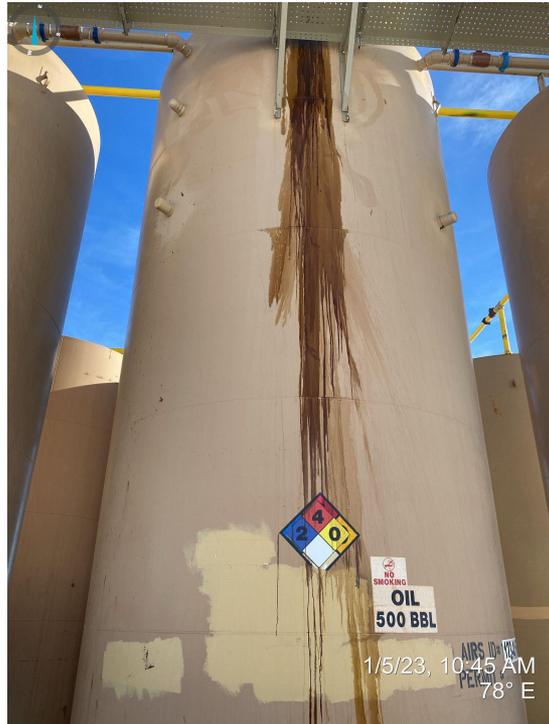
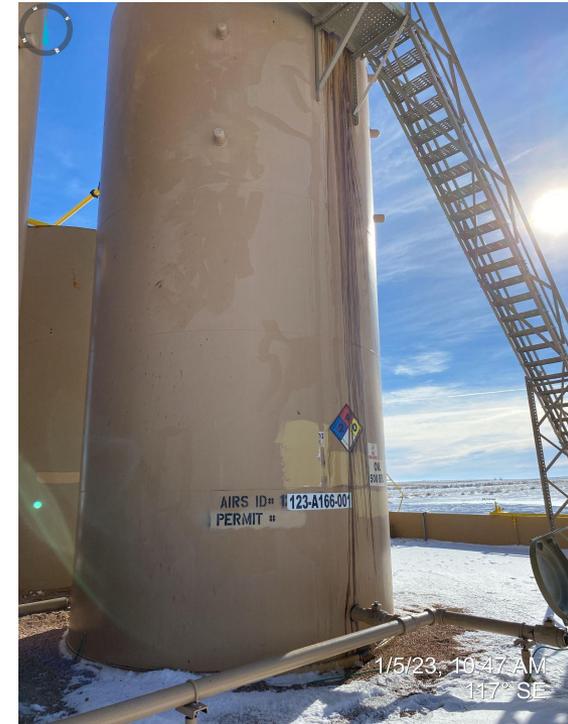
Photo 2. See comments in Photo 1.

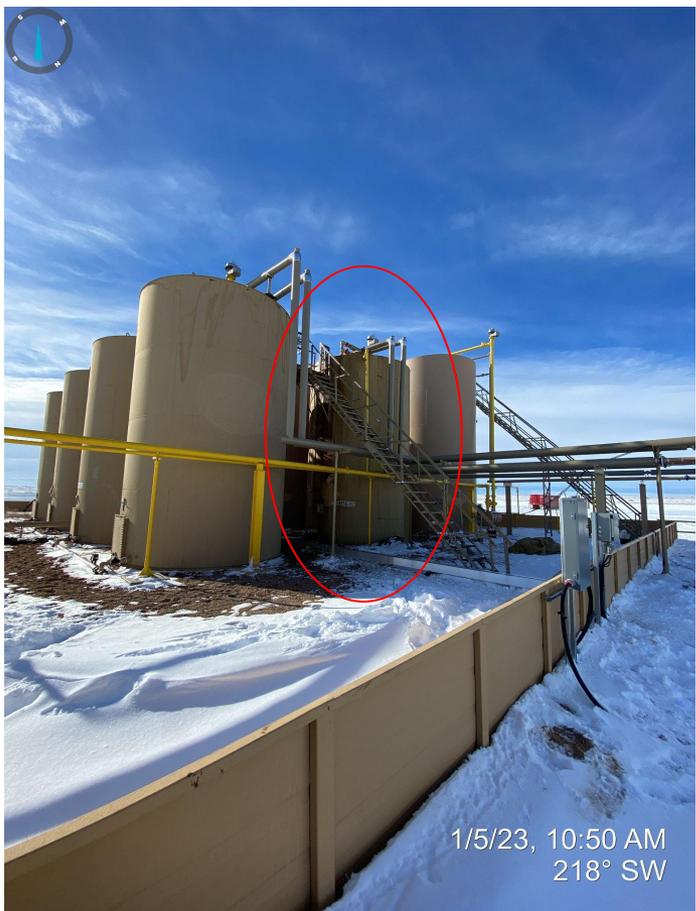
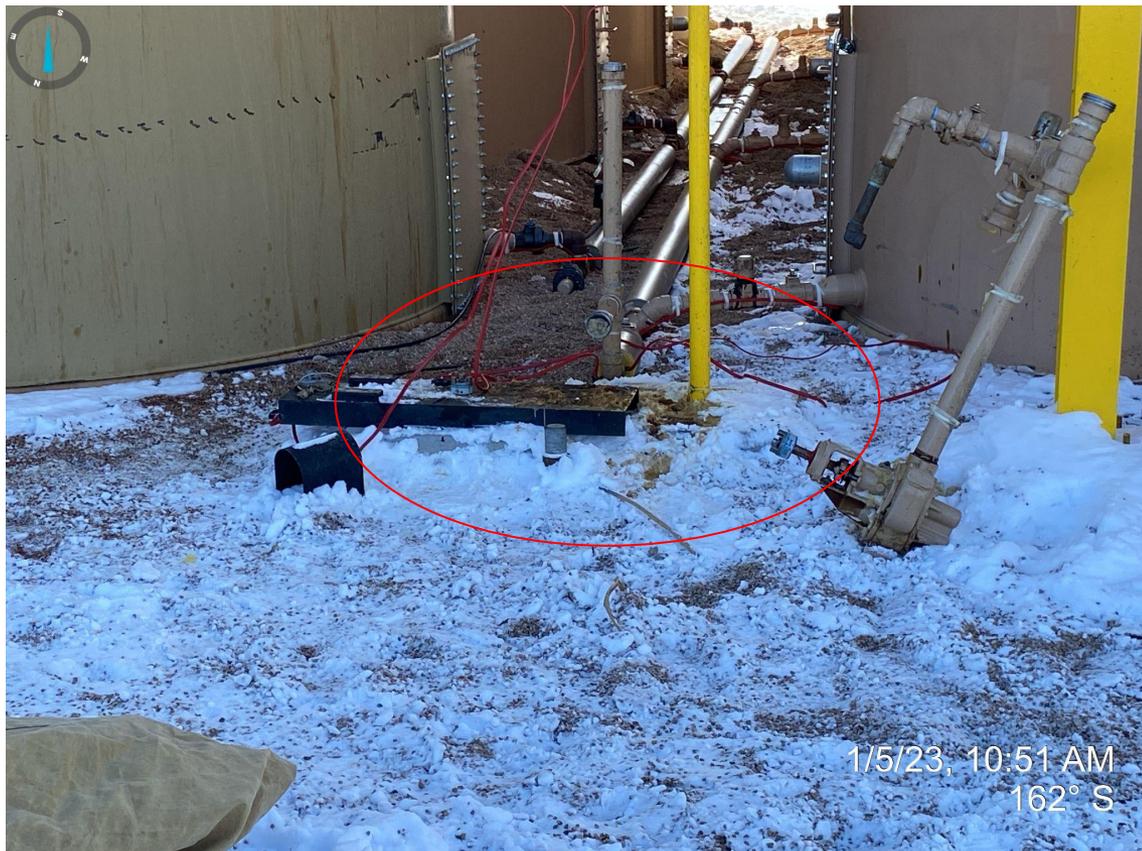
Photo 3. Facing southwest/south towards tank battery. Red outline shows crude spill on northern/middle tank.

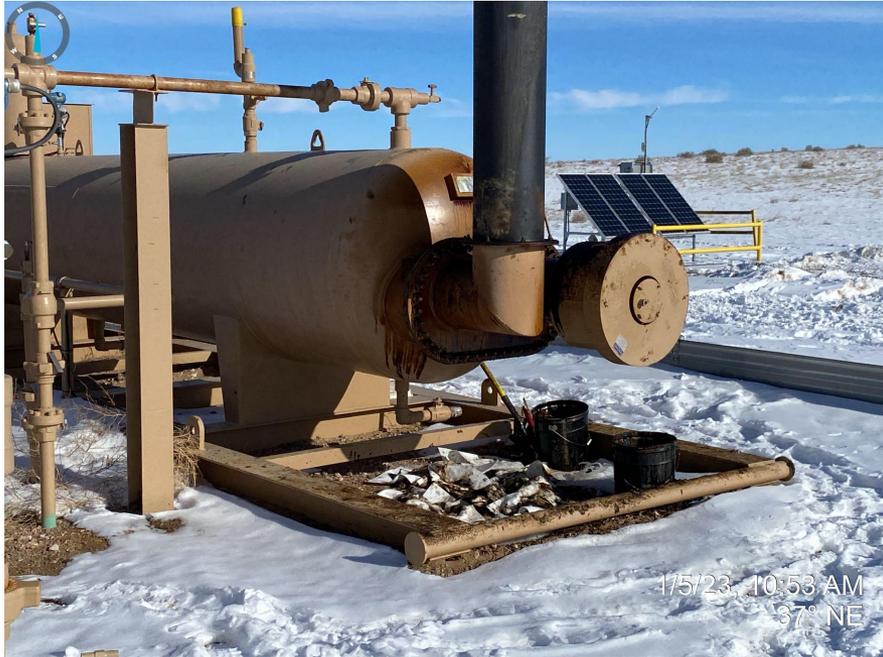
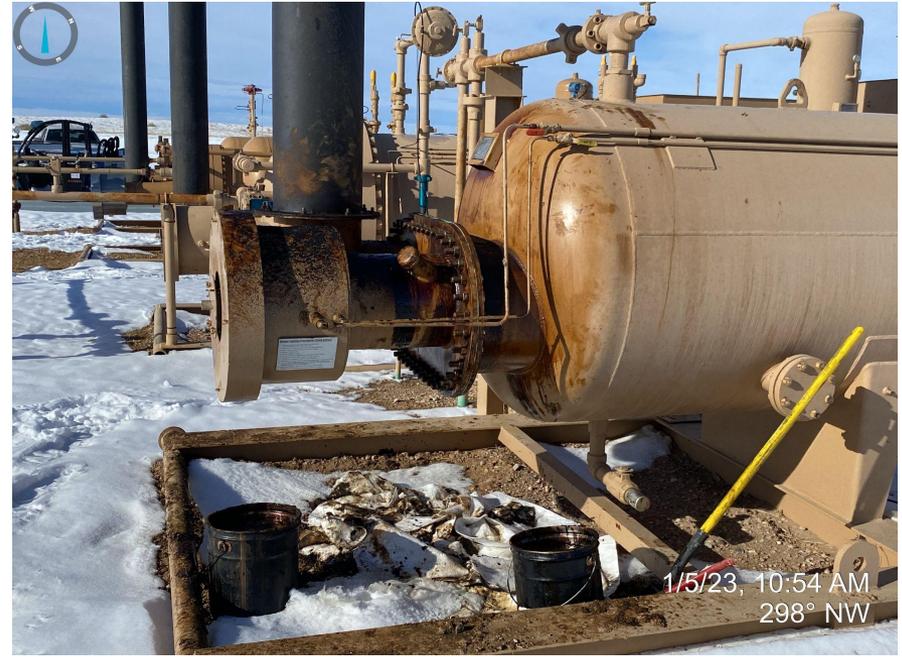
Photo 4. Facing northeast/northwest towards separator at the north end of the location. Photos illustrates a failed gasket that resulted in fluid exiting the equipment.

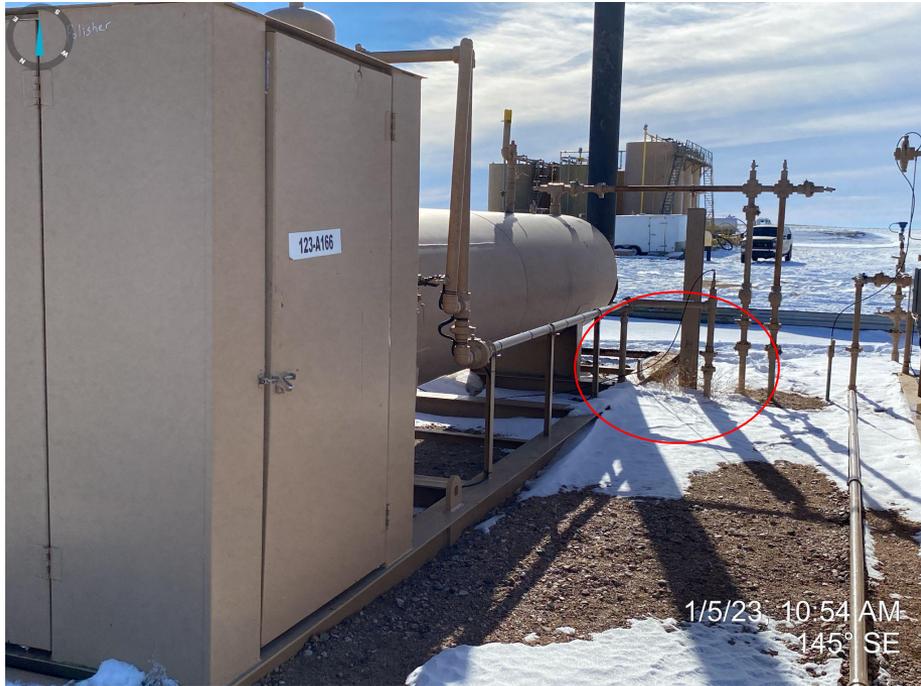
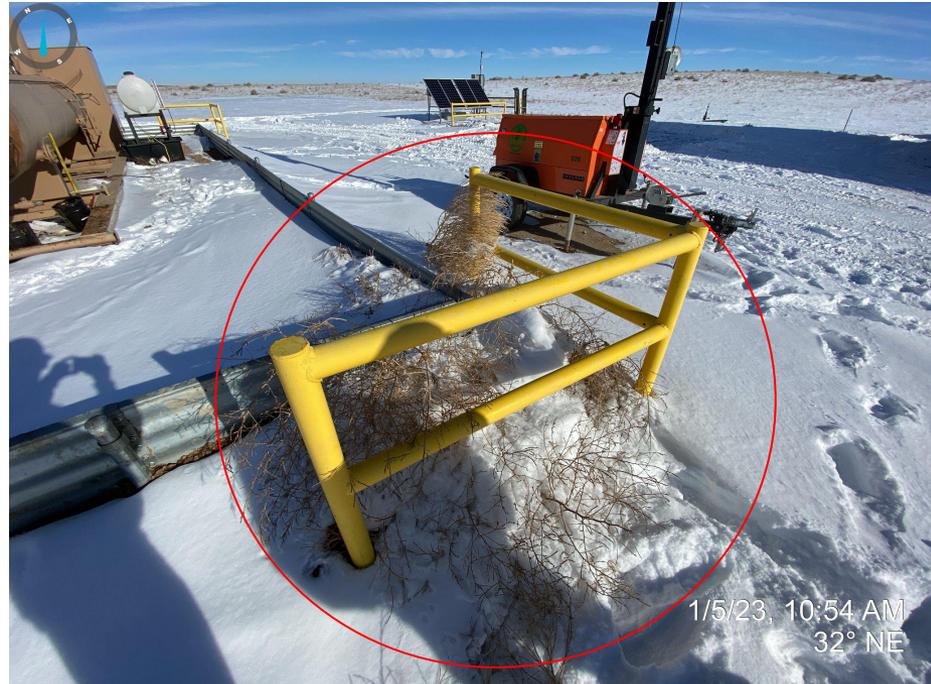
Photo 5. Facing southeast/northeast at the separators towards the north end of the location. Photo illustrates tumbleweeds accumulated in and around equipment. This is considered debris, presents a potential fuel source for fire, and needs to be disposed of.

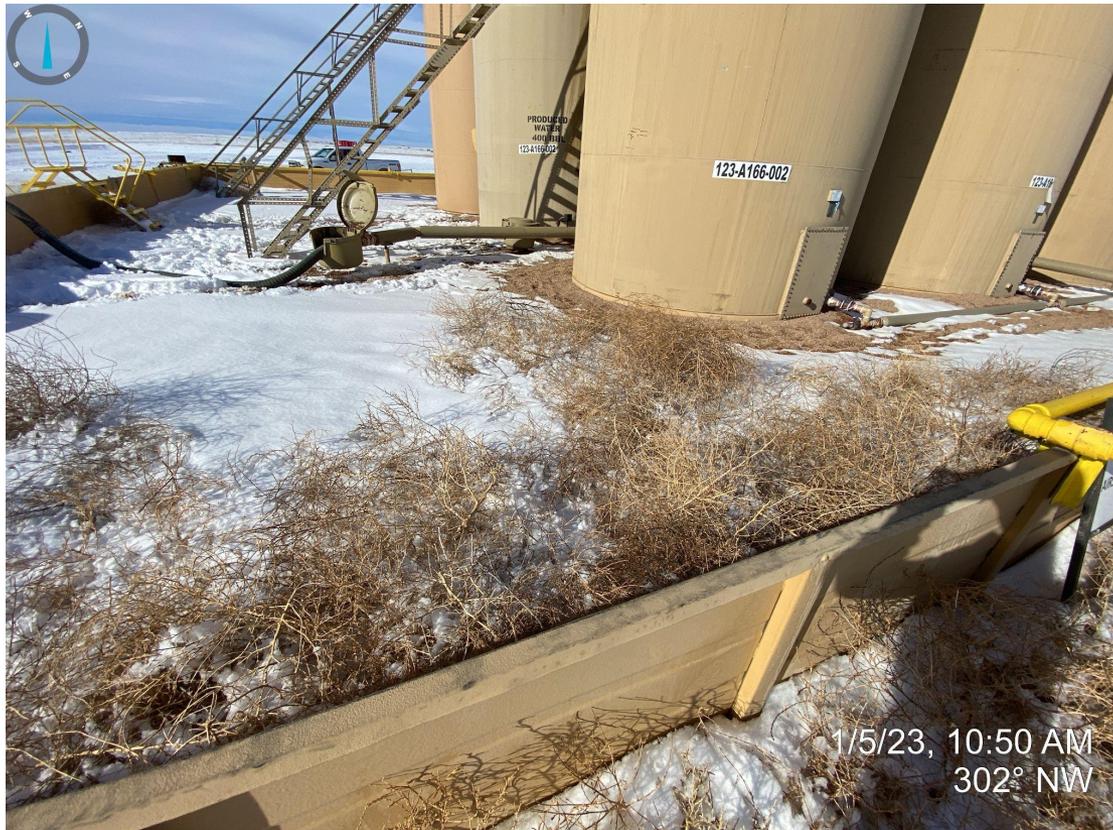
Photo 6. Facing northwest at tank battery. Photo illustrates tumbleweeds accumulated in and around equipment. This is considered debris, presents a potential fuel source for fire, and needs to be disposed of.

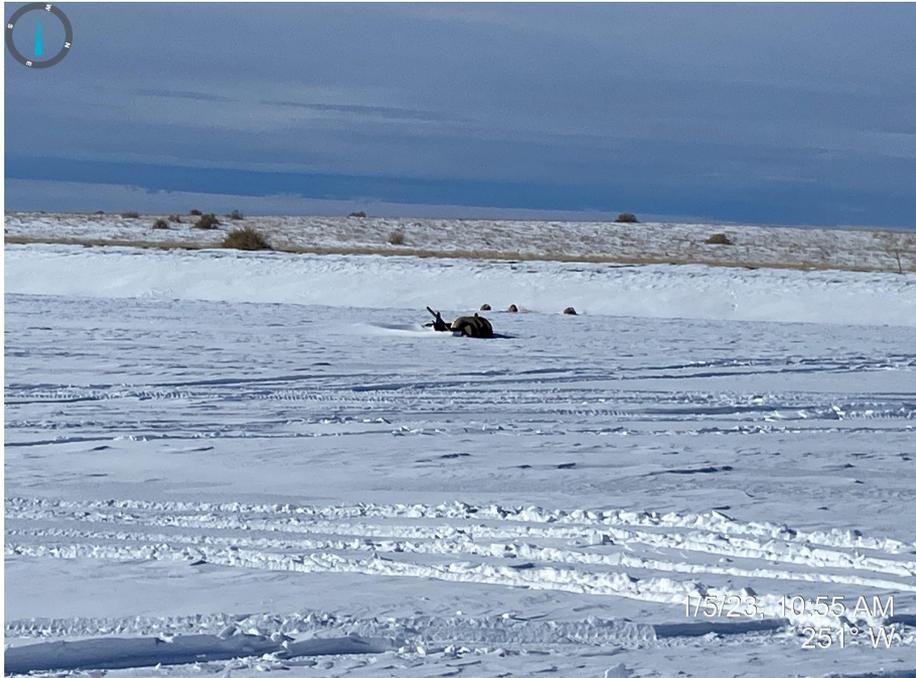
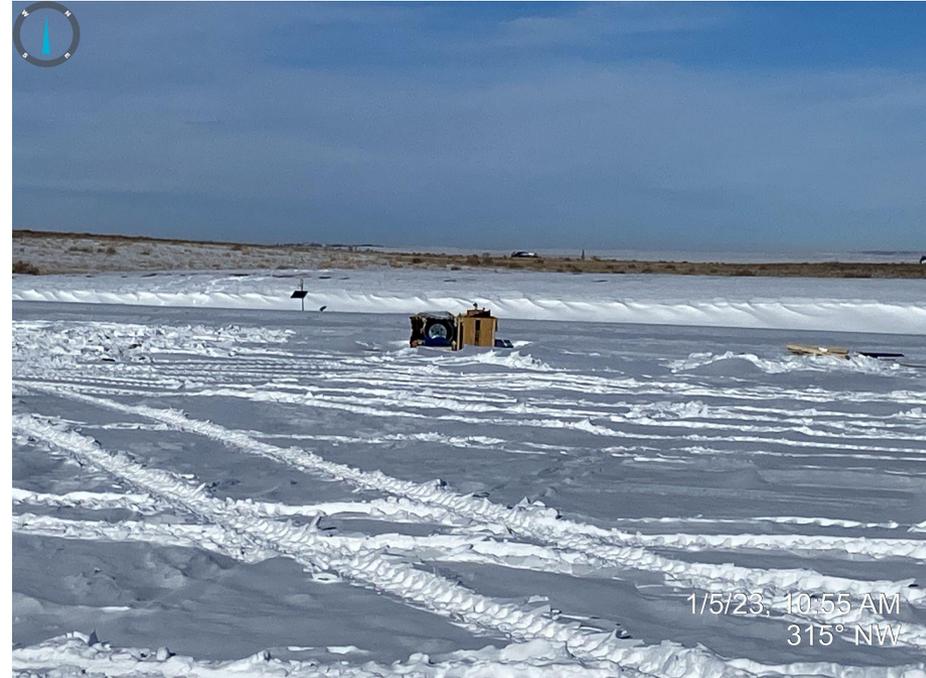
Photo 7. Facing west and northwest from location. Photos illustrate piles of supplies and smaller equipment being stored on location. Snow on top of these indicates they have been there for some time and need to be stored off location if not currently being used.
