# SITE-SPECIFIC QUALITY ASSURANCE & QUALITY CONTROL AUDIT

## PERMIT CLOSURE REPORT – DESIGNATION LAND USE CHANGE

Location ID - 321351

Location Name – ARAPAHOE-61N69W36SESW

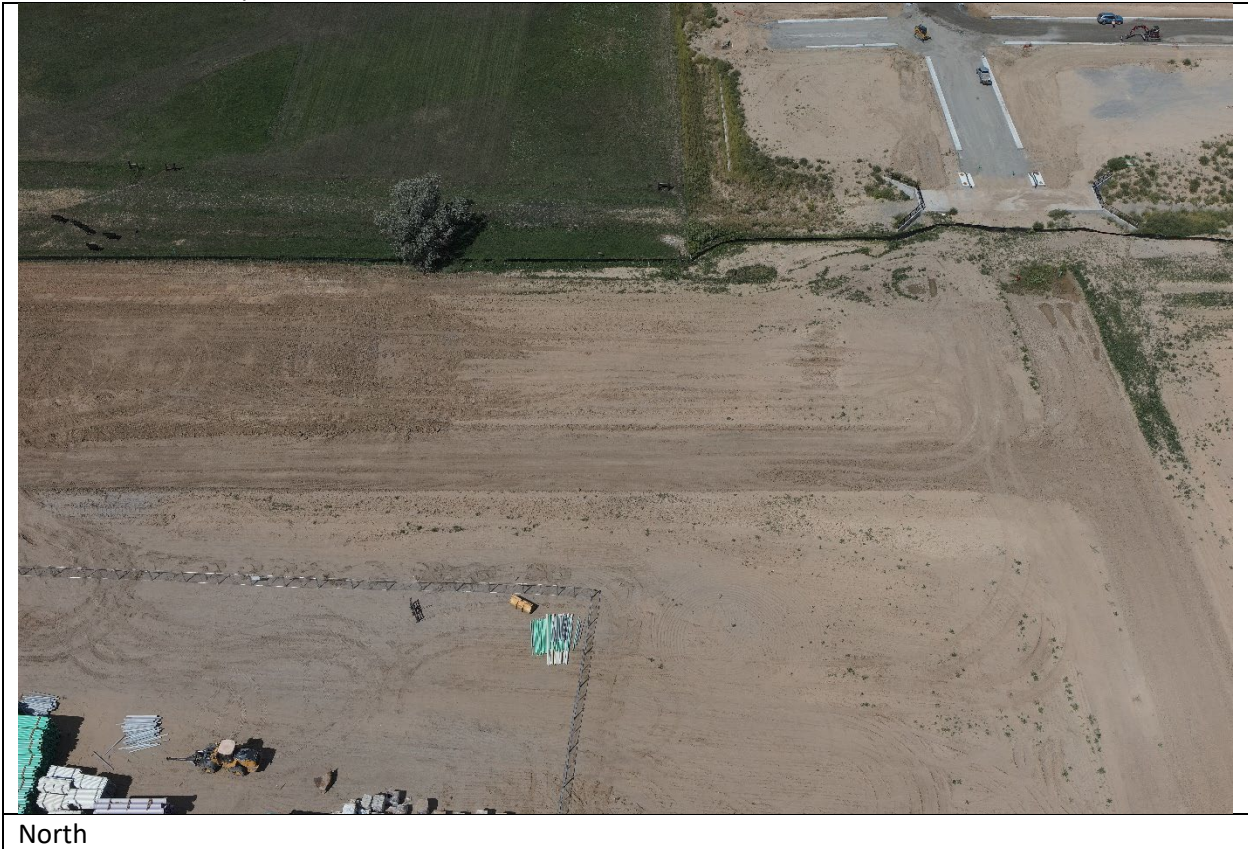
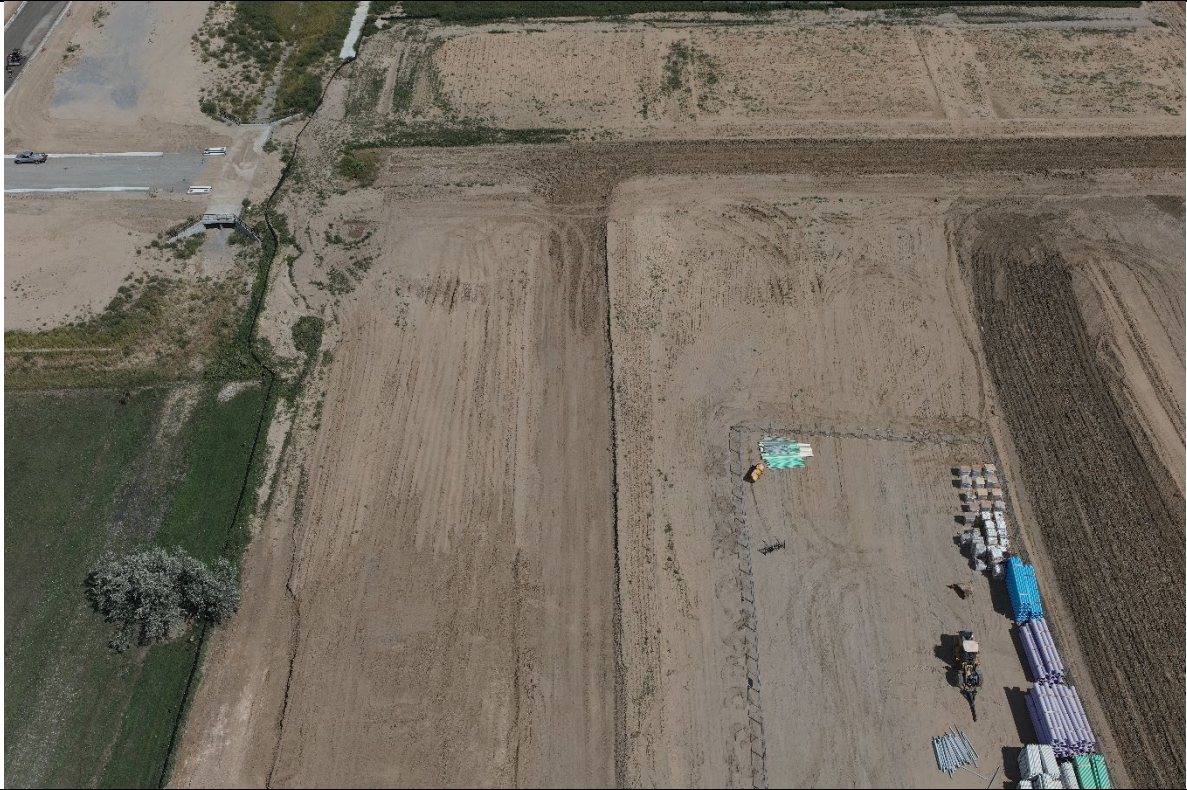
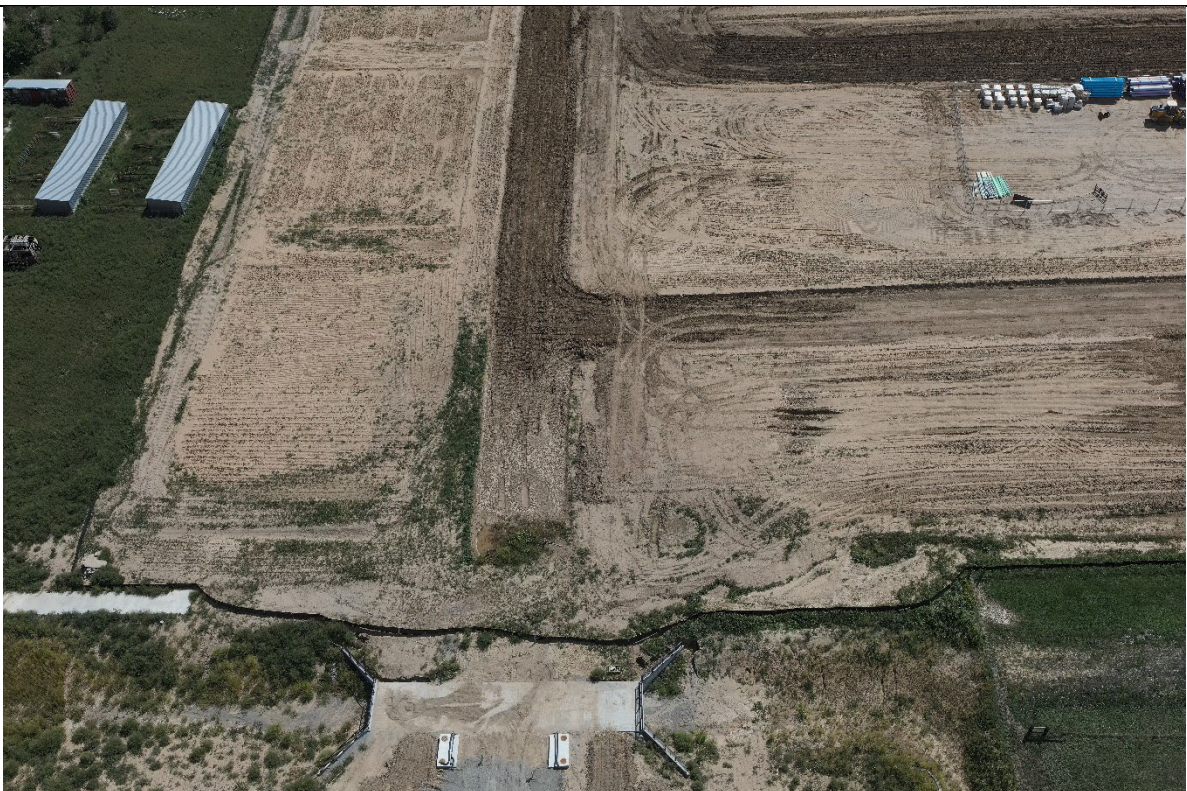
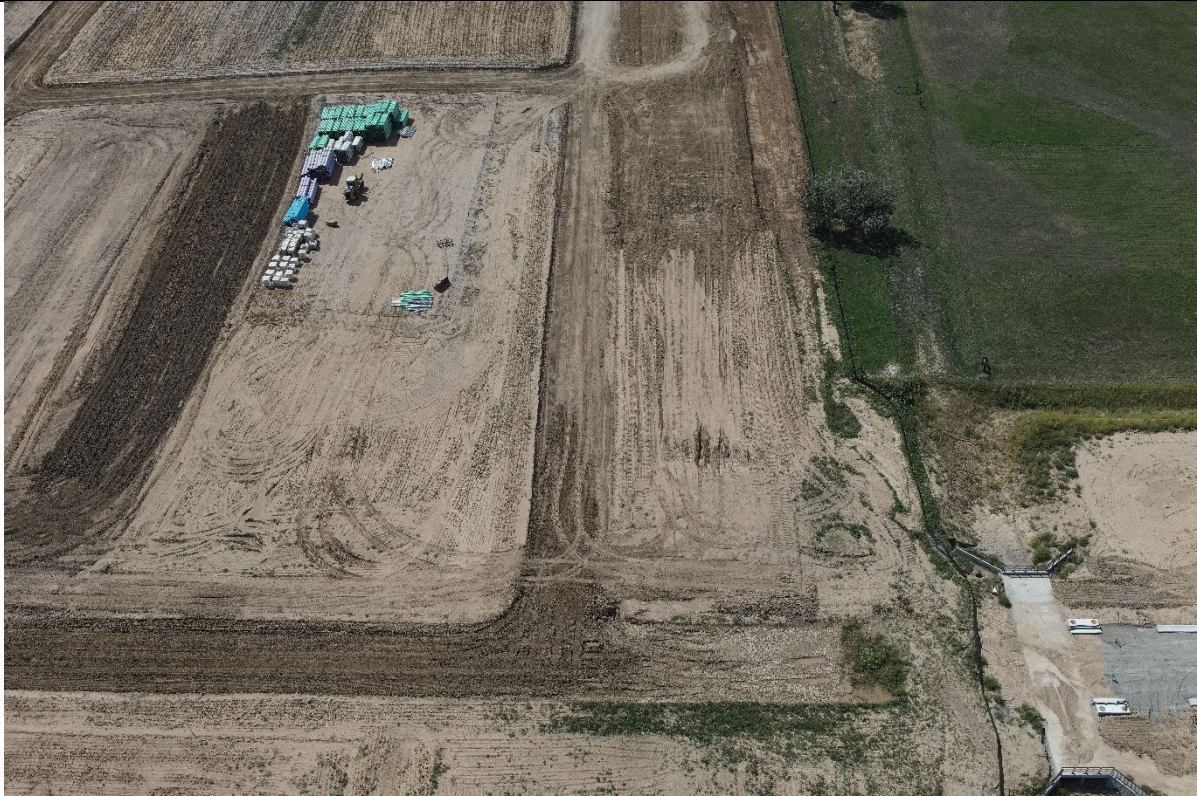
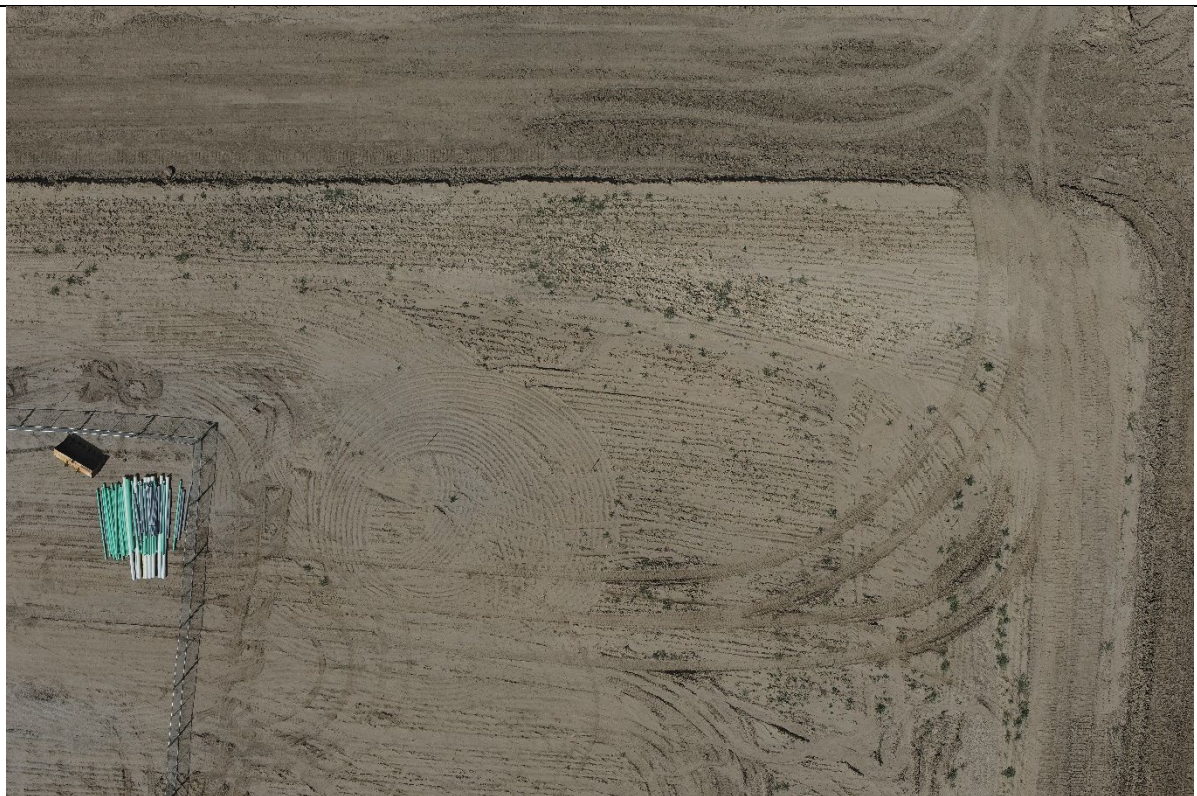
### *Reference Area Photos*

## Audit Key Findings - Designation Land Use Change Observations

PREVIOUS LAND USE	CURRENT LAND USE
Reference Imagery for Infrastructure – DRCOG 2014	Remotely Sense Imagery – 09/01/2022
Designation – Well Pad	Designation – Housing Development

Cardinal directional photos of the site

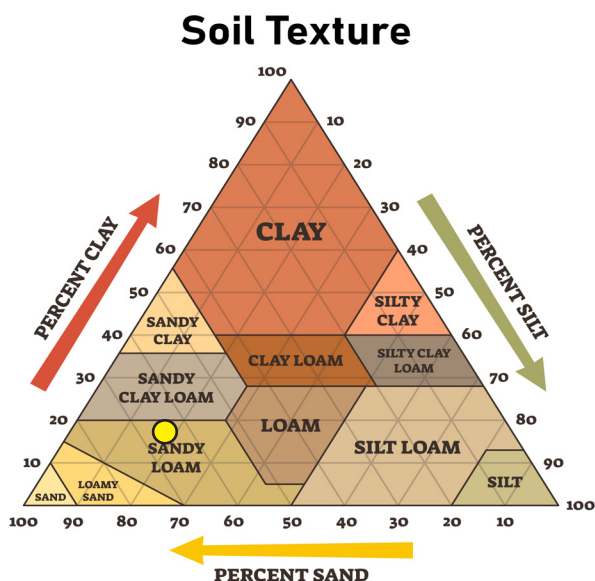
### Soil Texture Triangle reflect the 0-10 in depth

### Map Unit AcA Reference Soil information - Ascalon sandy loam

Depth (in)	Physical			Chemical			
	Texture	Bulk Density	Partical Size Percent sand, silt, clay	pH	EC	SAR	OM%
0-10	Sandy Loam	1.52	63-19-18	7.1	0.1	0.0	0.84
10-20	Sandy Clay Loam	1.51	58-17-25	7.5	0.1	0.0	0.47
20-30	Sandy Clay Loam	1.48	62-15-23	8.2	0.1	0.0	0.22
30-40	Sandy Clay Loam	1.55	69-13-18	8.2	0.1	0.0	0.16
40-50	Sandy Loam	1.62	75-11-14	8.2	0.1	0.0	0.10
50 +	Sandy Loam	1.62	75-11-14	8.2	0.1	0.0	0.10

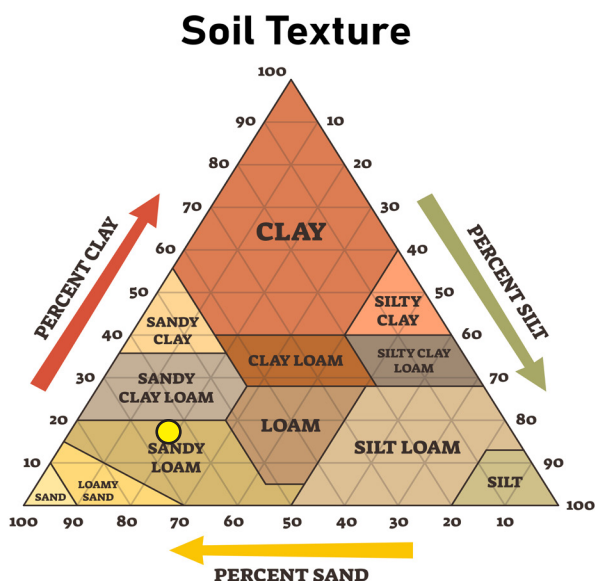
### Soil Texture Triangle reflect the 0-10 in depth

### Map Unit AcC Reference Soil information - Ascalon sandy loam

Depth (in)	Physical			Chemical			
	Texture	Bulk Density	Partical Size Percent sand, silt, clay	pH	EC	SAR	OM%
0-10	Sandy Loam	1.54	63-19-18	7.1	0.1	0.0	0.84
10-20	Sandy Clay Loam	1.57	57-18-25	7.5	0.1	0.0	0.47
20-30	Sandy Clay Loam	1.50	55-22-23	8.2	0.1	0.0	0.22
30-40	Sandy Clay Loam	1.56	65-16-19	8.2	0.1	0.0	0.16
40-50	Sandy Loam	1.62	75-11-14	8.2	0.1	0.0	0.10
50 +	Sandy Loam	1.62	75-11-14	8.2	0.1	0.0	0.10

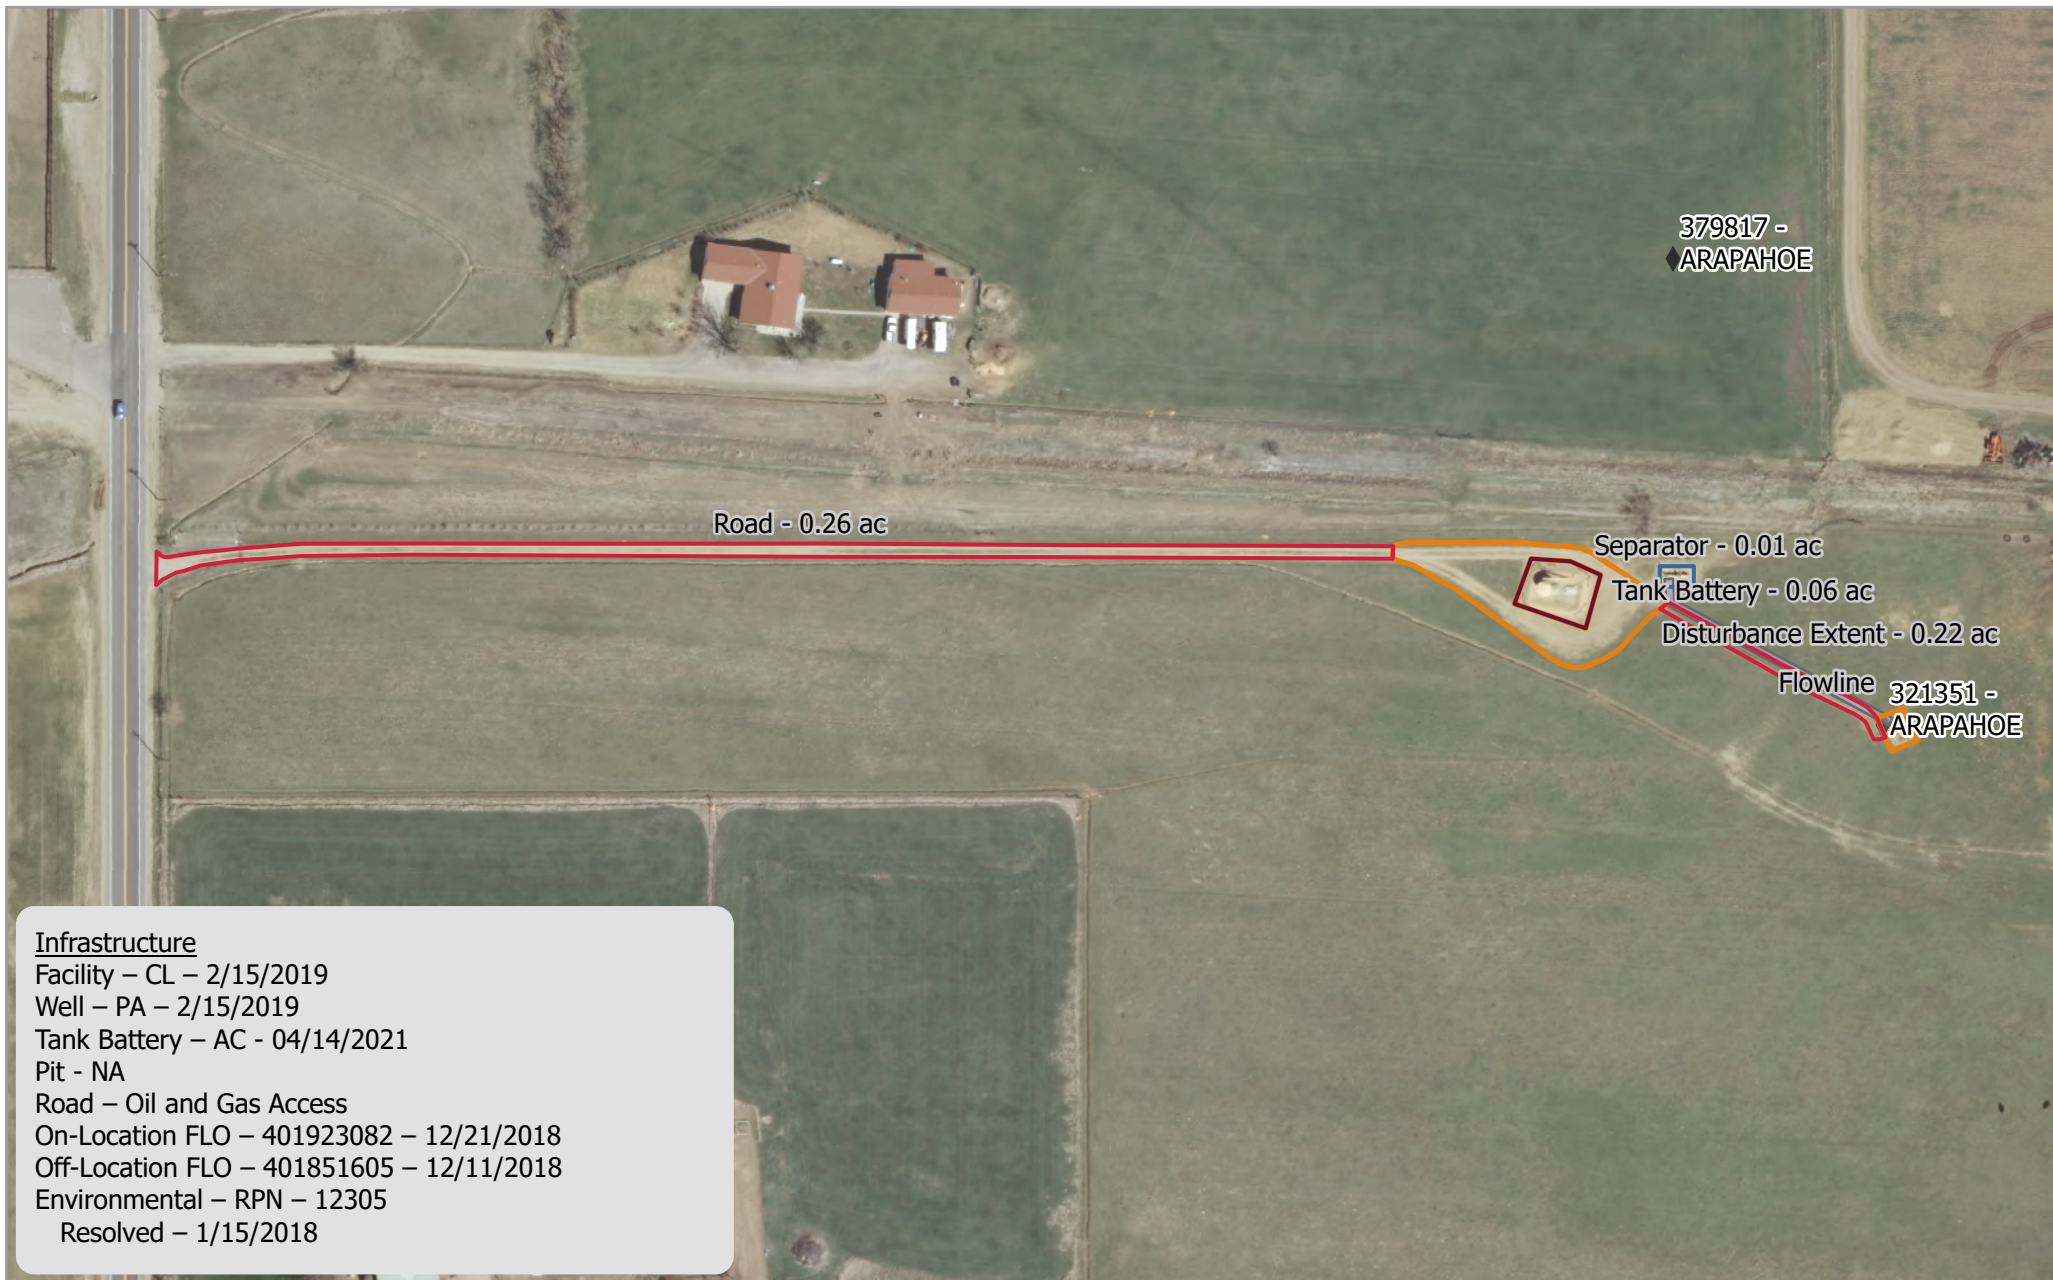
## CIV - 321351 - ARAPAHOE Map Extent - DRCOG 2010

Imagery: DRCOG  
 Imagery Date: 2010  
 Map Date: 09 Nov 2022  
 Datum: NAD\_1983\_UTM\_Zone\_13N  
 POC: Soil Sage

Overall Disturbance:  
0.53 acres

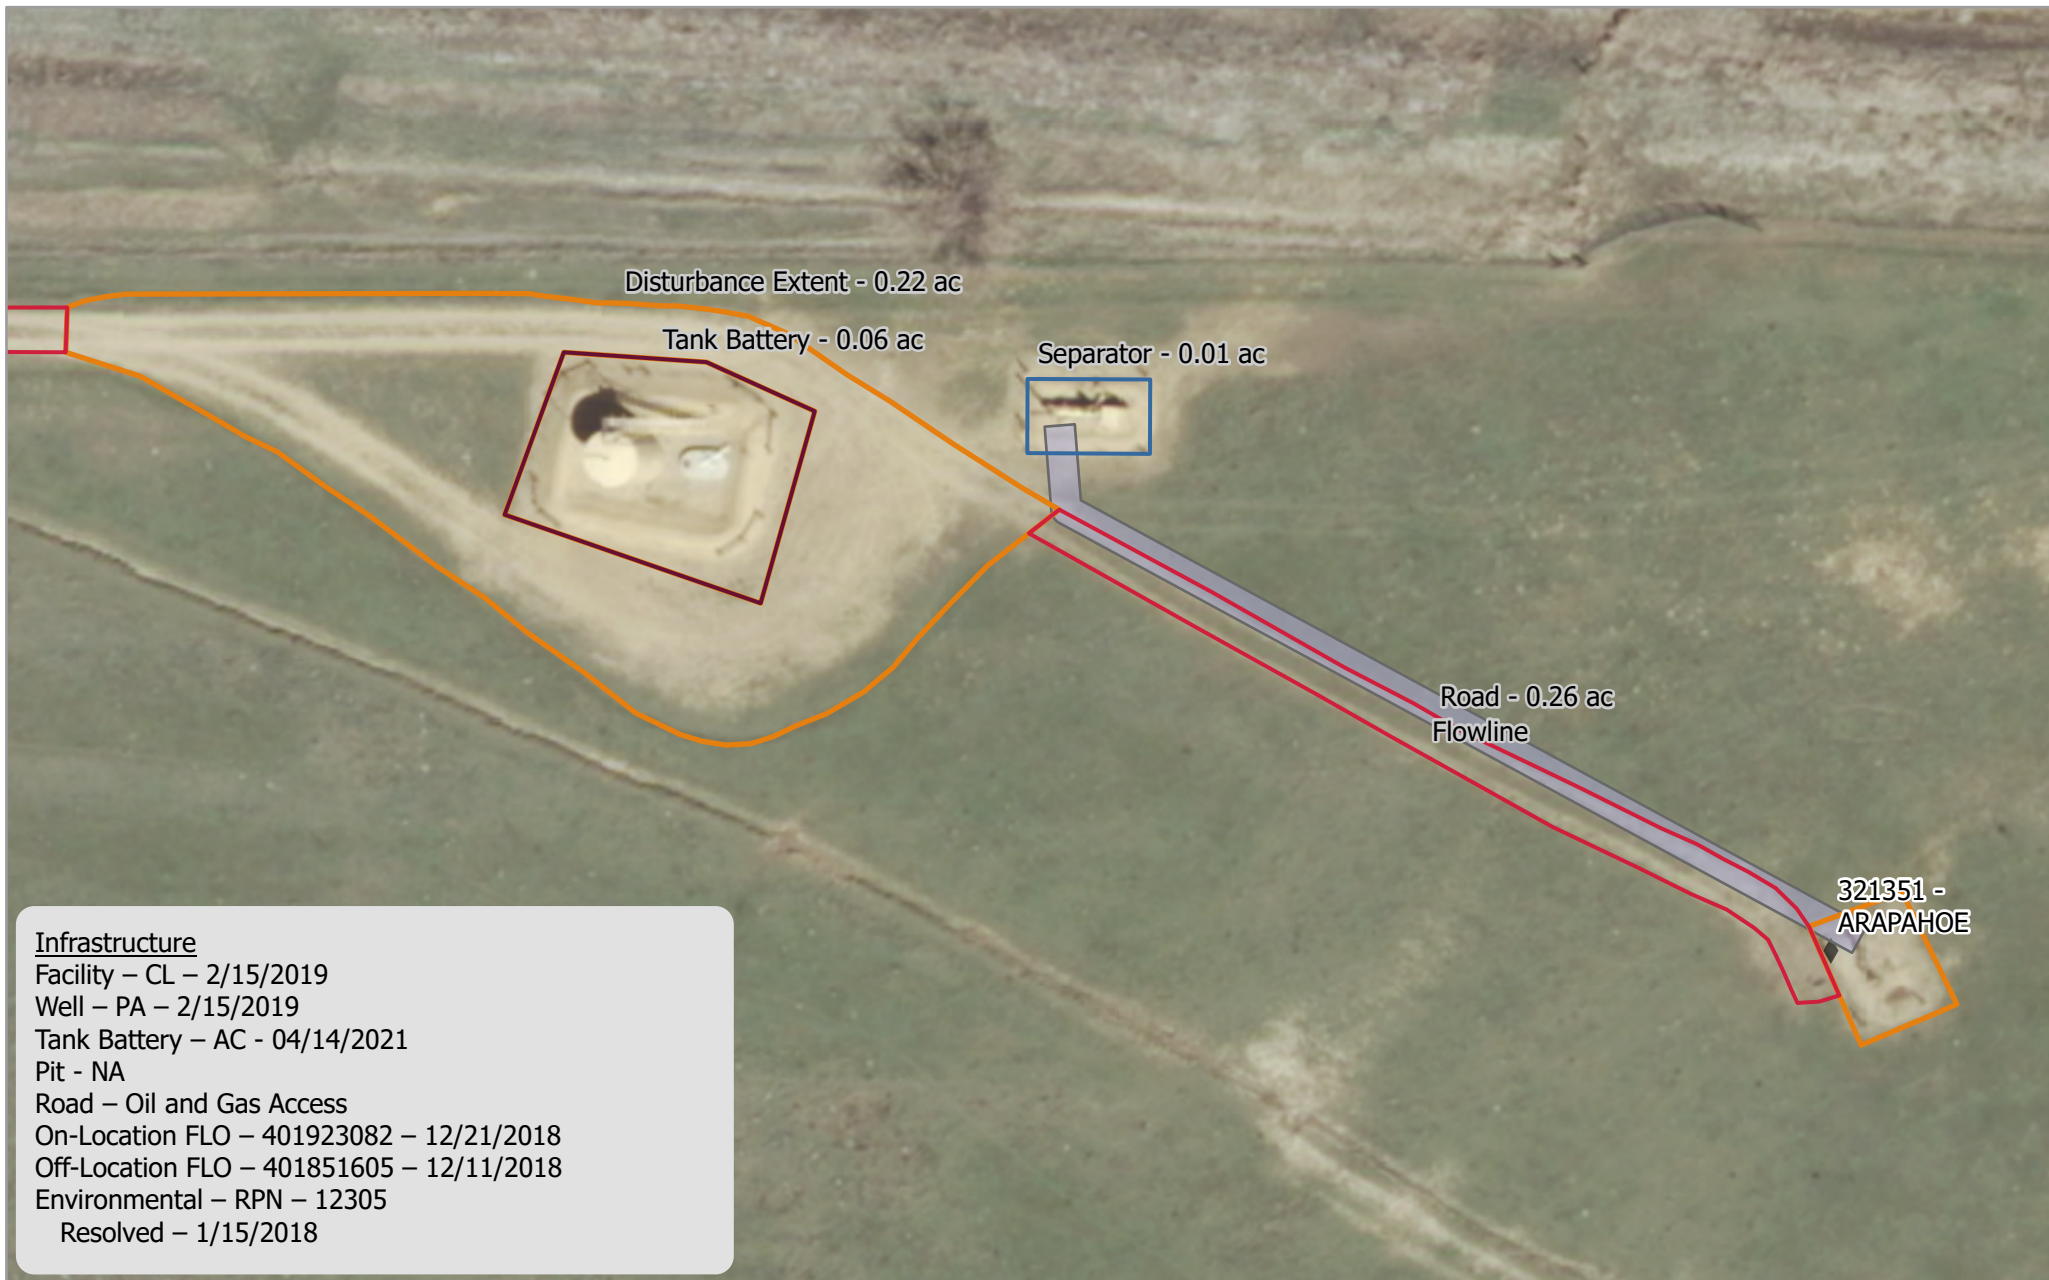
## CIV - 321351 - ARAPAHOE Map Extent - DRCOG 2010

Imagery: DRCOG  
 Imagery Date: 2010  
 Map Date: 09 Nov 2022  
 Datum: NAD\_1983\_UTM\_Zone\_13N  
 POC: Soil Sage

Overall Disturbance:  
0.53 acres

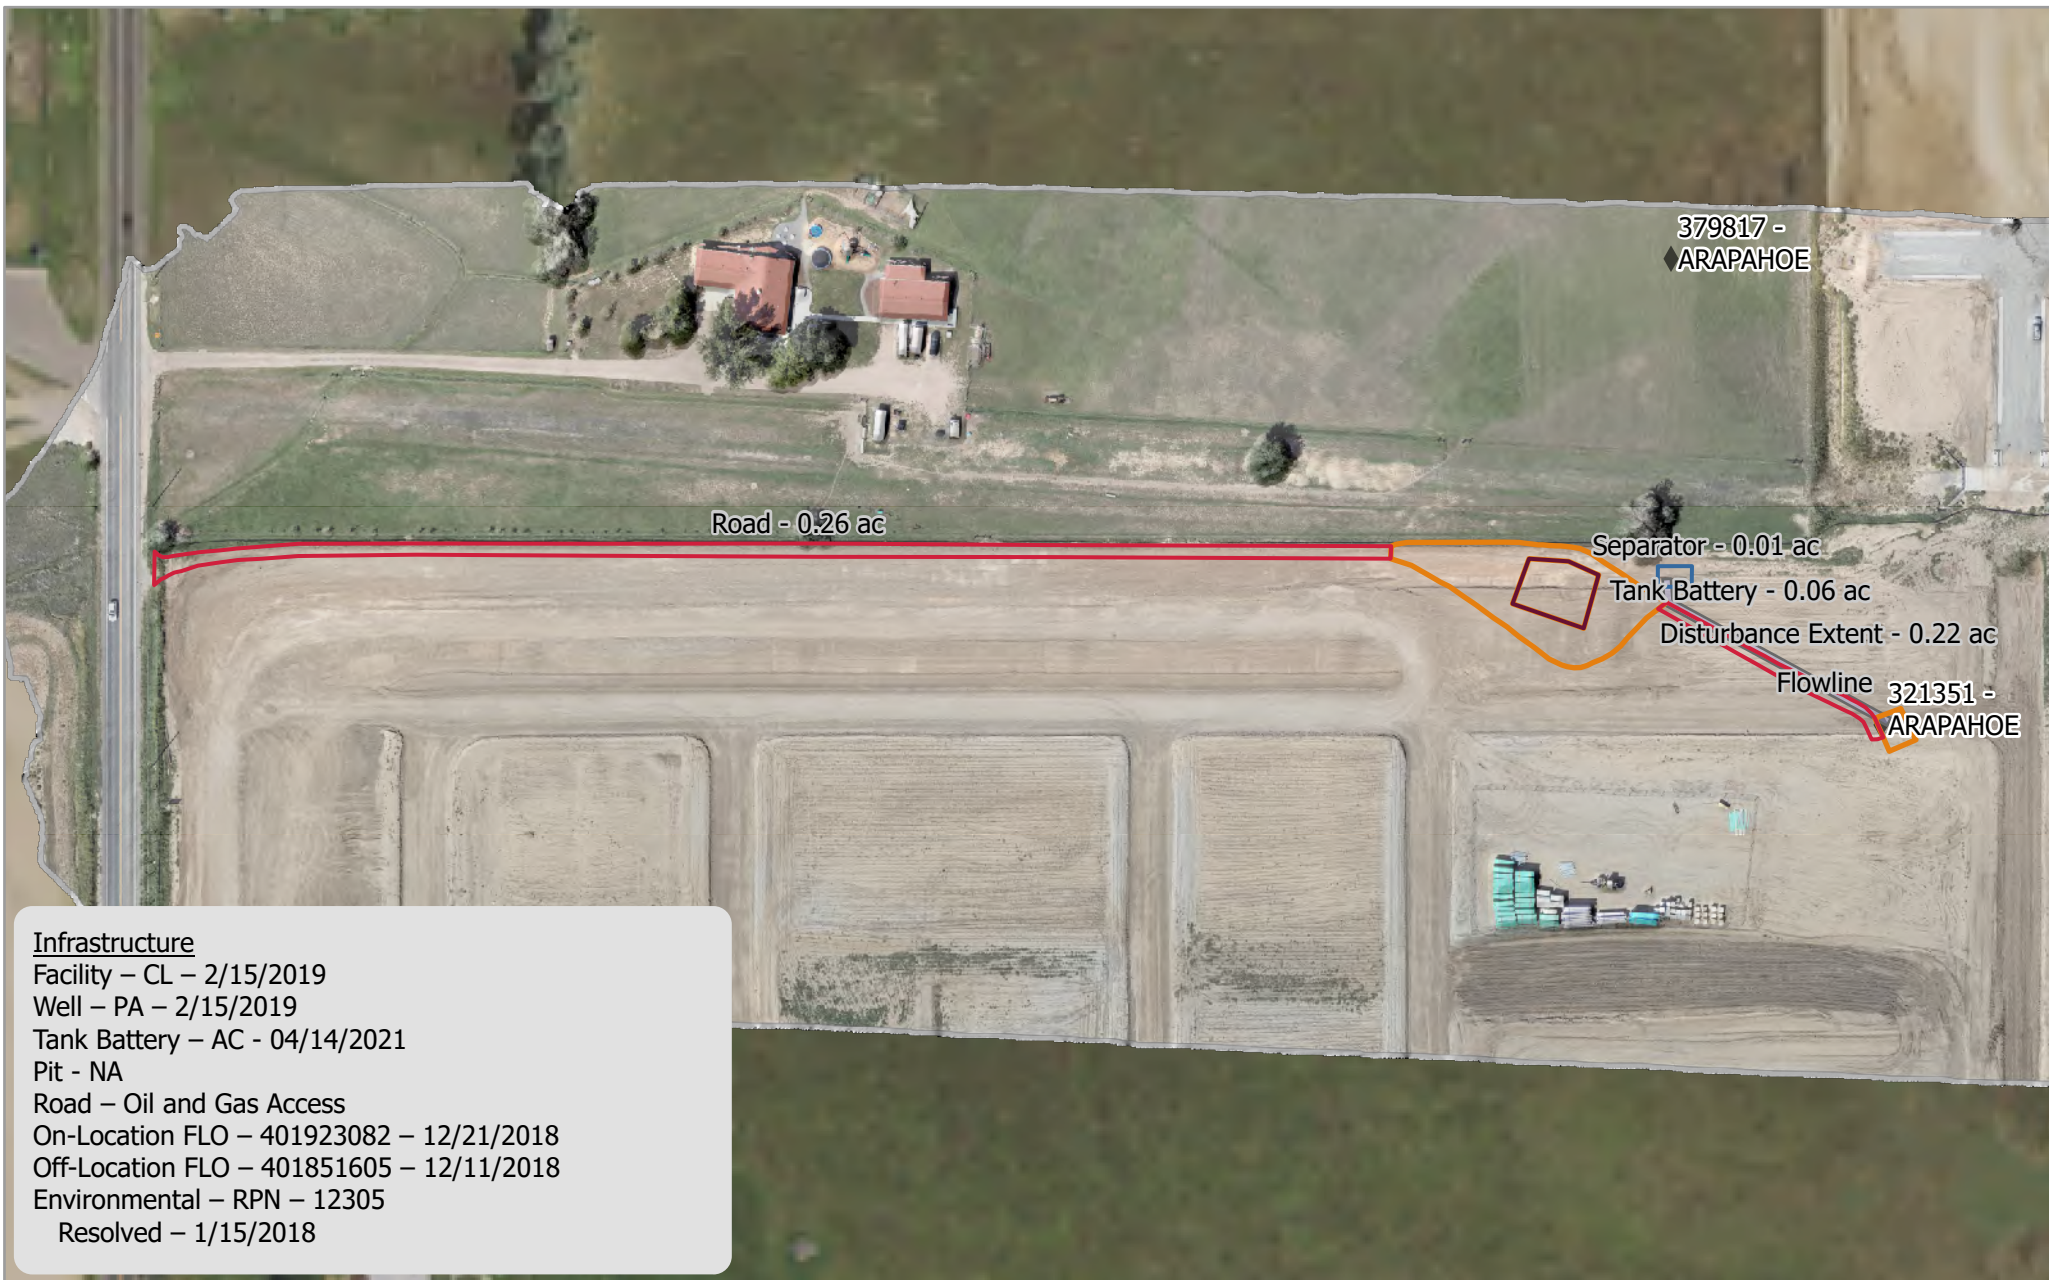
## CIV - 321351 - ARAPAHOE Map Extent - Overview

Imagery: RS Orthomosaic & DSM  
 Imagery Date: 1 Sep 2022  
 Map Date: 09 Nov 2022  
 Datum: NAD\_1983\_UTM\_Zone\_13N  
 POC: Soil Sage

Overall Disturbance:  
0.53 acres

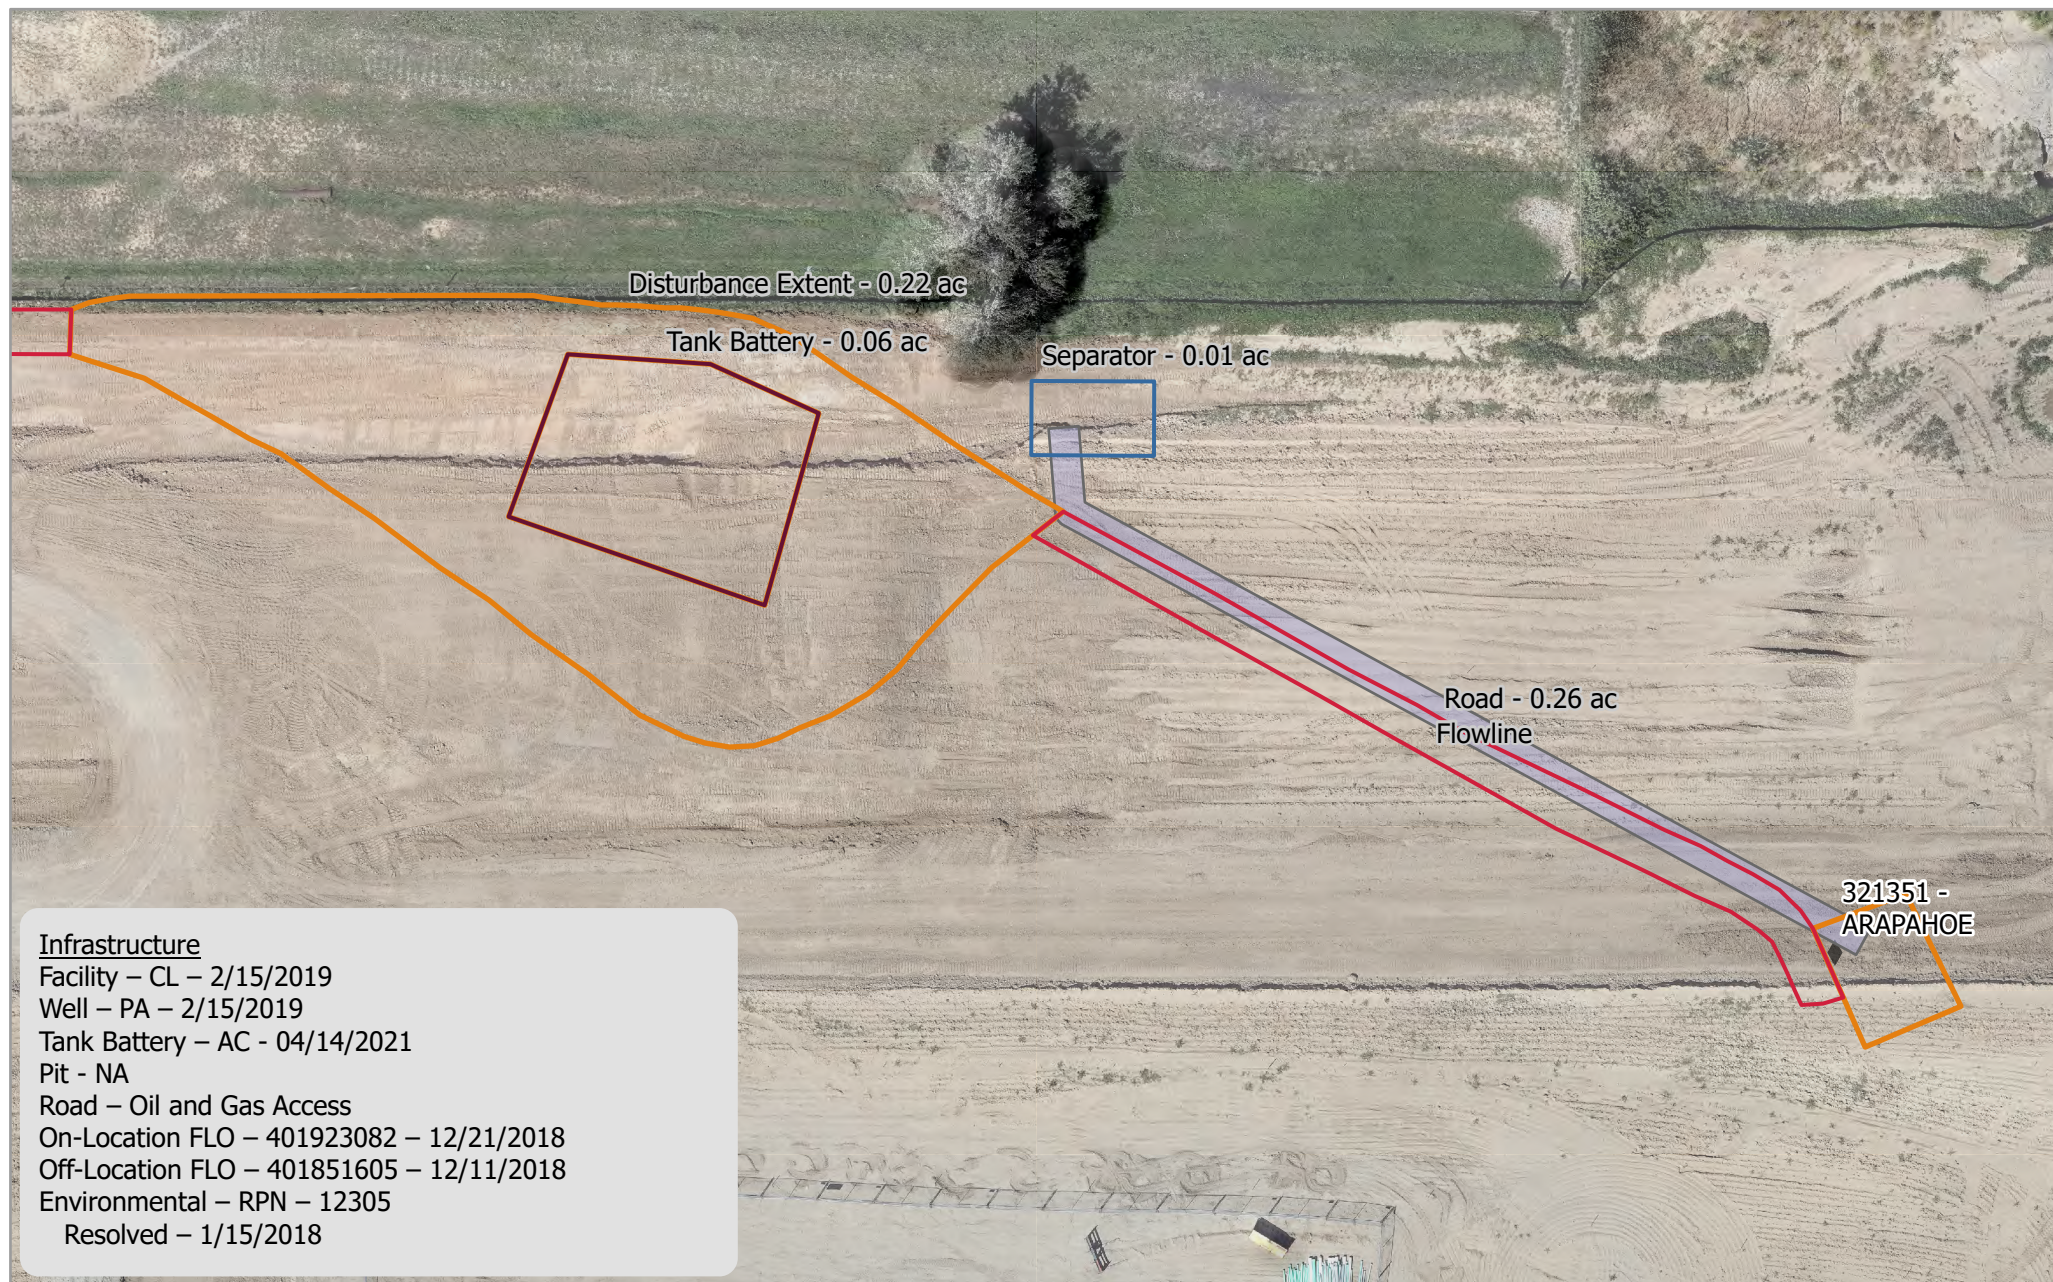
## CIV - 321351 - ARAPAHOE Map Extent - Overview

Imagery: RS Orthomosaic & DSM  
 Imagery Date: 1 Sep 2022  
 Map Date: 10 Nov 2022  
 Datum: NAD\_1983\_UTM\_Zone\_13N  
 POC: Soil Sage

Overall Disturbance:  
0.53 acres

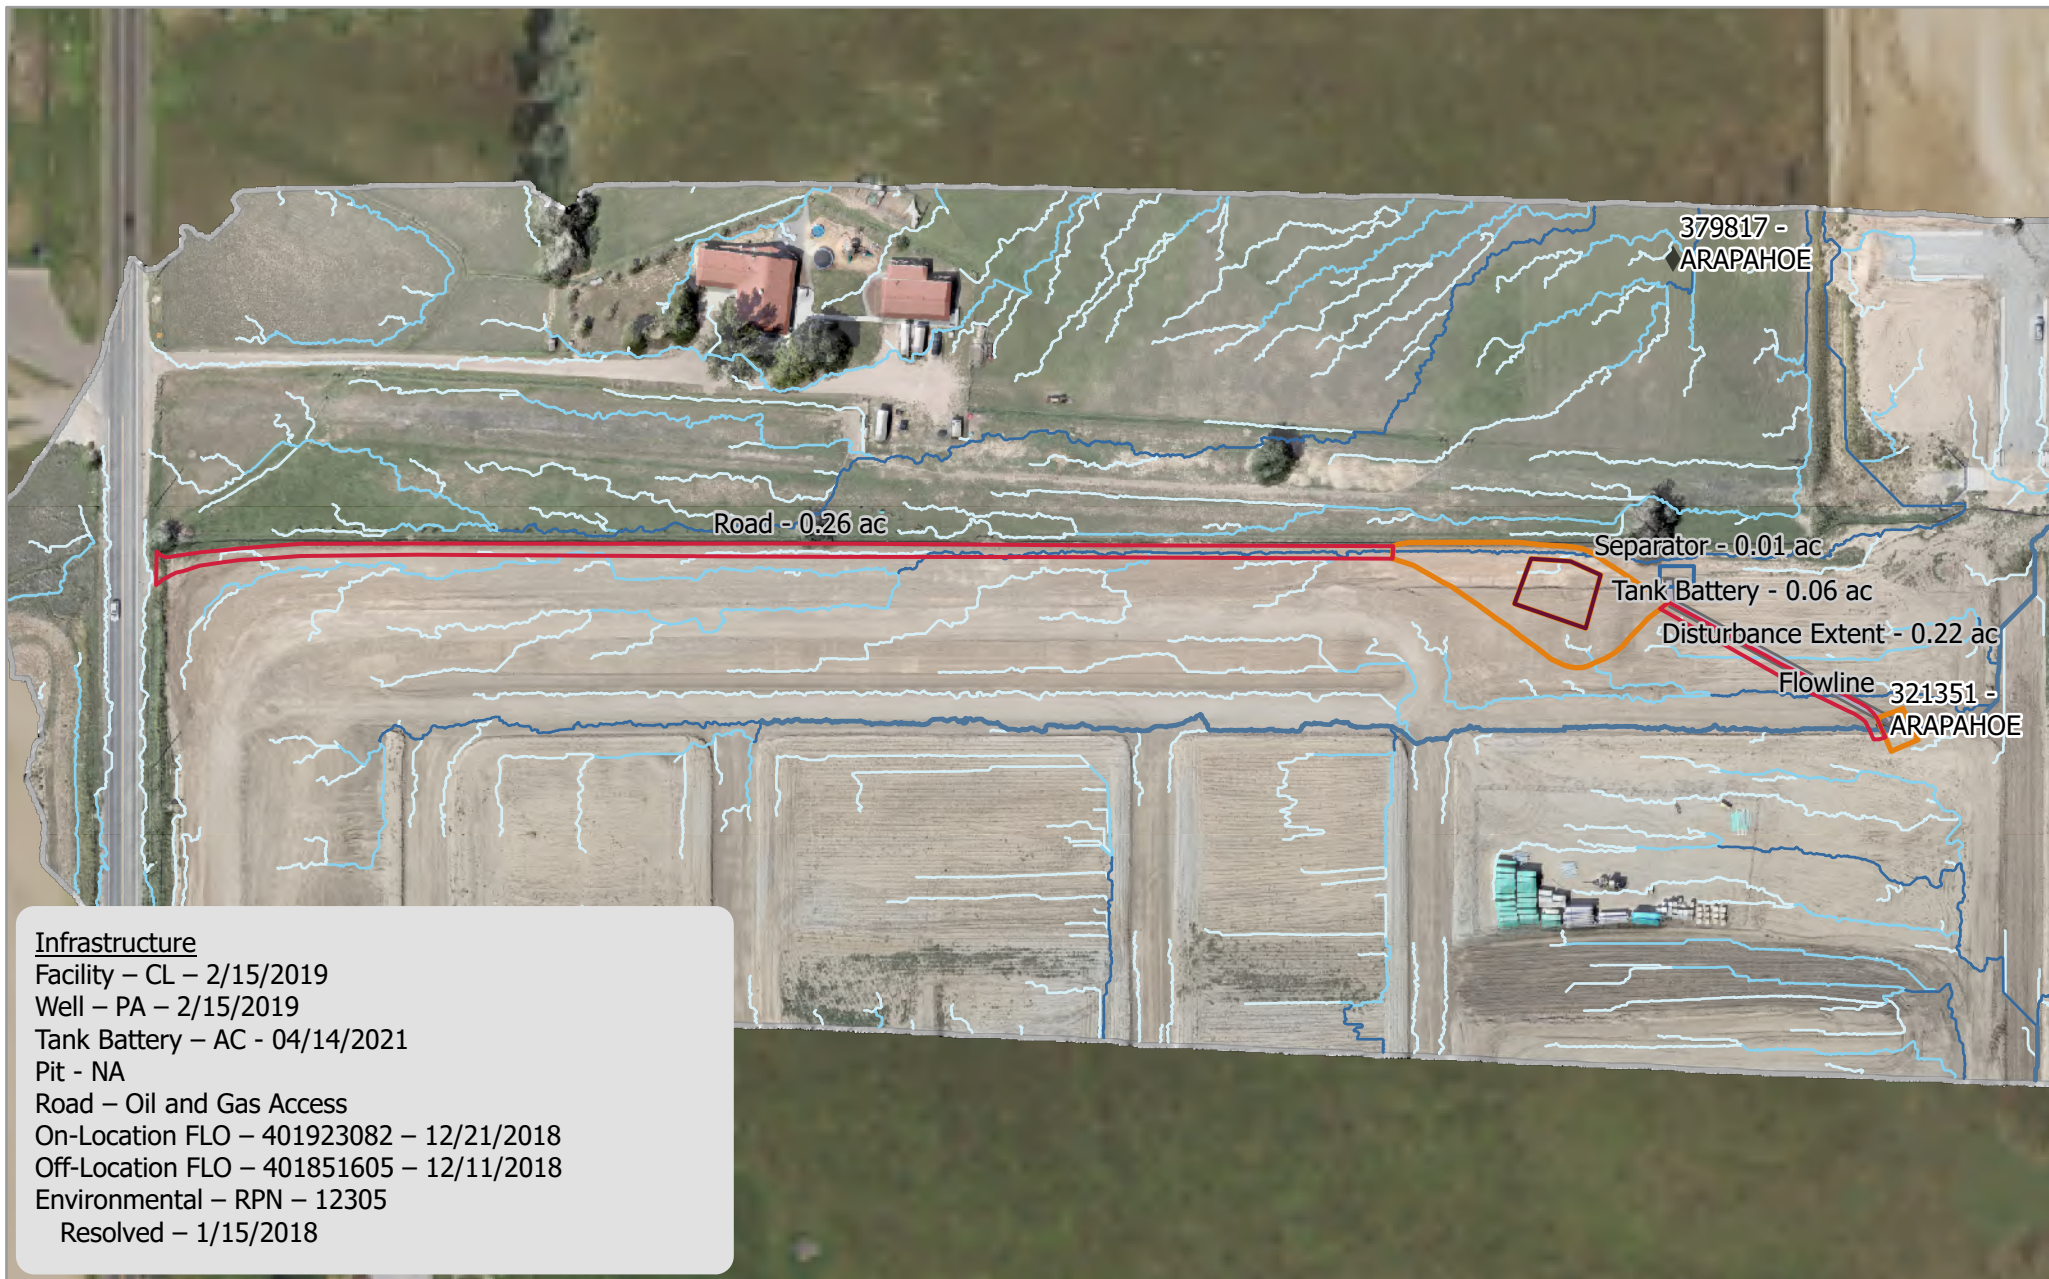
## CIV - 321351 - ARAPAHOE Map Extent - Hydrology

Imagery: RS Orthomosaic & DSM  
 Imagery Date: 1 Sep 2022  
 Map Date: 09 Nov 2022  
 Datum: NAD\_1983\_UTM\_Zone\_13N  
 POC: Soil Sage

Overall Disturbance:  
0.53 acres
