SITE-SPECIFIC QUALITY ASSURANCE & QUALITY CONTROL AUDIT

PERMIT CLOSURE REPORT – DESIGNATION LAND USE CHANGE

Location ID - 323083

Location Name – BICKLER-61N68W/34SWNW

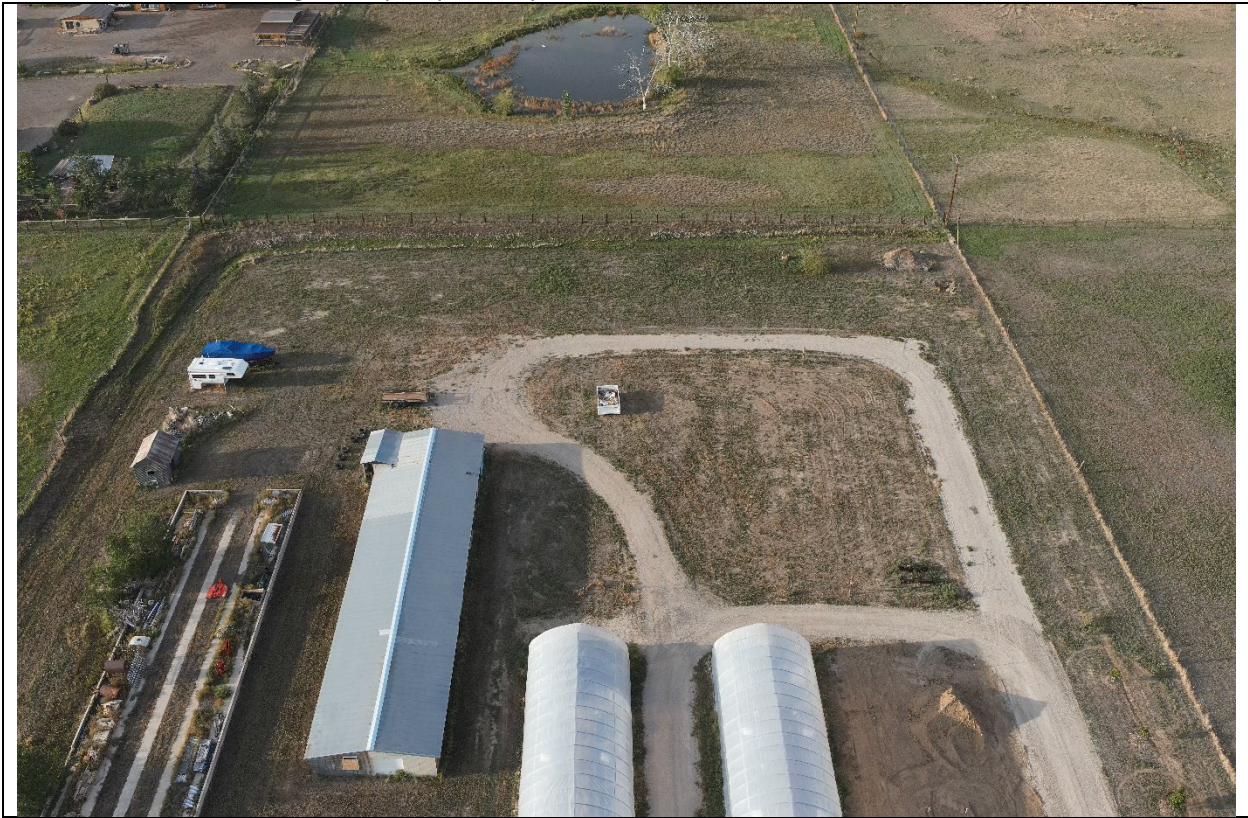
North

Cardinal directional and ground perspective photos of the site

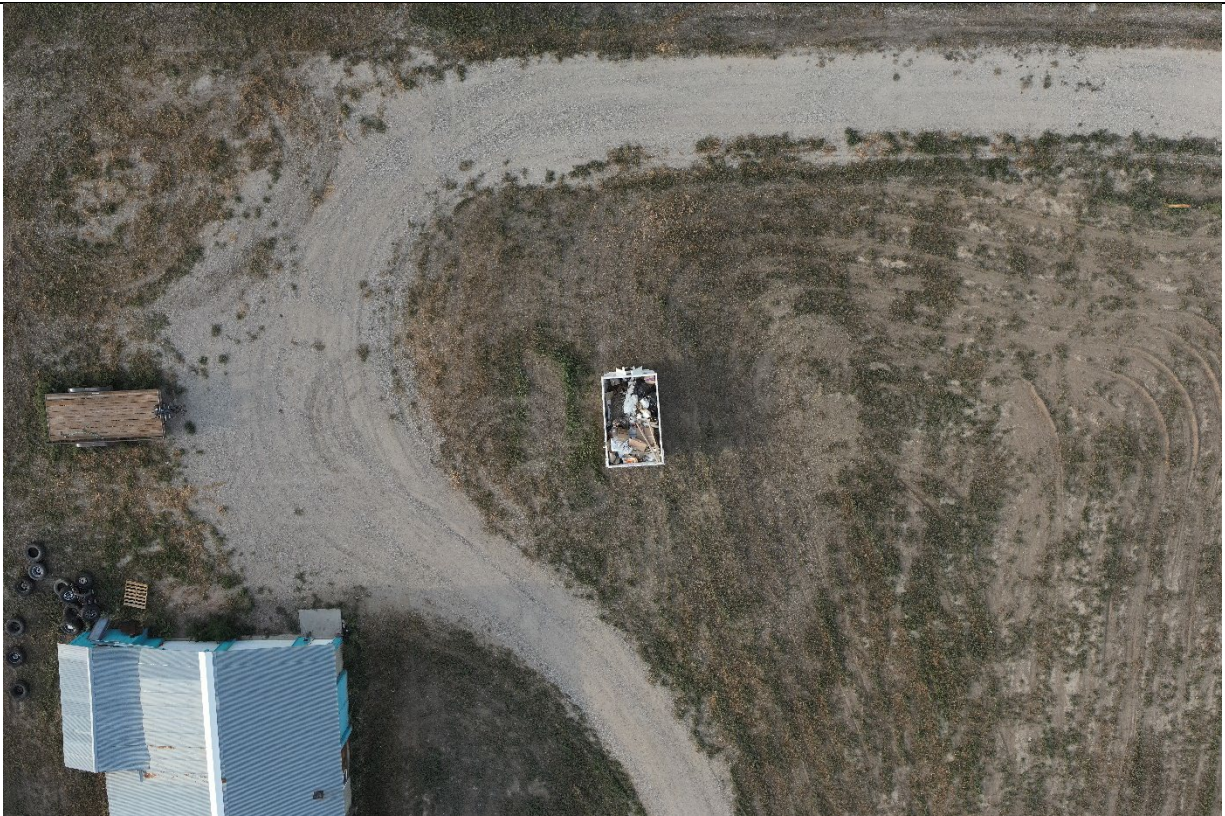
Overhead

PREVIOUS LAND USE	CURRENT LAND USE
<p>Reference Imagery for Infrastructure</p> <p>DRCOG 2010</p>	<p>Remotely Sense Imagery</p> <p>09/13/2022</p>
<p>Designation</p> <p>Well Pad</p>	<p>Designation</p> <p>Greenhouse Agriculture</p>

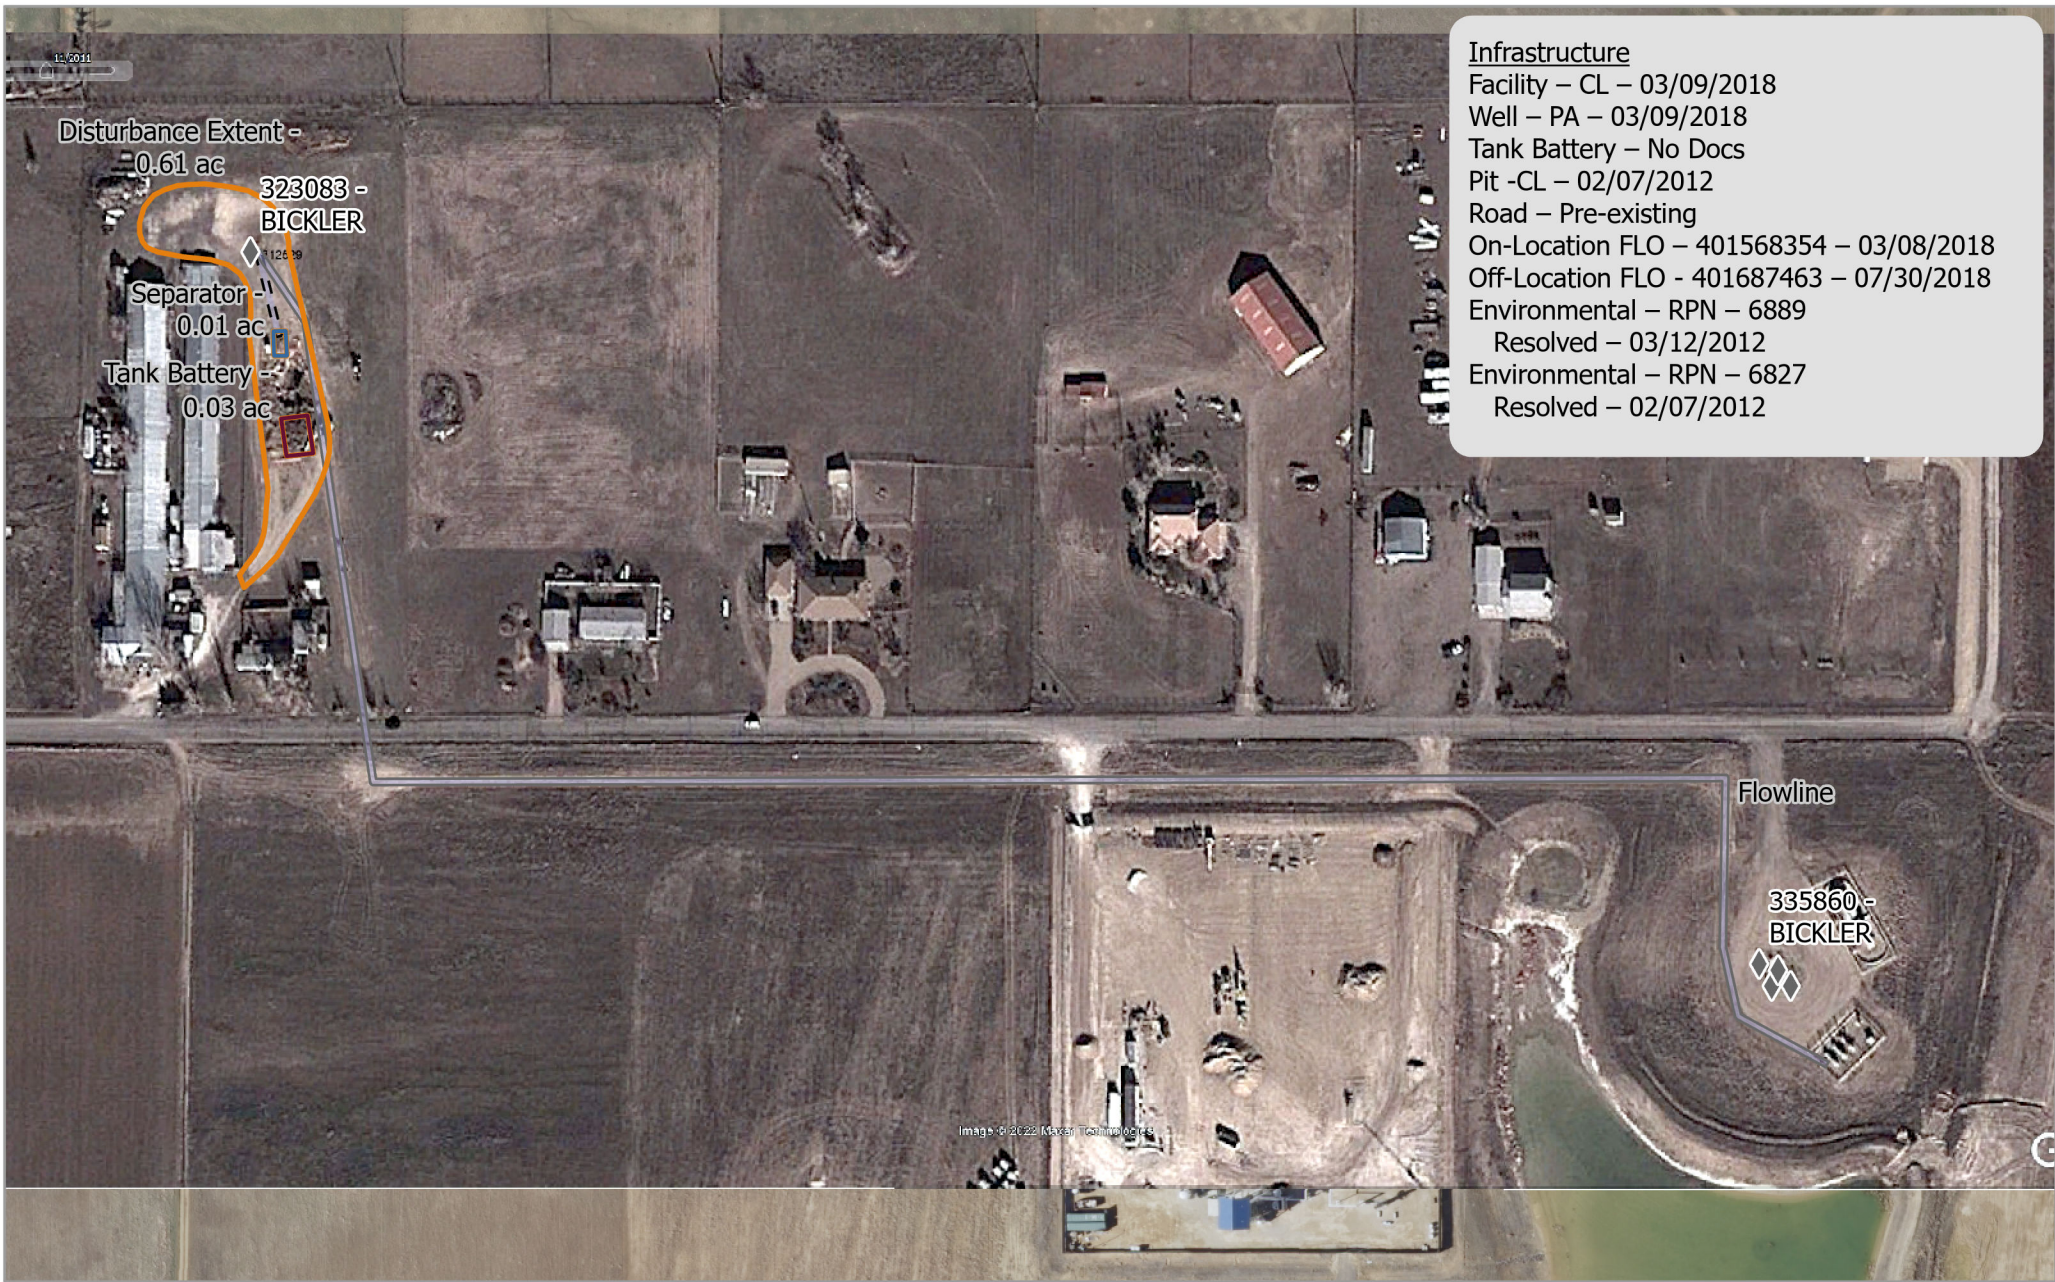
CIV - 323083 - BICKLER
Map Extent - Maxar 2011

Infrastructure
 Facility – CL – 03/09/2018
 Well – PA – 03/09/2018
 Tank Battery – No Docs
 Pit -CL – 02/07/2012
 Road – Pre-existing
 On-Location FLO – 401568354 – 03/08/2018
 Off-Location FLO - 401687463 – 07/30/2018
 Environmental – RPN – 6889
 Resolved – 03/12/2012
 Environmental – RPN – 6827
 Resolved – 02/07/2012

Imagery: Maxar
 Imagery Date: 25 Nov 2011
 Map Date: 10 Dec 2022
 Datum: WGS 1984 UTM Zone 13N
 POC: Soil Sage

Overall Disturbance:
0.65 Acres

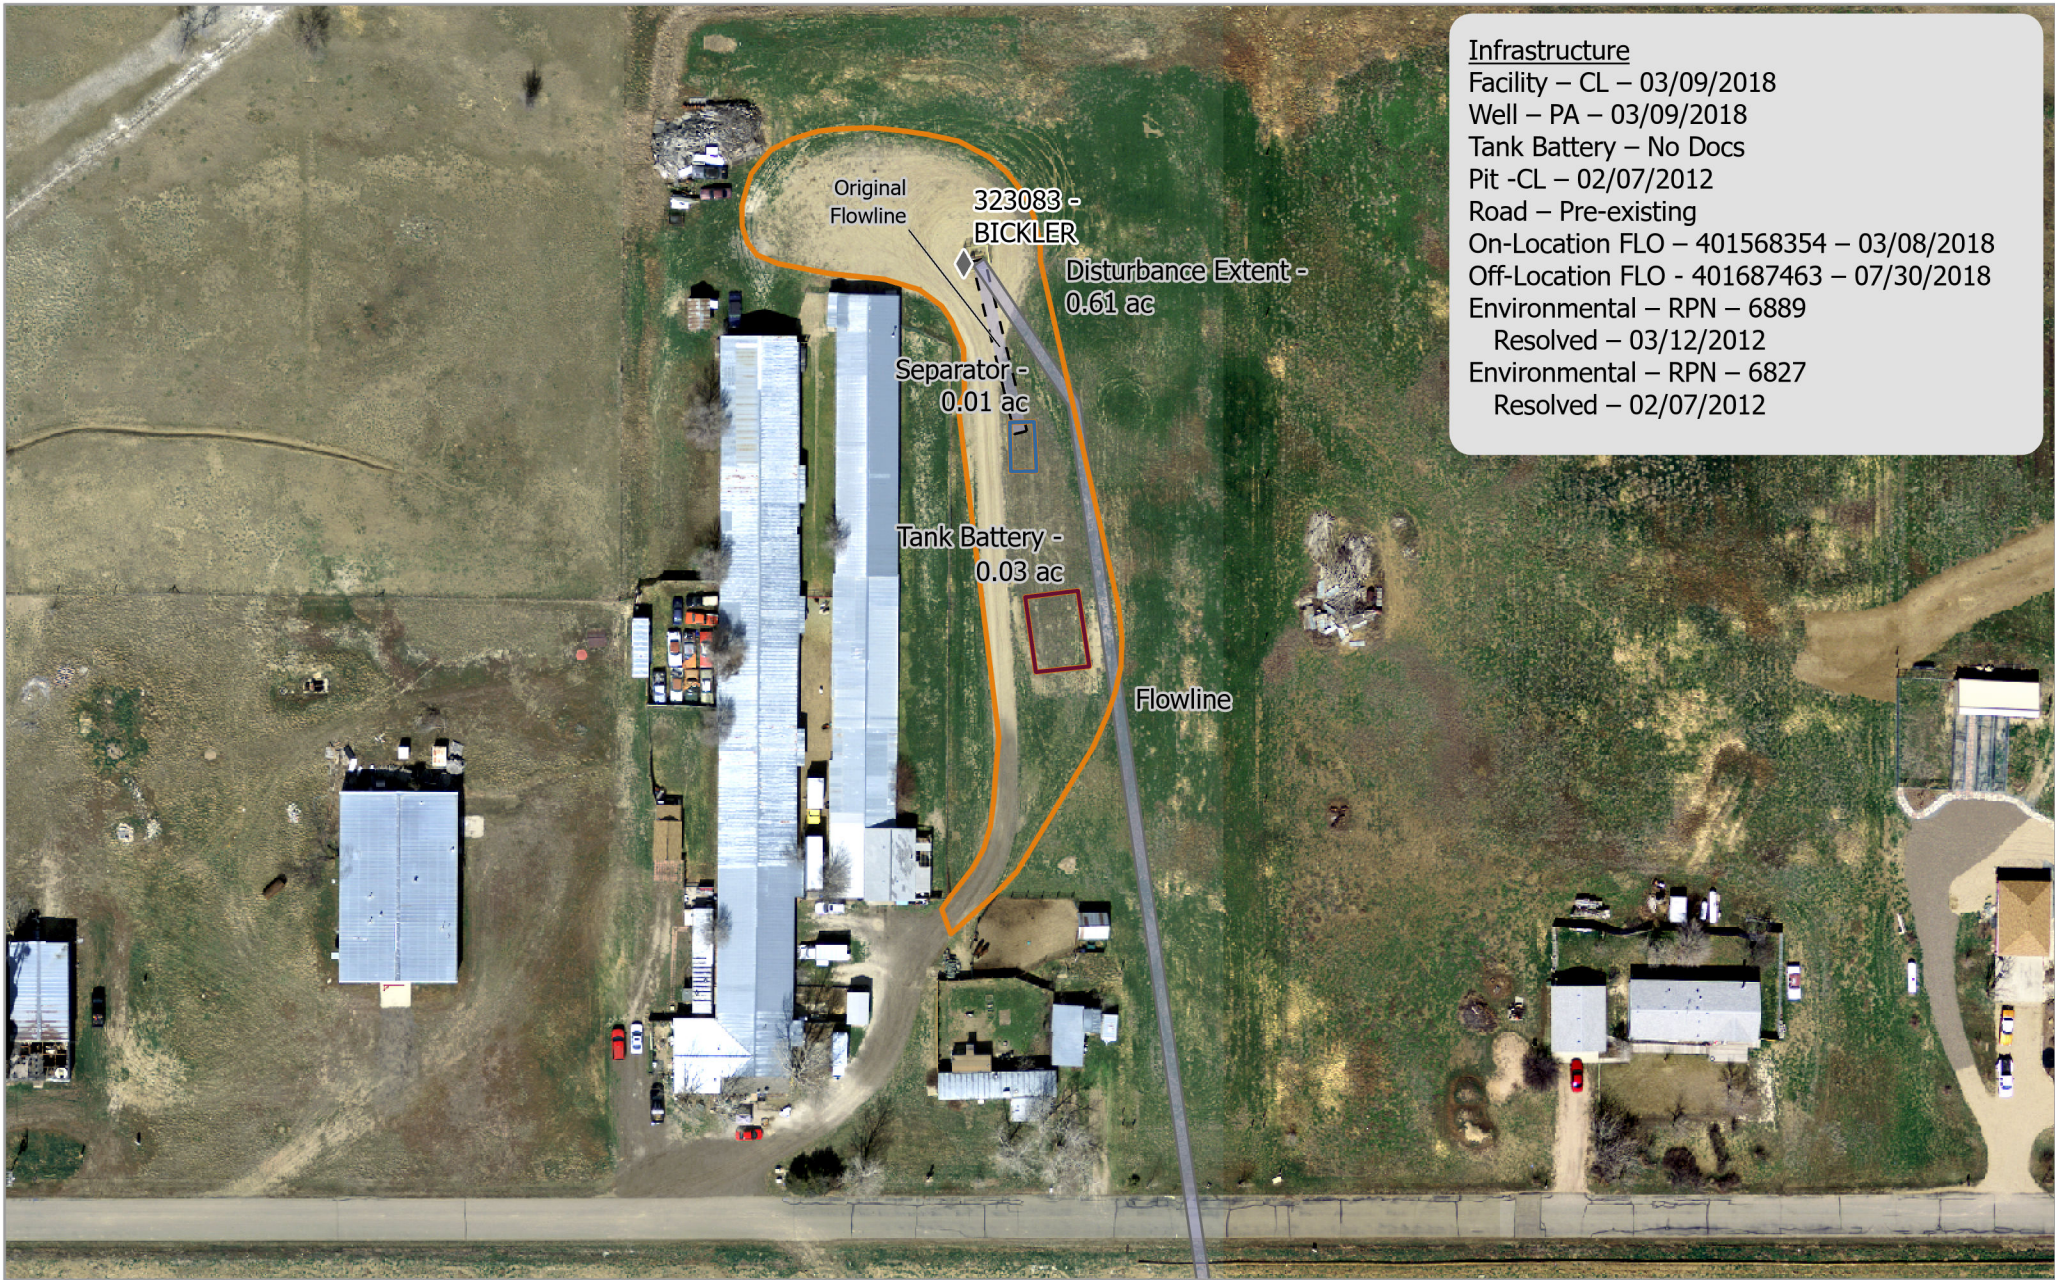
CIV - 323083 - BICKLER
Map Extent - DRCOG 2014 large

Infrastructure
 Facility – CL – 03/09/2018
 Well – PA – 03/09/2018
 Tank Battery – No Docs
 Pit -CL – 02/07/2012
 Road – Pre-existing
 On-Location FLO – 401568354 – 03/08/2018
 Off-Location FLO - 401687463 – 07/30/2018
 Environmental – RPN – 6889
 Resolved – 03/12/2012
 Environmental – RPN – 6827
 Resolved – 02/07/2012

Imagery: DROCG
 Imagery Date: 2014
 Map Date: 10 Dec 2022
 Datum: WGS 1984 UTM Zone 13N
 POC: Soil Sage

Overall Disturbance:
0.65 Acres

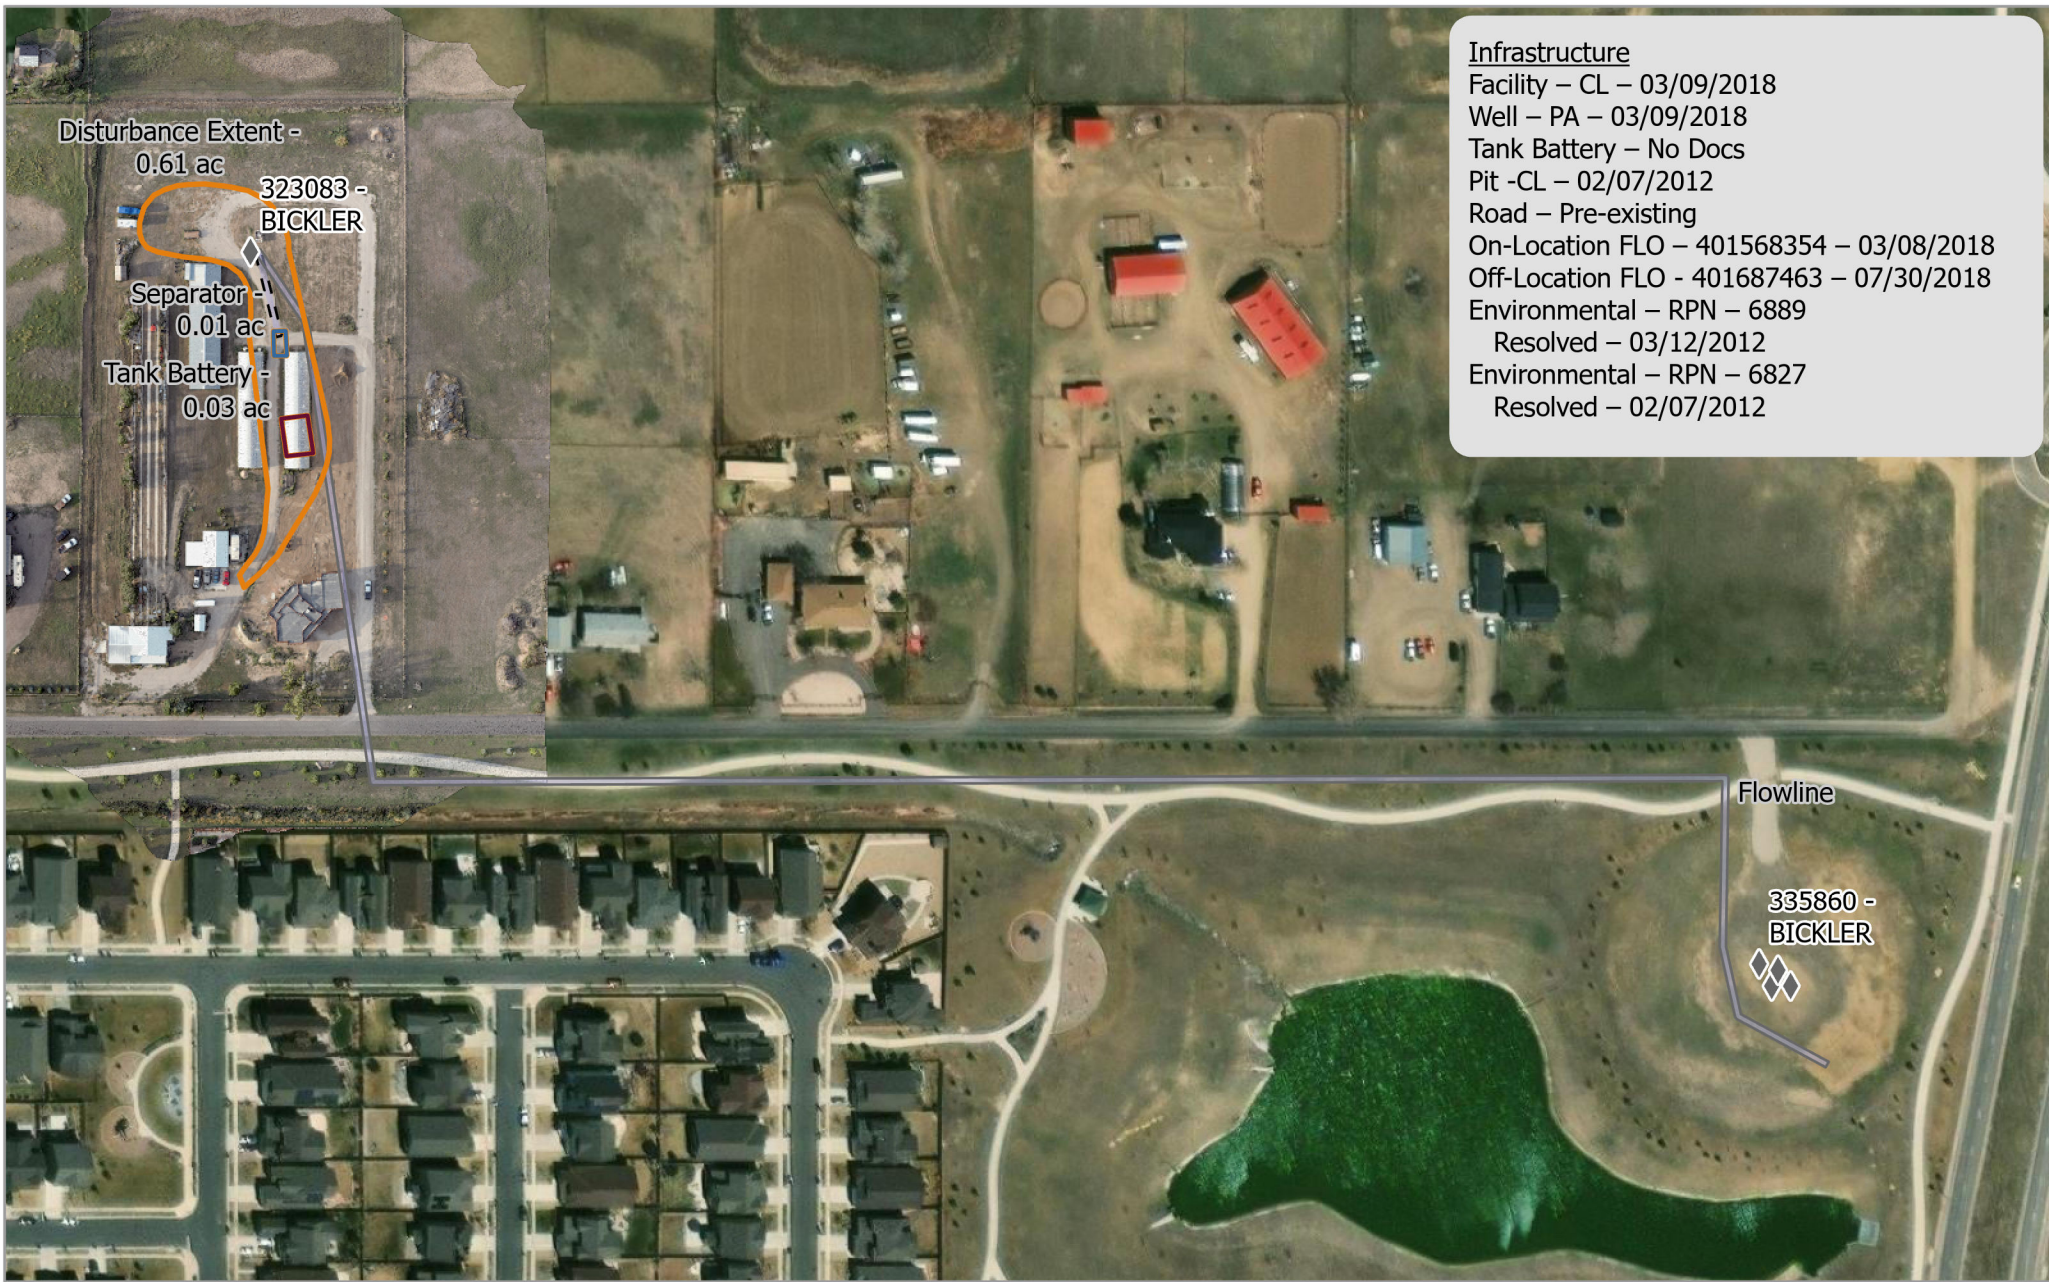
**CIV - 323083- BICKLER
 Map Extent - Overview**

Infrastructure
 Facility – CL – 03/09/2018
 Well – PA – 03/09/2018
 Tank Battery – No Docs
 Pit -CL – 02/07/2012
 Road – Pre-existing
 On-Location FLO – 401568354 – 03/08/2018
 Off-Location FLO - 401687463 – 07/30/2018
 Environmental – RPN – 6889
 Resolved – 03/12/2012
 Environmental – RPN – 6827
 Resolved – 02/07/2012

Imagery: RS Orthomosaic & DSM
 Imagery Date: 13 Sep 2022
 Map Date: 10 Dec 2022
 Datum: WGS 1984 UTM Zone 13N
 POC: Soil Sage

Overall Disturbance:
0.65 Acres

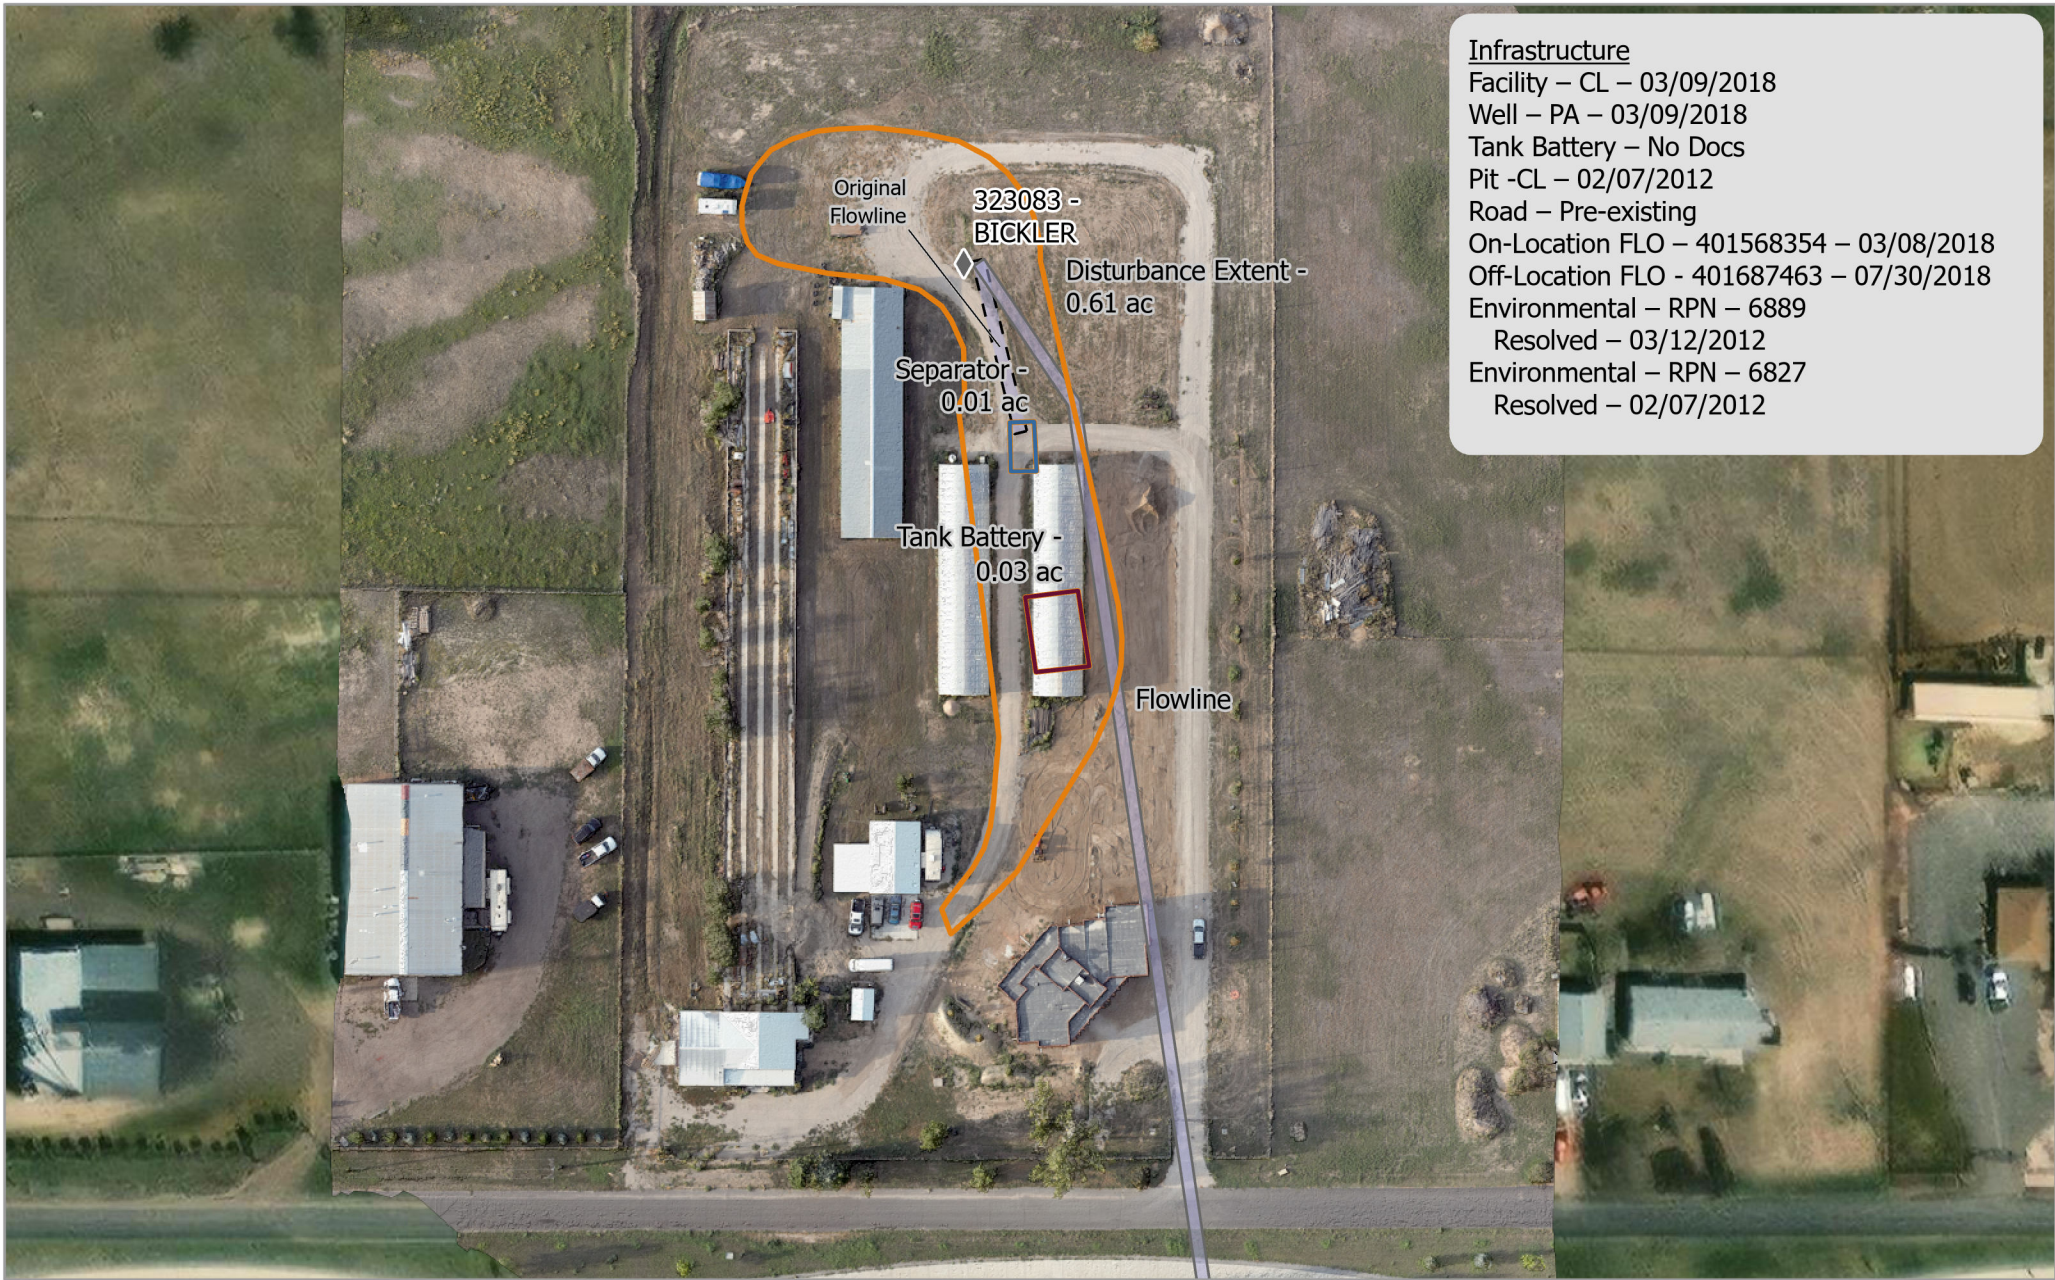
CIV - 323083- BICKLER
Map Extent - Overview

Infrastructure
 Facility – CL – 03/09/2018
 Well – PA – 03/09/2018
 Tank Battery – No Docs
 Pit -CL – 02/07/2012
 Road – Pre-existing
 On-Location FLO – 401568354 – 03/08/2018
 Off-Location FLO - 401687463 – 07/30/2018
 Environmental – RPN – 6889
 Resolved – 03/12/2012
 Environmental – RPN – 6827
 Resolved – 02/07/2012

Imagery: RS Orthomosaic & DSM
 Imagery Date: 13 Sep 2022
 Map Date: 10 Dec 2022
 Datum: WGS 1984 UTM Zone 13N
 POC: Soil Sage

Overall Disturbance:
0.65 Acres

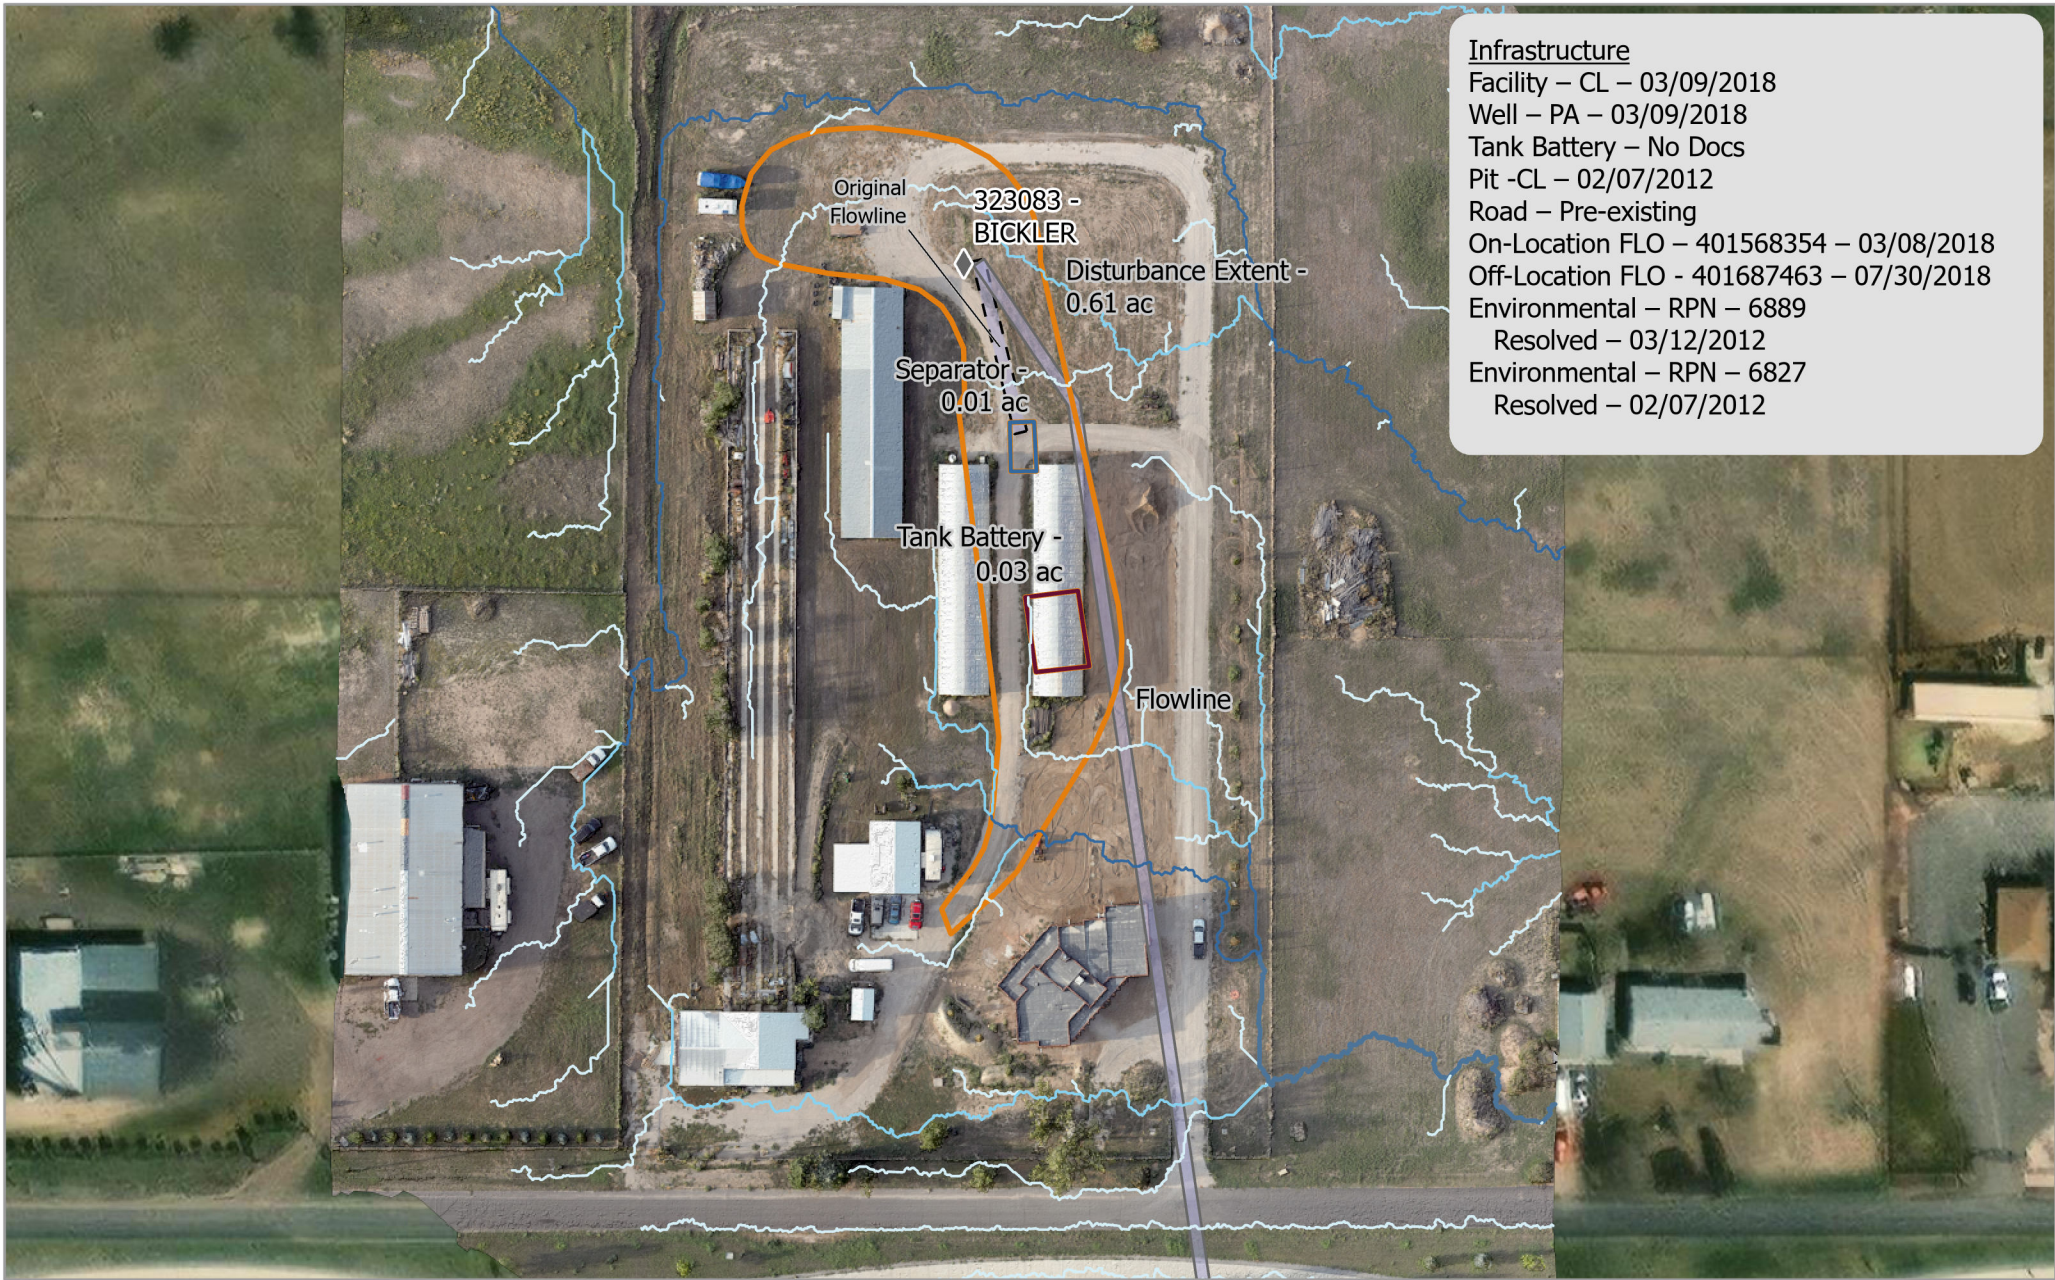
CIV - 323083- BICKLER
Map Extent - Hydrology

Infrastructure
 Facility – CL – 03/09/2018
 Well – PA – 03/09/2018
 Tank Battery – No Docs
 Pit -CL – 02/07/2012
 Road – Pre-existing
 On-Location FLO – 401568354 – 03/08/2018
 Off-Location FLO - 401687463 – 07/30/2018
 Environmental – RPN – 6889
 Resolved – 03/12/2012
 Environmental – RPN – 6827
 Resolved – 02/07/2012

Imagery: RS Orthomosaic & DSM
 Imagery Date: 13 Sep 2022
 Map Date: 10 Dec 2022
 Datum: WGS 1984 UTM Zone 13N
 POC: Soil Sage

◆ Wells	Stream Order
▭ Disturbance Extent	— 1
▭ Tank Battery	— 2
▭ Separator	— 3
▭ Flowline	— 4

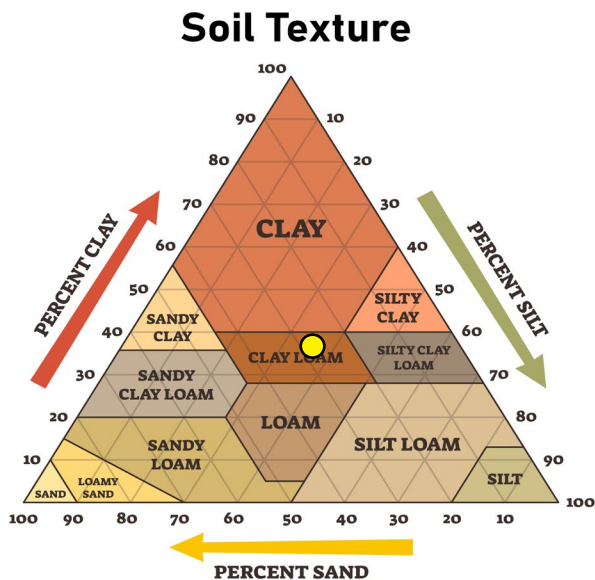
Depth (in)	Physical			Chemical			
	Texture	Bulk Density	Partical Size Percent sand, silt, clay	pH	EC	SAR	OM%
0-10	Clay Loam	1.28	29-33-38	7.7	0.5	0.0	1.40
10-20	Clay	1.24	26-30-44	7.9	1.0	0.0	0.69
20-30	Clay Loam	1.28	27-34-39	8.2	1.0	0.0	0.25
30-40	Clay Loam	1.28	27-34-39	8.2	1.0	0.0	0.25
40-50	Clay Loam	1.28	27-34-39	8.2	1.0	0.0	0.25
50 +	Clay Loam	1.28	27-34-39	8.2	1.0	0.0	0.25

Soil Texture Triangle reflect the 0-10 in depth
