# SITE-SPECIFIC QUALITY ASSURANCE & QUALITY CONTROL AUDIT

## PERMIT CLOSURE REPORT – DESIGNATION LAND USE CHANGE

Location ID – 327044

Location Name – ROBB-PM F-65N65W 15SWNE

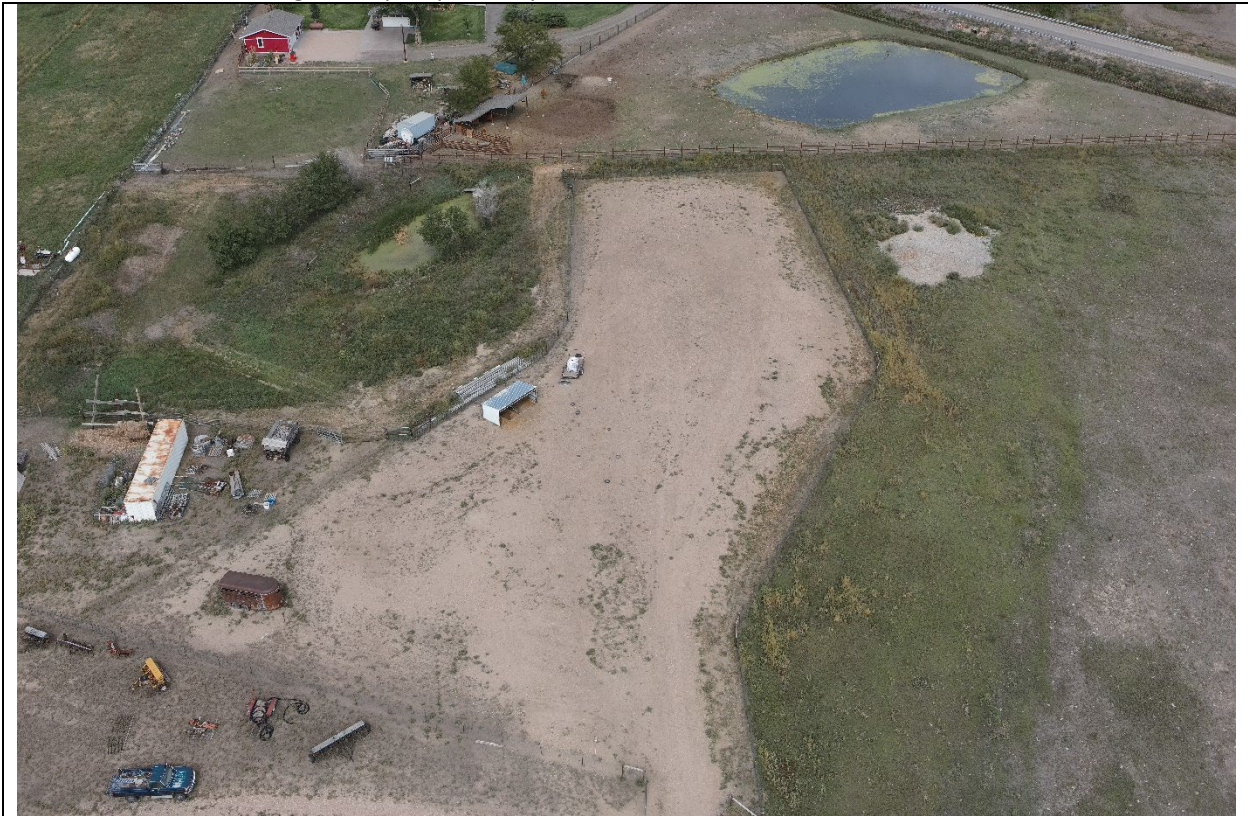
North

Due to landowner activity, in the form of a goat pasture, vegetation recovery is not possible.

Cardinal directional and ground perspective photos of the site

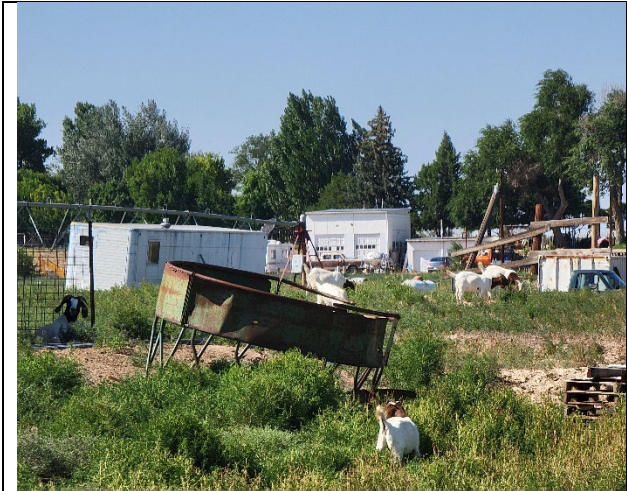
Ground perspective of the well site locations

Goats

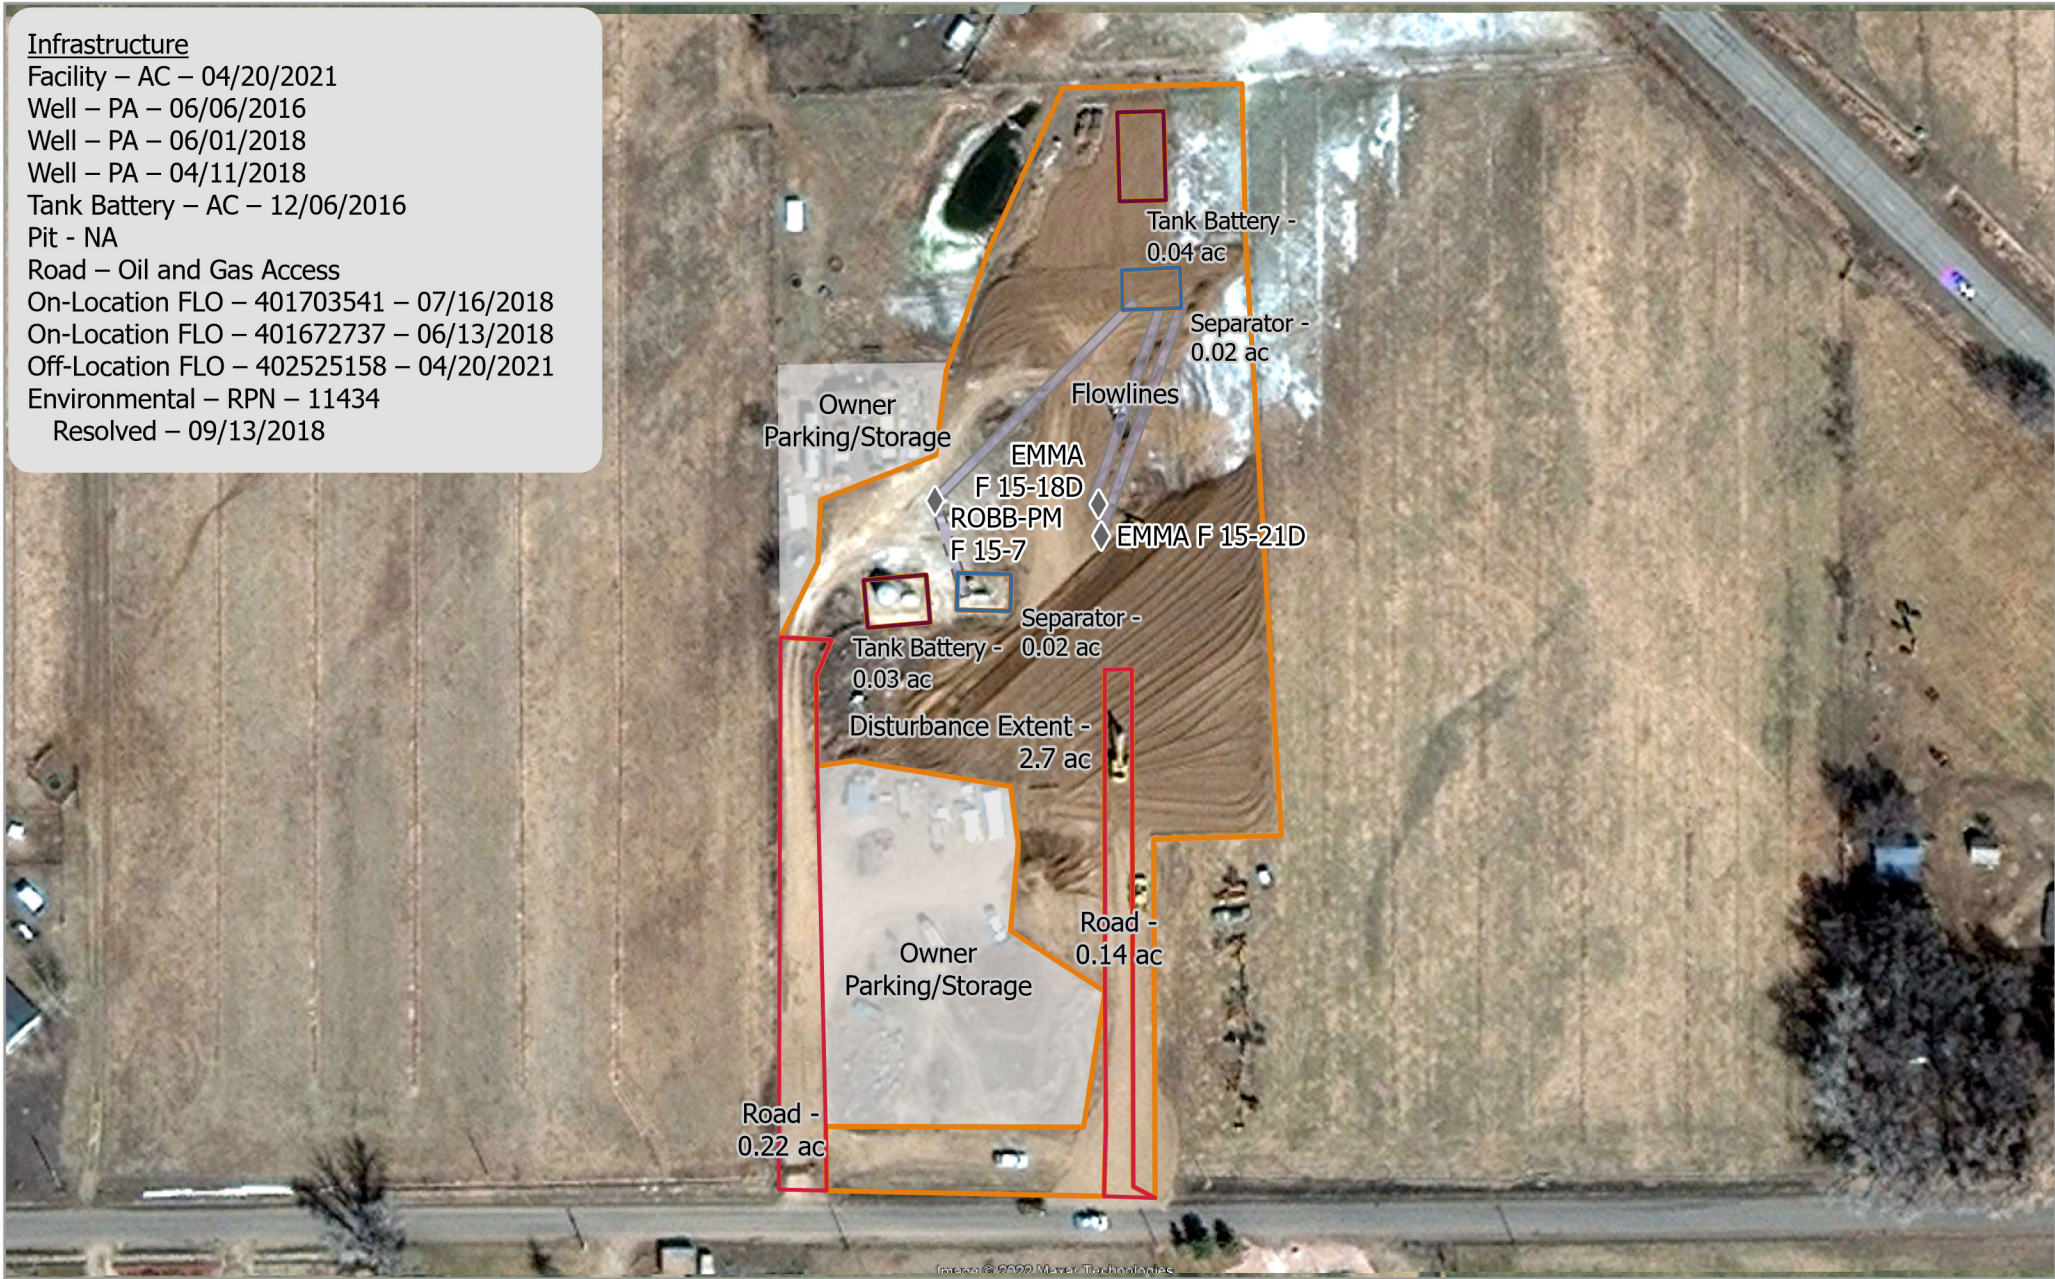
**CIV - 327044- ROBB-PM F  
Map Extent - MAXAR 2010**

Imagery: MAXAR  
Imagery Date: 11 Mar 2010  
Map Date: 12 Dec 2022  
Datum: WGS 1984 UTM Zone 13N  
POC: Soil Sage

Overall Disturbance:  
3.20 Acres  
Scale: 1:1,500

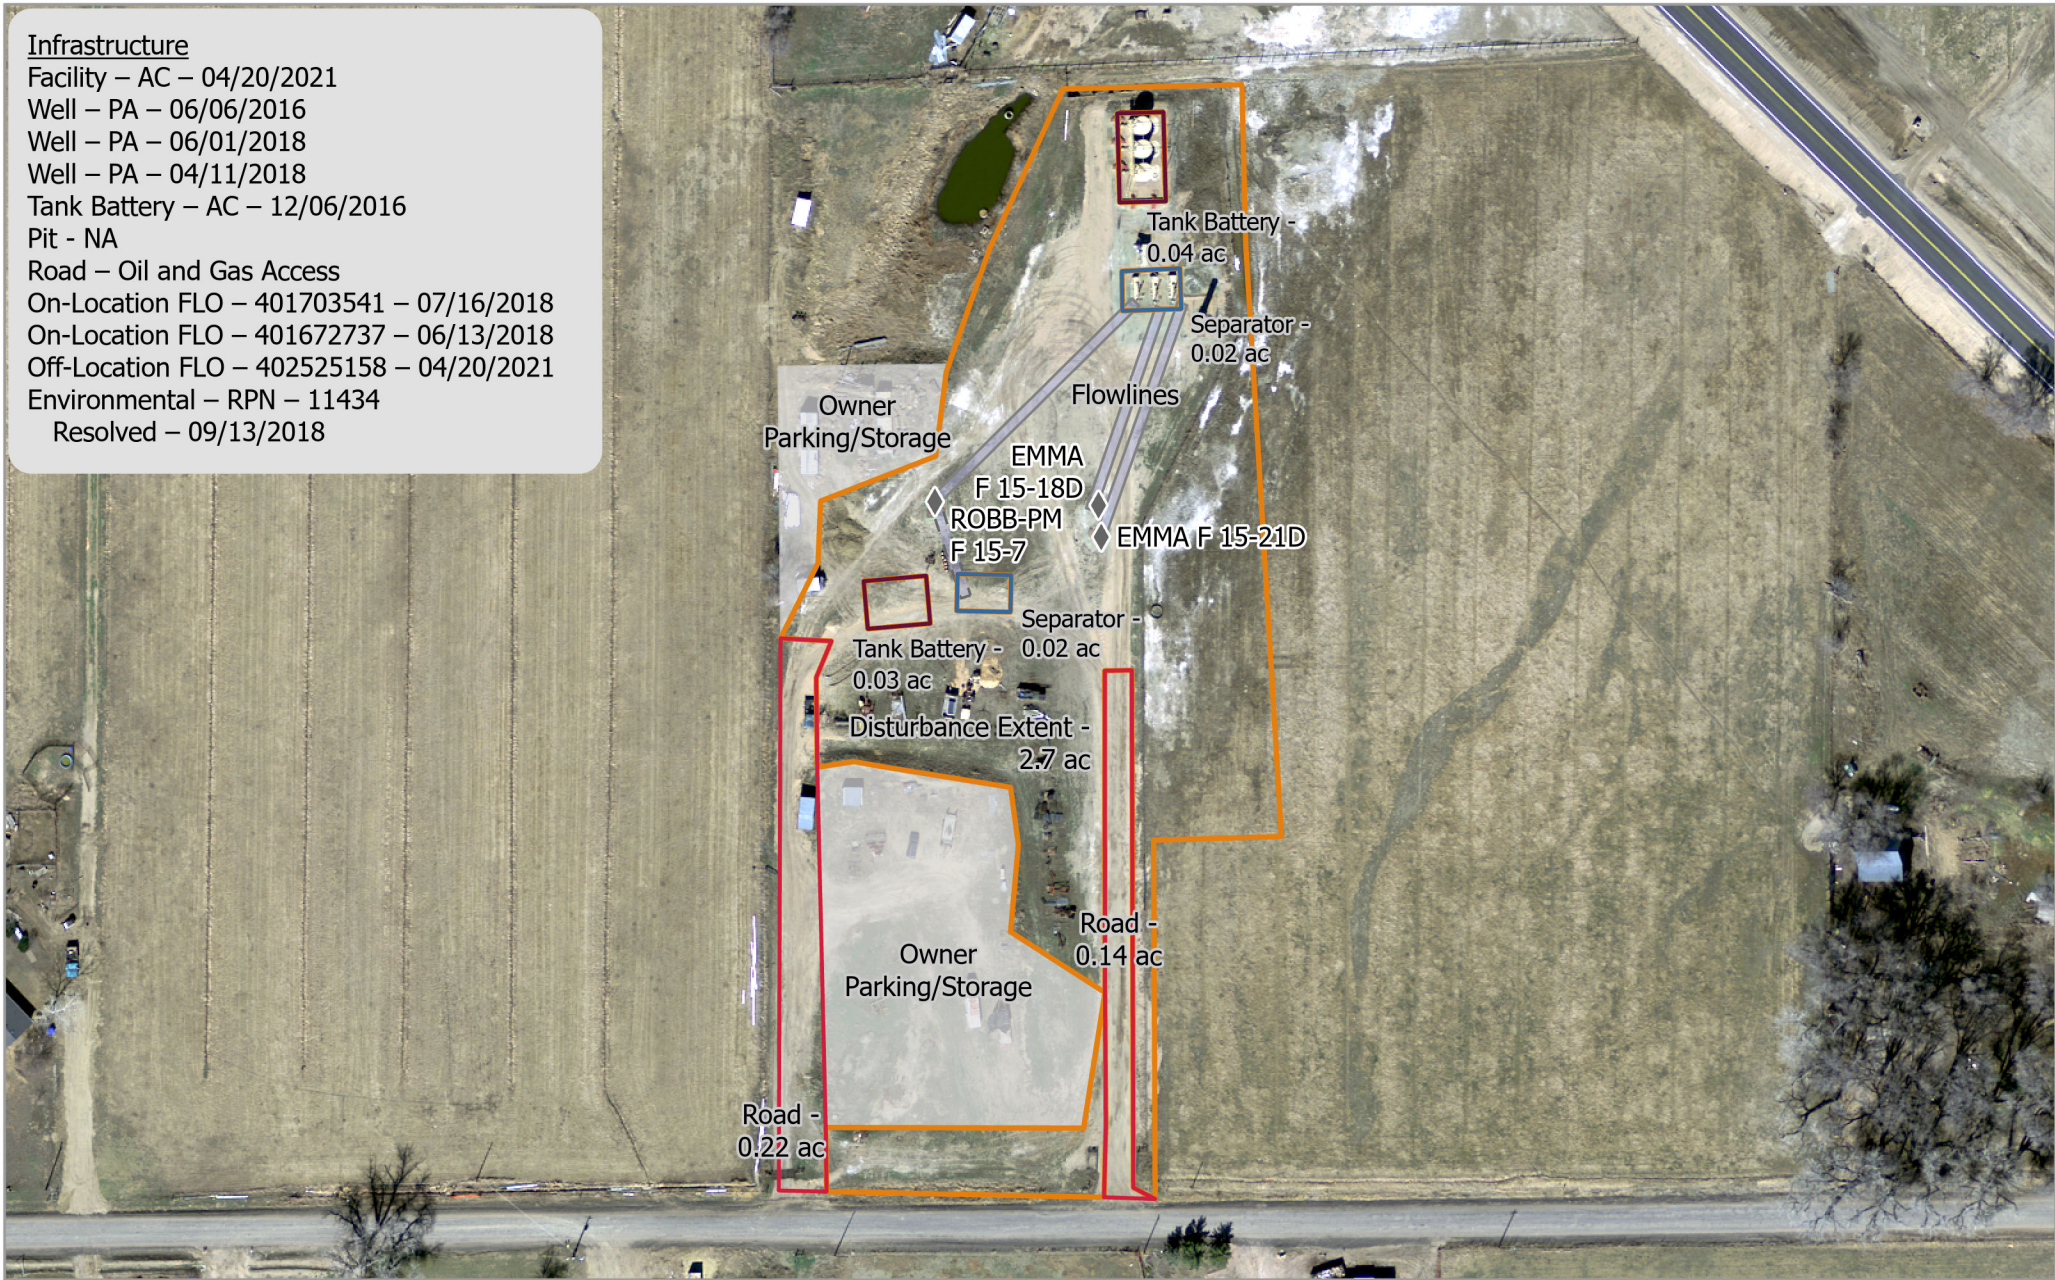
**CIV - 327044- ROBB-PM F  
Map Extent - DRCOG 2014**

Imagery: DRCOG  
 Imagery Date: 2014  
 Map Date: 12 Dec 2022  
 Datum: WGS 1984 UTM Zone 13N  
 POC: Soil Sage

Overall Disturbance:  
3.20 Acres

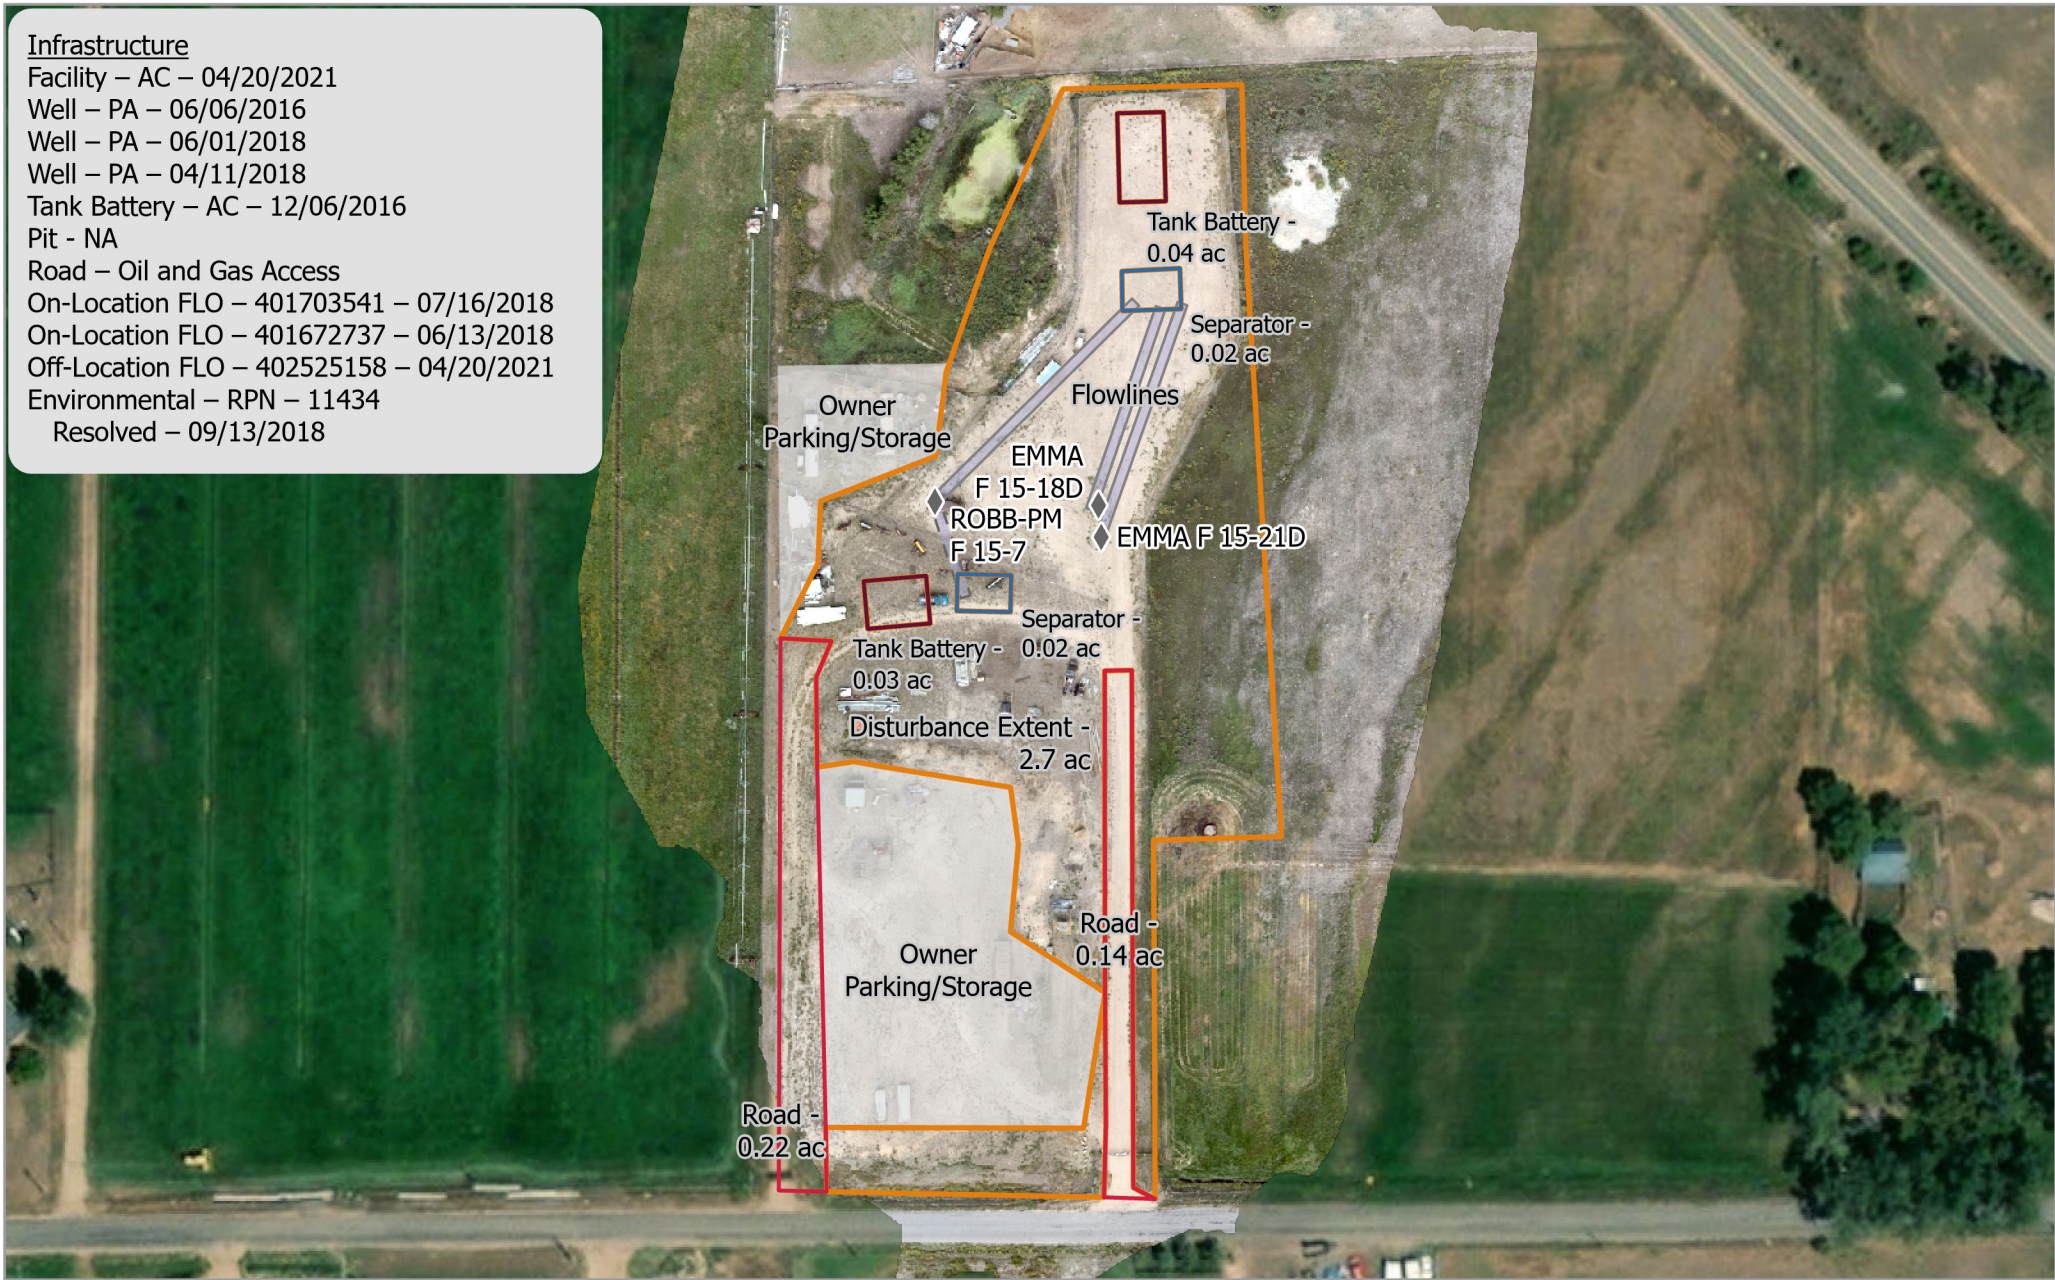
**CIV - 327044- ROBB-PM F  
Map Extent - Overview**

Imagery: RS Orthomosaic & DSM  
Imagery Date: 20 Sep 2022  
Map Date: 12 Dec 2022  
Datum: WGS 1984 UTM Zone 13N  
POC: Soil Sage

Overall Disturbance:  
3.20 Acres  
Scale: 1:1,500

PREVIOUS LAND USE	CURRENT LAND USE
Reference Imagery for Infrastructure – DRCOG 2004, 2014, Maxar 2010	Remotely Sensed Imagery – September 20, 2022
Designation – Oil and Gas Facility	Designation – Fenced Goat Area

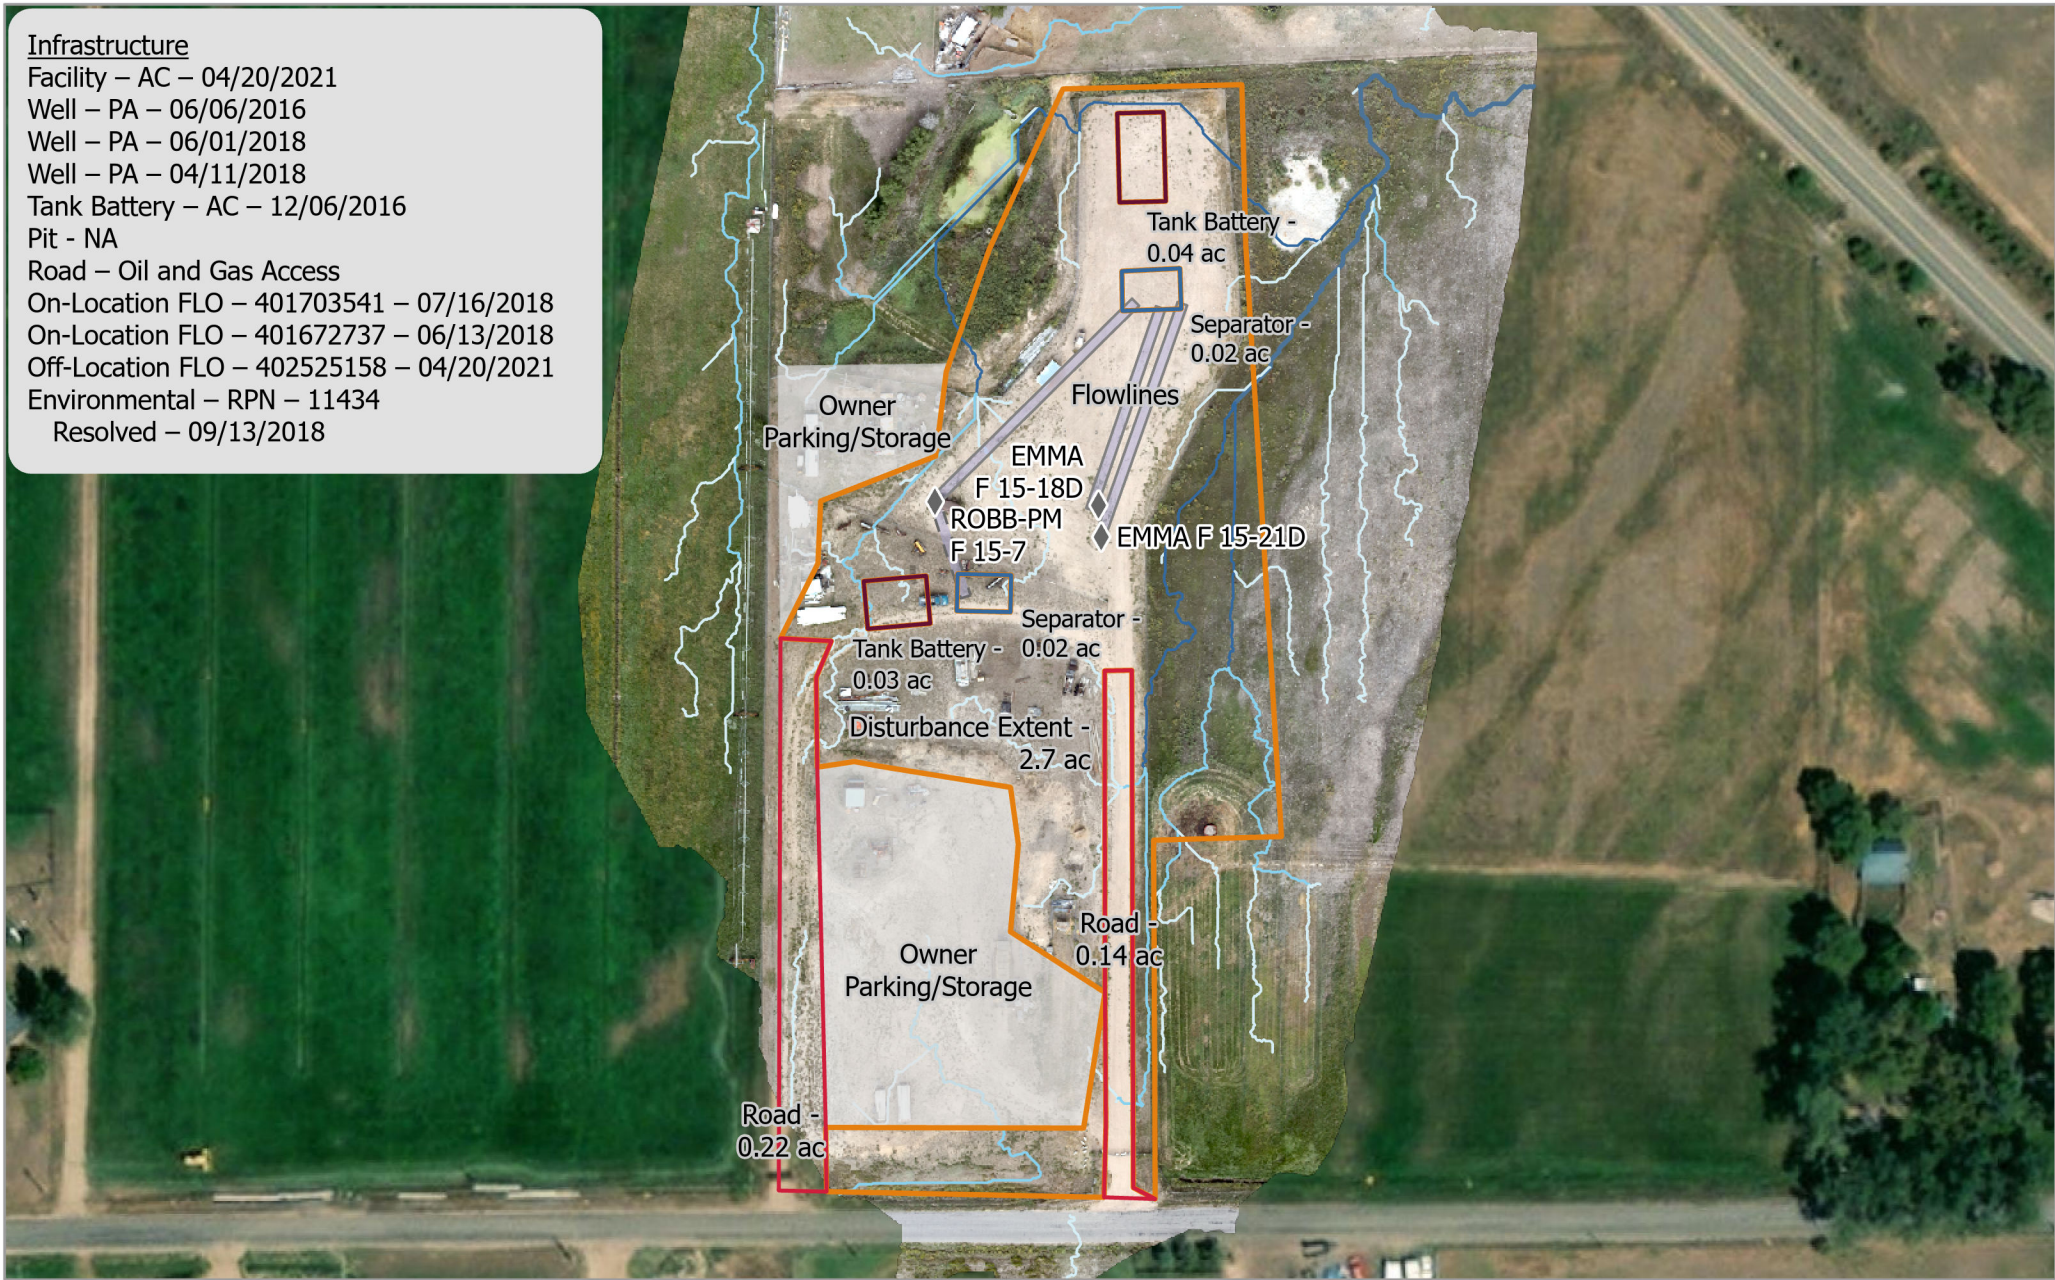
**CIV - 327044- ROBB-PM F  
Map Extent - Hydrology**

Imagery: RS Orthomosaic & DSM  
 Imagery Date: 20 Sep 2022  
 Map Date: 12 Dec 2022  
 Datum: WGS 1984 UTM Zone 13N  
 POC: Soil Sage

◆ Wells	Stream Order
▭ Disturbance Extent	1
▭ Road	2
▭ Separator	3
▭ Tank Battery	4
▭ Flowlines

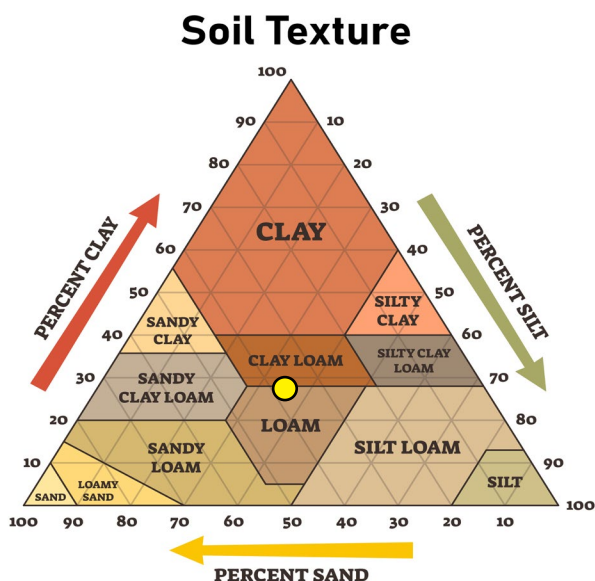
### Soil Texture Triangle reflect the 0-10 in depth

Depth (in)	Physical			Chemical			
	Texture	Bulk Density	Partical Size Percent sand, silt, clay	pH	EC	SAR	OM%
0-10	Loam, Variable	1.28	39-35-26	7.9	2.0	0.0	2.00
10-20	Loam, Variable	1.28	39-35-26	7.9	2.0	0.0	2.00
20-30	Loam, Variable	1.28	39-35-26	7.9	2.0	0.0	2.00
30-40	Loam, Variable	1.28	39-35-26	7.9	2.0	0.0	2.00
40-50	Loam, Variable	1.35	51-29-20	7.9	2.0	0.0	1.70
50 +	Gravelly Sand, Very Gravelly Sand	1.62	97-1-2	7.9	2.0	0.0	0.50
