# SITE-SPECIFIC QUALITY ASSURANCE & QUALITY CONTROL AUDIT

## PERMIT CLOSURE REPORT – DESIGNATION LAND USE CHANGE

Location ID - 320768

Location Name – UPRC-64S64W 21NENW

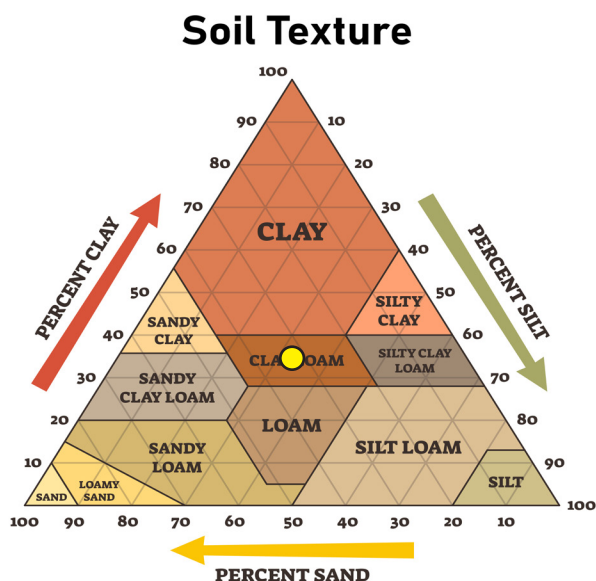
### Soil Texture Triangle reflect the 0-10 in depth

The location of the site is contained within one soil type, Renohill-Buick loams.

### Map Unit RhD Reference Soil information - Renohill-Buick loams

This soil is formed from loam silty and clayey alluvium, alluvium and/or eolian deposits. Landform is drainageways, ridges, with the Loamy Plains Ecological Site. Soils are well drained with a low to high water holding capacity, and slope 3-9 percent.

Depth (in)	Physical			Chemical			
	Texture	Bulk Density	Partial Size Percent sand, silt, clay	pH	EC	SAR	OM%
0-10	Loam	1.3	31-33-36	7.2	0.0	0.0	1.05
10-20	Clay, Clay Loam	1.29	28-30-42	7.3	0.2	0.0	0.70
20-30	Clay Loam, Sandy Clay Loam	1.33	37-36-27	7.9	1.0	0.0	0.50
30-40	Unweathered Bedrock, Sandy Clay Loam						
40-50	Sandy Clay Loam						
50 +	Sandy Clay Loam

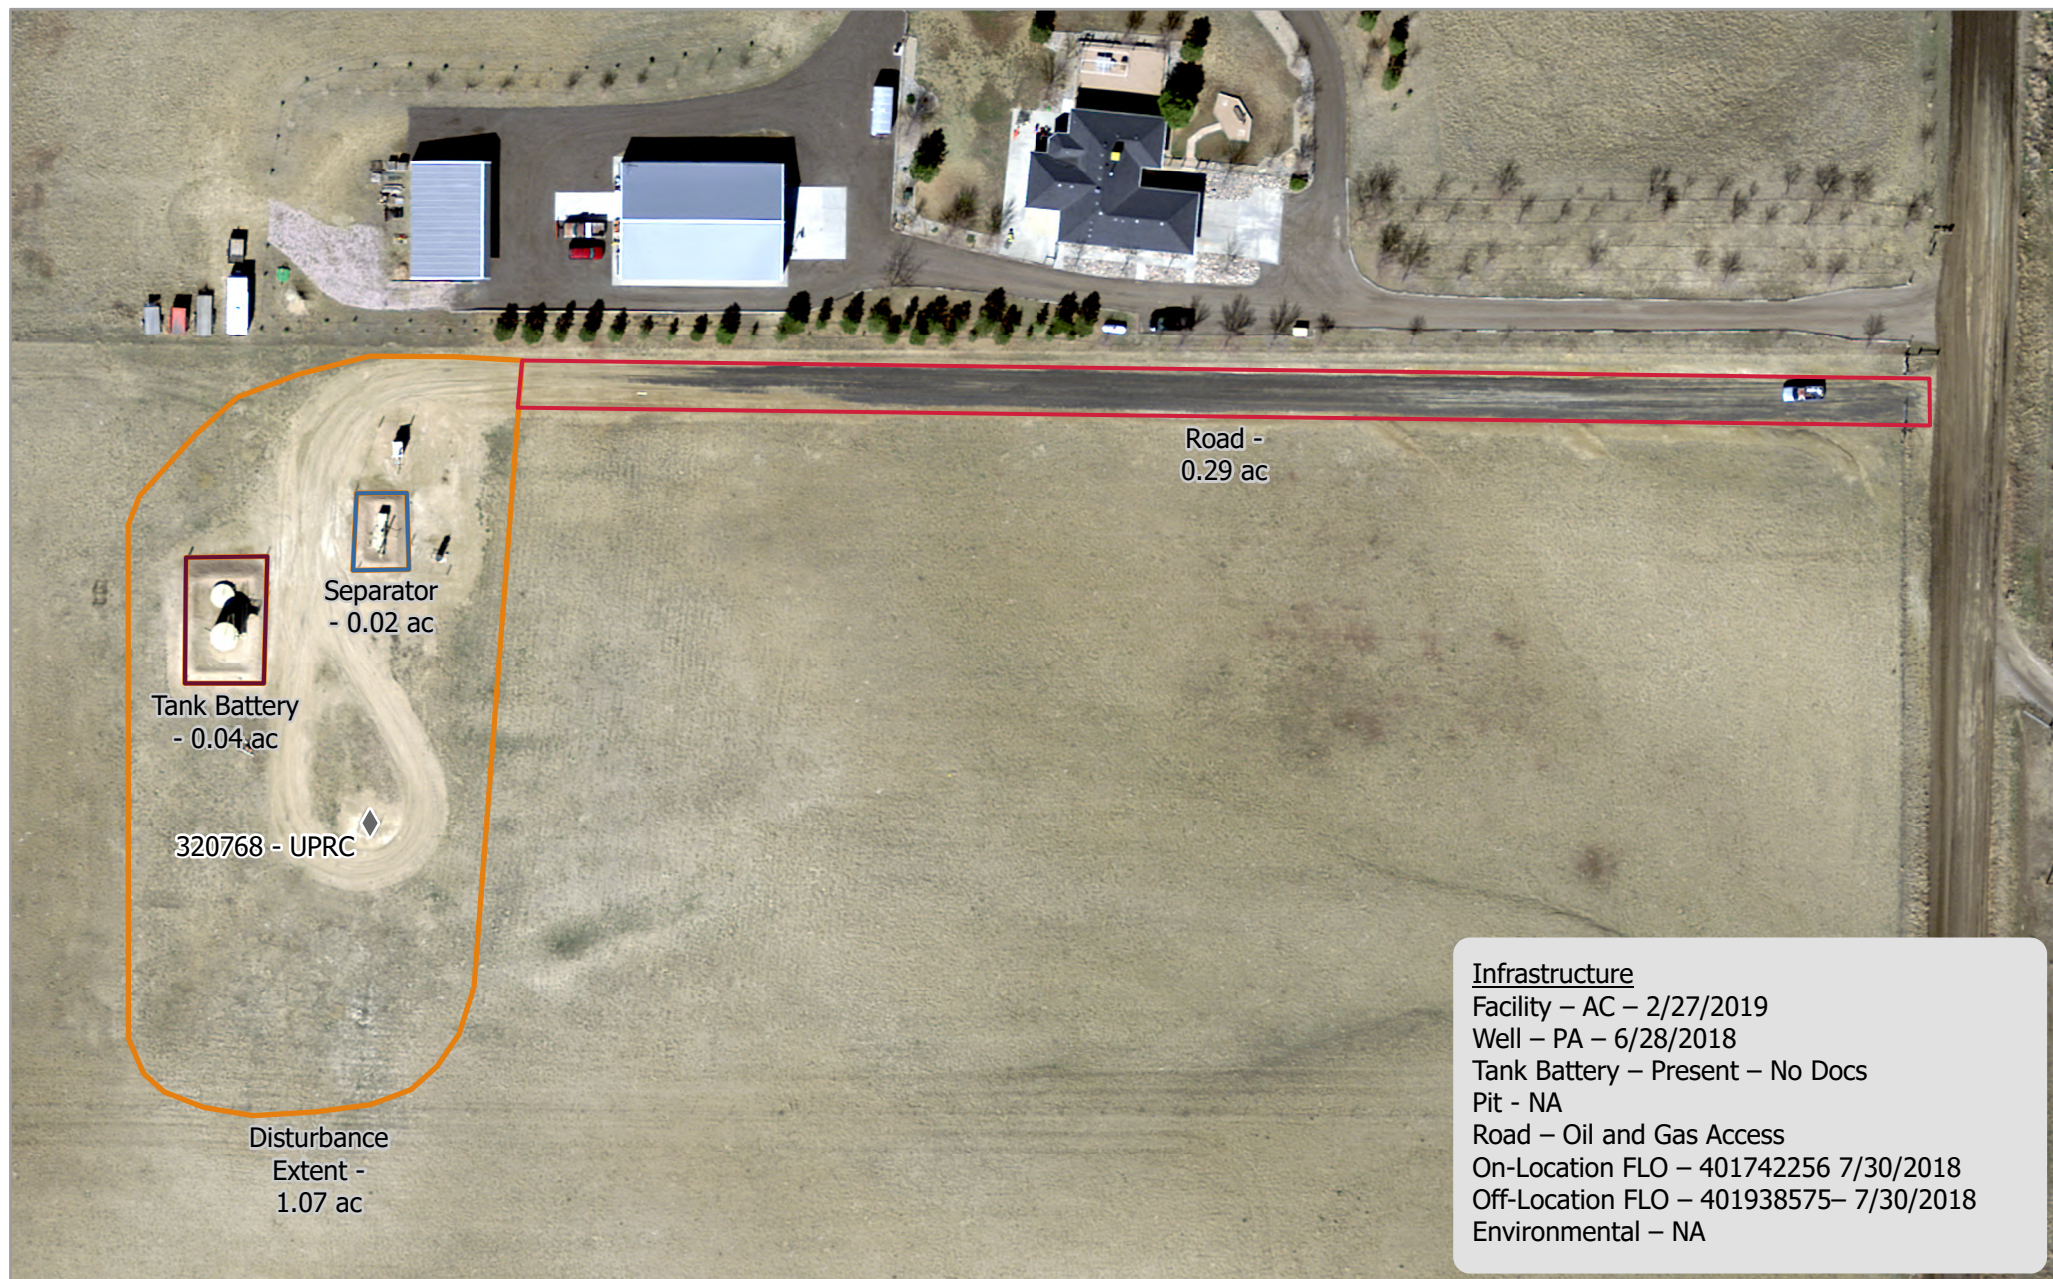
## CIV - 320768- UPRC Map Extent - DRCOG 2014

Infrastructure  
 Facility – AC – 2/27/2019  
 Well – PA – 6/28/2018  
 Tank Battery – Present – No Docs  
 Pit - NA  
 Road – Oil and Gas Access  
 On-Location FLO – 401742256 7/30/2018  
 Off-Location FLO – 401938575– 7/30/2018  
 Environmental – NA

Overall Disturbance:  
 1.42 Acres  
 Scale: 1:1,000

PREVIOUS LAND USE	CURRENT LAND USE
Reference Imagery for Infrastructure – DRCOG 2014	Remotely Sense Imagery – 09/24/2022
Designation – Well Pad	Designation – Homestead

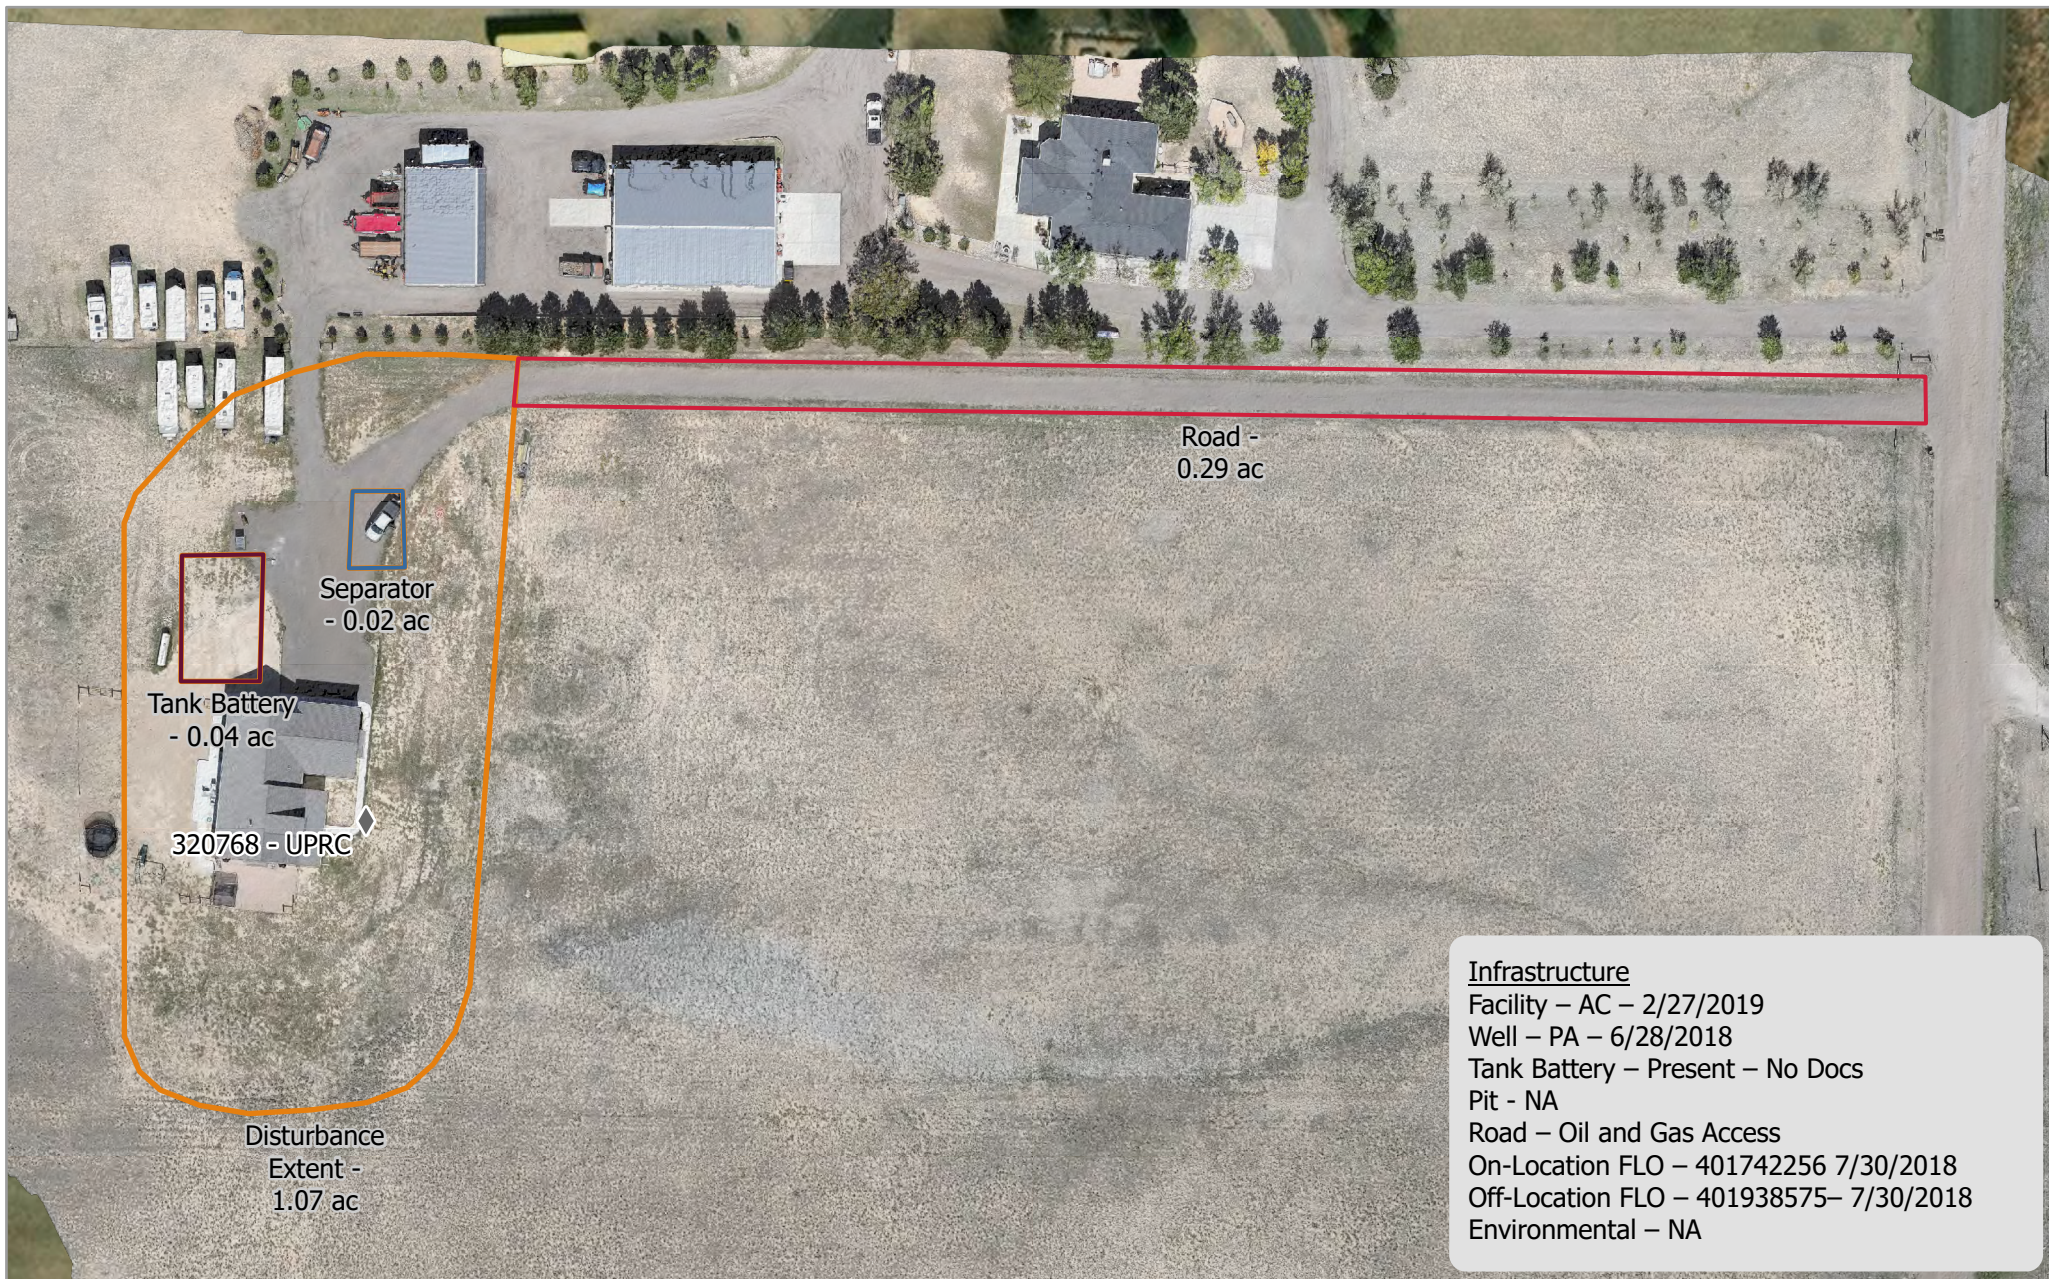
## CIV - 320768- UPRC Map Extent - Overview

#### Infrastructure

Facility – AC – 2/27/2019

Well – PA – 6/28/2018

Tank Battery – Present – No Docs

Road – Oil and Gas Access

On-Location FLO – 401742256 7/30/2018

Off-Location FLO – 401938575– 7/30/2018

Tank battery was on-site, no related documents were found within the database.

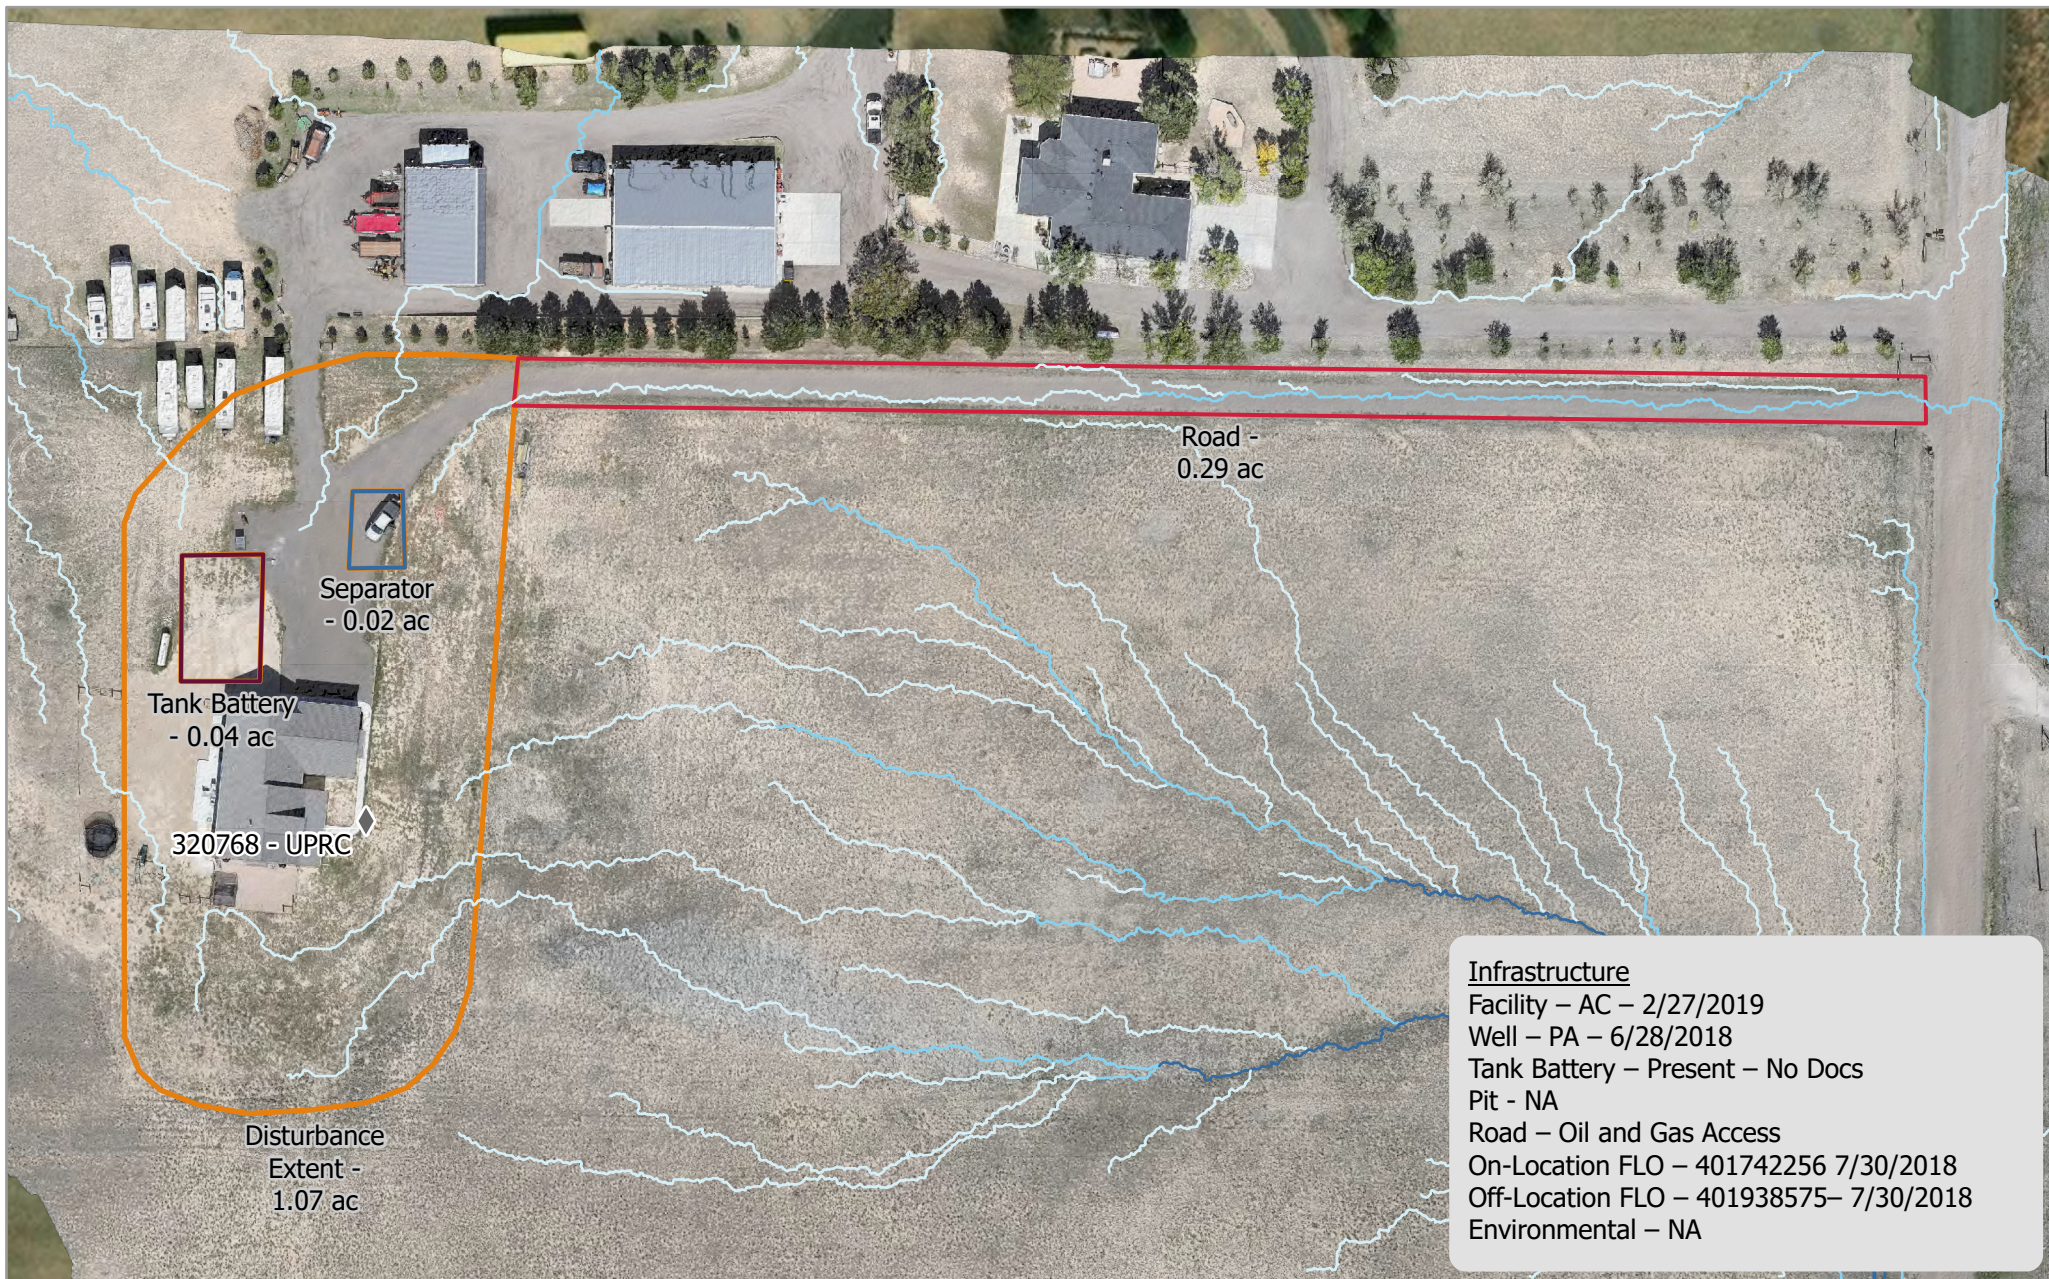
## CIV - 320768- UPRC Map Extent - Hydrology

Overall Disturbance:  
1.42 Acres  
Scale: 1:1,000

Hydrology – (2 CCR 404-1 – 303.b.3.G pg.34)
