Inspection Photos

API: 071-08114

Operator: EVERGREEN NATURAL RESOURCES

Inspection Date: 1/17/2023

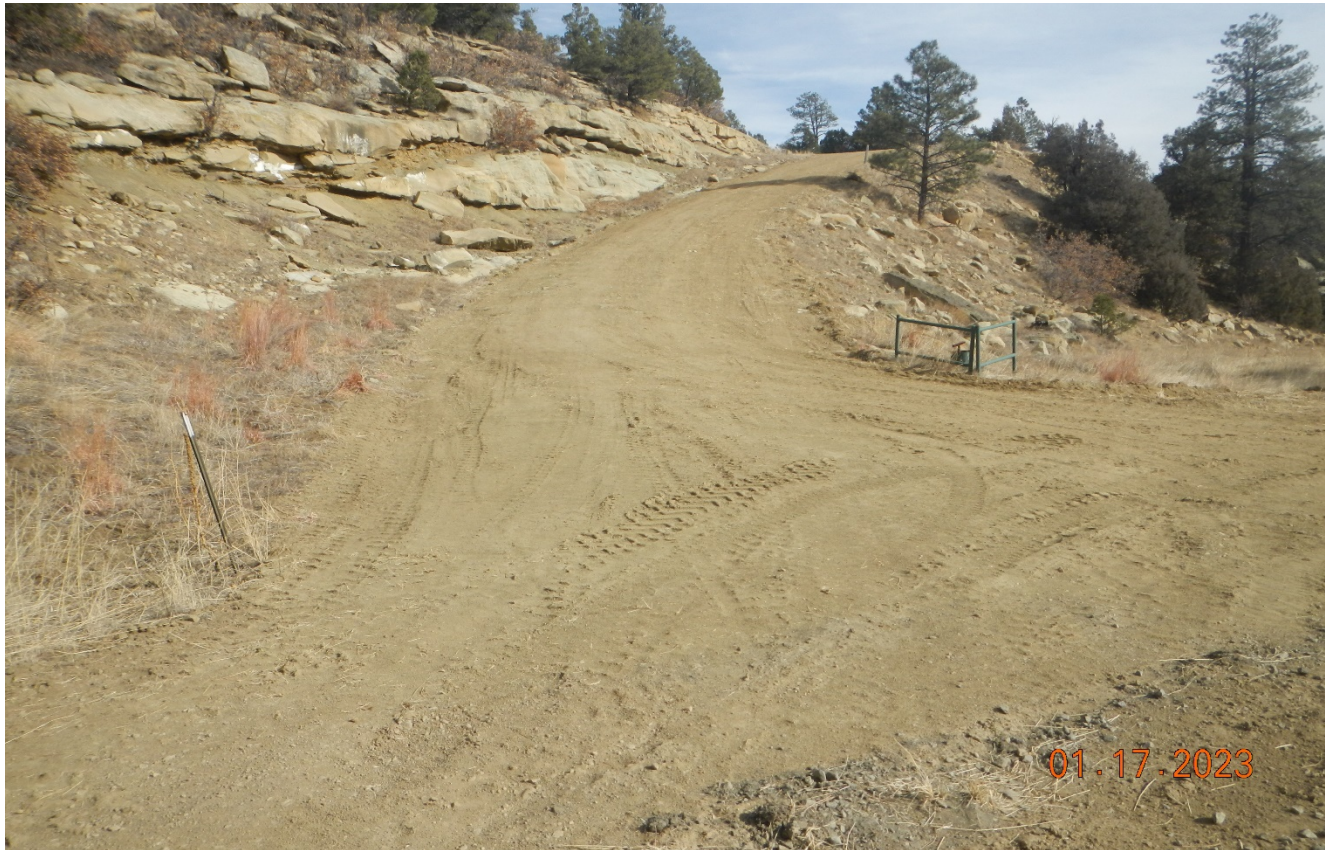
Photo 1. Facing at the beginning of the access road. The road was regraded however there was no BMP's installed to prevent erosion from reoccurring. Grading has caused disturabce which needs to be stabilized.

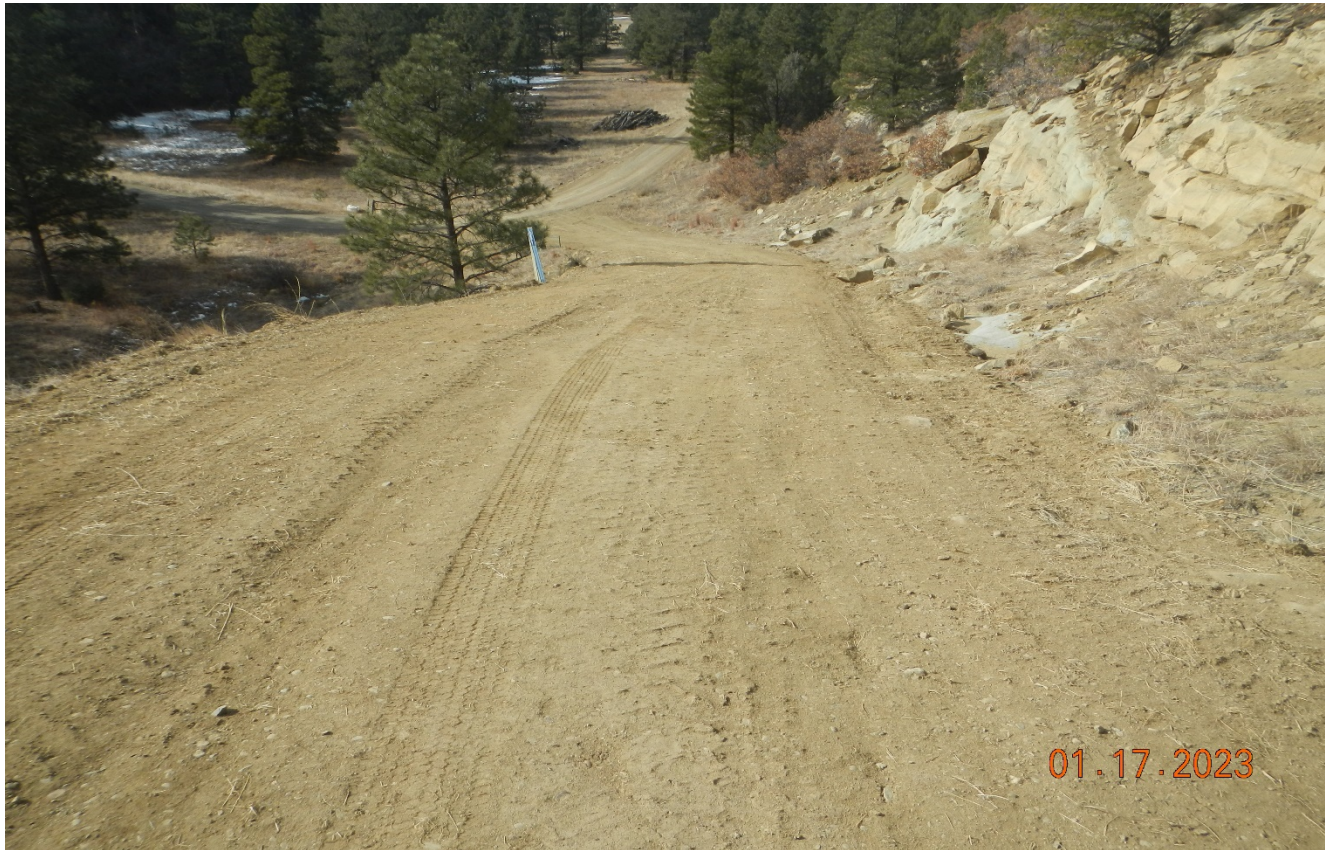
Photo 2. Facing back down the steep portion of the road. BMP's need to be installed to prevent erosion which may include road base, water bars, check dams ect.

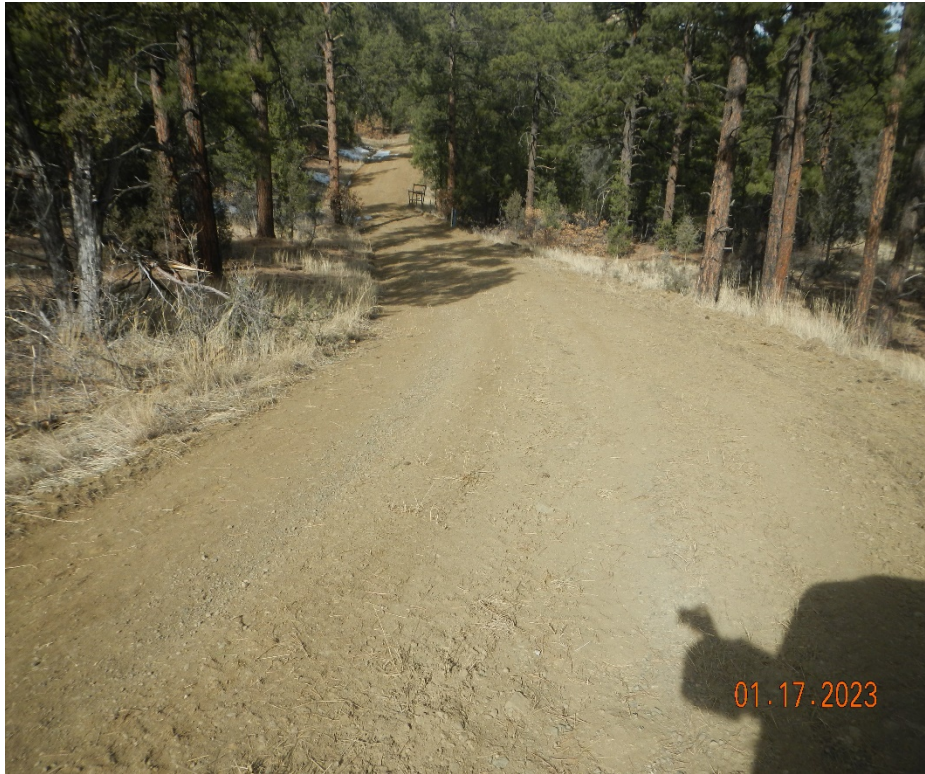
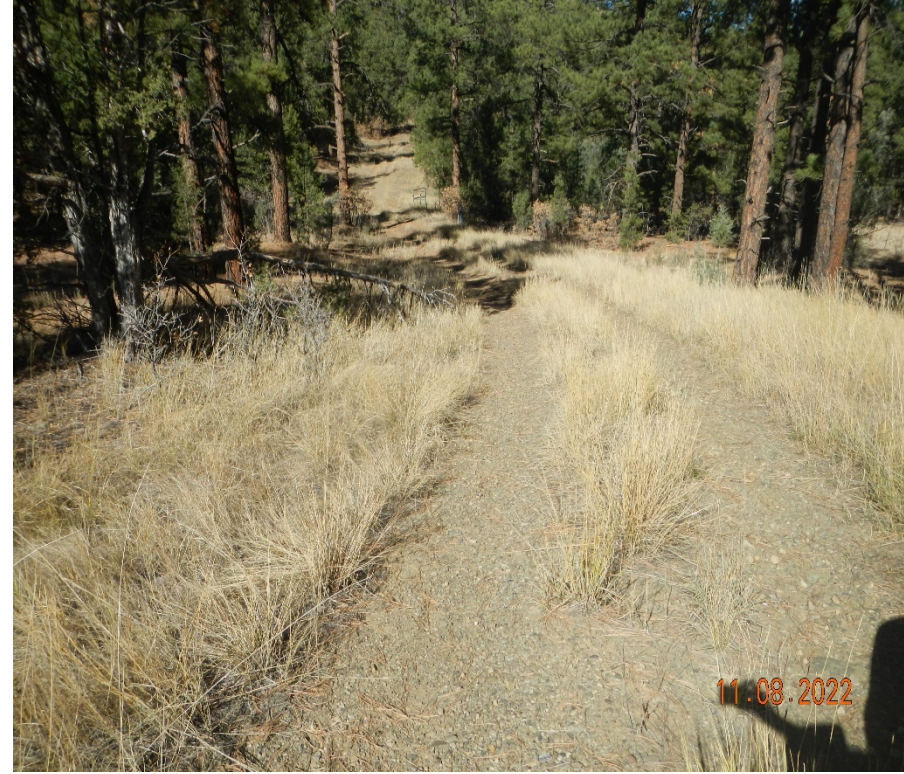
Photo 3. The photo on the right shows the remainder of the road which was previously stabilized with vegetation and gravel. The photo on the left is after grading which has created unnecessary disturbance which may lead to erosion.
