Inspection Photos

116587,312756,11

Date:1/10/2023

COLORADO
Oil & Gas Conservation
Commission
Department of Natural Resources

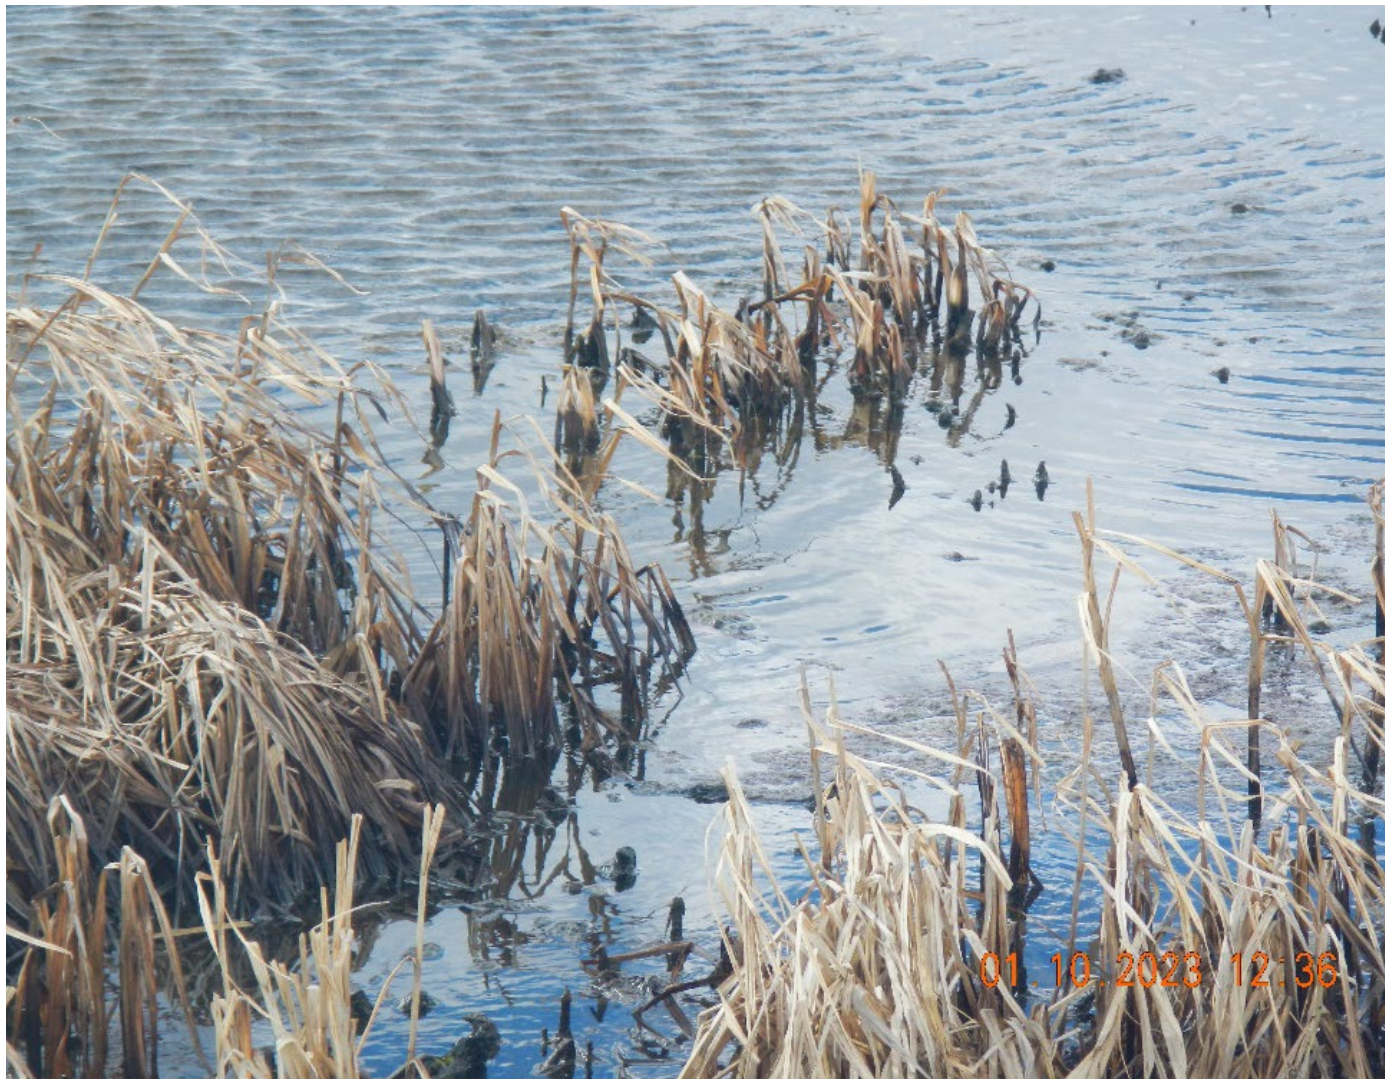
Photo #1 Location of photo is near access road and Seeping Spring Gulch near 40.312194,-107.691265.

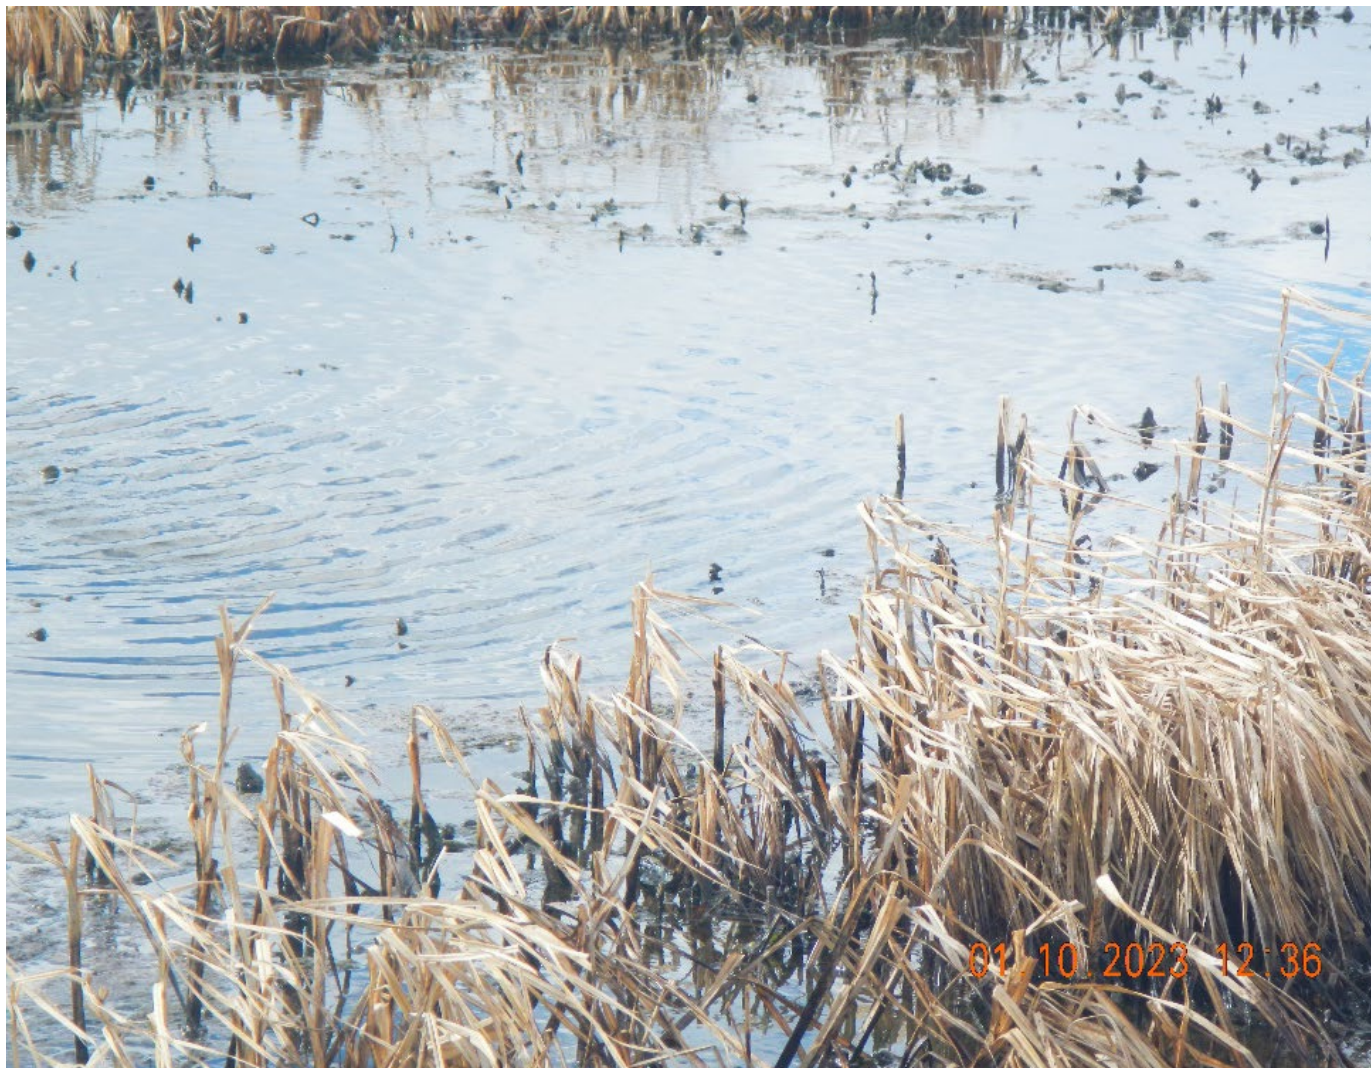
Photo #2 Location of photo is near access road and Seeping Spring Gulch near 40.312194,-107.691265. Rainbow on water were observed at this location.

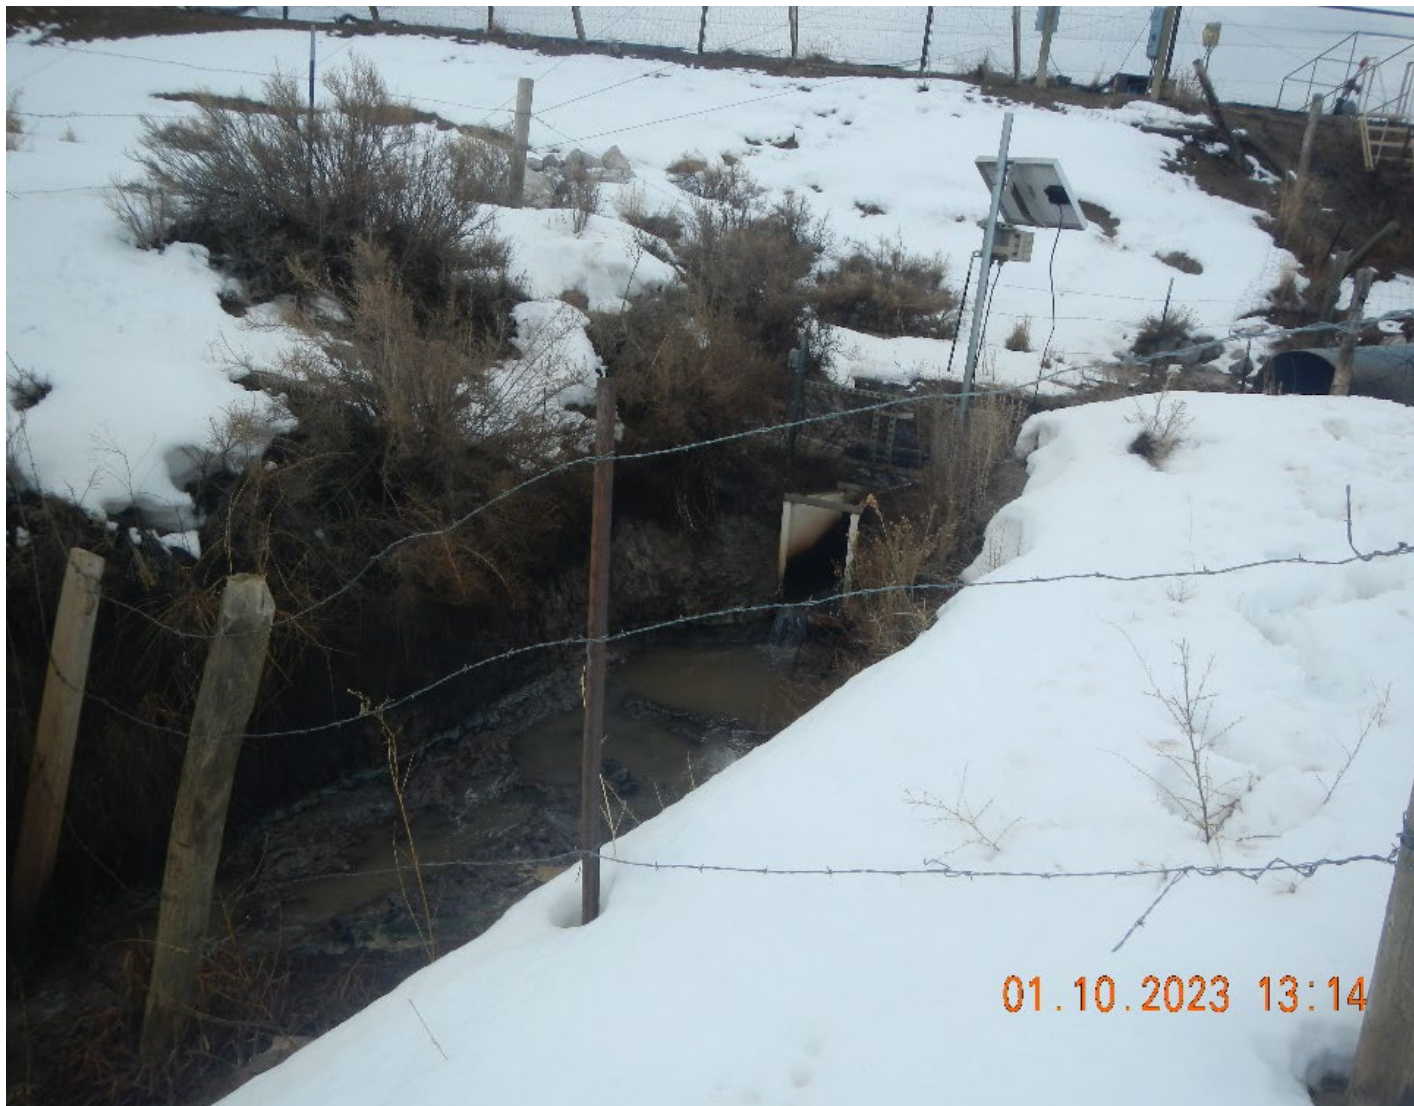
Photo #3 Location data from camera 40.307953,-107.690228. photo is of weir, discharge culvert can be seen to right of photo. Oil was observed in the creek bed, on rocks and vegetation. The discharge to Seeping Spring was reduced to a fraction of it's previous observed volume. Rainbows were observed on the surface of the water in Seeping Spring.

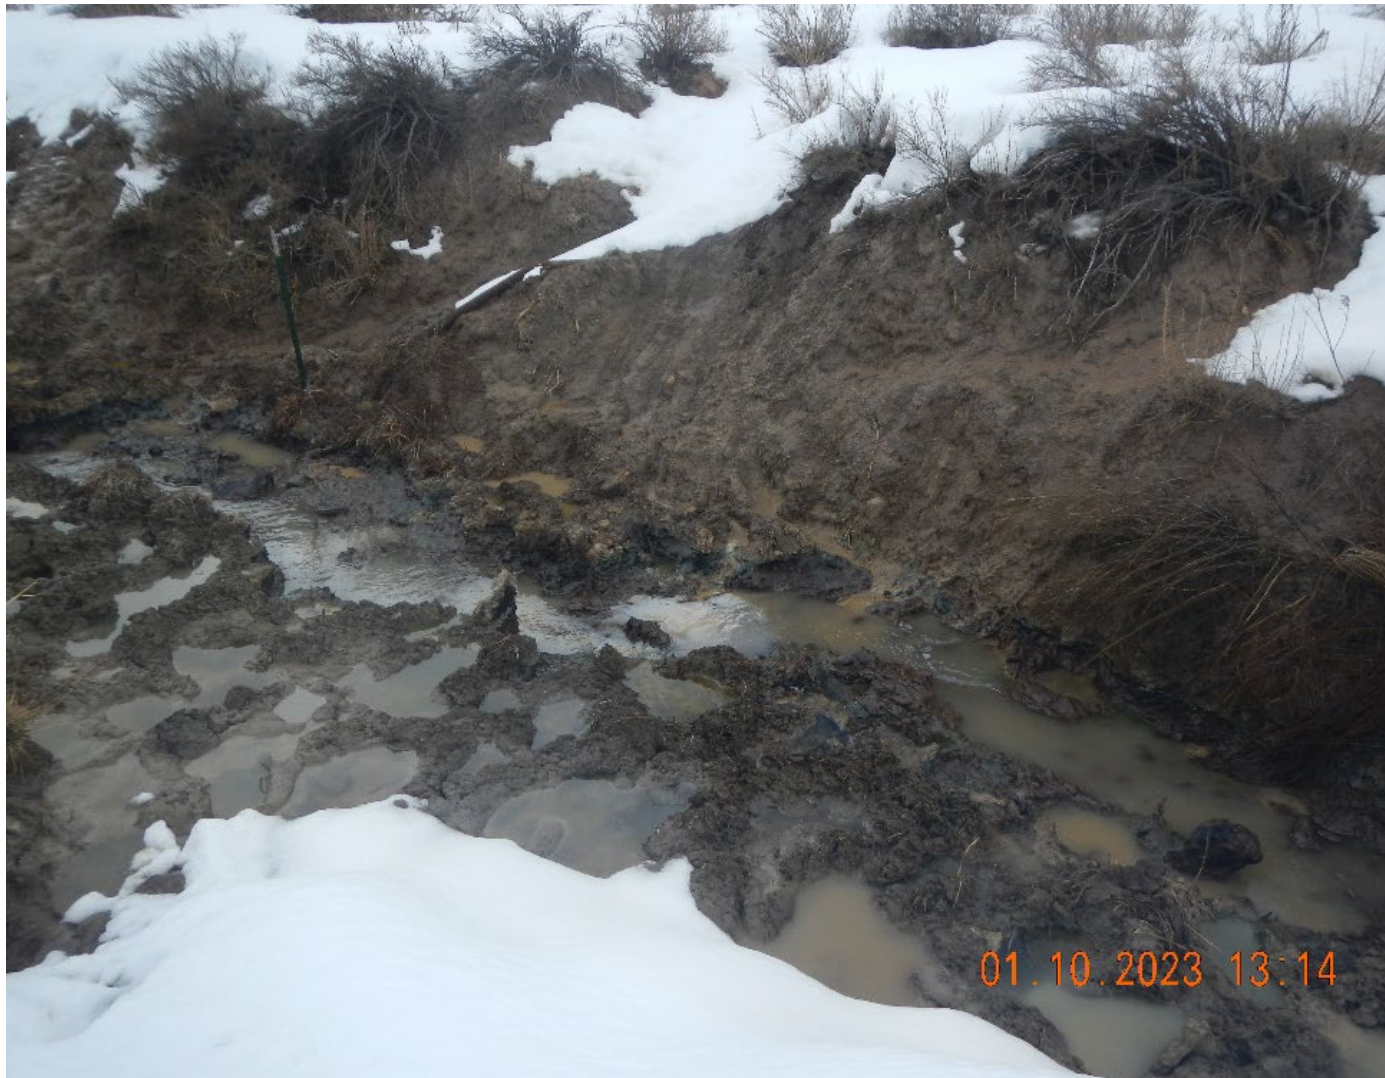
Photo #4 Location data from camera 40.308038,-107.690223. Oil was observed in the creek bed, on rocks and vegetation. Rainbows were observed on the surface of the water in Seeping Spring from the discharge to the county road.

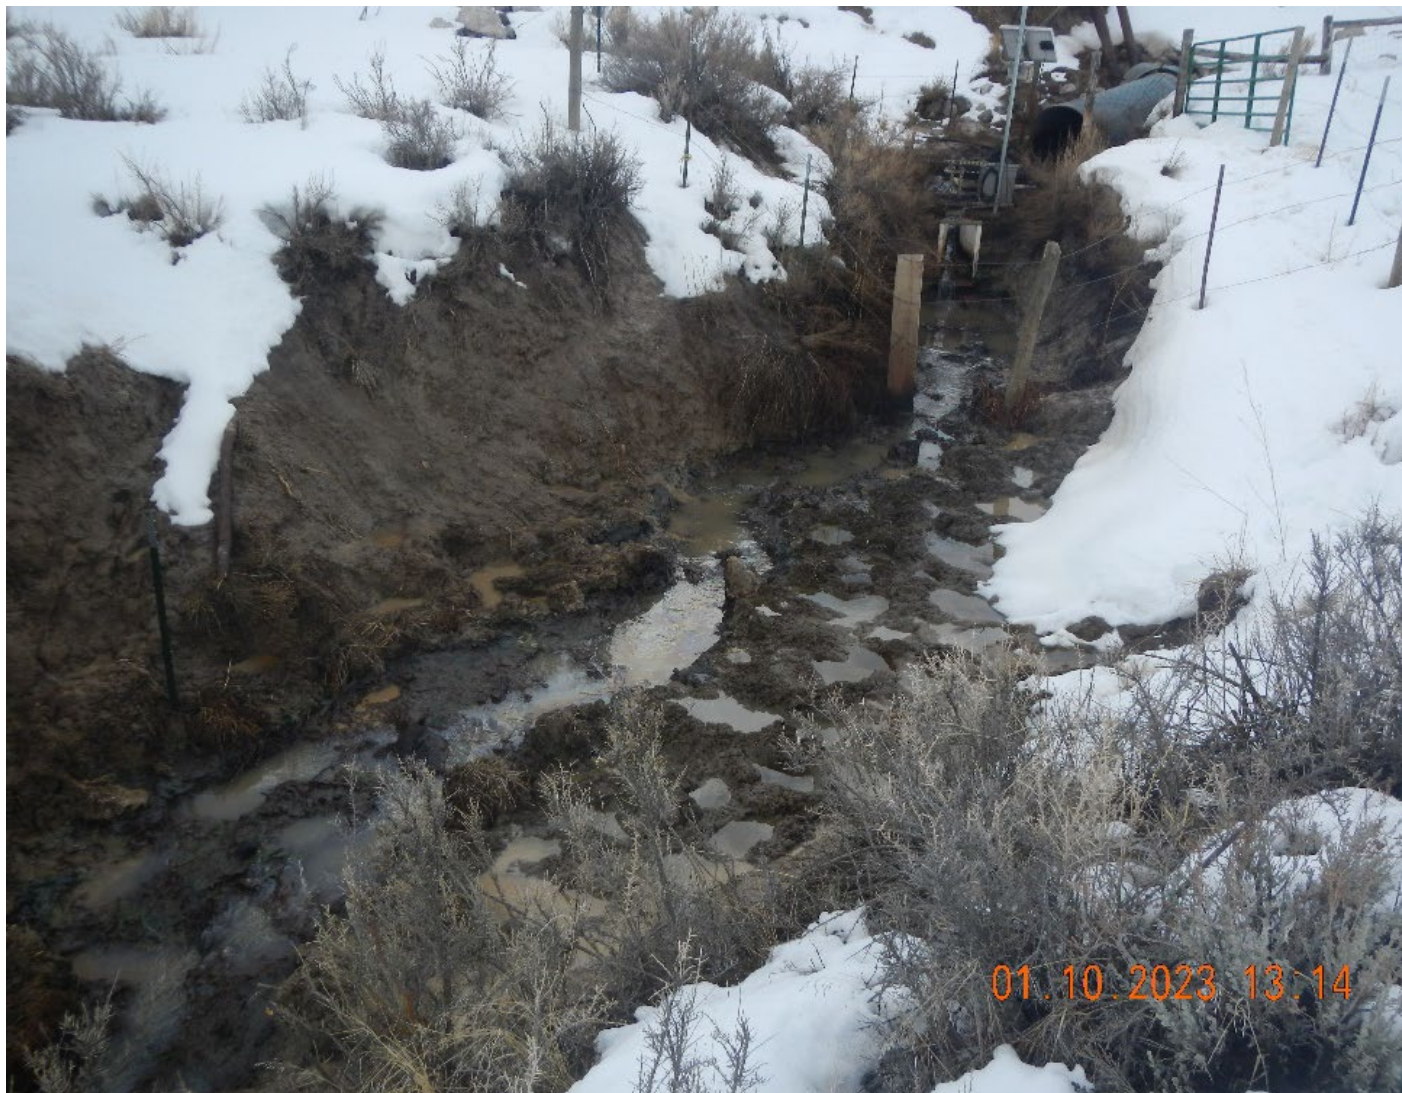
Photo #5 Location data from camera 40.308158,-107.690230. Oil was observed in the creek bed, on rocks and vegetation. Rainbows were observed on the surface of the water in Seeping Spring from the discharge to the county road.

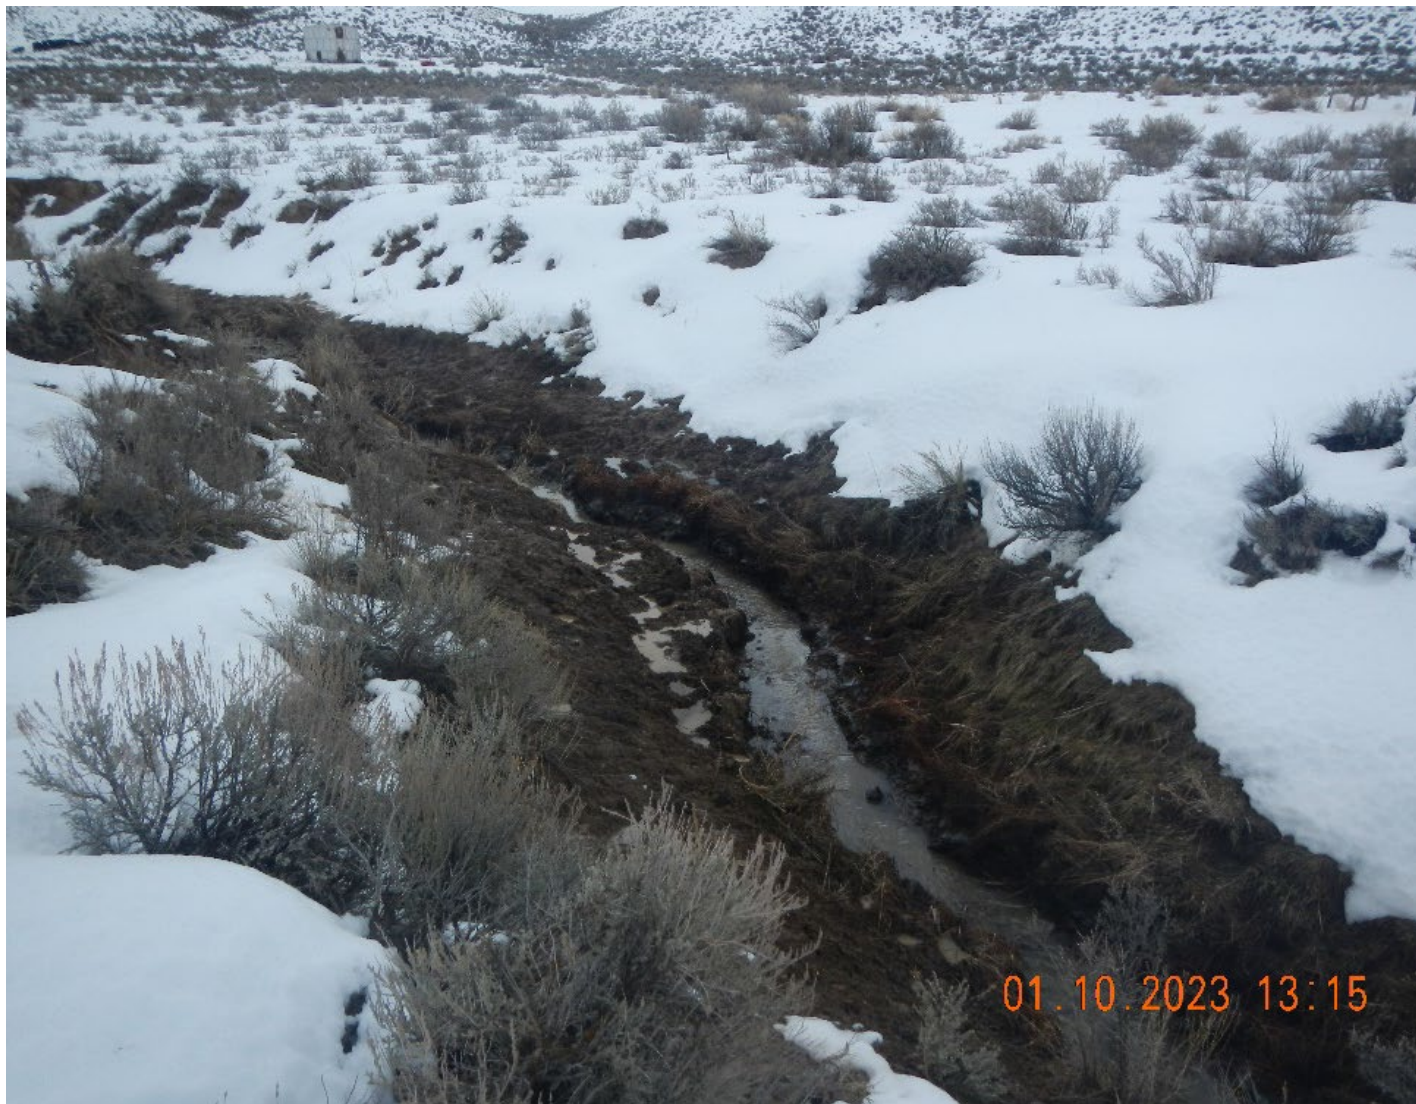
Photo #6 Location data from camera 40.308278,-107.690083. Oil was observed in the creek bed, on rocks and vegetation. Rainbows were observed on the surface of the water in Seeping Spring from the discharge to the county road.

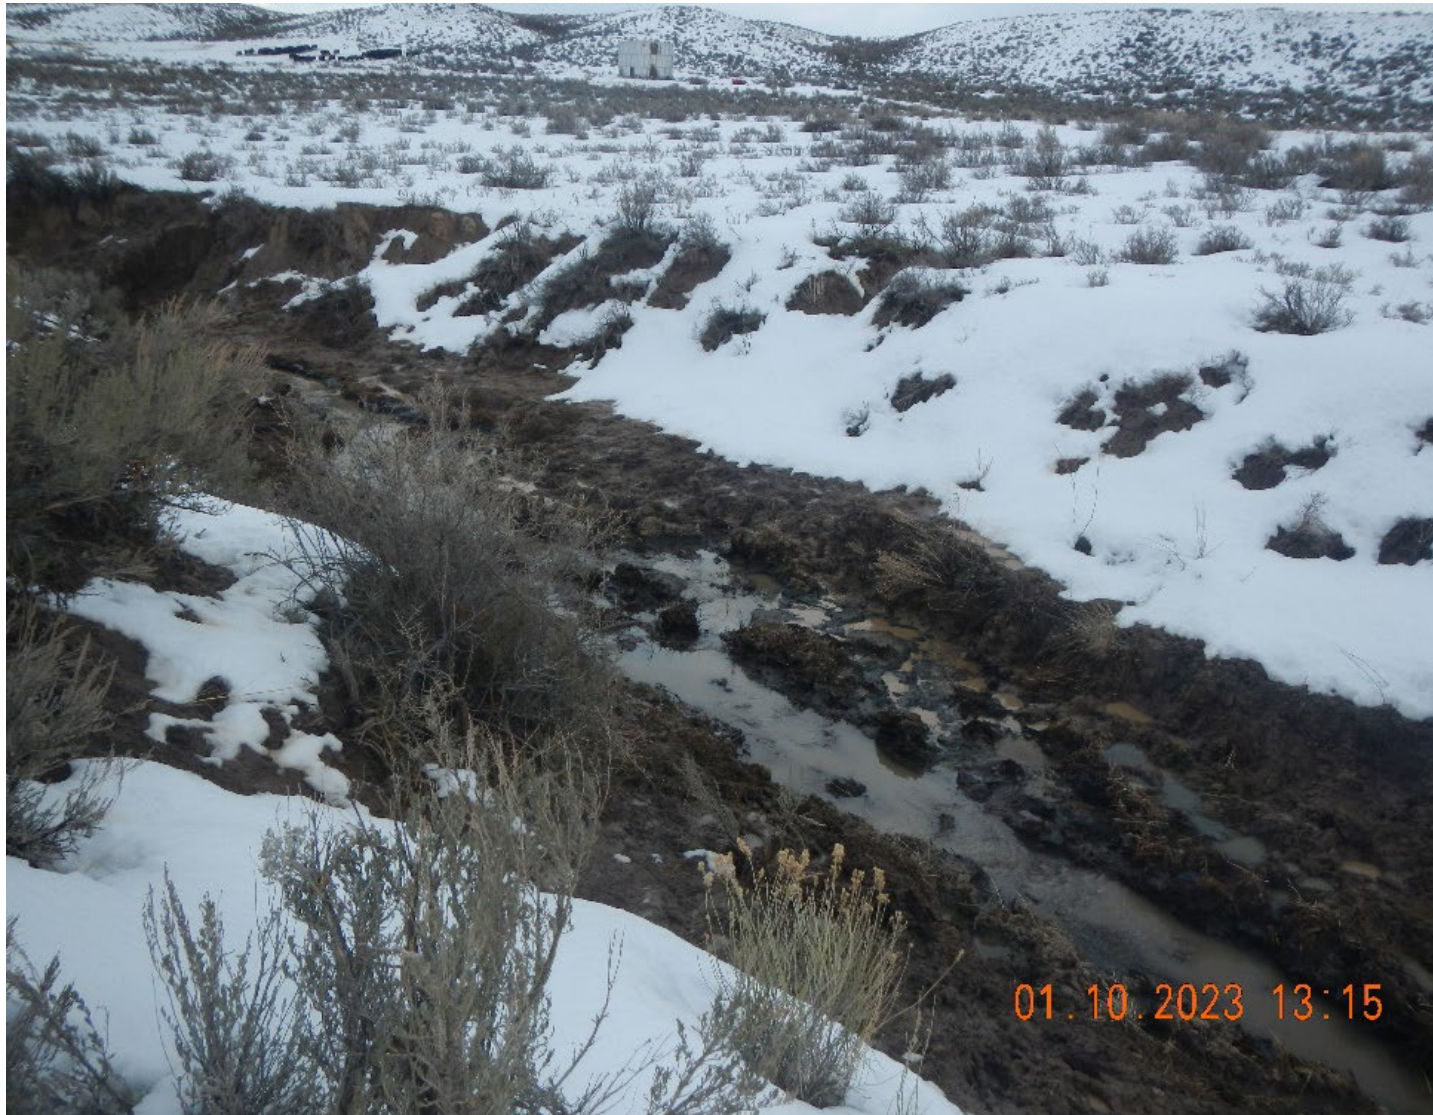
Photo #7 Location data from camera 40.308352,-107.690015. Oil was observed in the creek bed, on rocks and vegetation. Rainbows were observed on the surface of the water in Seeping Spring from the discharge to the county road.

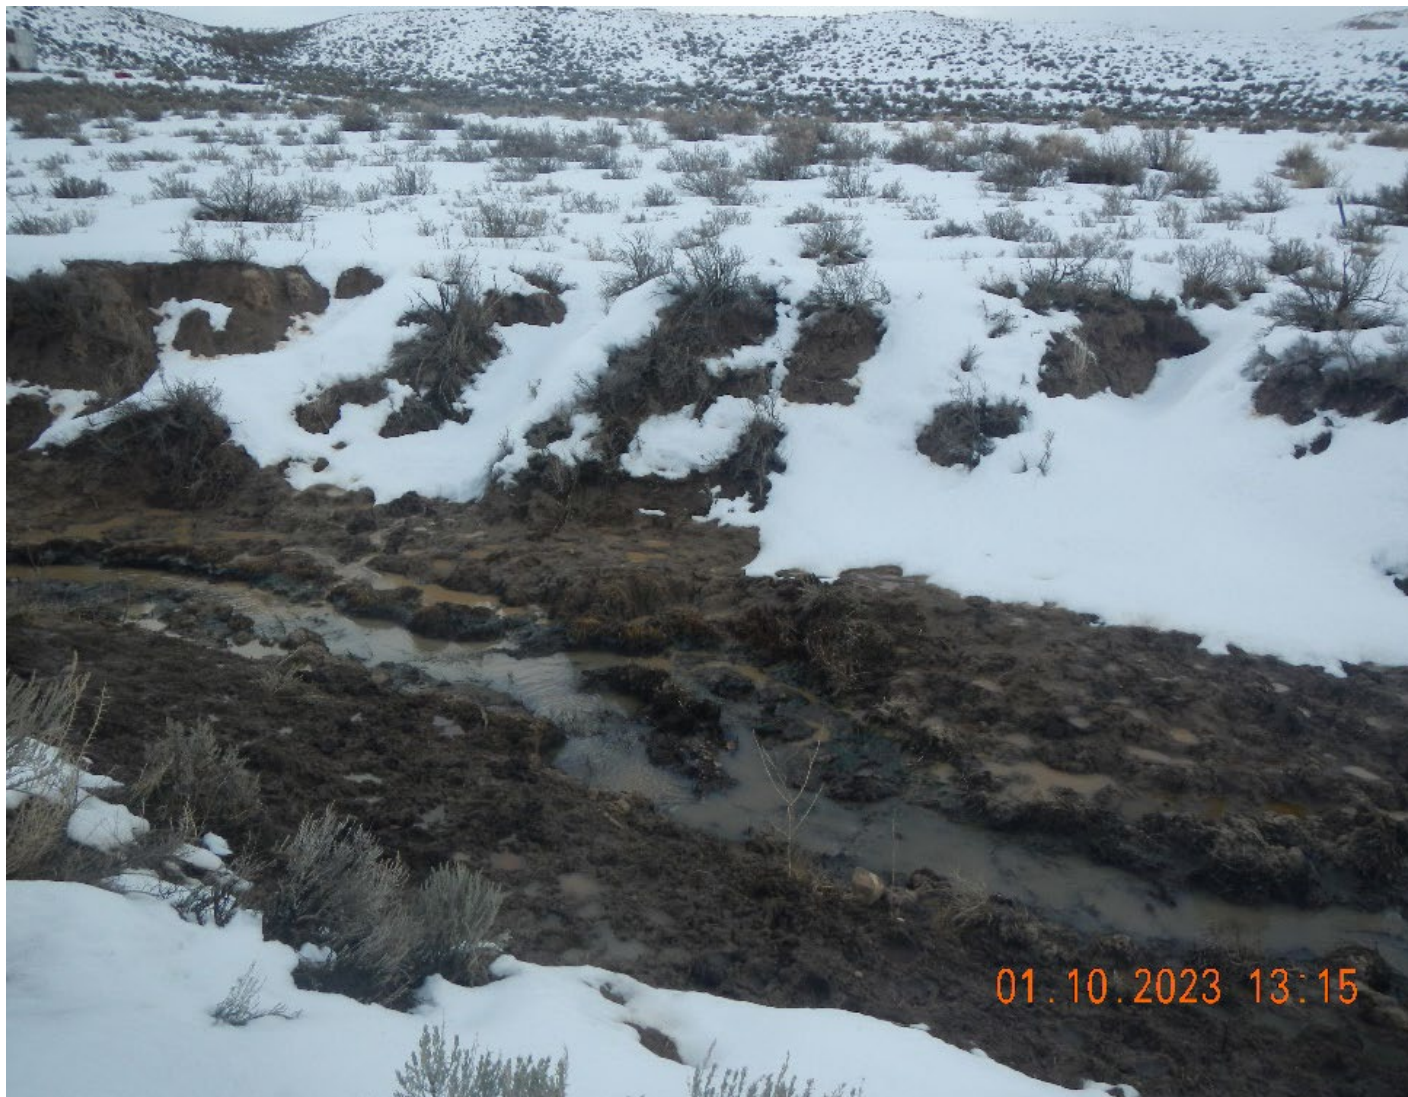
Photo #8 Location data from camera 40.308440,-107.689962. Oil was observed in the creek bed, on rocks and vegetation. Rainbows were observed on the surface of the water in Seeping Spring from the discharge to the county road.

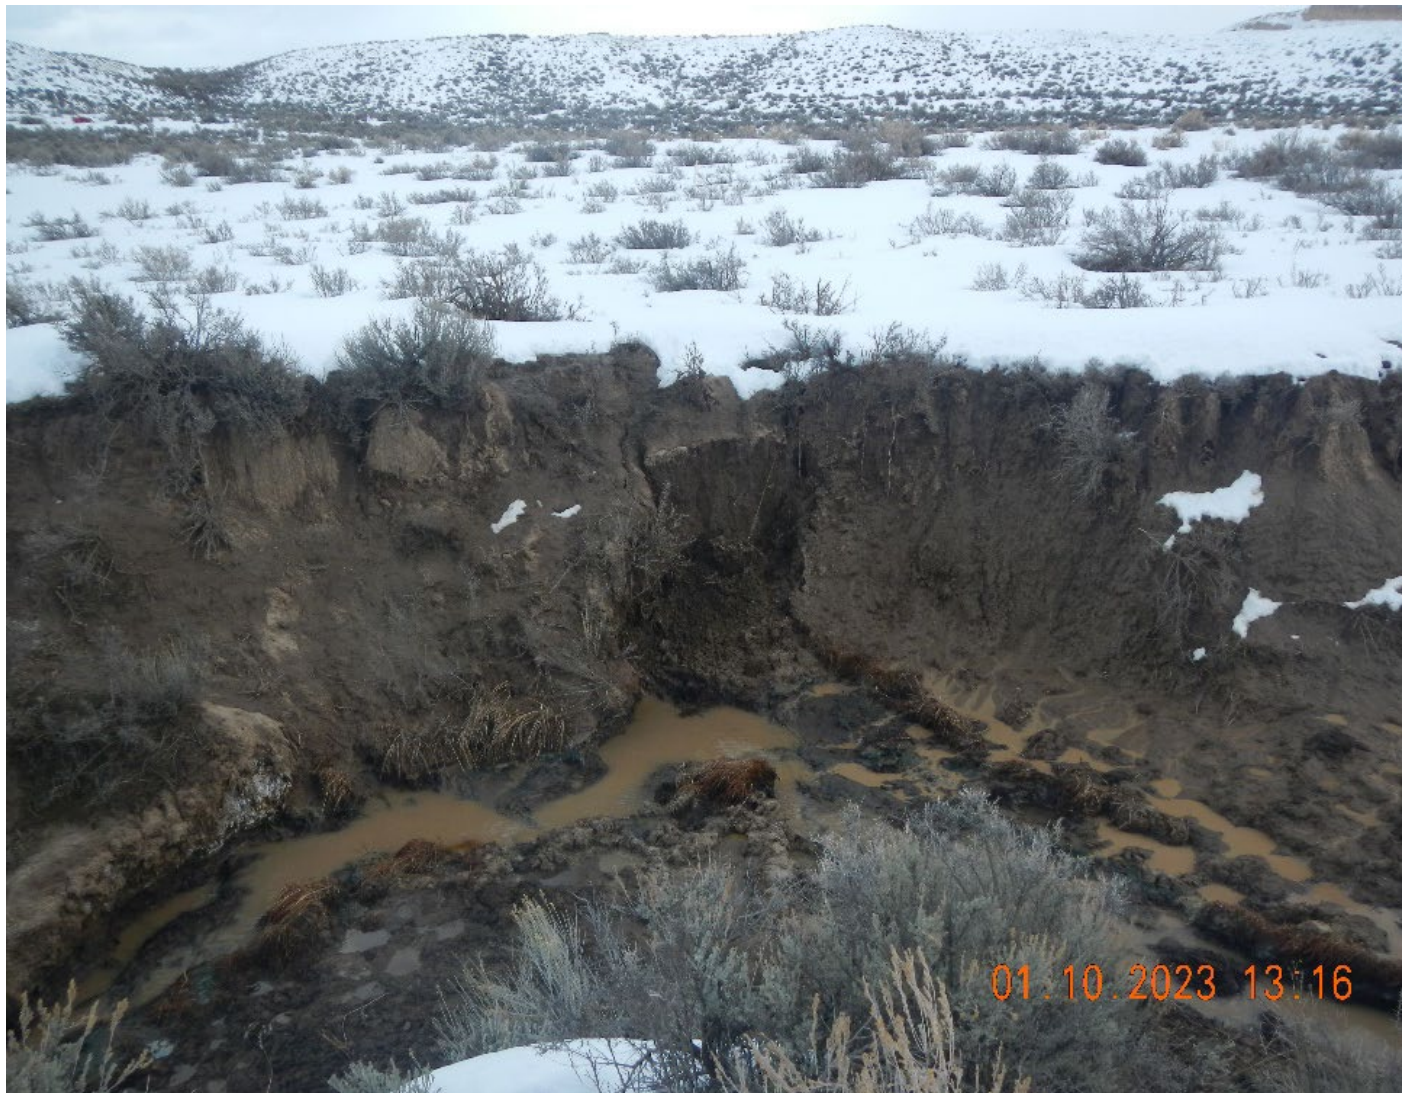
Photo #9 Location data from camera 40.308563,-107.689897. Oil was observed in the creek bed, on rocks and vegetation. Rainbows were observed on the surface of the water in Seeping Spring from the discharge to the county road.

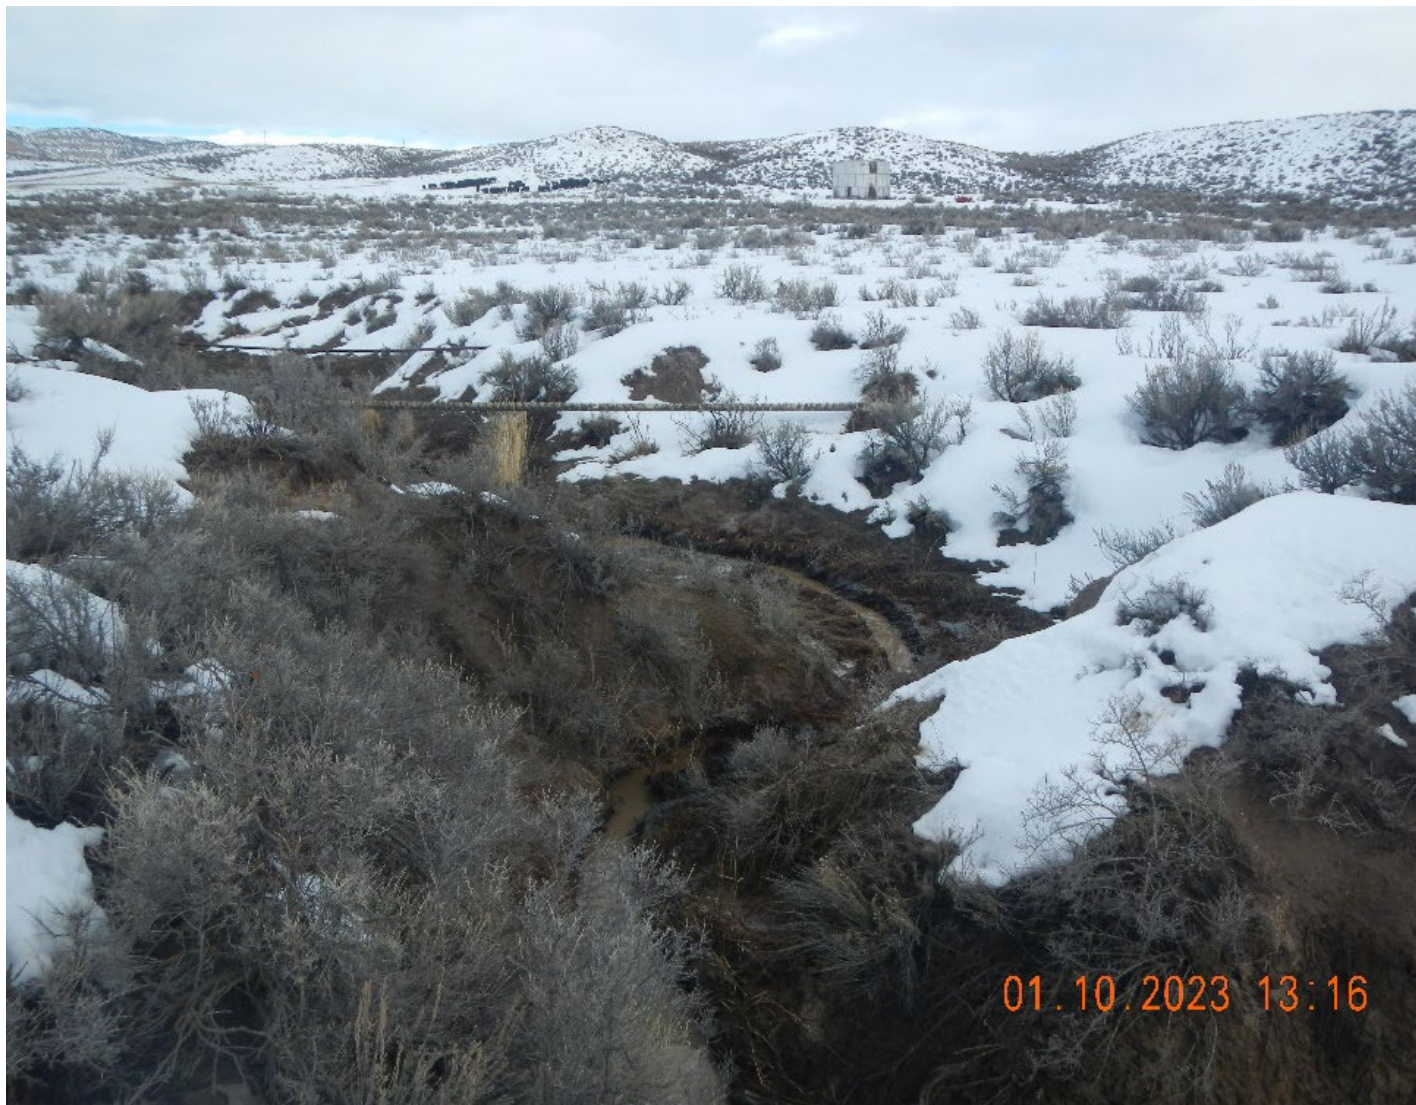
Photo #10 Location data from camera 40.308740,-107.689907. Oil was observed in the creek bed, on rocks and vegetation. Rainbows were observed on the surface of the water in Seeping Spring from the discharge to the county road.

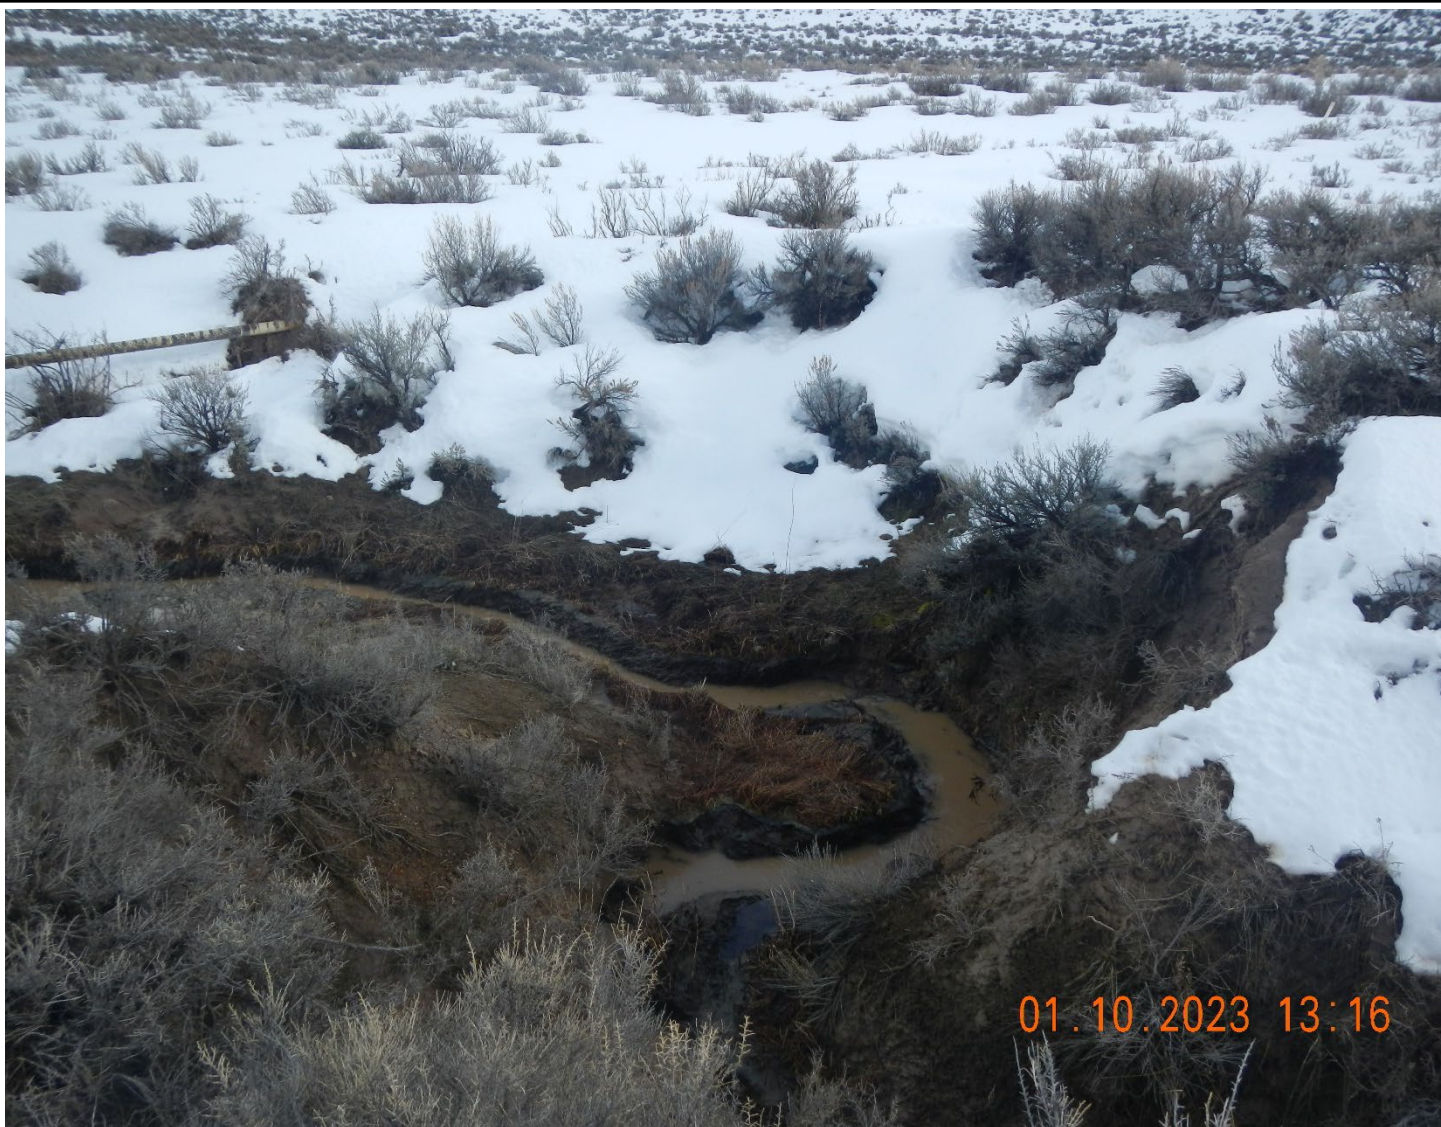
Photo #11 Location data from camera 40.308780,-107.689880. Oil was observed in the creek bed, on rocks and vegetation. Rainbows were observed on the surface of the water in Seeping Spring from the discharge to the county road.

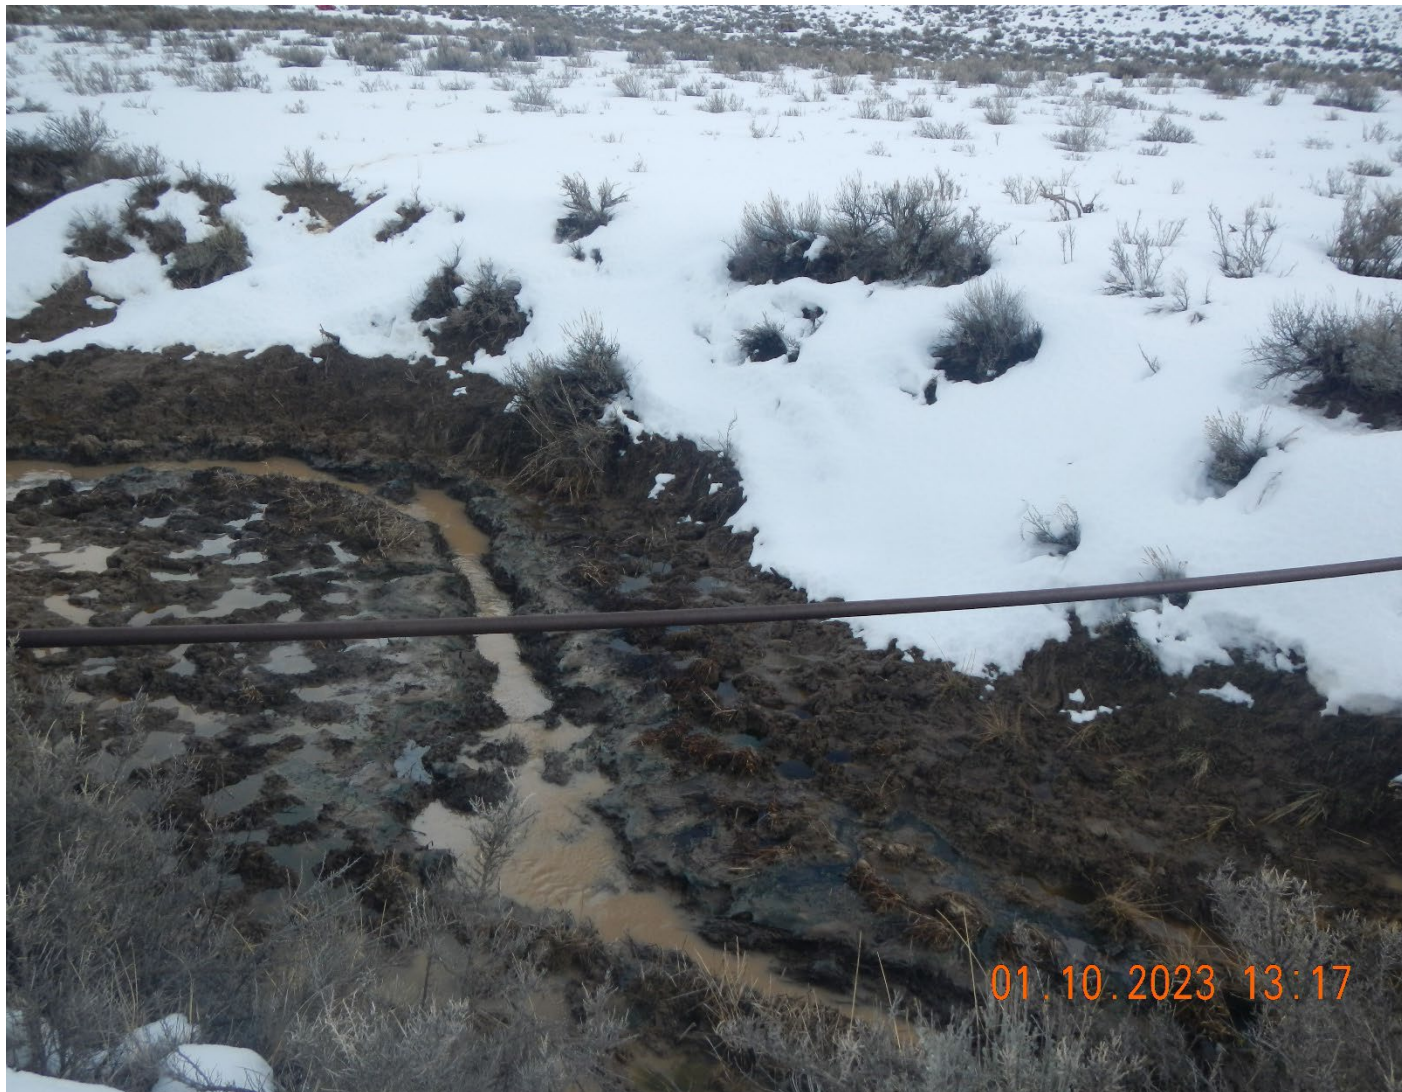
Photo #12 Location data from camera 40.308957,-107.689772. Oil was observed in the creek bed, on rocks and vegetation. Rainbows were observed on the surface of the water in Seeping Spring from the discharge to the county road.

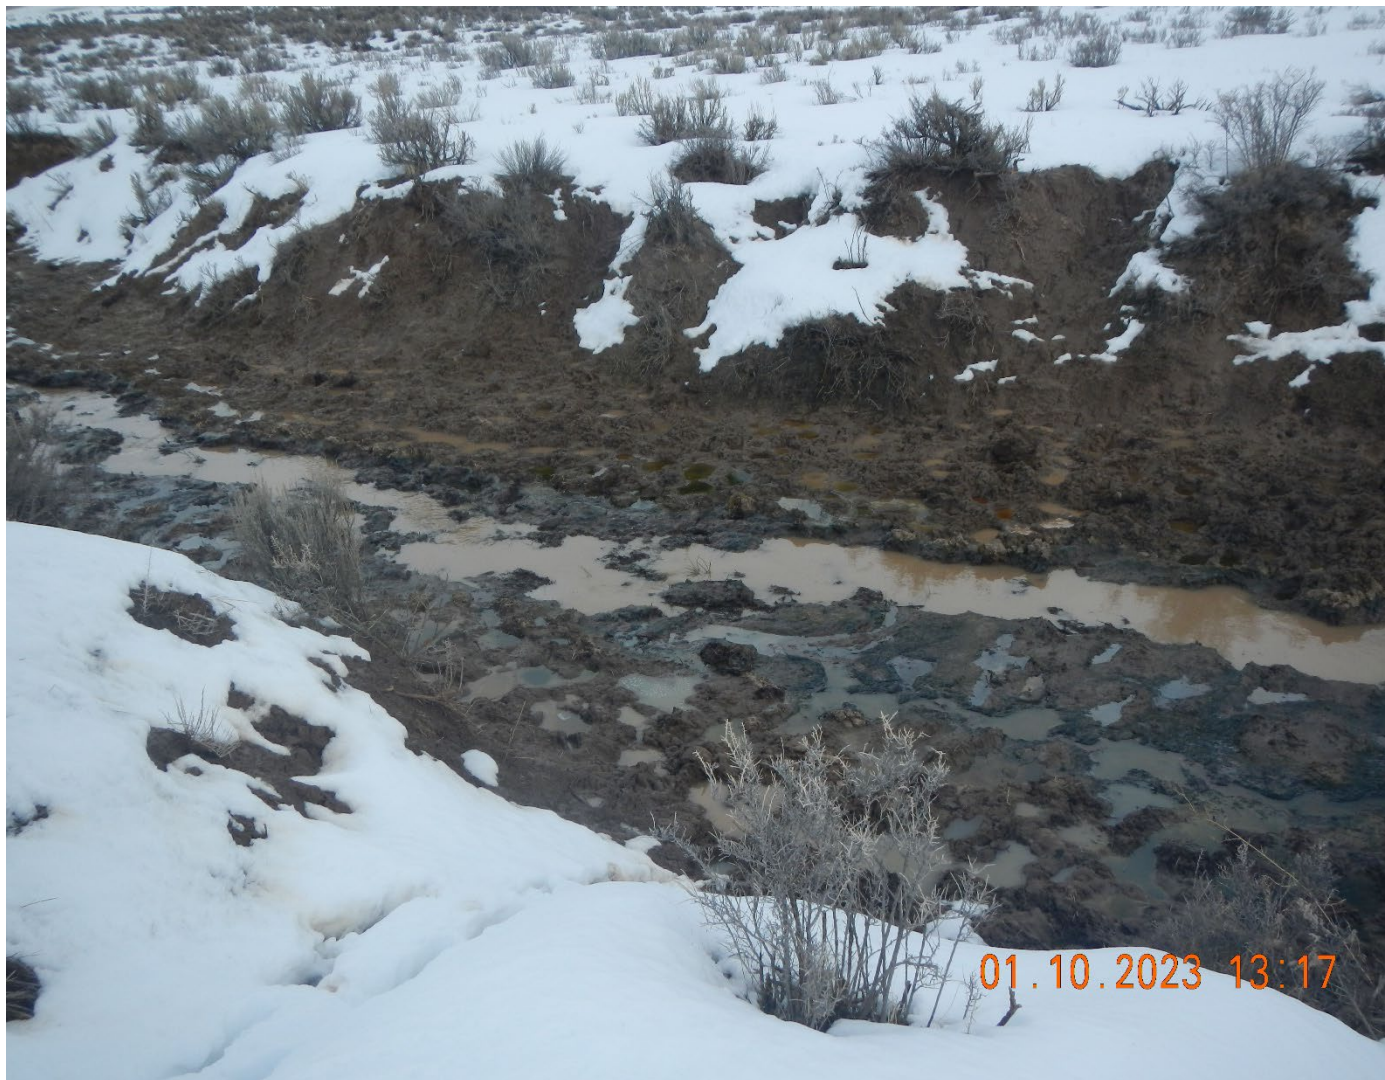
Photo #13 Location data from camera 40.309047,-107.689760. Oil was observed in the creek bed, on rocks and vegetation. Rainbows were observed on the surface of the water in Seeping Spring from the discharge to the county road.

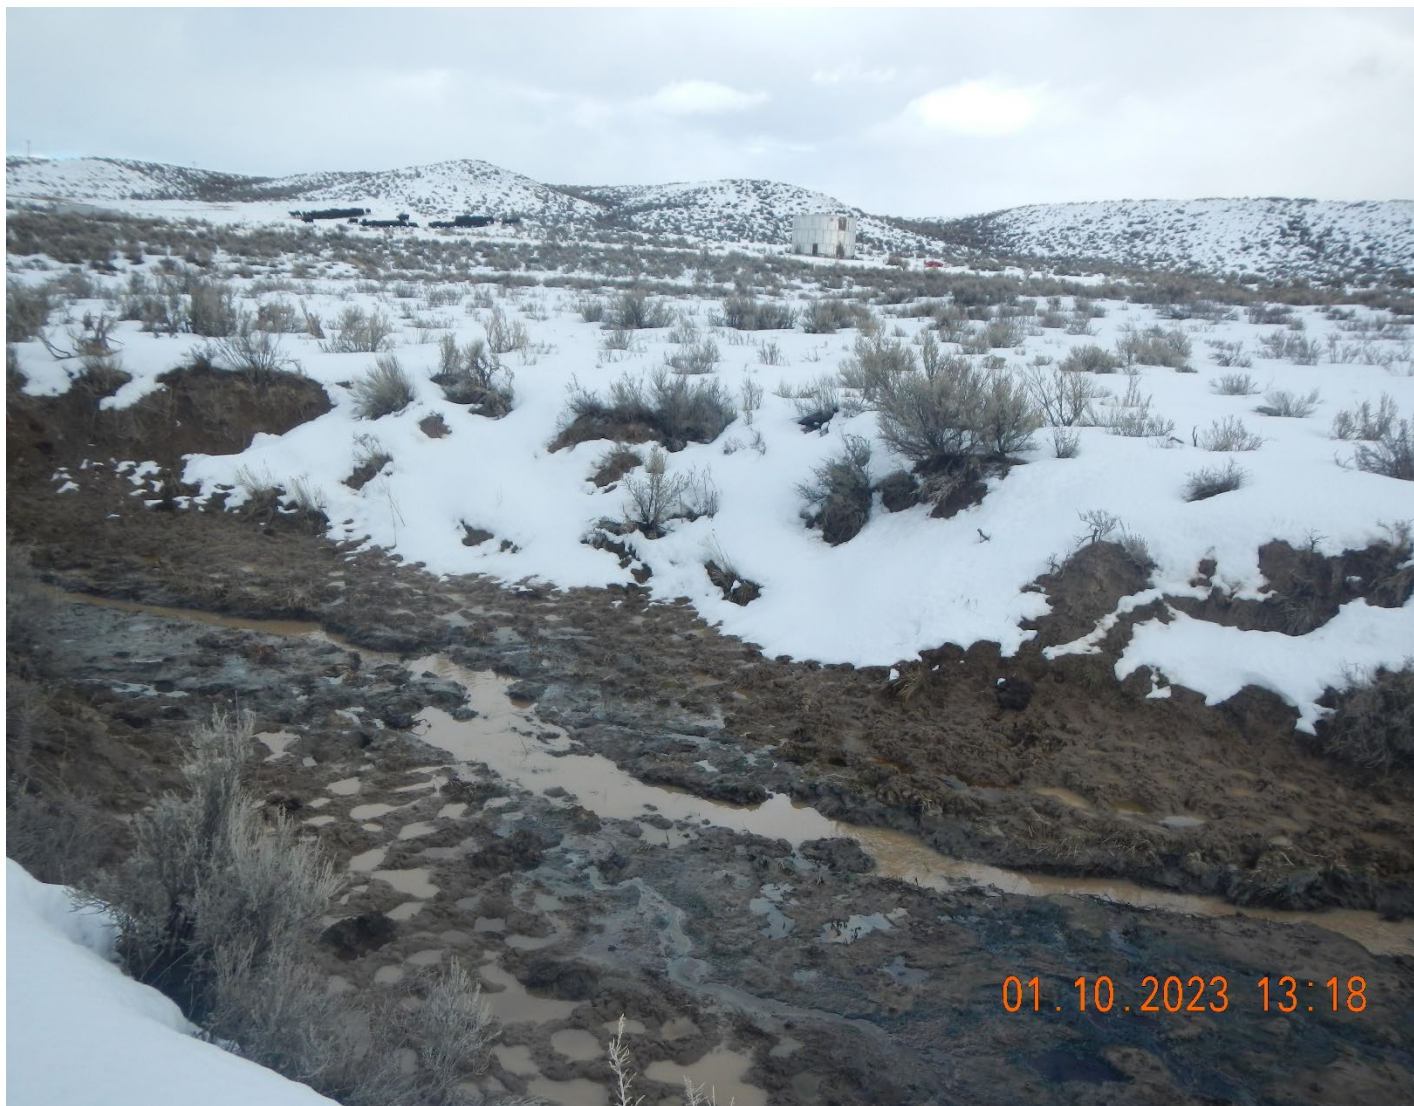
Photo #14 Location data from camera 40.309158,-107.689770. Oil was observed in the creek bed, on rocks and vegetation. Rainbows were observed on the surface of the water in Seeping Spring from the discharge to the county road.
