Inspection Photos

116587,312756,11

Date:1/10/2023

COLORADO
Oil & Gas Conservation
Commission
Department of Natural Resources

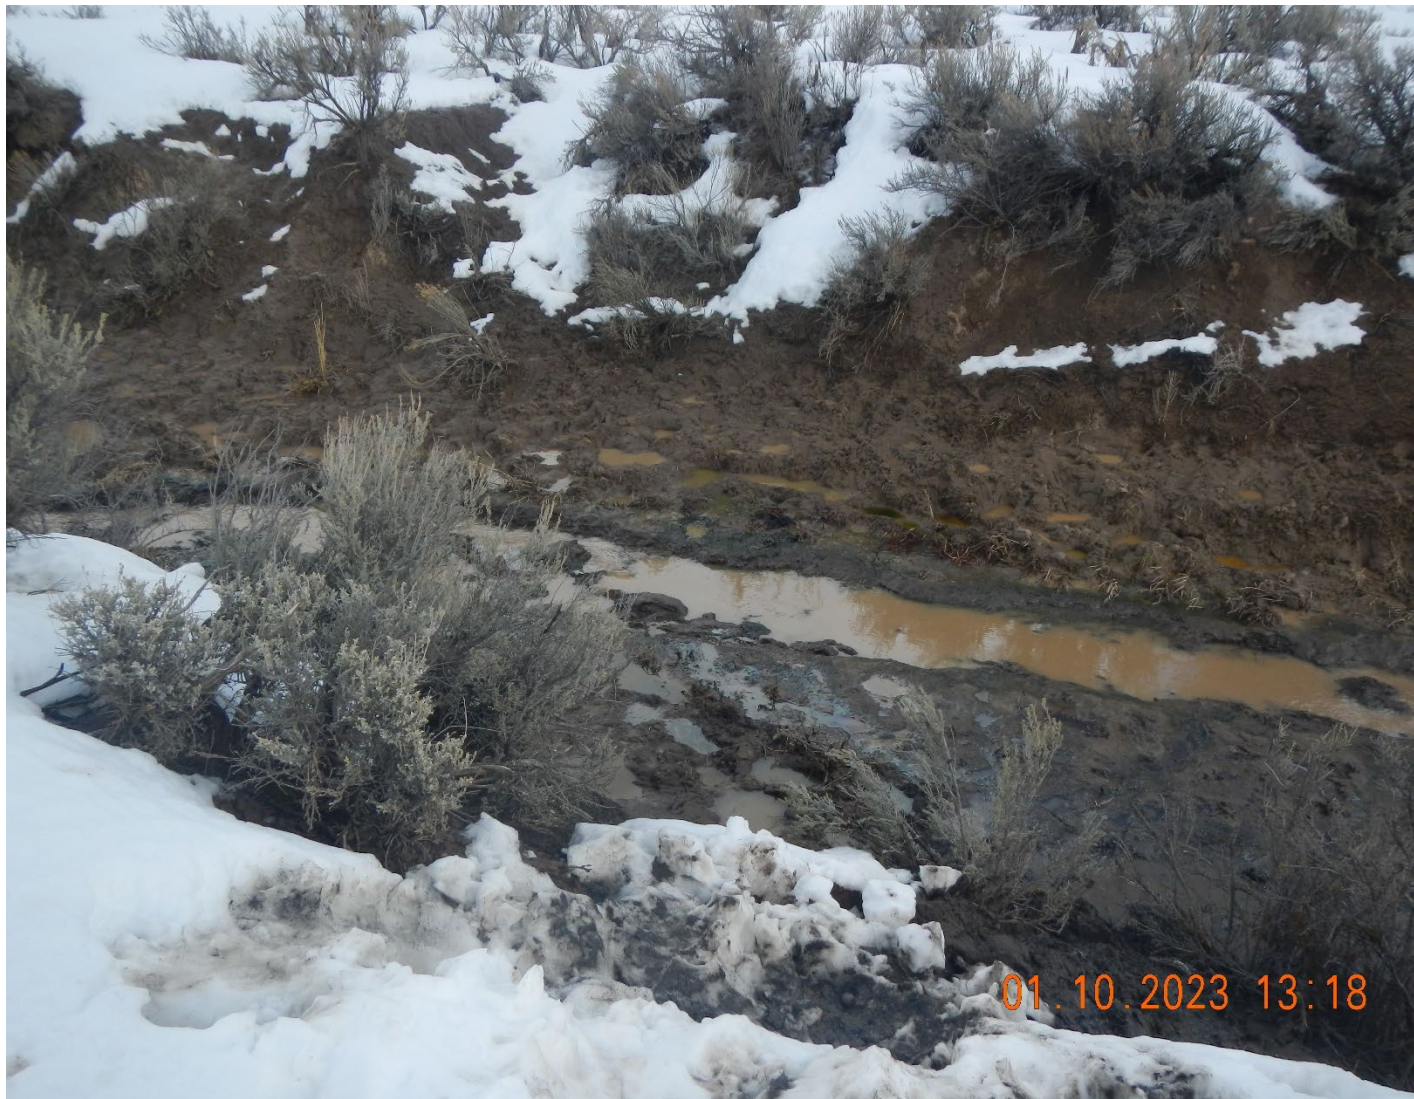
Photo #15 Location data from camera 40.309318,-107.689752. Oil was observed in the creek bed, on rocks and vegetation. Rainbows were observed on the surface of the water in Seeping Spring from the discharge to the county road.
