Inspection Photos

Operator: Caerus Piceance LLC - #10456

Location Name: SCHAEFFER DISPOSAL-67S93W/12NWNW

Inspection Document #: 702801163

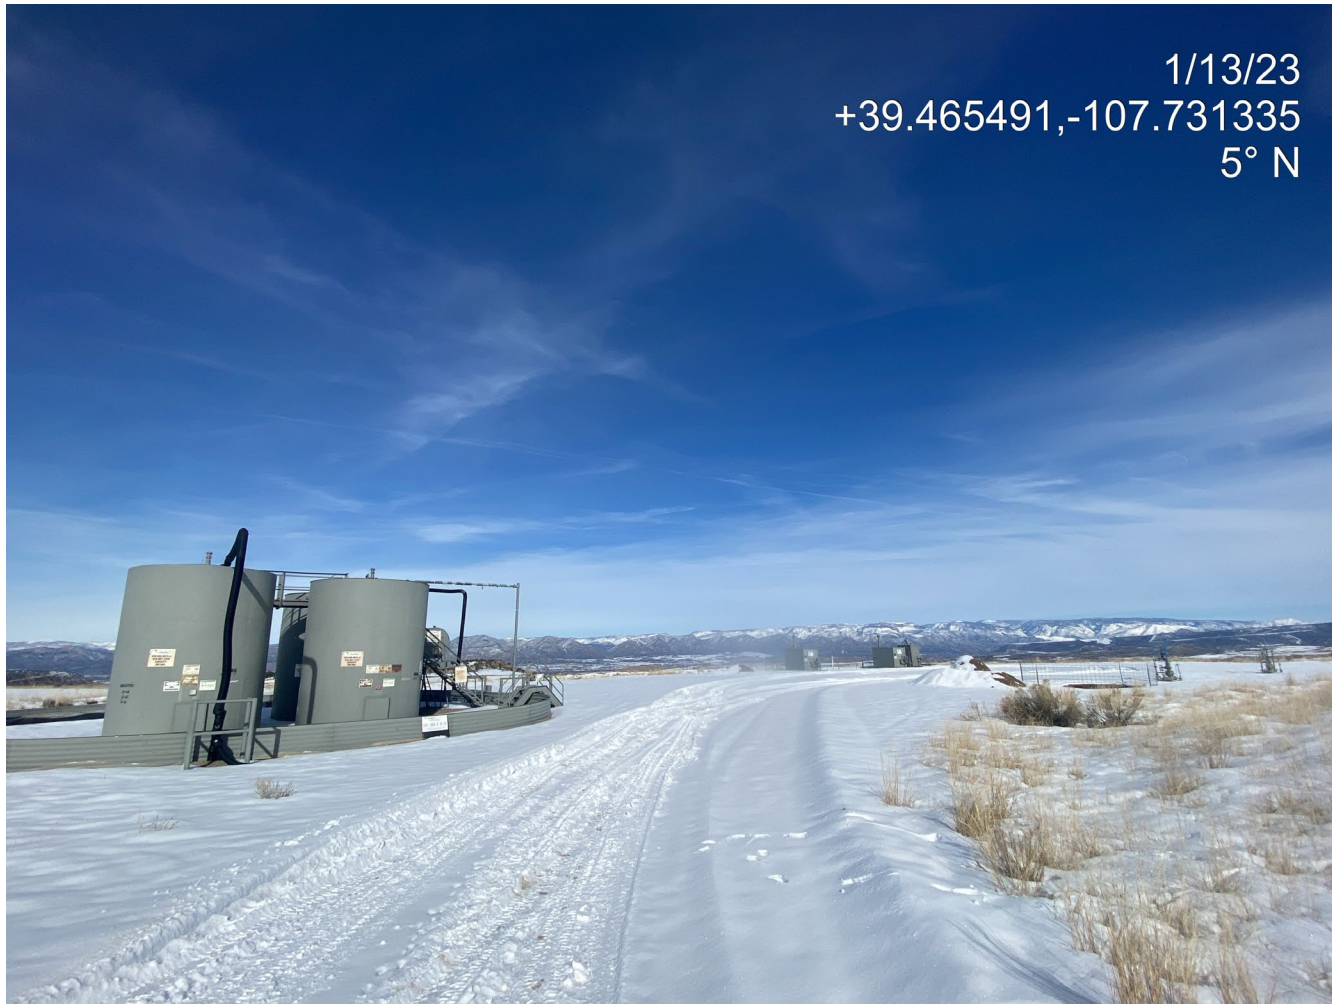
Photo 1. Photo taken from the south shows an overview of the location.

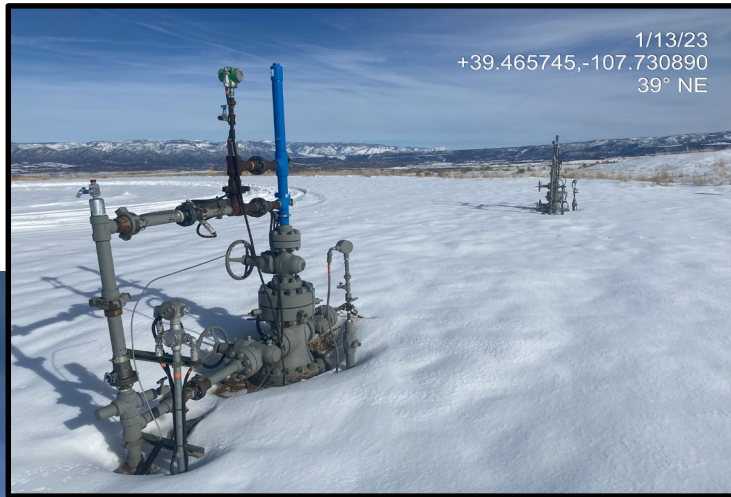
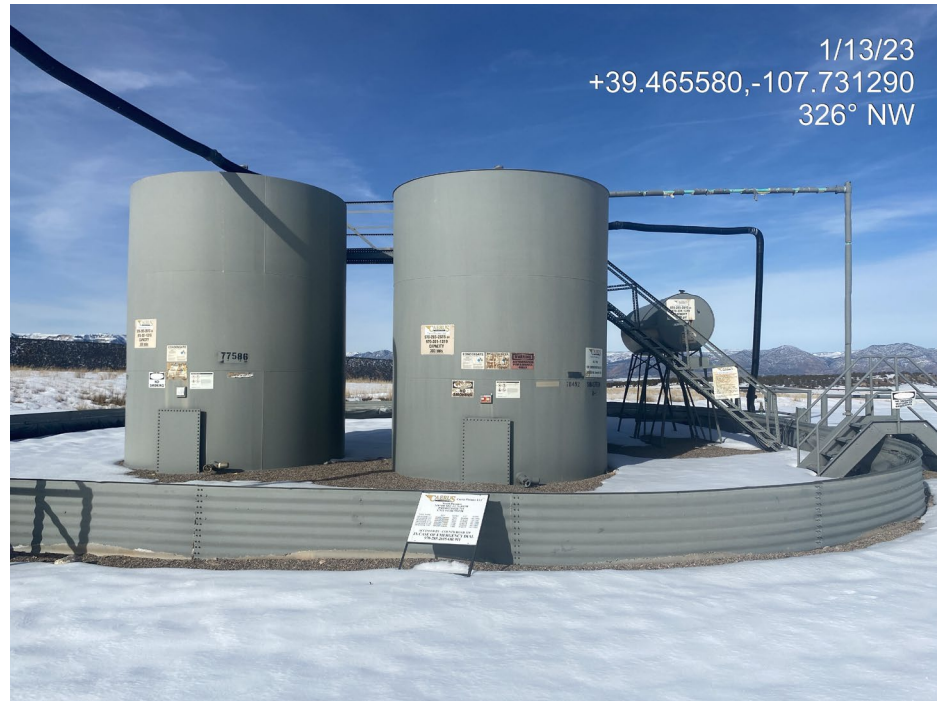
Photo 2. Photos show production areas.

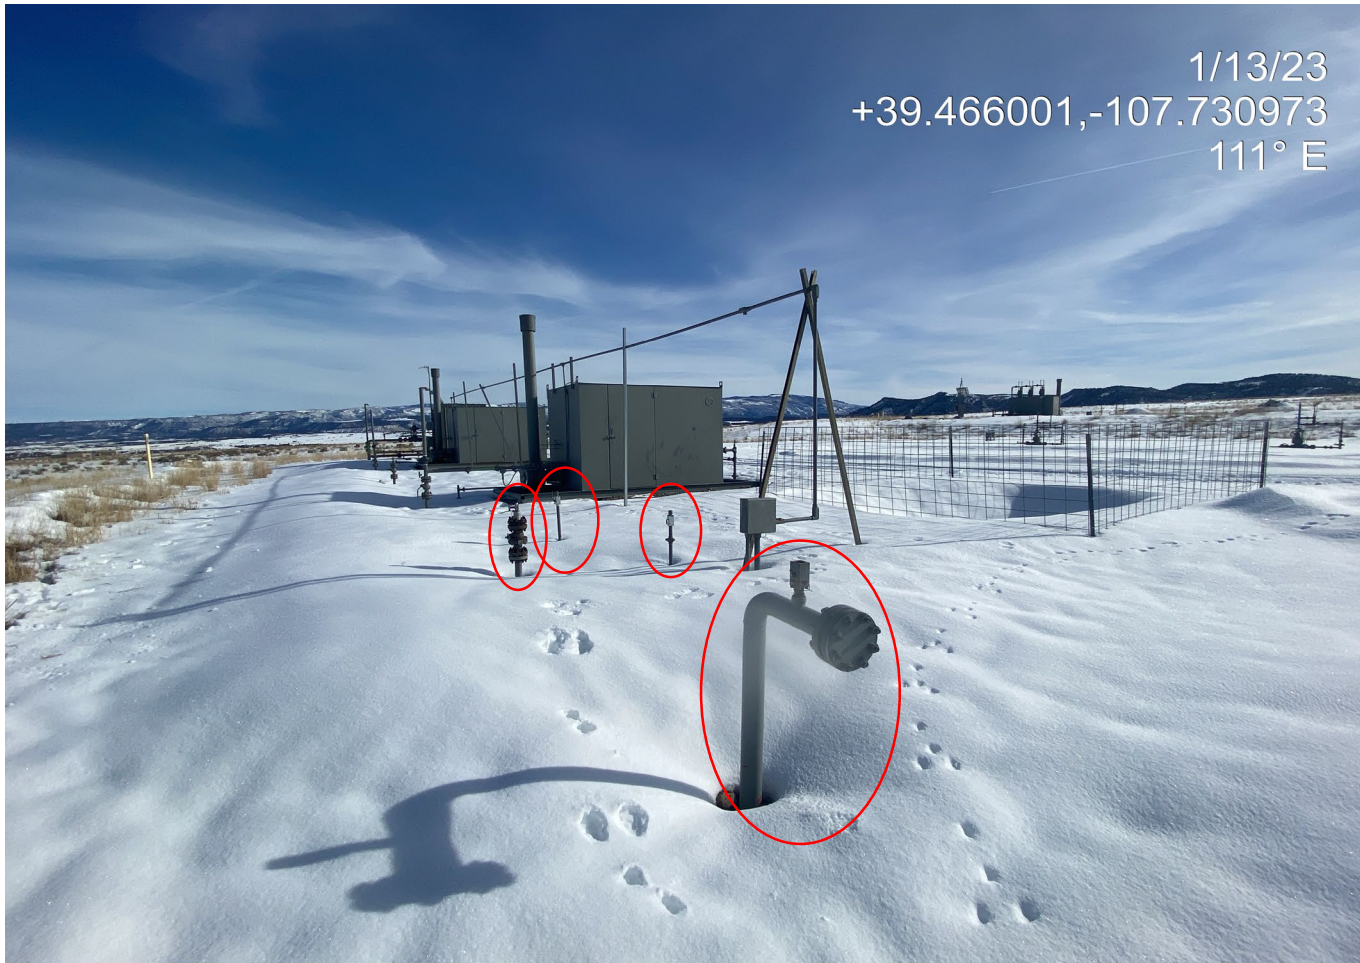
Photo 3. Photo shows four (4) risers which appear to be associated with plugged and abandoned well API #045-07504. Unused equipment must be removed.

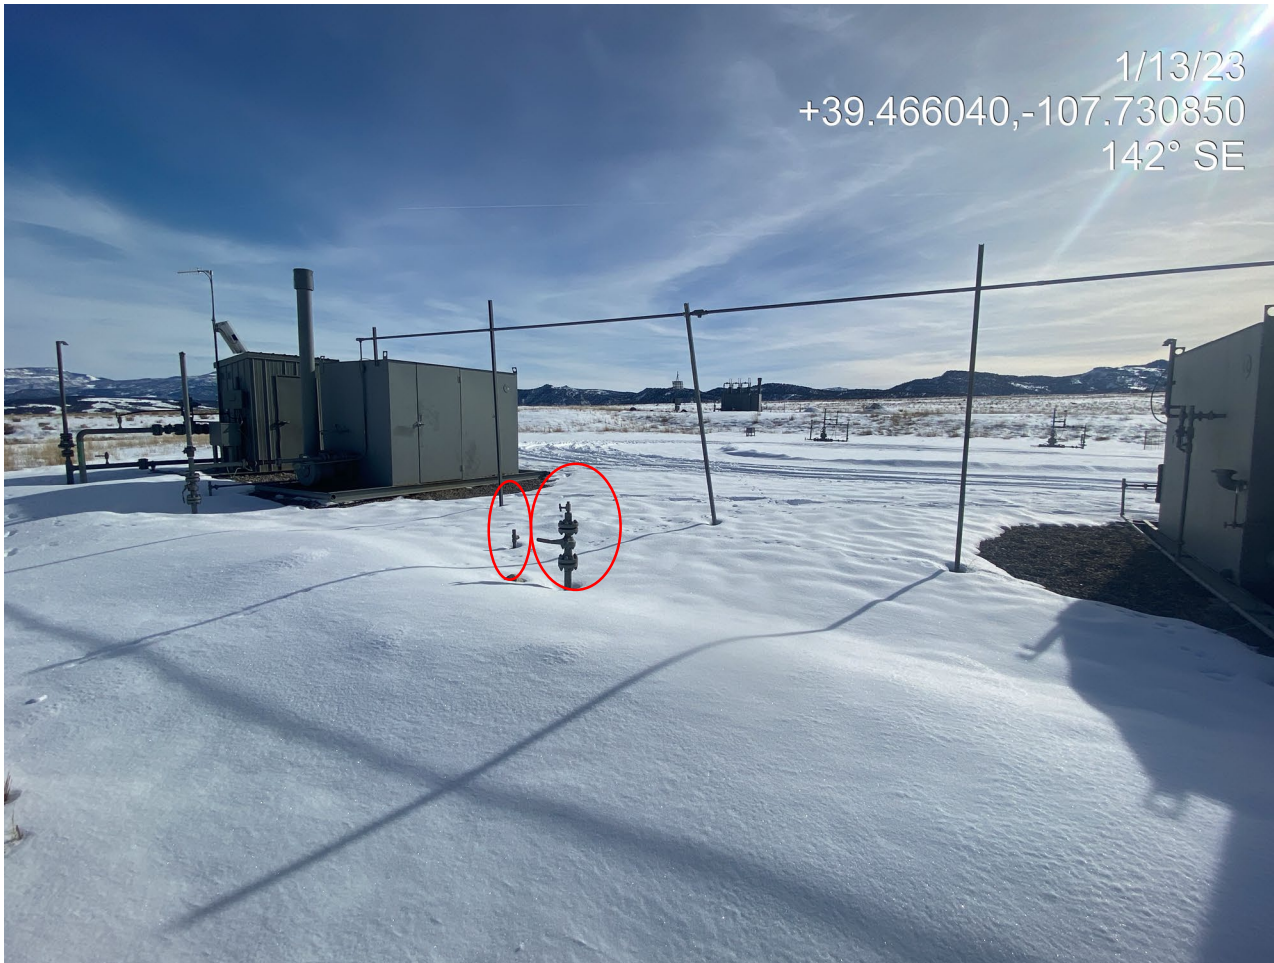
Photo 4. Photo shows two (2) risers which appear to be associated with plugged and abandoned well API #045-05064. Unused equipment must be removed.

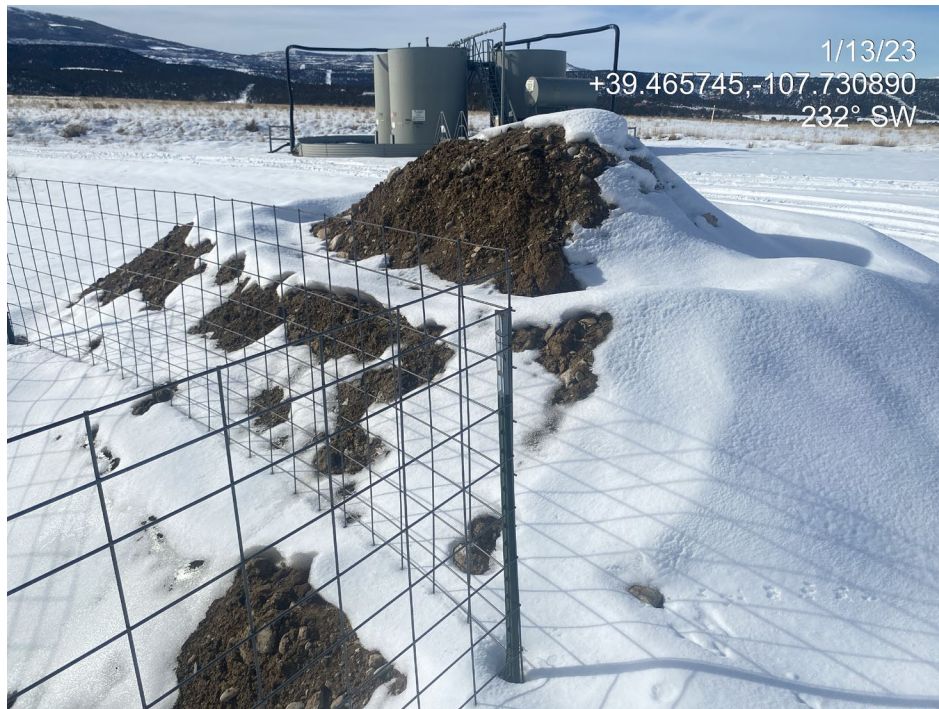
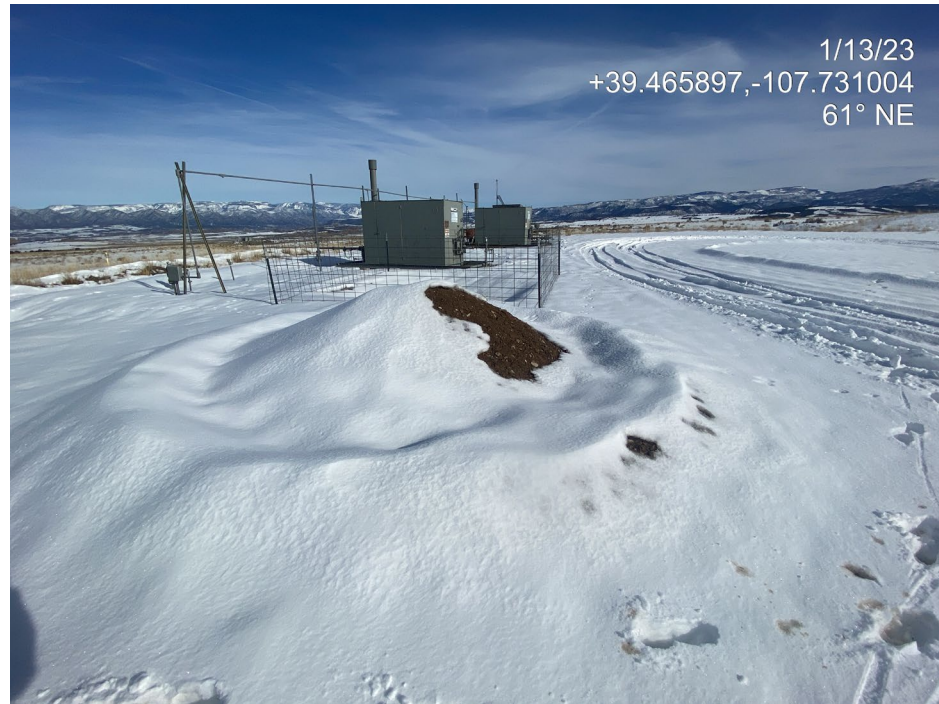
Photo 5. Photos show soil stockpiles from the plugged and abandoned well (left) and flowline (right) excavations. Excavated soil is surrounded by a berm of loose, unconsolidated soil.

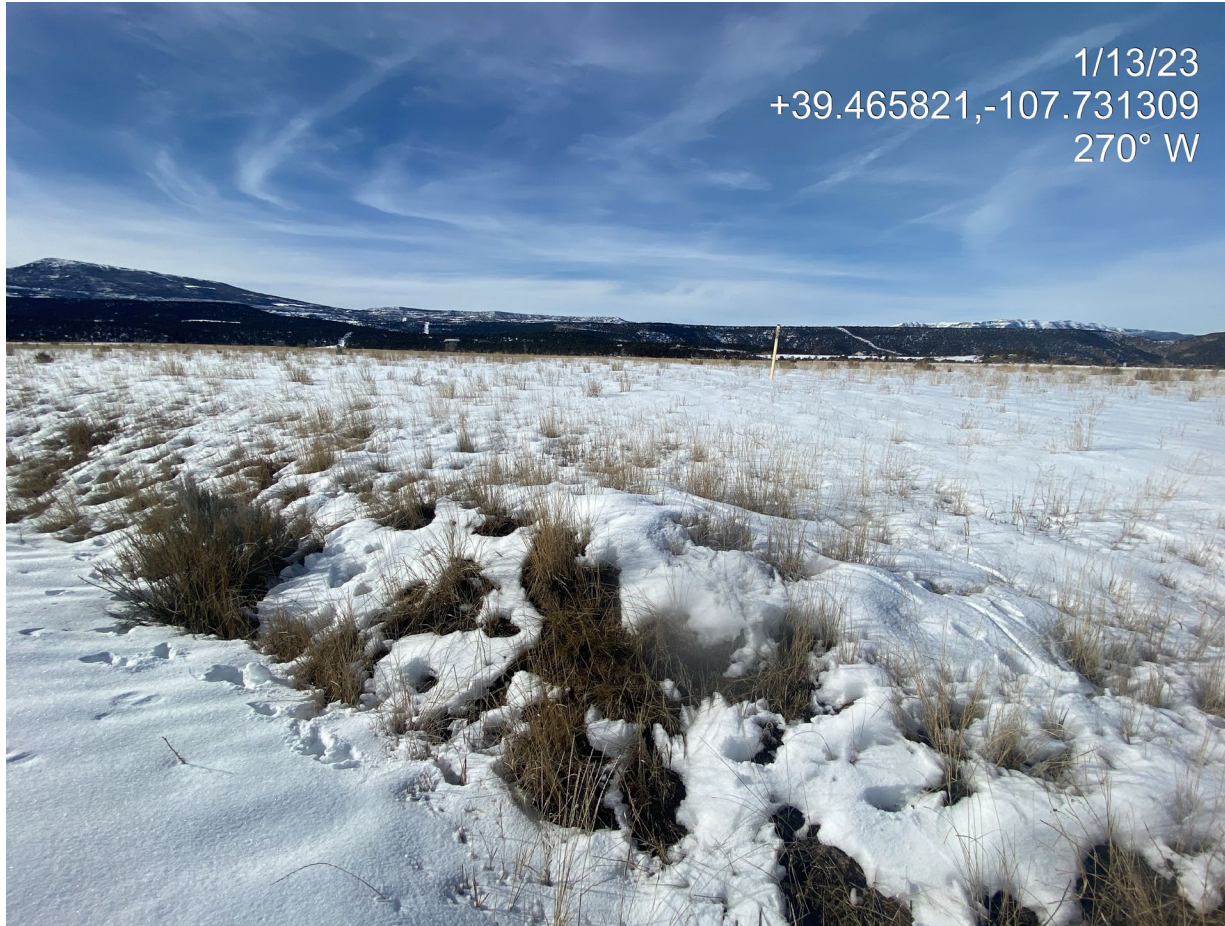
Photo 6. Photo shows an example of location interim areas. Introduced perennial grasses appear established.
