Inspection Photos

Operator: TEP ROCKY MOUNTAIN LLC - 96850

Location #334359

Garfield County, CO

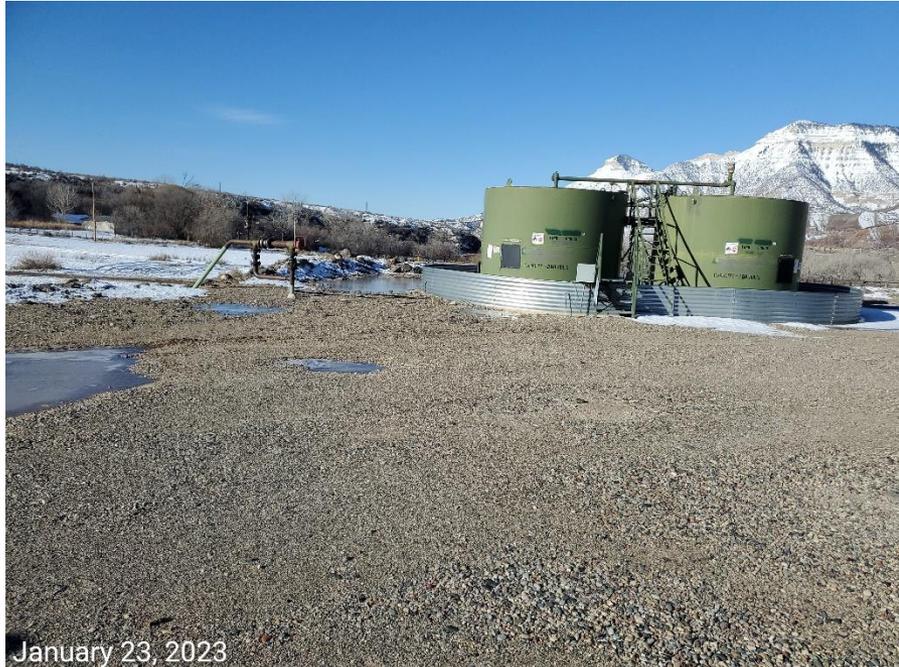
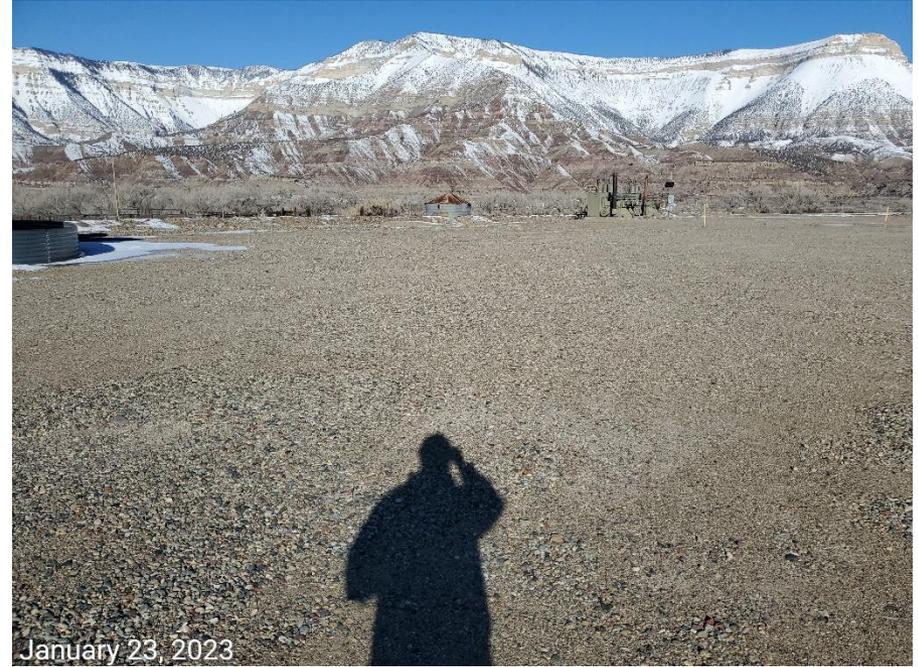
Photo 1: Photos 1-2 taken from the south end of the Location. Photos provide an overview of the location from west, northwest, northeast to east.

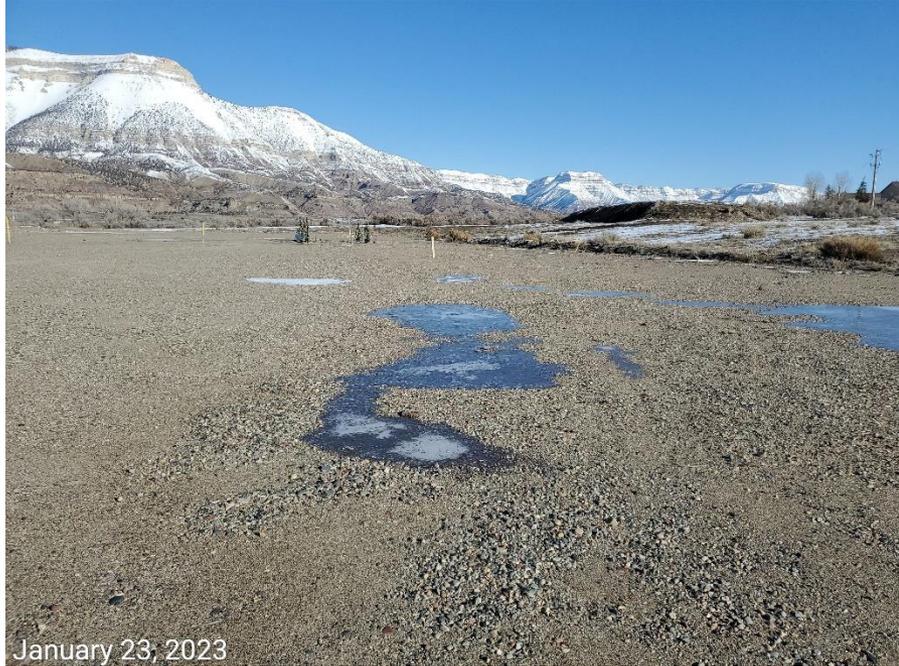
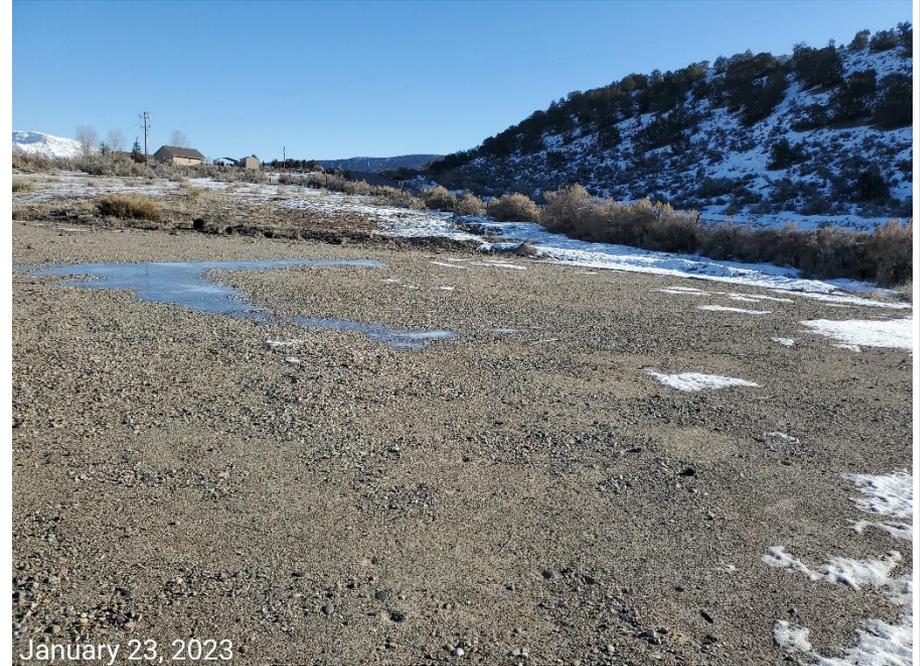
Photo 2: See comment under photo 1.

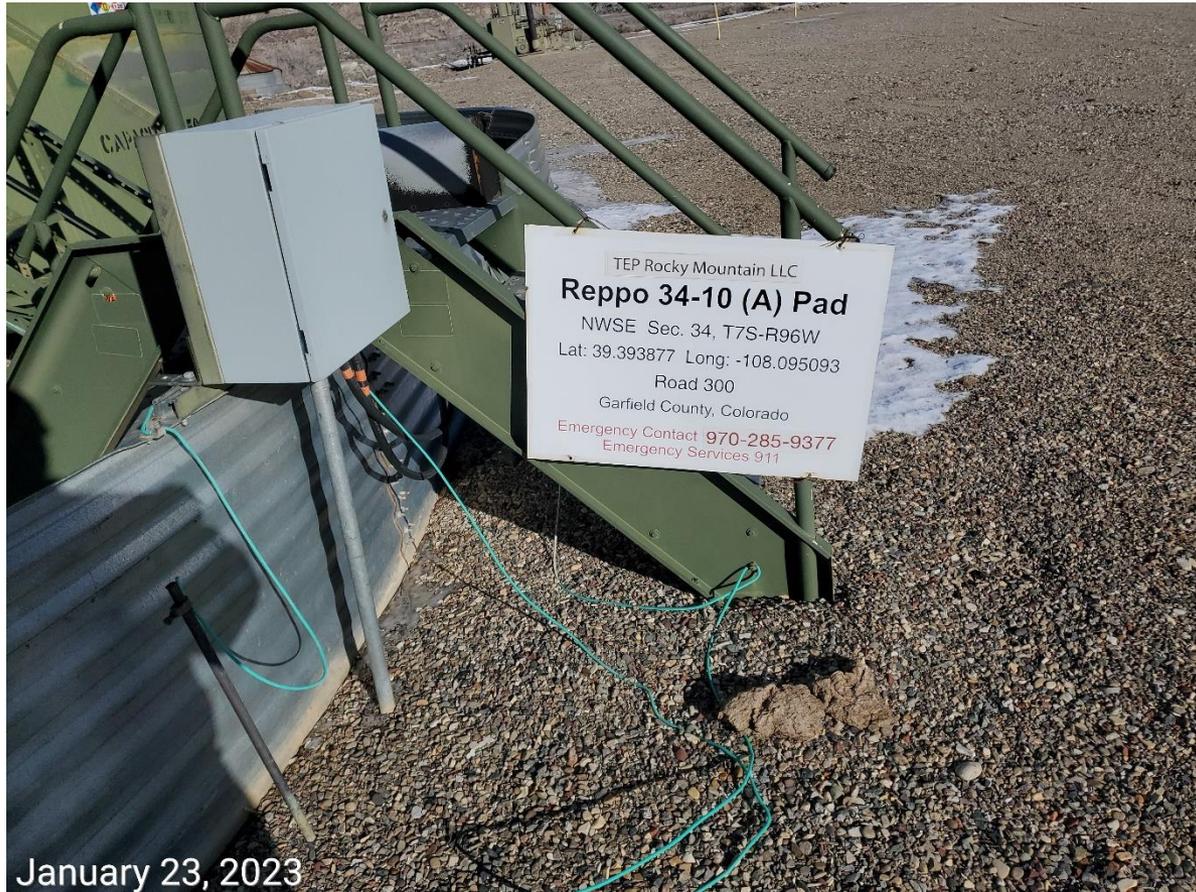
Photo 3: Photo shows signage and the tank battery. Signage missing required information such as Well name(s) and API number(s) associated with the Tank battery.

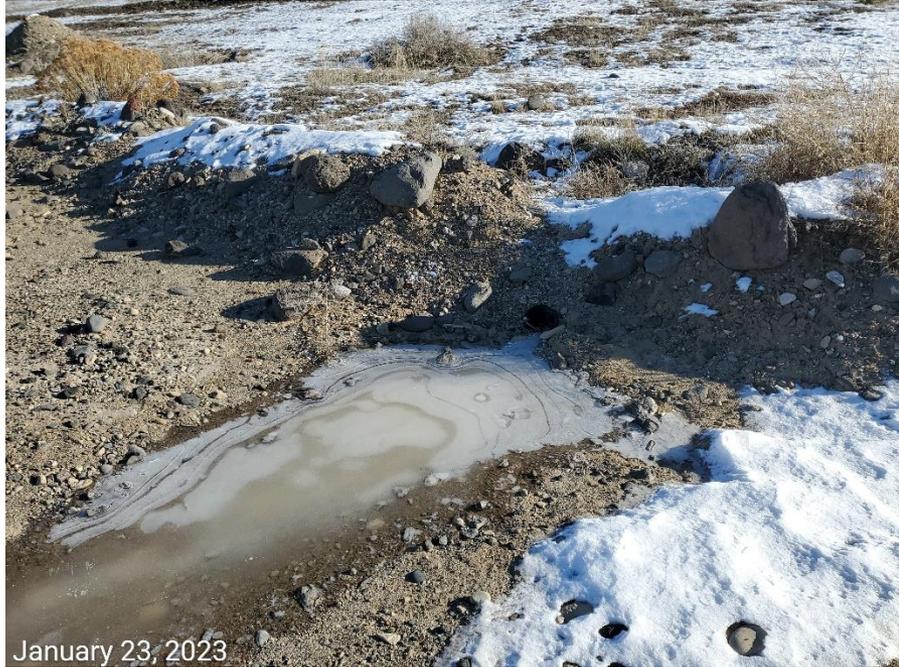
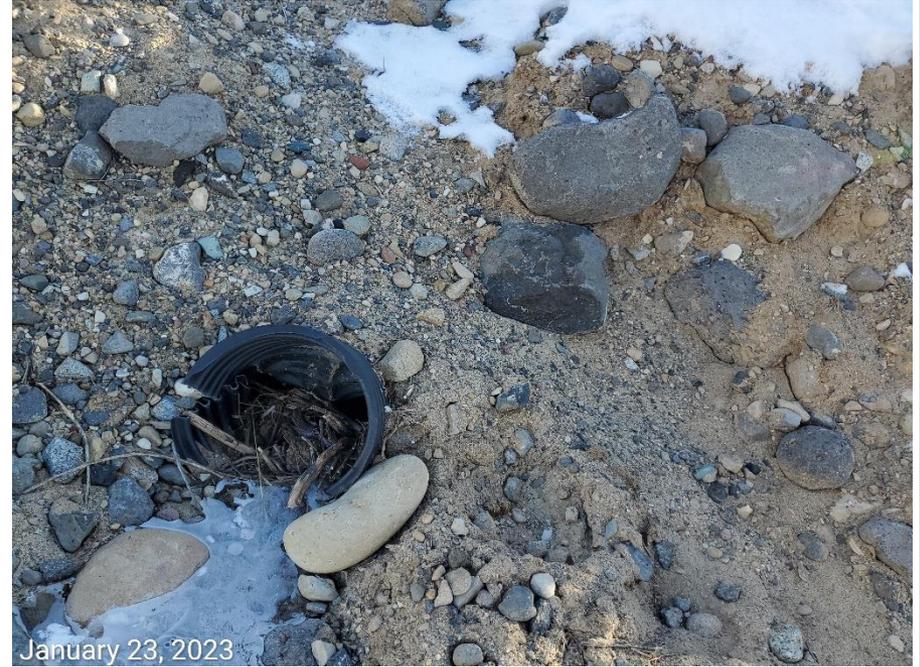
Photo 4: Photo taken from the stormwater outlet on the east end of the Location. Drain pipe appears to have been either crushed, filled with sediment/material, or both, and is no longer allowing for stormwater to discharge from the working pad, resulting in ponding.
