Inspection Photos

01/23/2023

Operator: TEP ROCKY MOUNTAIN LLC - 96850

Location #334393

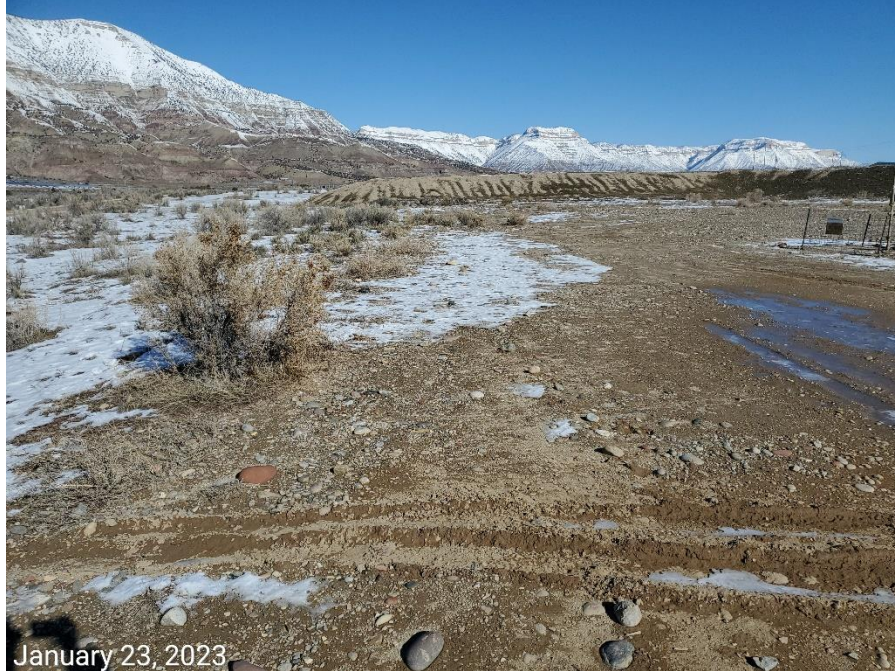
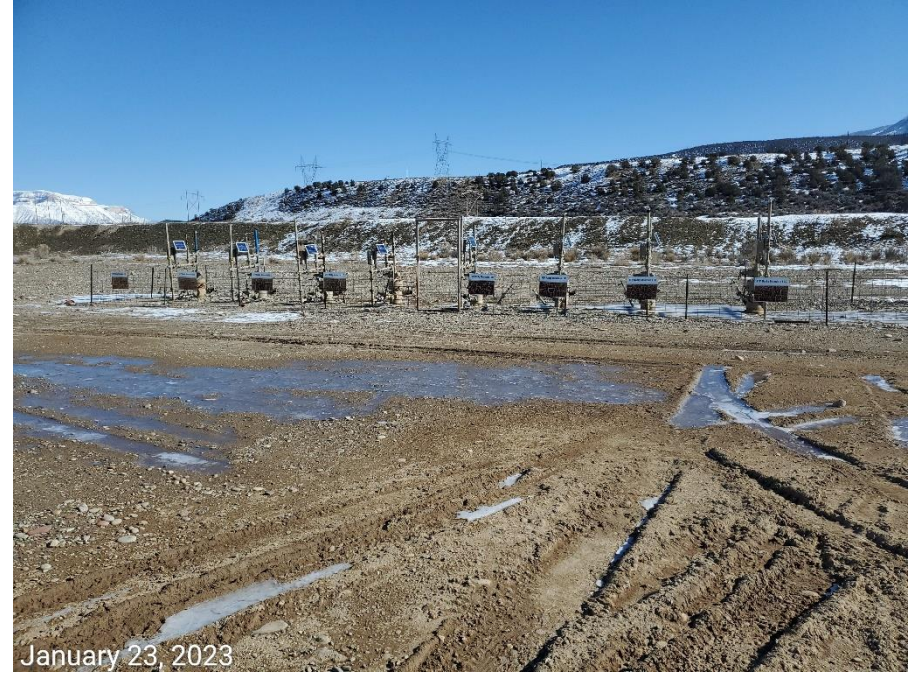
Photo 1: Photos taken from the west end of the Location, facing north. Photos 1-2 provide an overview of the Location from north, northeast, southeast to south. Photos 1-3 also show that BMPs to stabilize the Location, and to minimize degradation, tracking and sediment transport from the working pad areas are missing or insufficient.

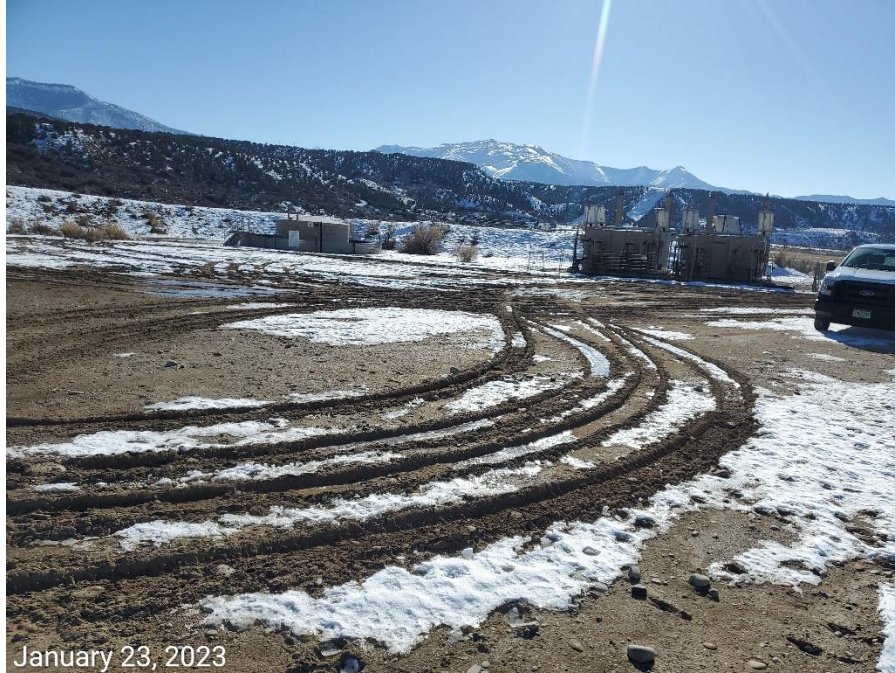
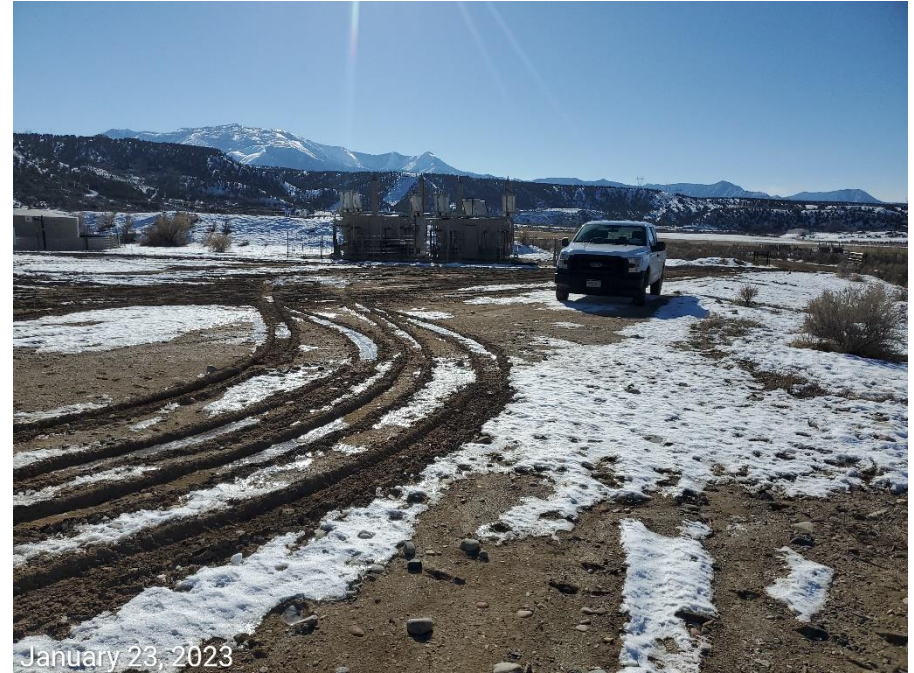
Photo 2: See comment under photo 1.

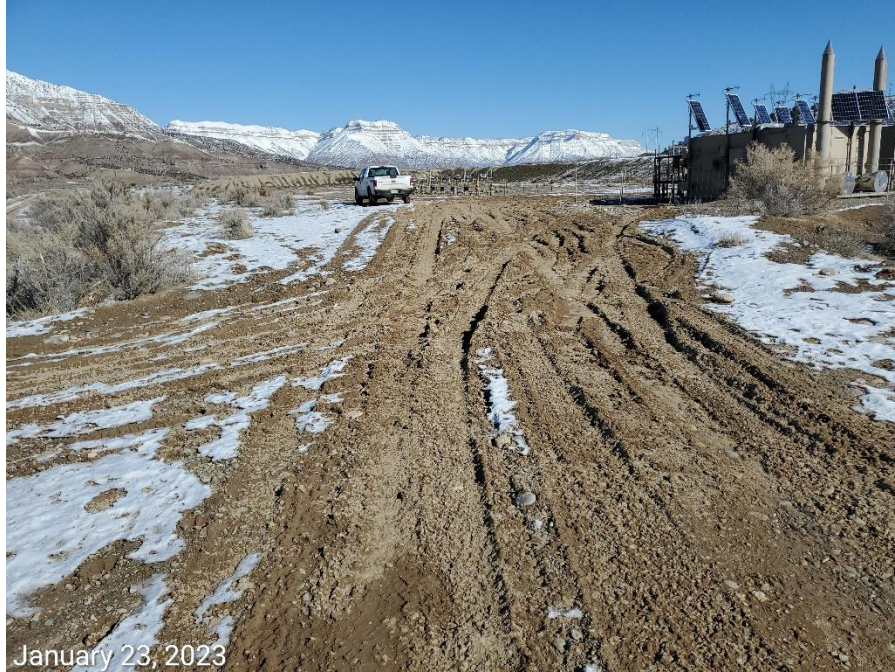
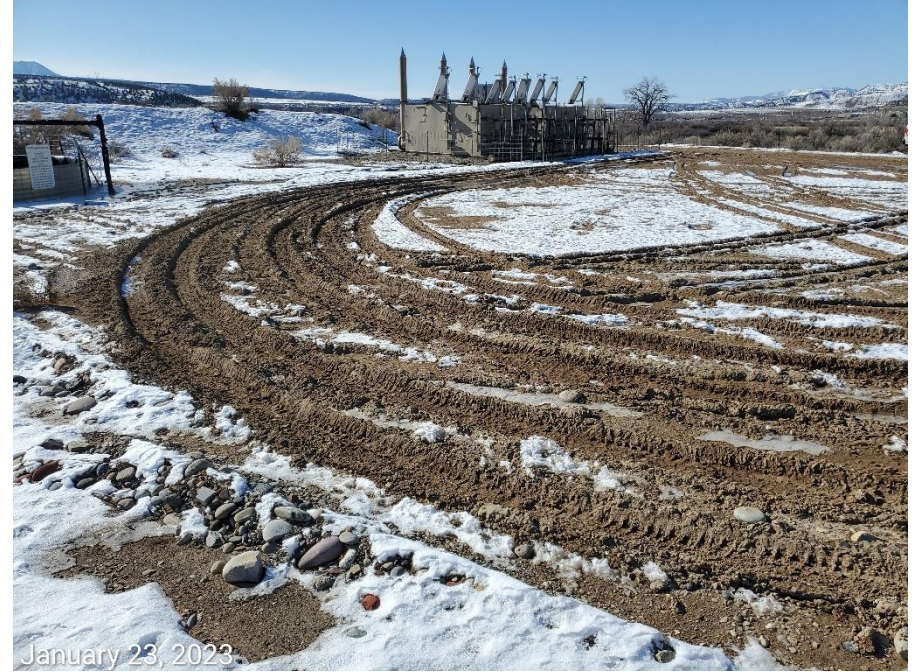
Photo 3: See comments under photo 1.

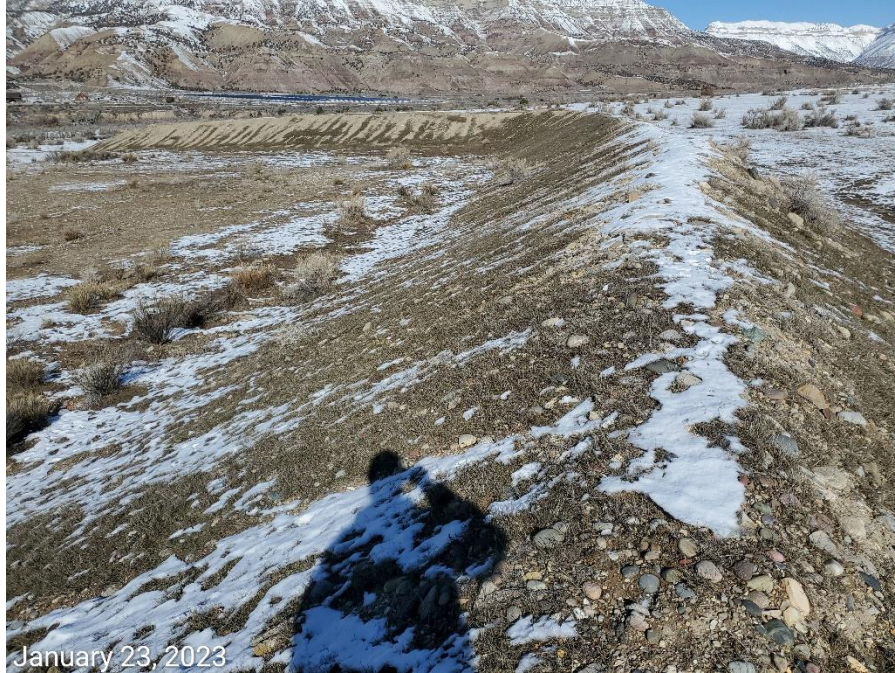
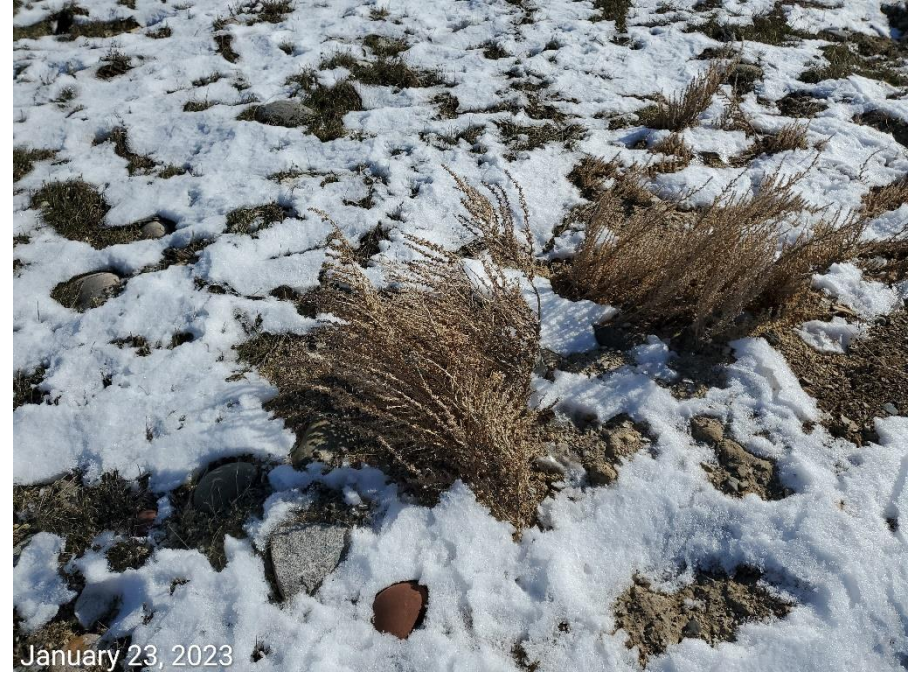
Photo 4: Photos taken from the soil stockpiles along the perimeter of the Location. Vegetation observed on the stockpiles predominantly Undesirable Plant Species such as Annual Wheatgrass, Cheatgrass. Other Undesirable Plant species observed included Halogeton (photo right). Photo left also shows areas on the north end of the Location that are not reasonably needed for production, requiring interim reclamation.

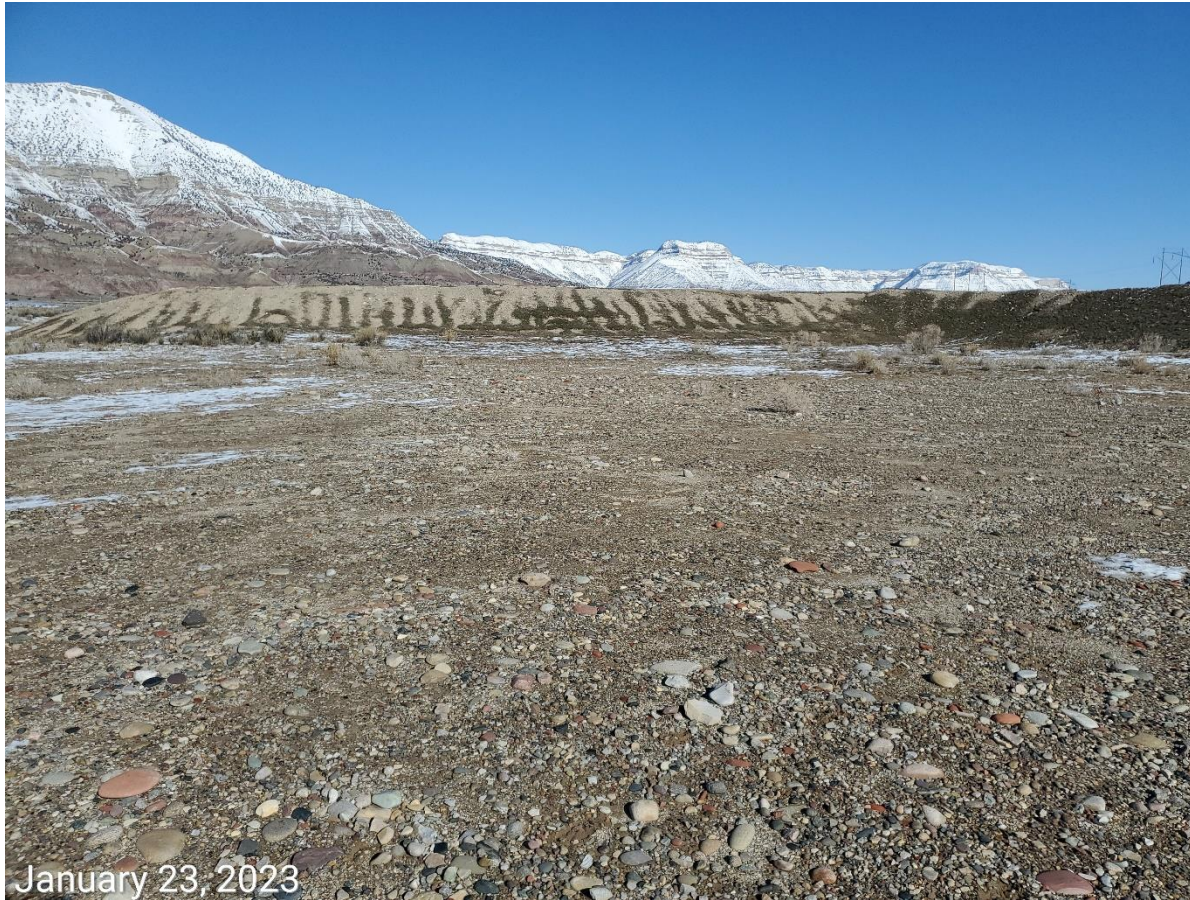
Photo 5: Photo taken from the north end of the Location, facing north. Photo example shows areas on the north end of the Location that are not reasonably needed for production. Interim reclamation including, but not limited to, removal of gravel/road base, compaction alleviation, replacement of soils and revegetation required.

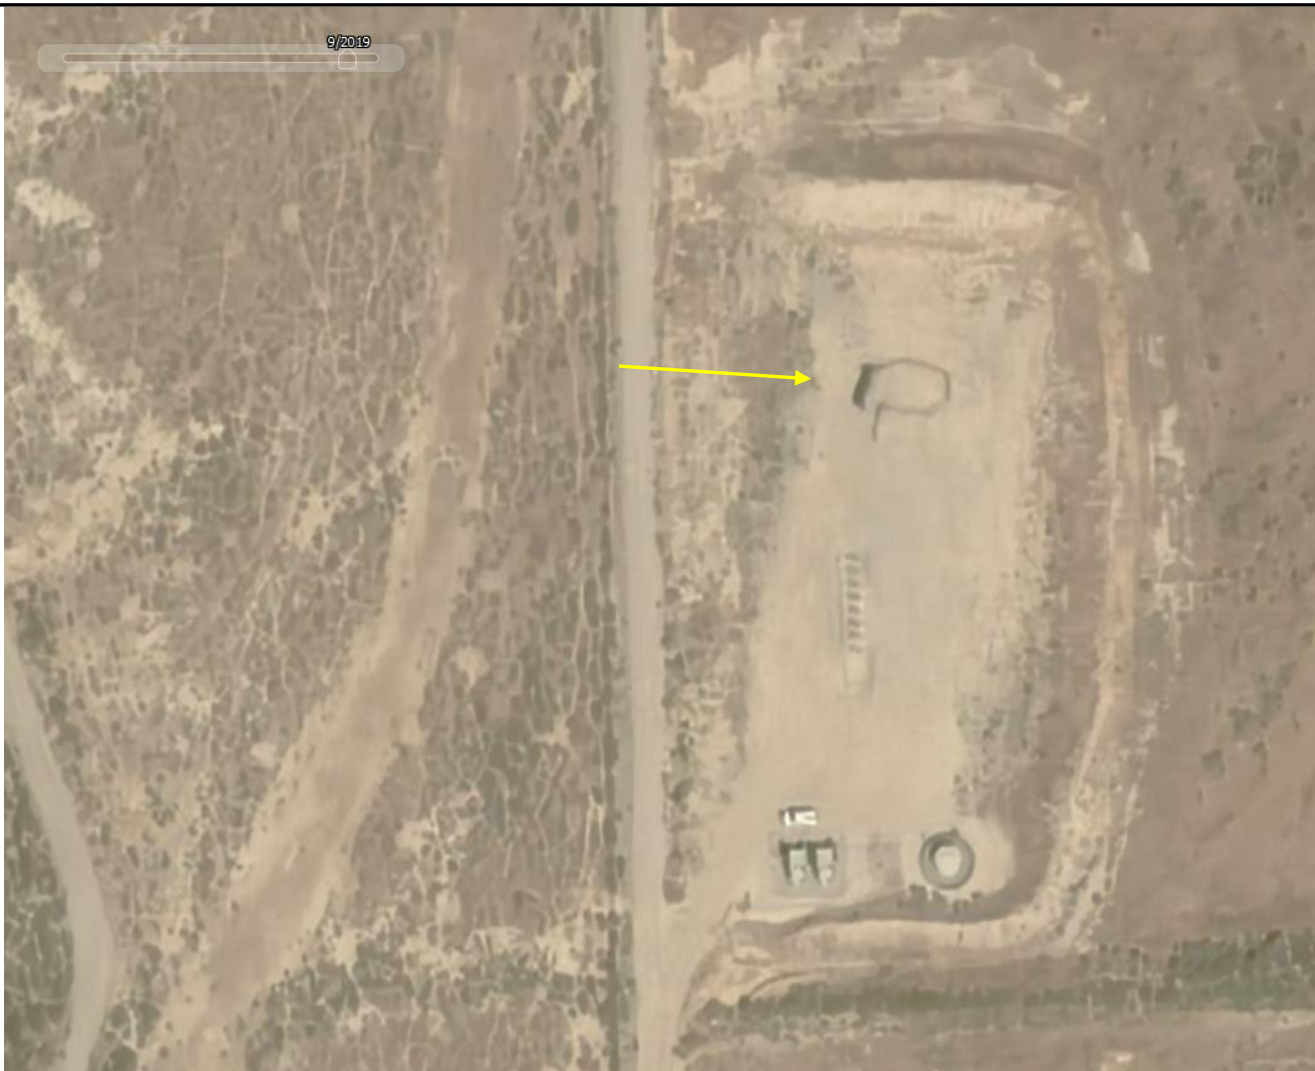
Photo 6: 2009 Google Earth aerial imagery of the Location. Arrow shows unknown equipment existing on the north end of the Location.

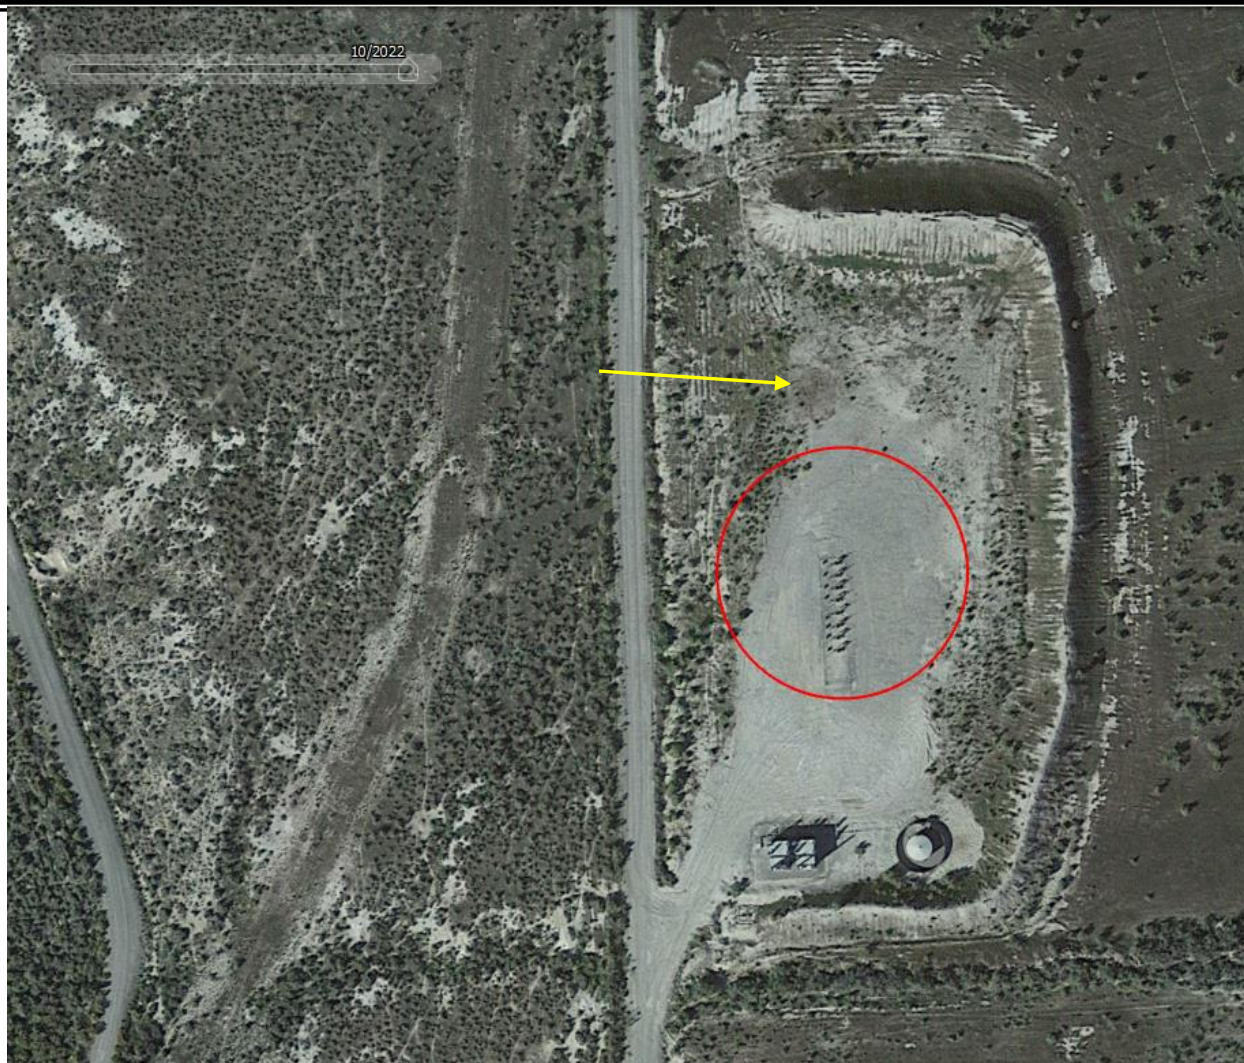
Photo 7: 2022 Google Earth Aerial imagery. Unknown equipment identified in Photo 6 has been removed. Red Polygon represents a 75' buffer around the northern-most well(s). Northern areas no longer necessary for production.
