Inspection Photos

01/23/2023

Operator: TEP ROCKY MOUNTAIN LLC - 96850

Location #334702

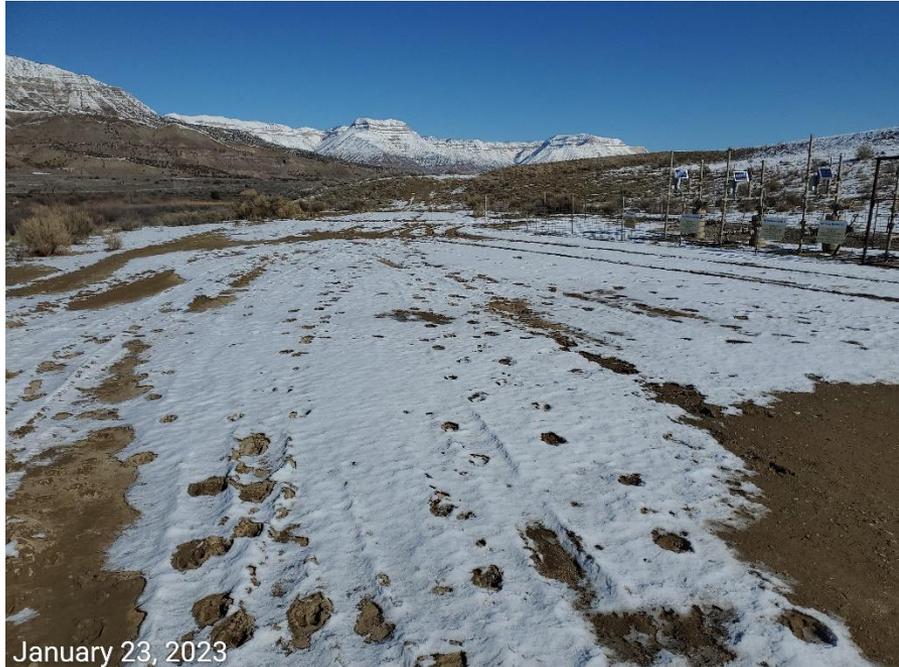
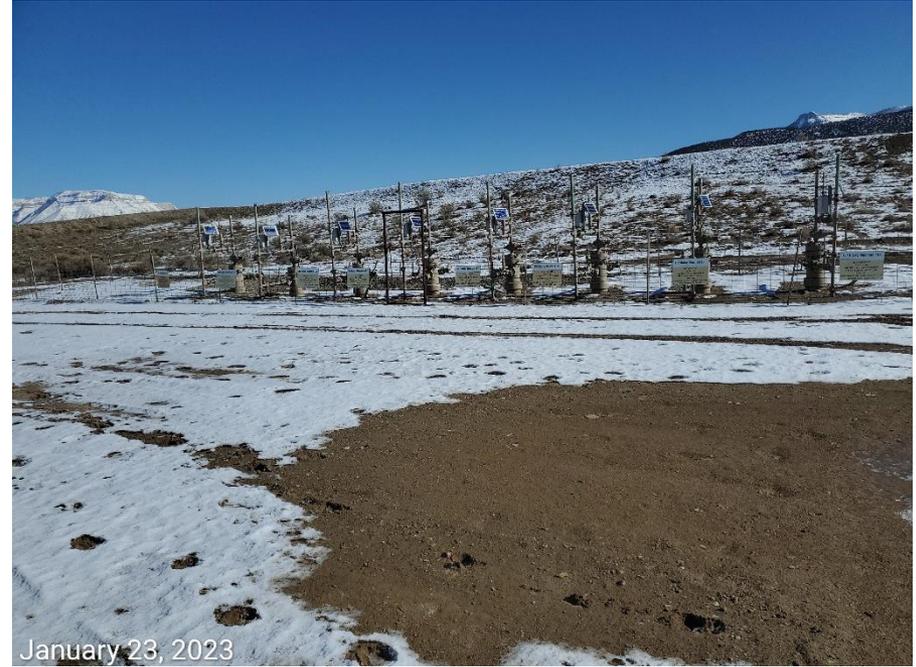
Photo 1: Photos taken from the west end of the Location, facing north. Photos 1-4 provide an overview of the Location from north, northeast, southeast to south. Photos 1-3 also show that BMPs to stabilize the Location, and to minimize degradation, tracking and sediment transport from the working pad areas are missing or insufficient.

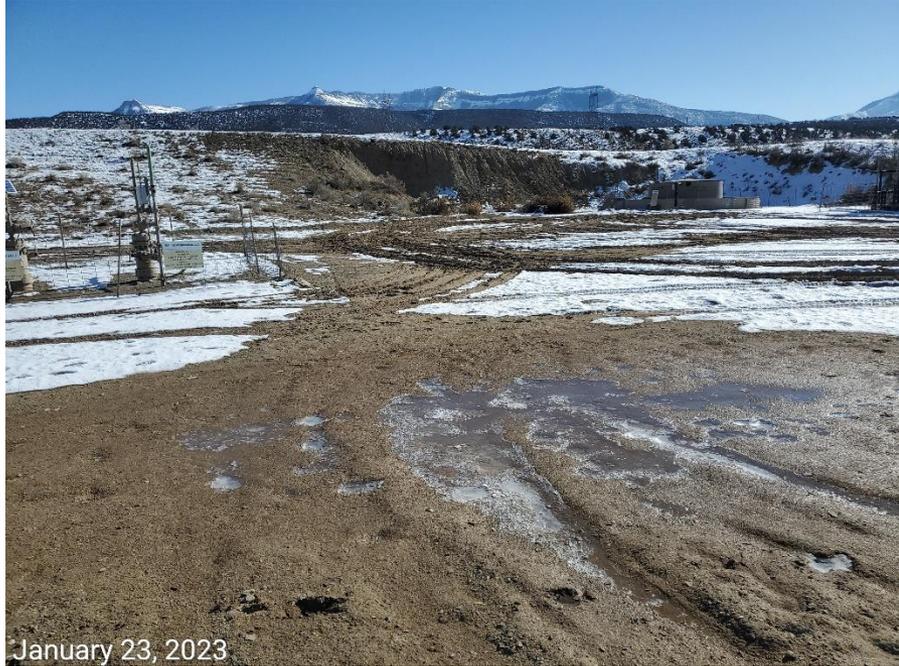
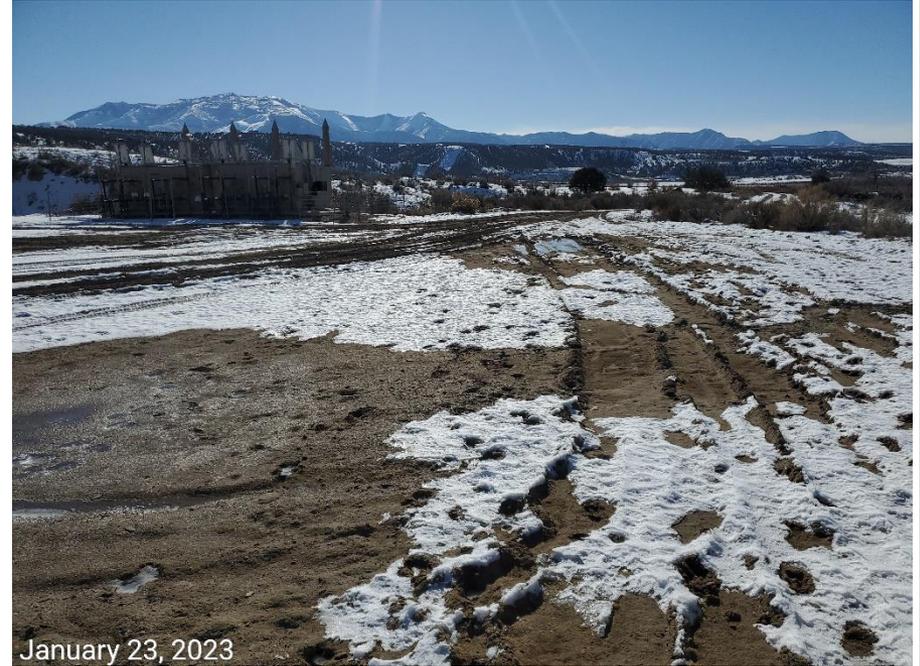
Photo 2: See comment under photo 1.

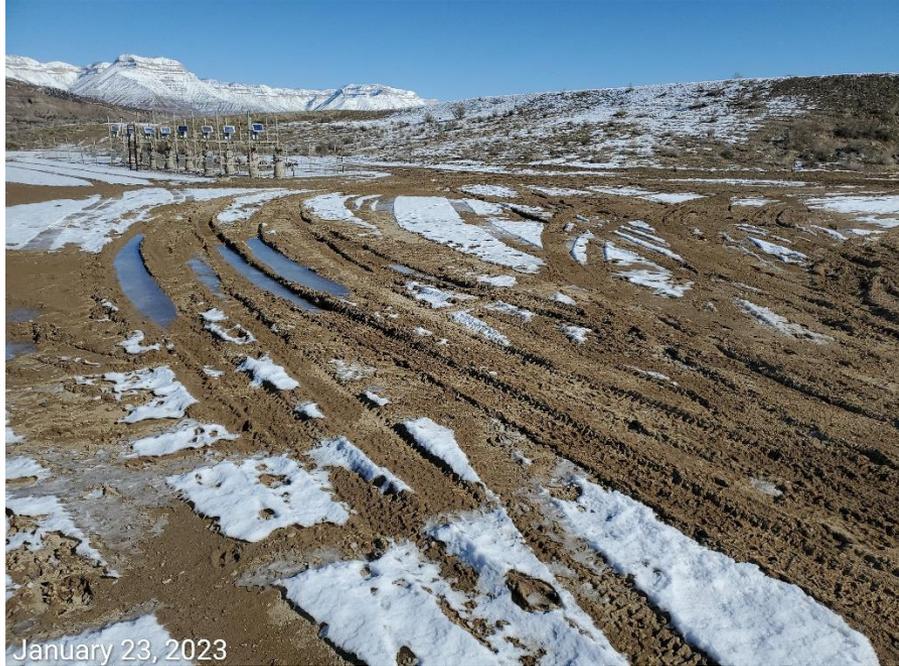
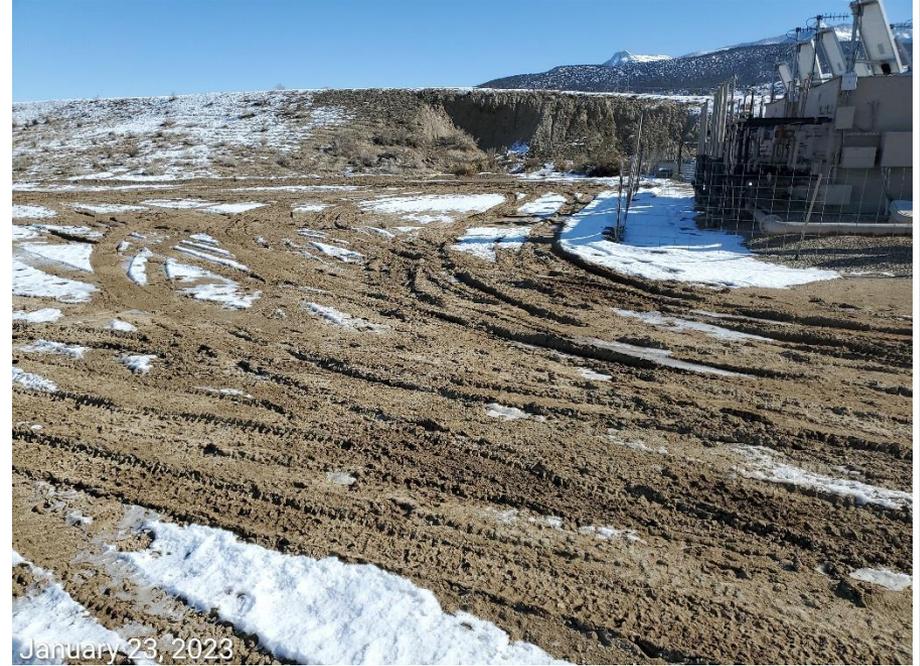
Photo 3: See comments under photo 1.

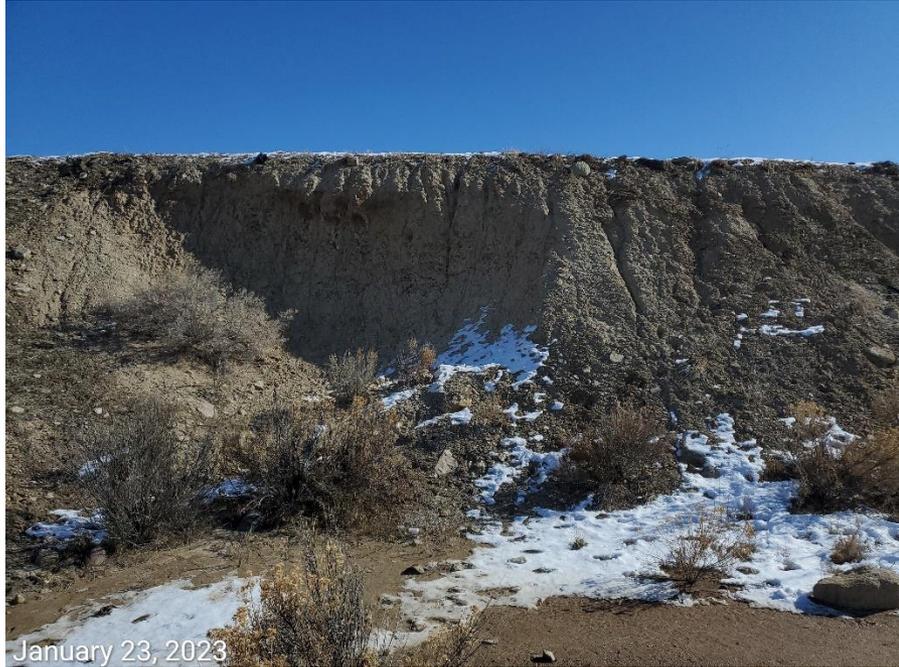
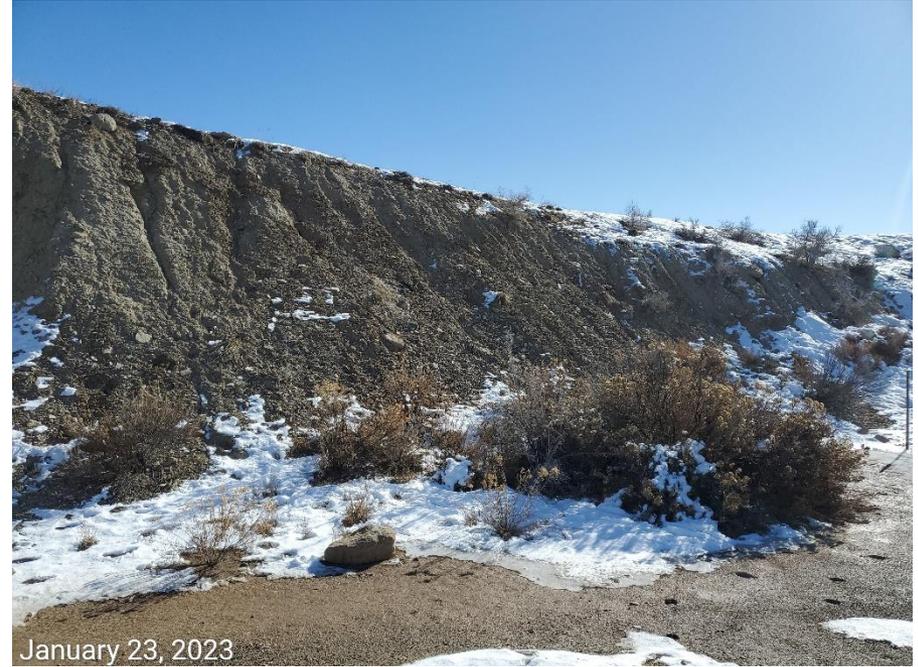
Photo 4: Photos taken southwest end of the Location. Photos show BMPs to minimize erosion and degradation are missing or insufficient at the slopes; there are areas of the slopes that appear to have sloughed off; erosion degradation evident.
