Inspection Photos

Operator: TEP ROCKY MOUNTAIN LLC - 96850

Location #334114

Garfield County, CO

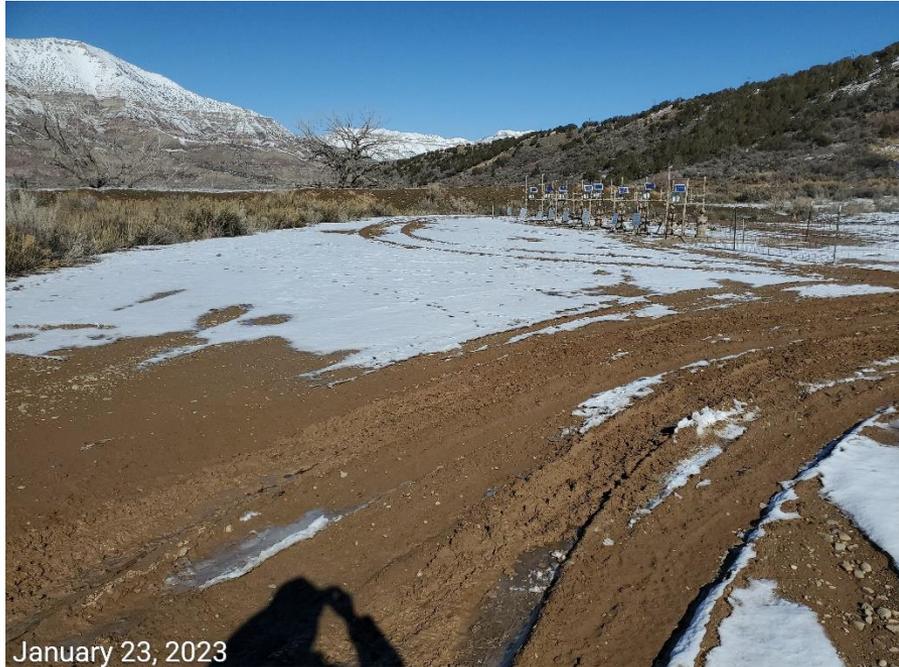
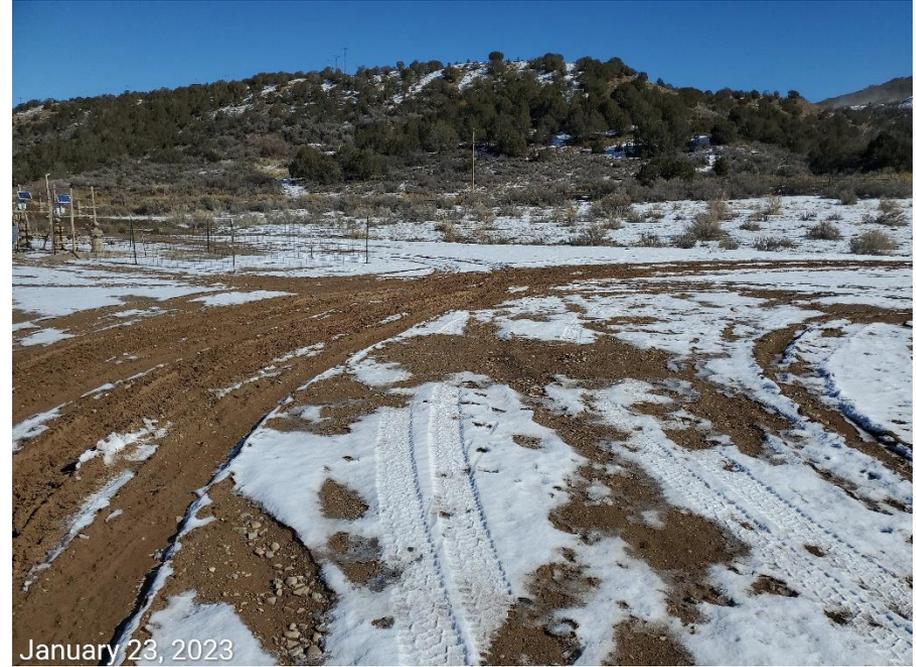
Photo 1: Photos taken from the west end of the Location, facing north. Photos 1-4 provide an overview of the Location from north, northeast, southeast to south. Photos 1-3 also show that BMPs to stabilize the Location, and to minimize degradation, tracking and sediment transport from the working pad areas are missing or insufficient.

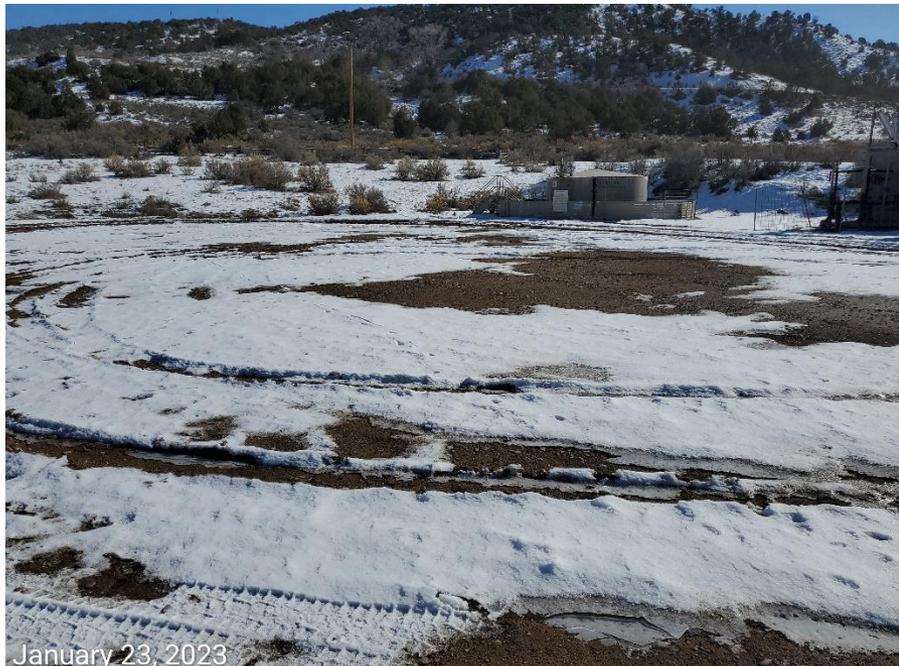
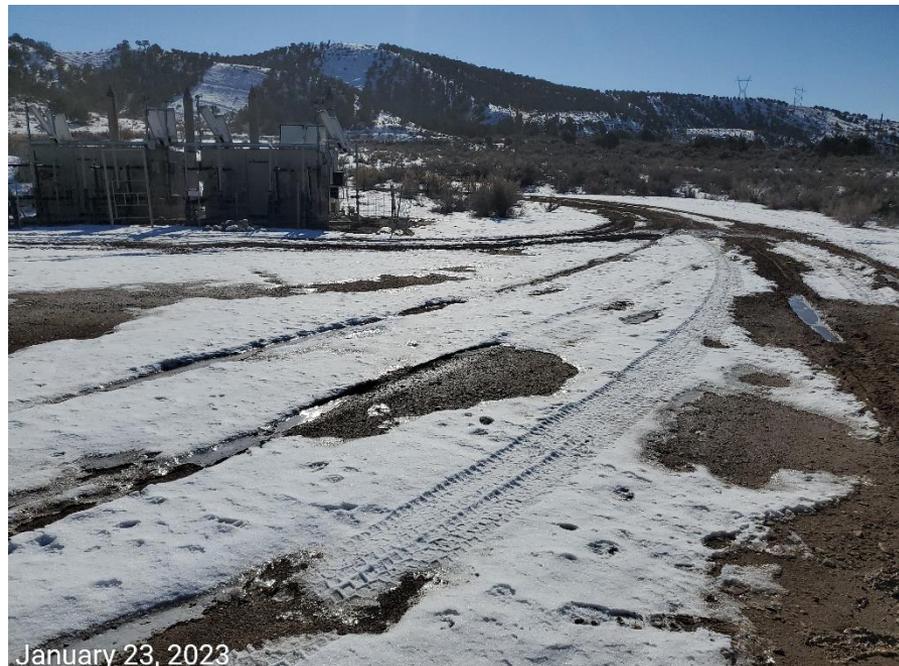
Photo 2: See comment under photo 1.

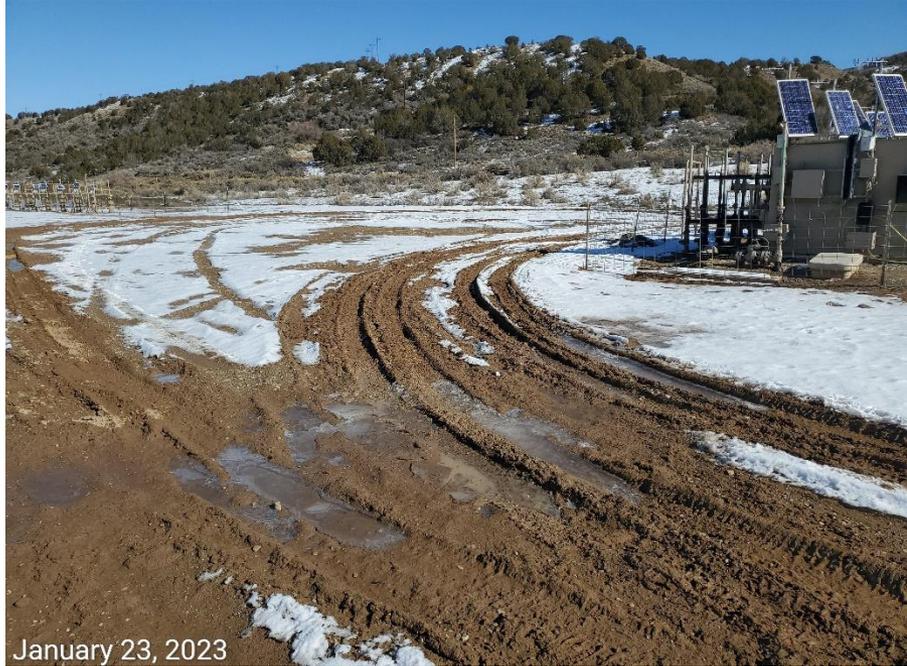
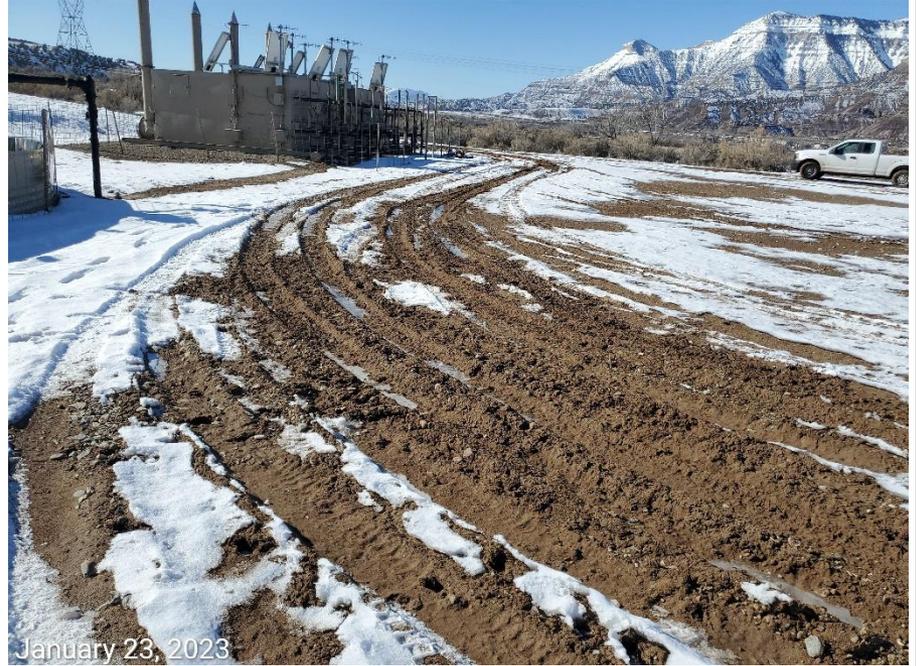
Photo 3: See comments under photo 1.

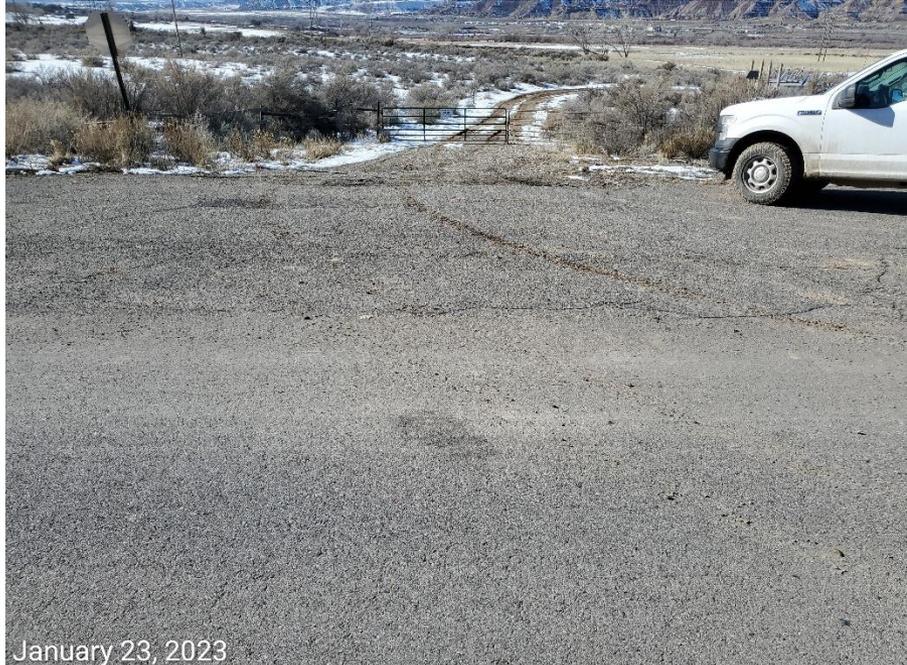
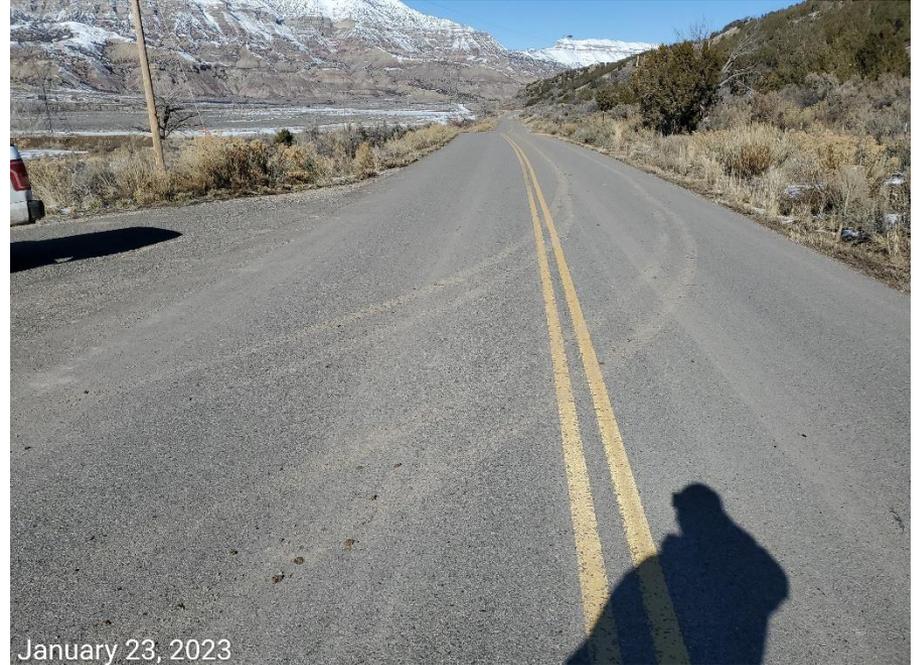
Photo 4: Photos taken from the access road entrance point from Stone Quarry Road. Photo shows sediment transport via vehicle tracking from the Location onto the county road.
