Interim Reclamation and Stormwater Inspection

Date: 01/24/2023

Operator: VERDAD RESOURCES LLC - 10651

Location ID: 432694

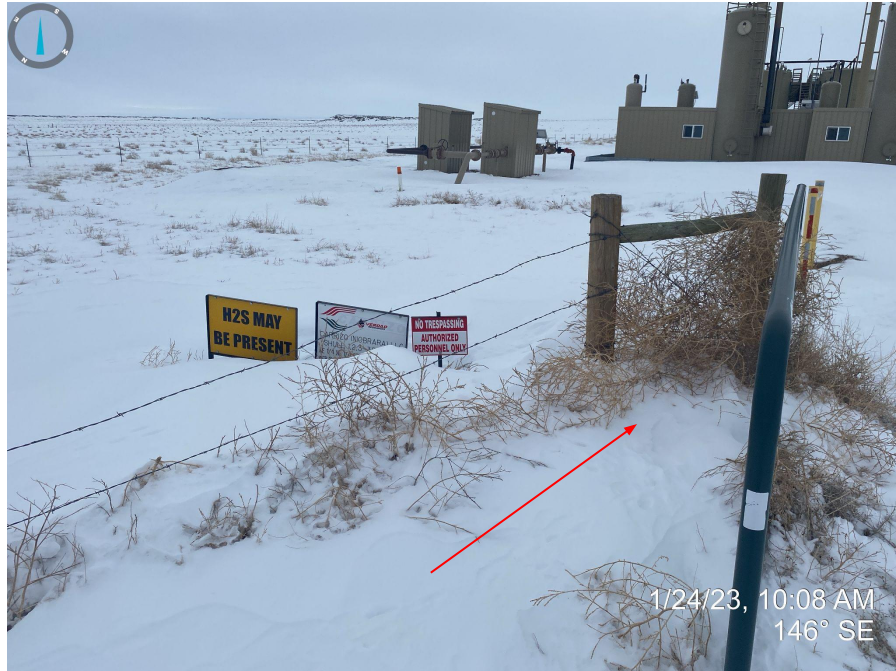
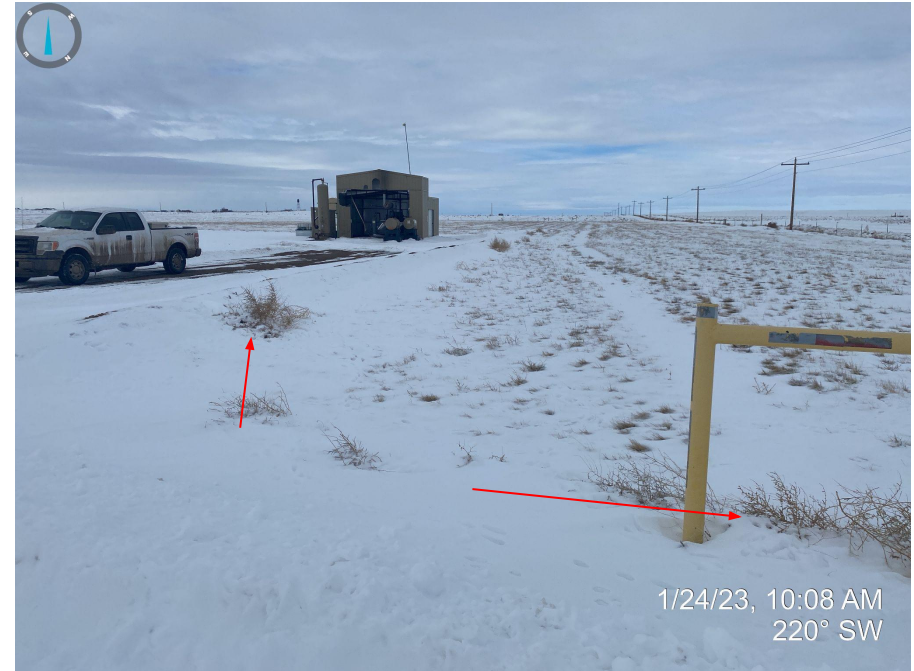
Photos 1 & 2. Facing southeast (photo 1) and southwest (photo 2) near the location entrance. Undesirable vegetation (e.g. russian thistle and kochia) was observed throughout the location. This is now considered debris and needs to be disposed of. Operator should inspect entire location for debris, not just examples in the above photos.

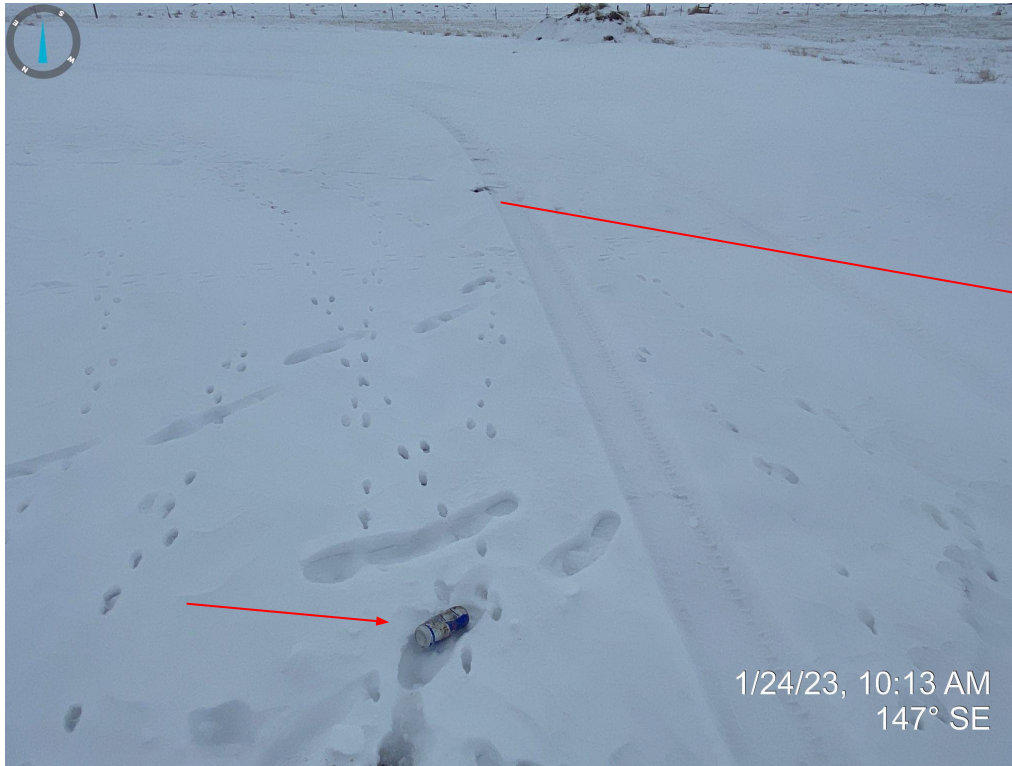
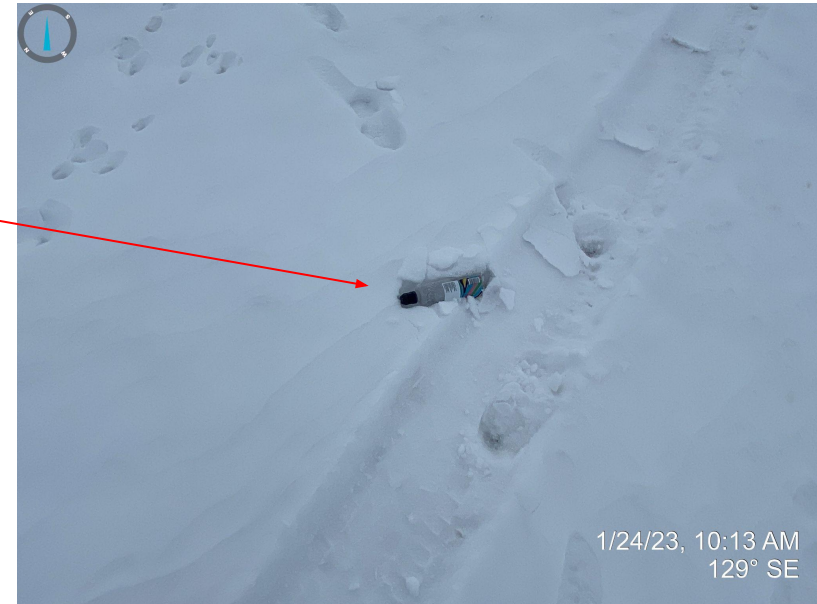
Photos 3 & 4. Debris was observed throughout the location, above examples were observed on the center/western portion of the location near the wellheads.

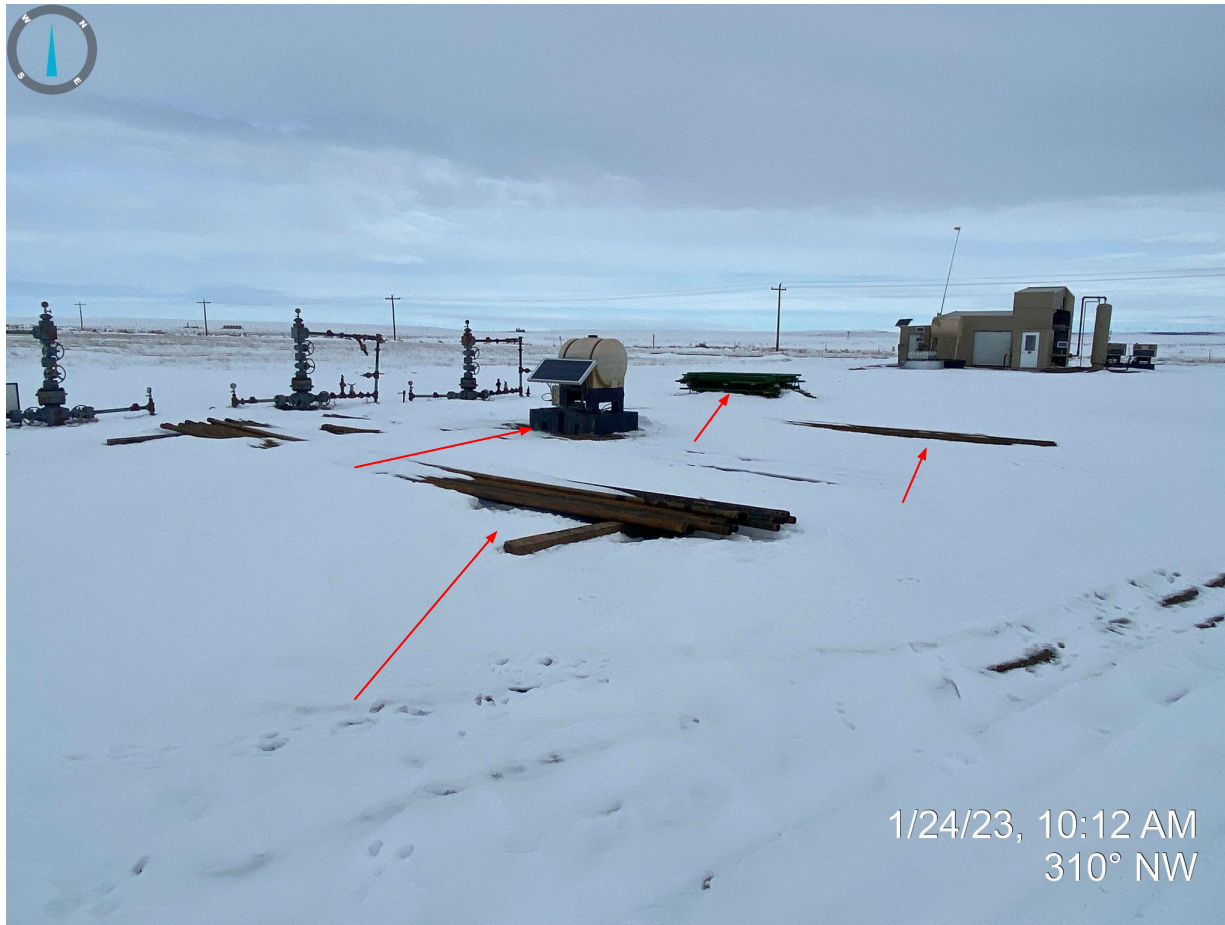
Photo 5. Facing northwest from the center portion of the location. Photo illustrates unused equipment being stored on location.

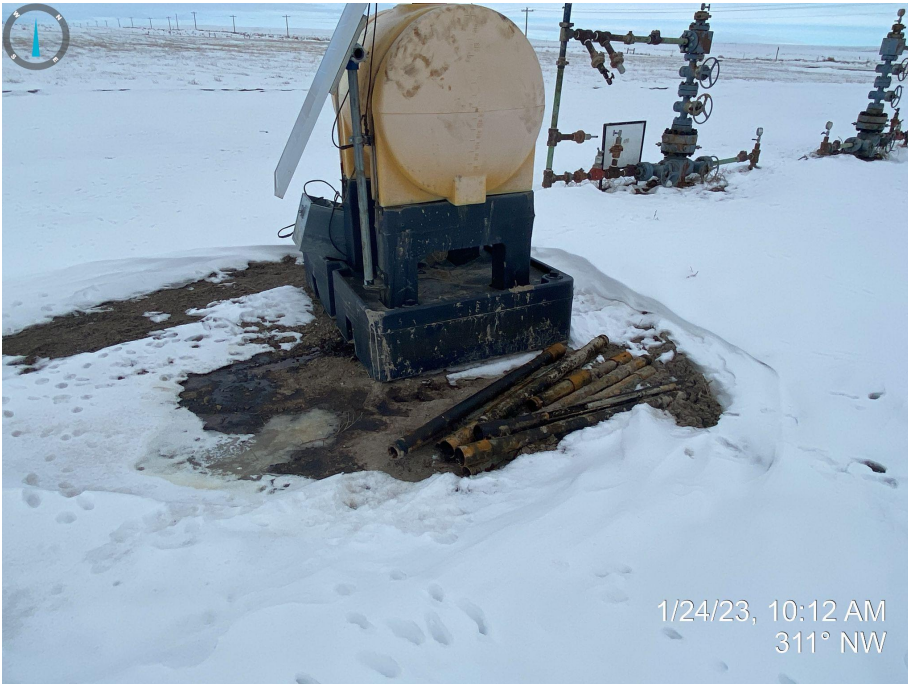
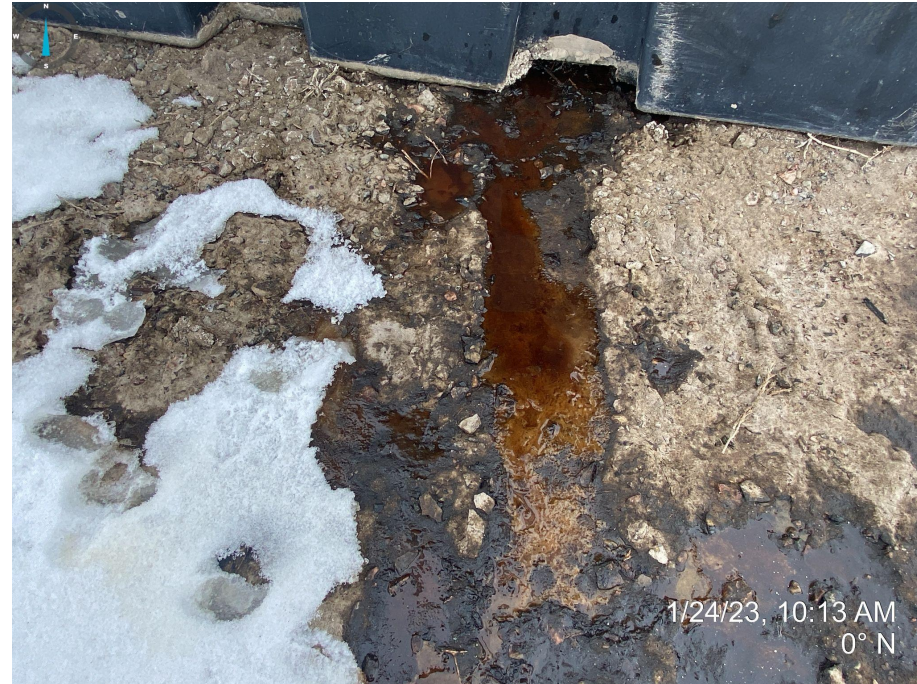
Photos 6 & 7. Facing northwest near the wellheads. Photos illustrate unknown fluid leaking from container/tank and unused equipment. Stained soil will need to be cleaned up and tank integrity will need to be inspected by operator.

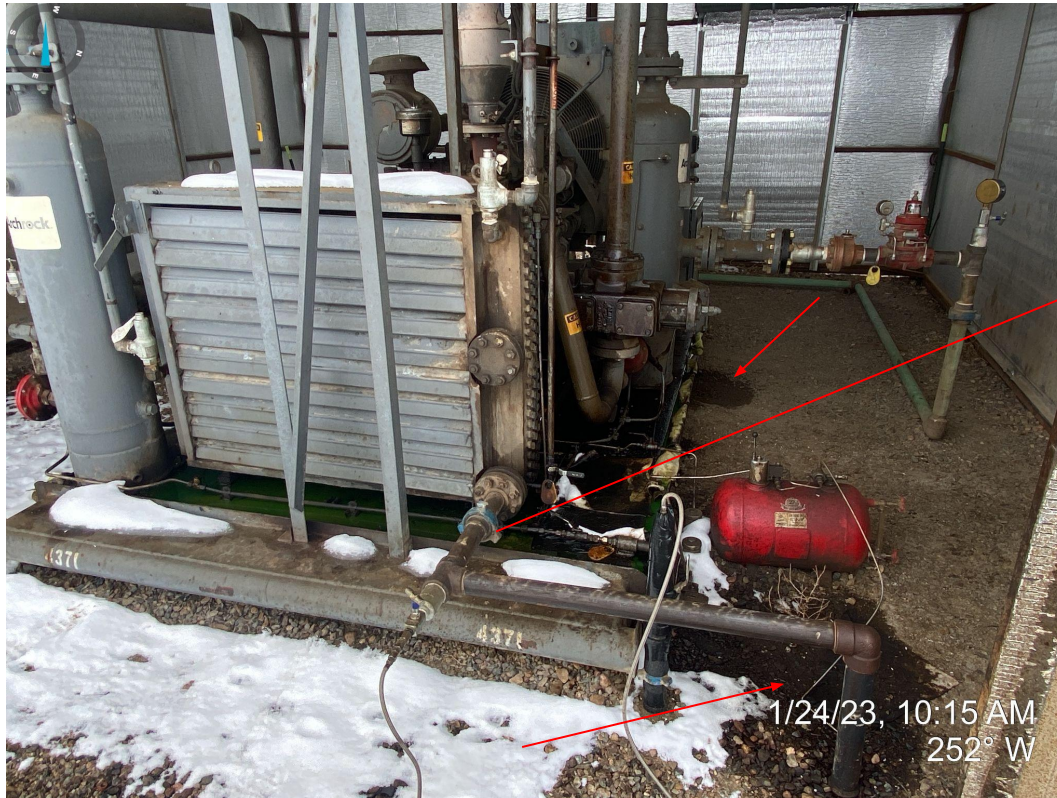
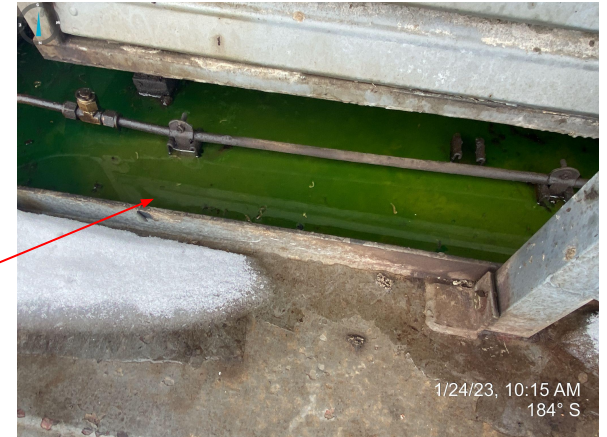
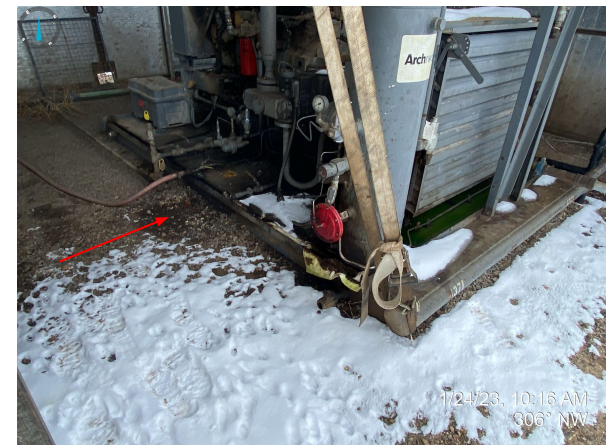
Photos 8, 9, & 10. Close up photos of compressor station located on northwest corner of location. An apparent antifreeze spill was observed along with oil stained soil around engine skid. The free fluids will need to be cleaned up and properly disposed of and the operator will need to install temporary exclusion devices to deter wildlife contact before more permanent devices are installed (e.g. doors, gates, netting, etc).
