Inspection Photos
Spill 483729
1/26/23
All Photos taken
by Kris Neidel

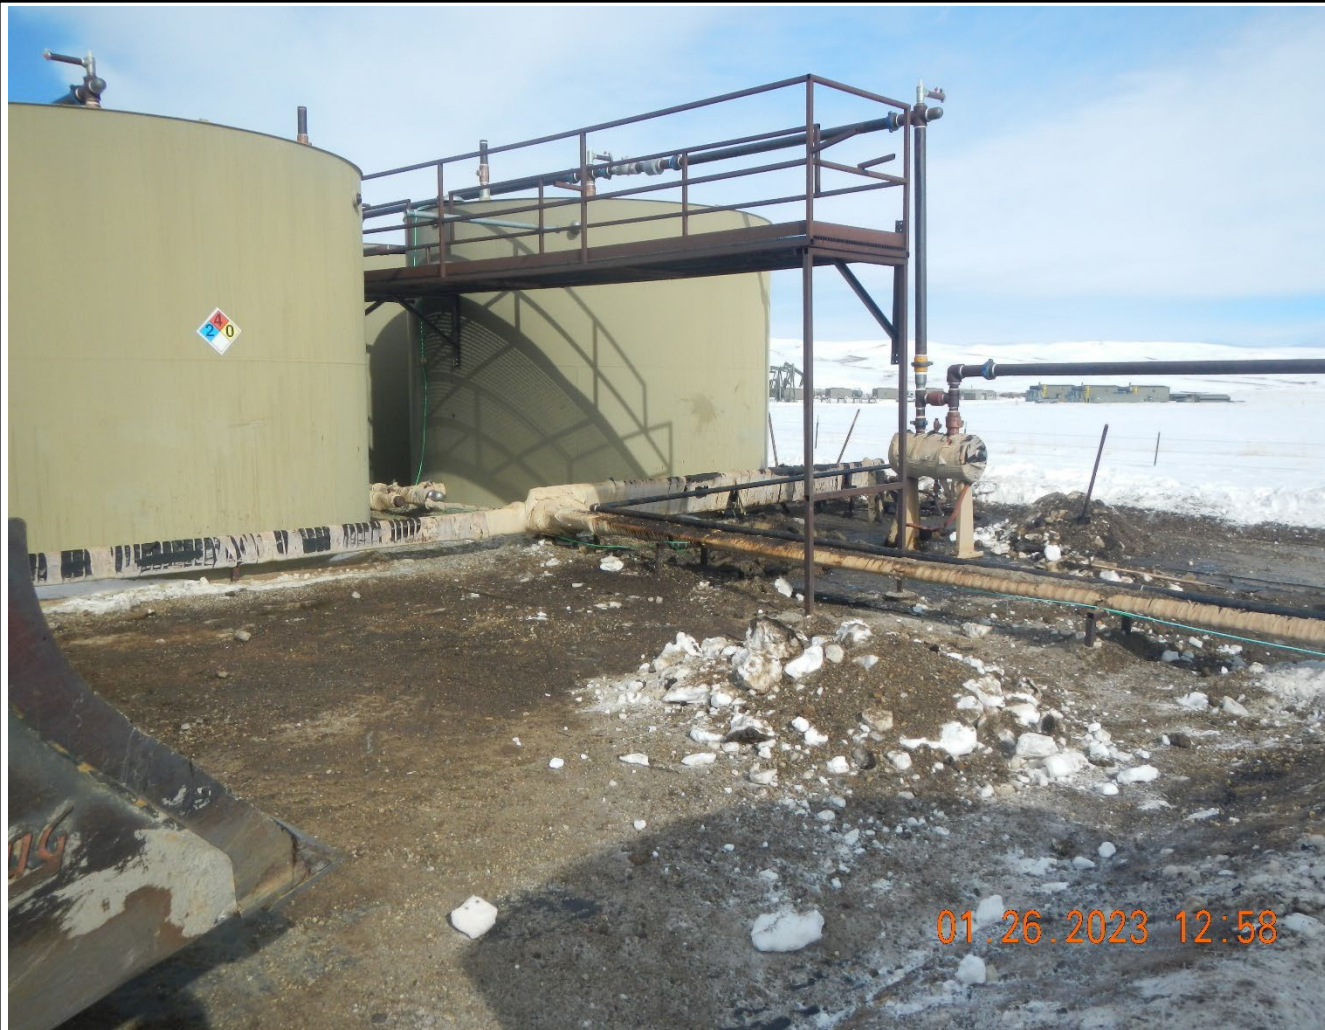
Photo #1 South side of tank battery. This area has an engineered liner. Crews chipped up frozen water and were placing it into a truck for disposal in milner.

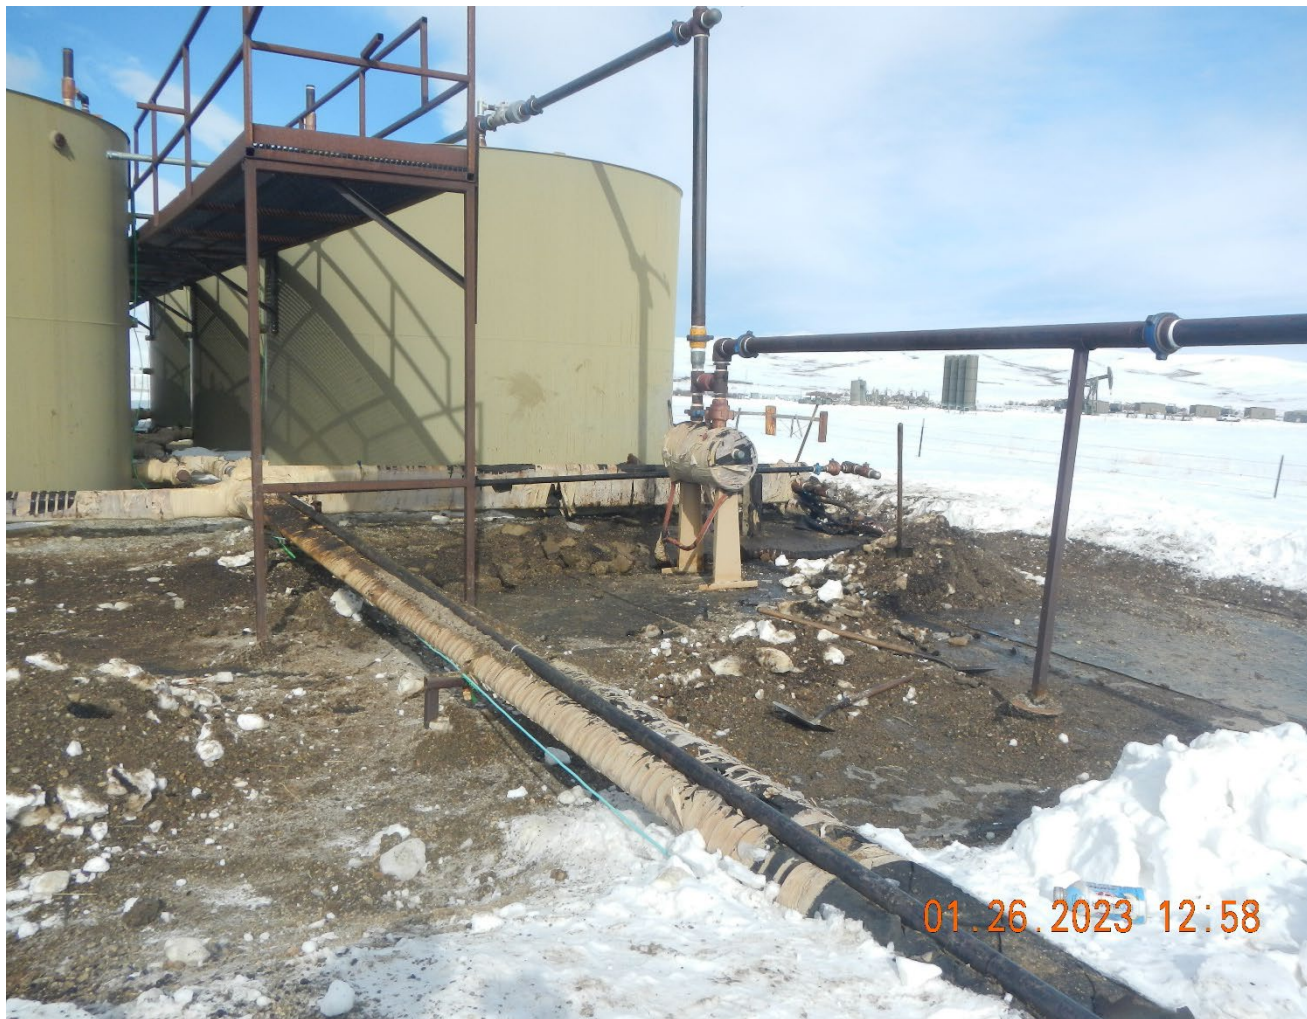
Photo #2 spill started from valve in center of this picture (can not really see it, see Photo #4). Photos 1-4 show the area were Ice was chipped by hand and loaded into a side dump for offsite disposal as E&P waste.

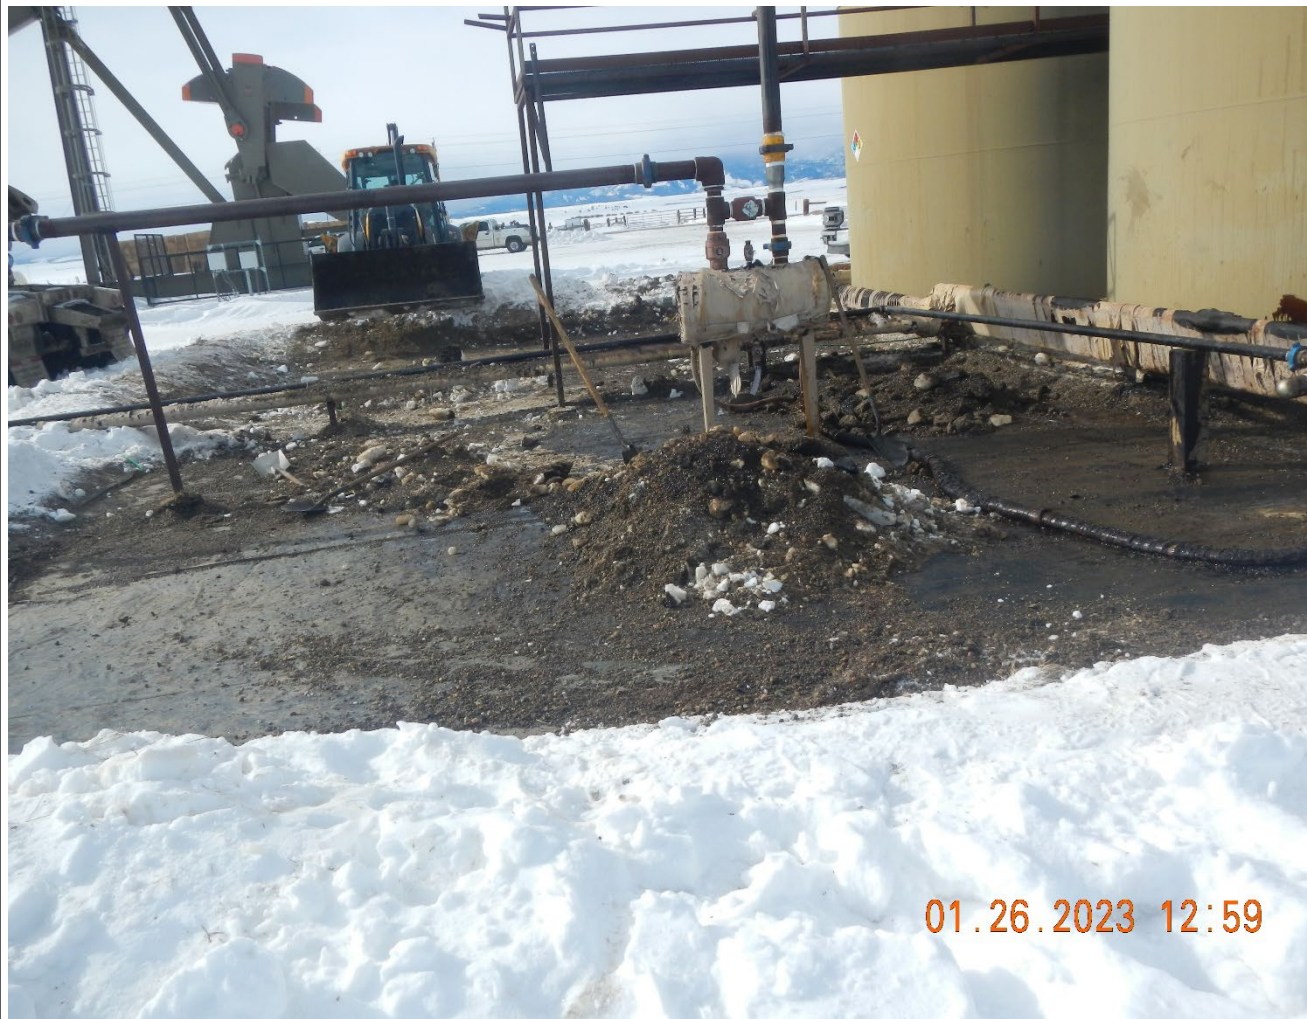
Photo #3 Photos 1-4 show the area where ice was chipped by hand and loaded into a side dump for offsite disposal as E&P waste.

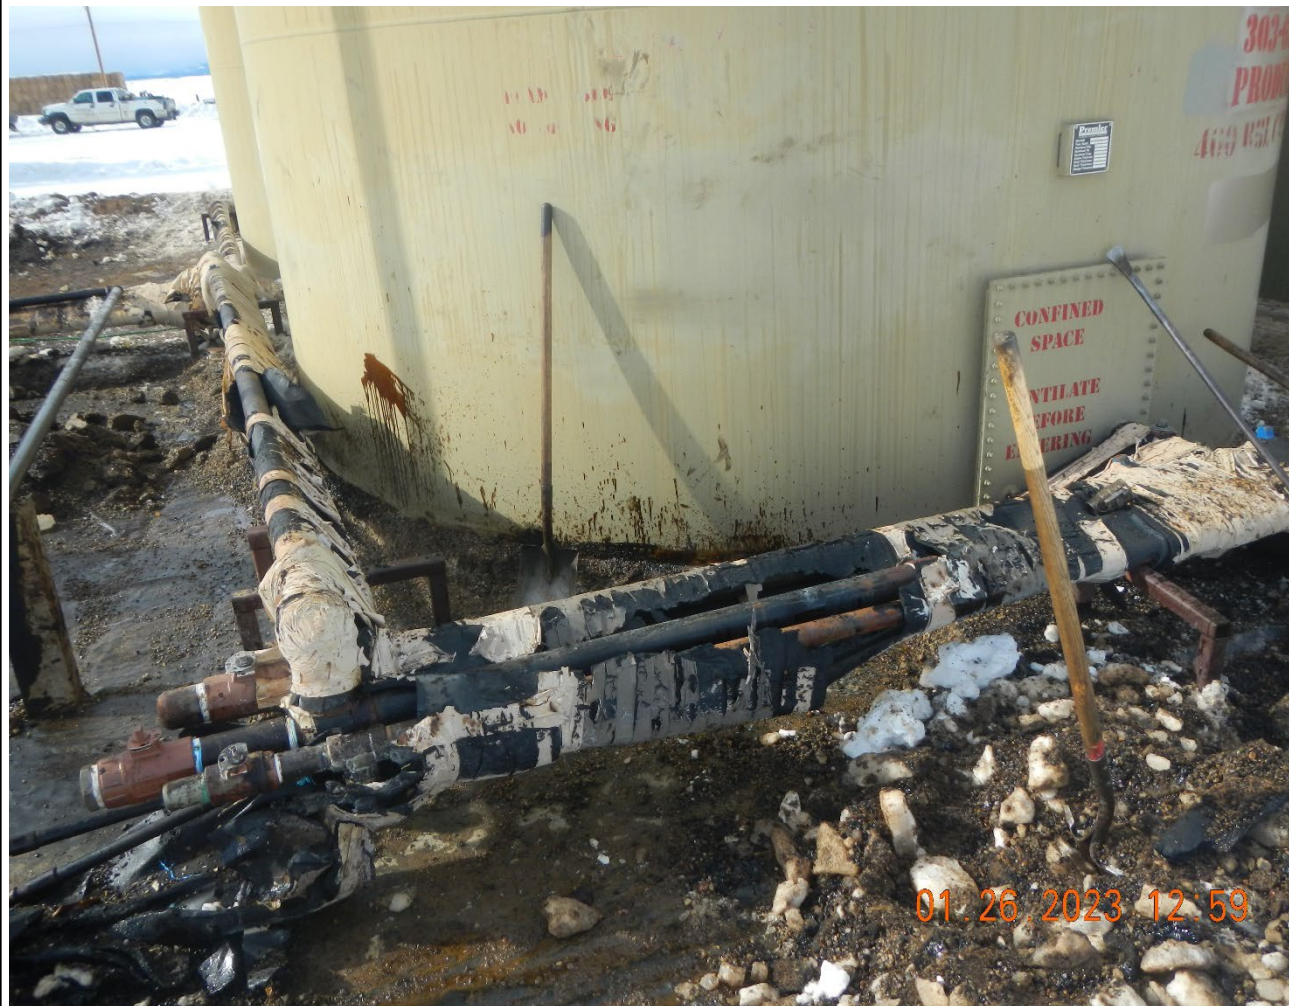
Photo #4 The Valve at left of photo is the valve that froze and released the produced water. Photos 1-4 show the area were Ice was chipped by hand and loaded into a side dump for offsite disposal as E&P waste.

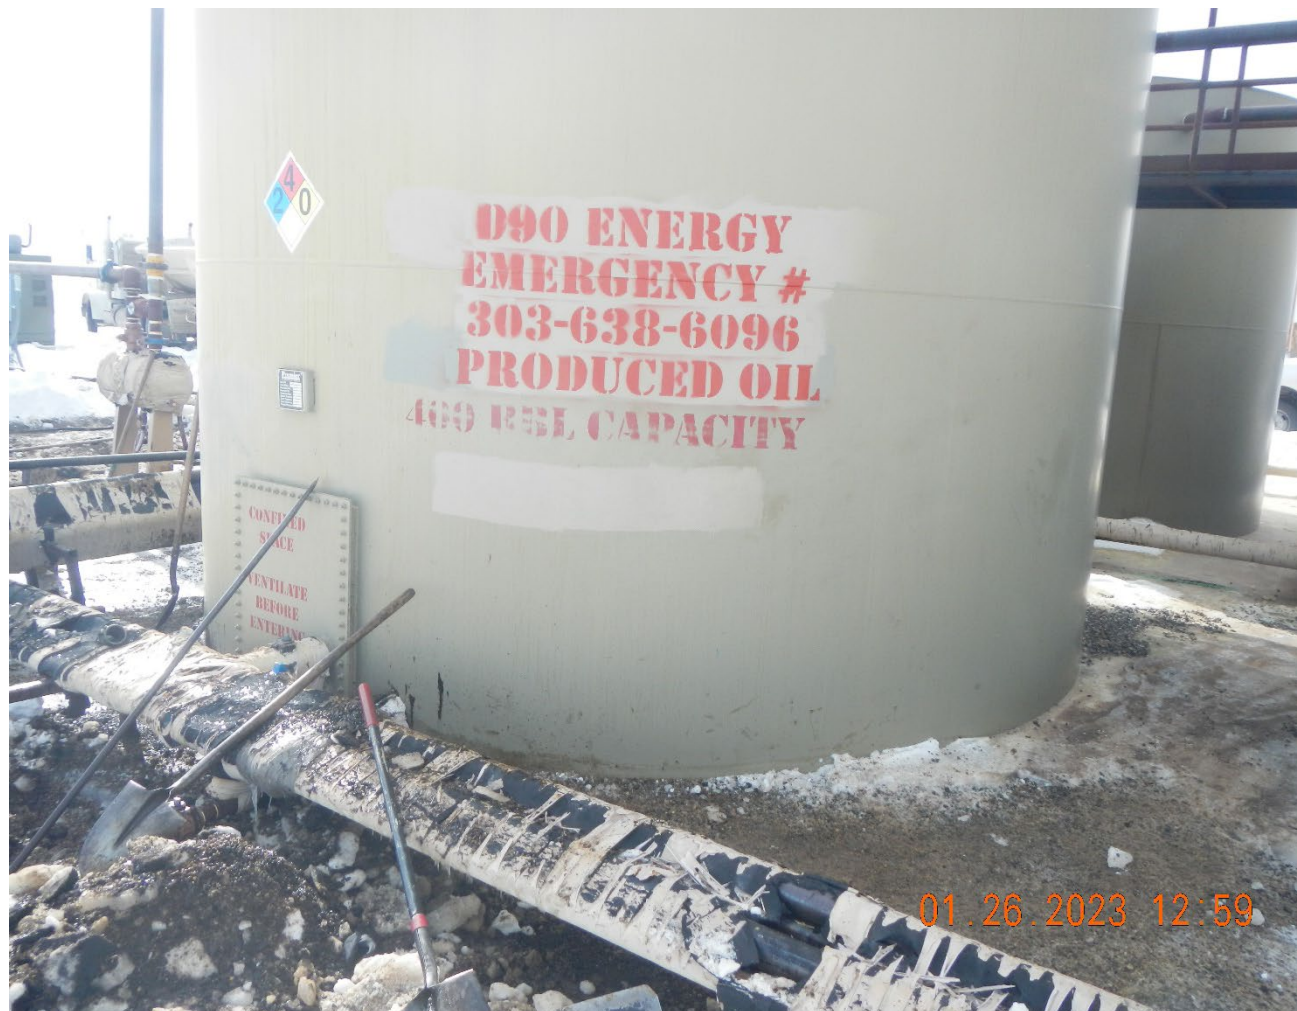
Photo #5 ice to right of tank has yet to be removed.

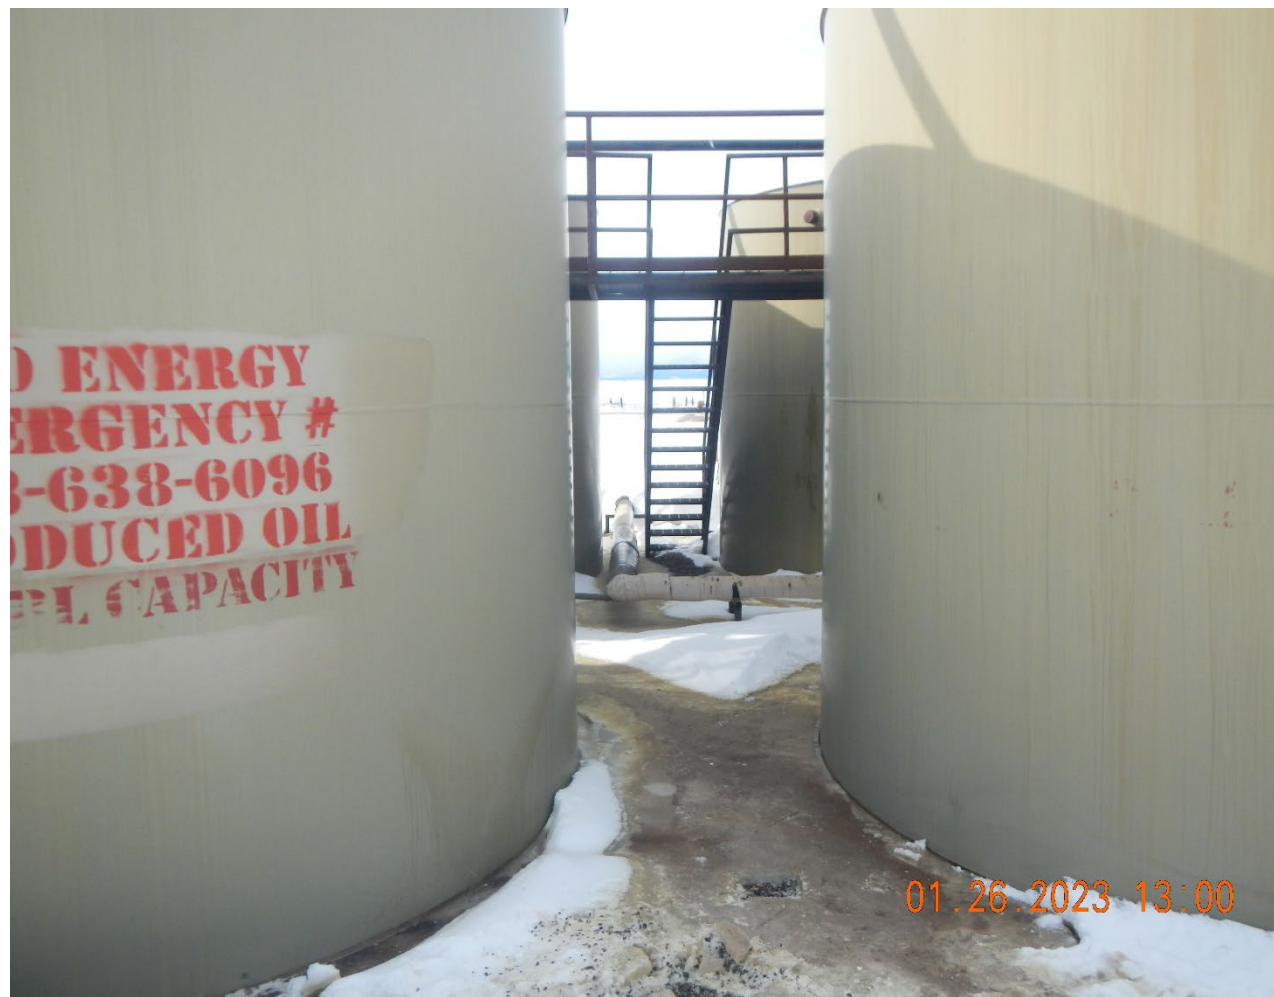
Photo #6 frozen Produced water

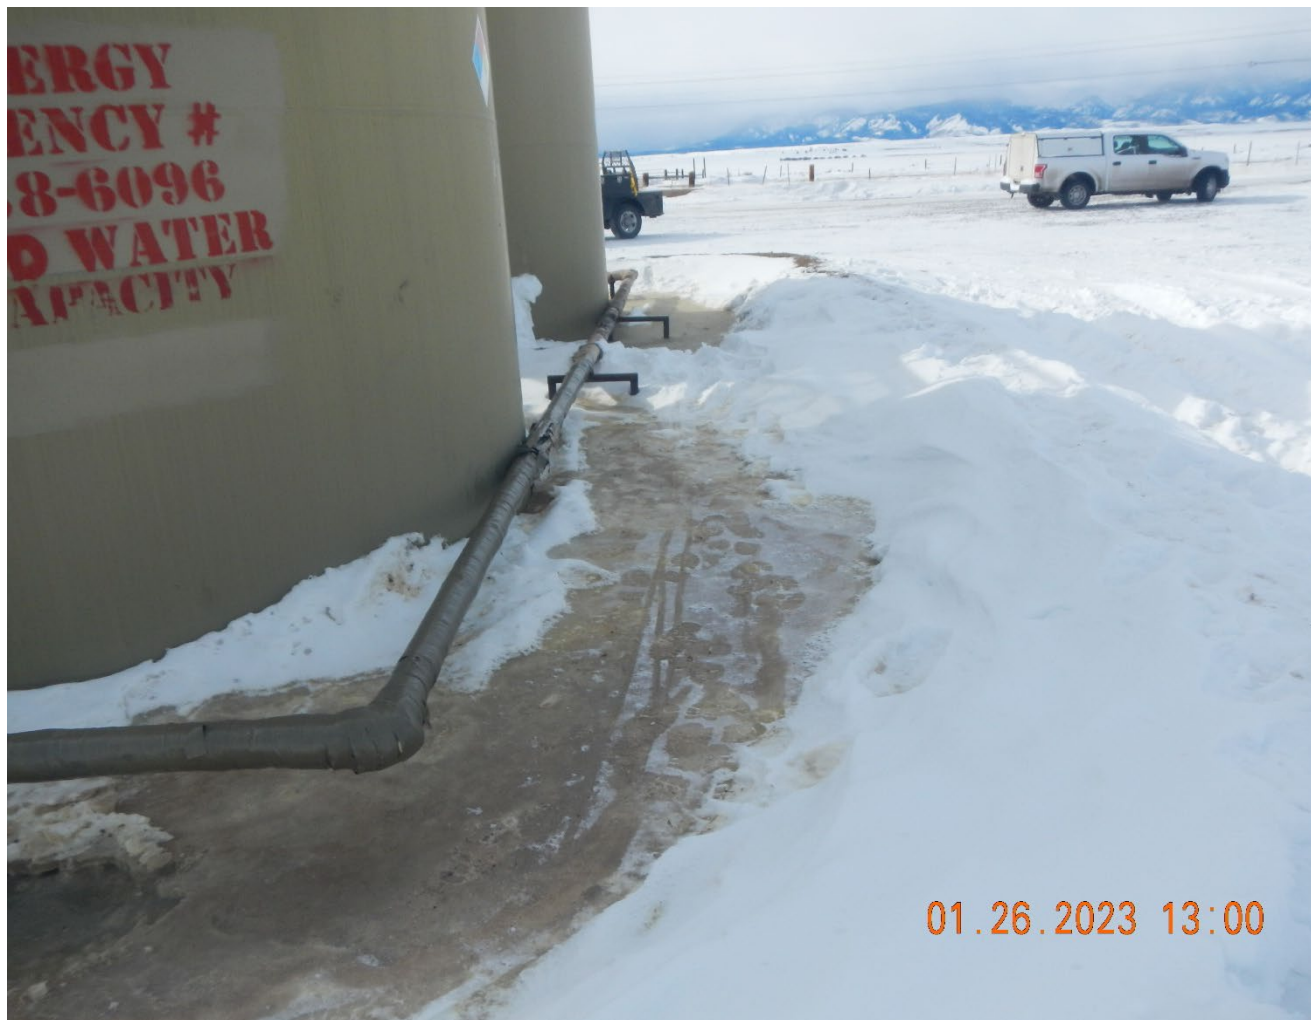
Photo #7 north side of tank battery. Frozen produced water.
