Interim Reclamation and Stormwater Inspection

Operator: NOBLE ENERGY INC - 100322

Location ID: 460414

Inspection Document #: 696105699

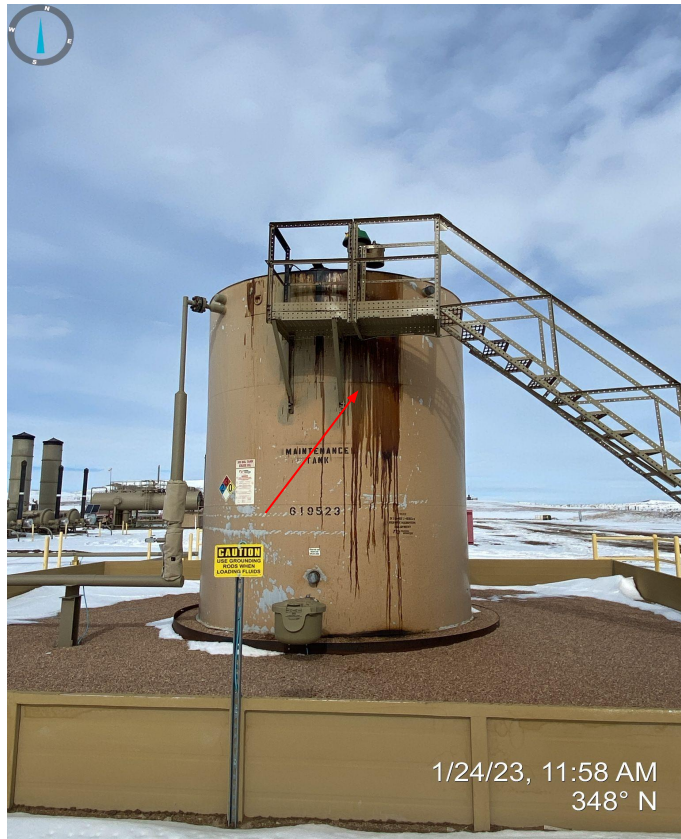
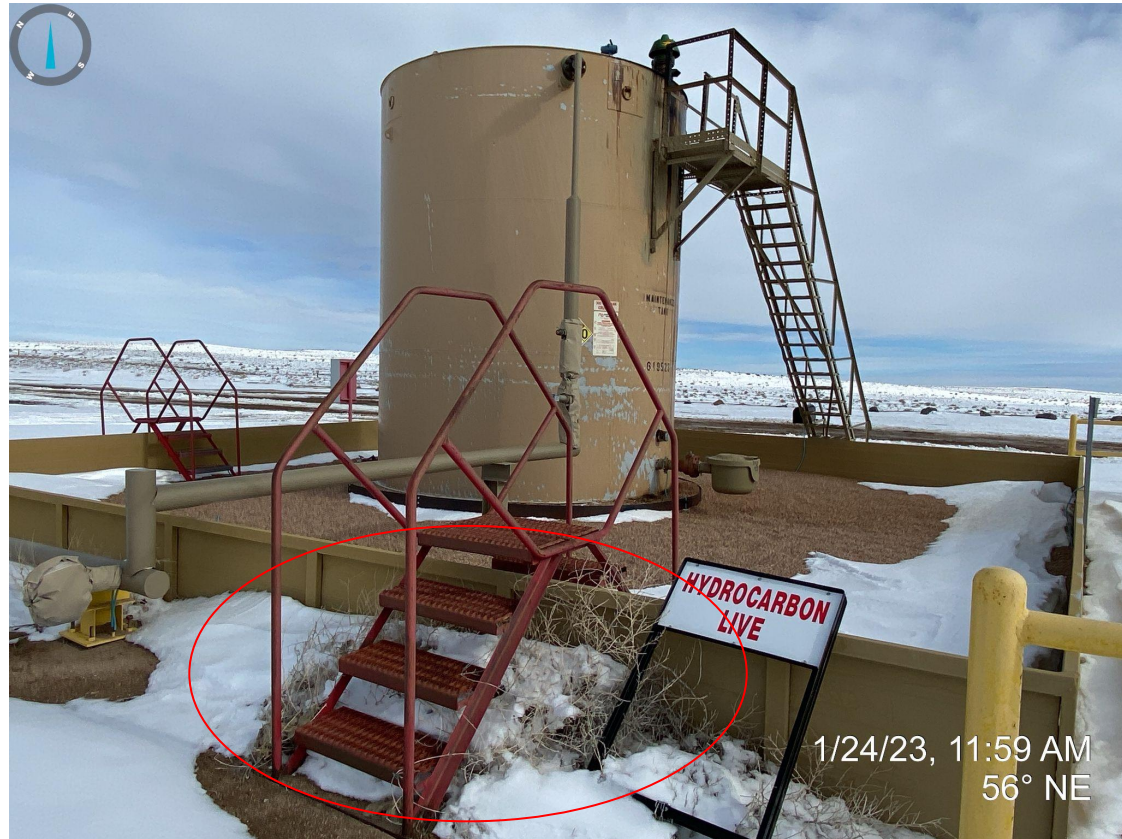
Photos 1 & 2. Facing north and northeast from the southern portion of the location. Photos illustrate that there appears to be a leak originating from the thief hatch portion of the crude tank battery. Also pictured, tumbleweed accumulation near equipment.

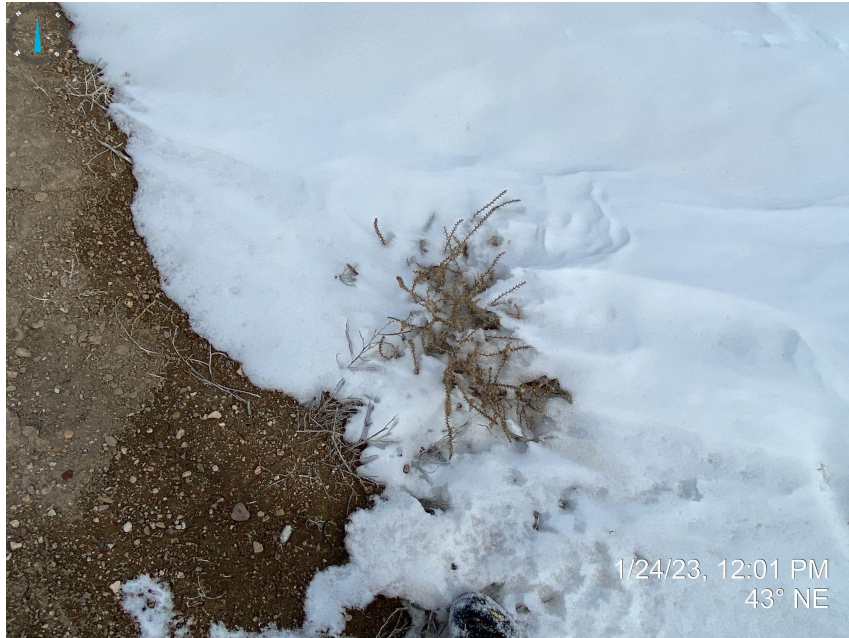
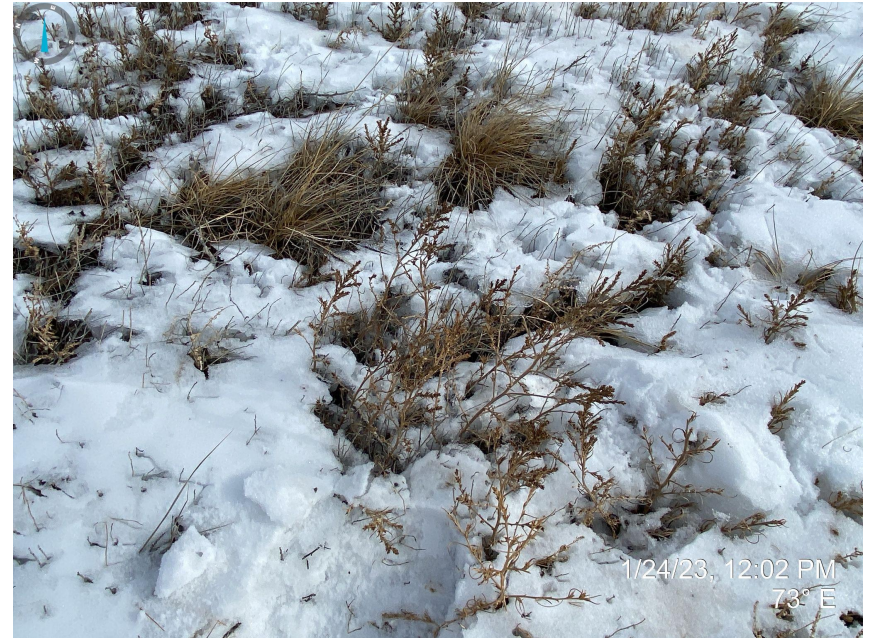
Photos 3 & 4. Close up photos of undesirable vegetation (e.g. russian thistle) that was observed throughout the location.

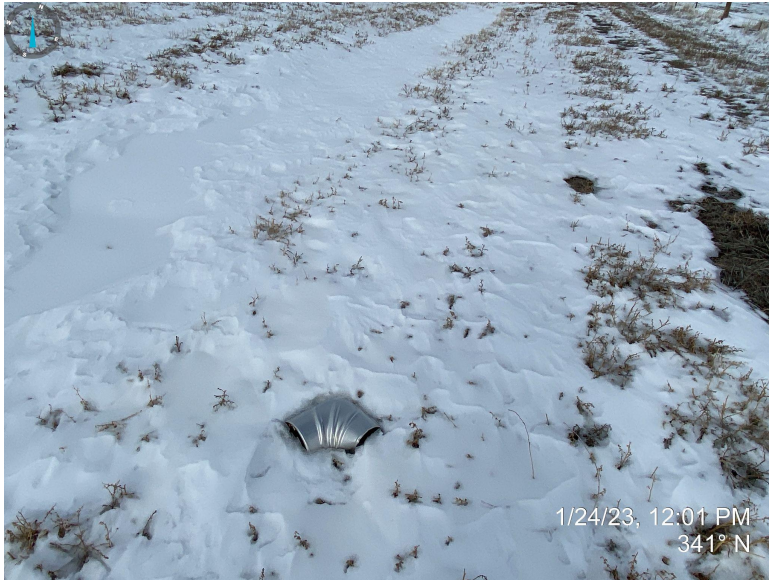
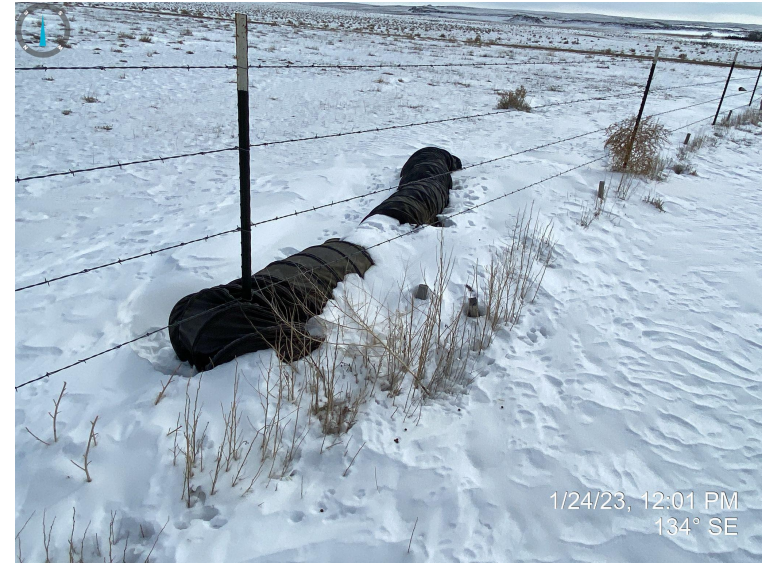
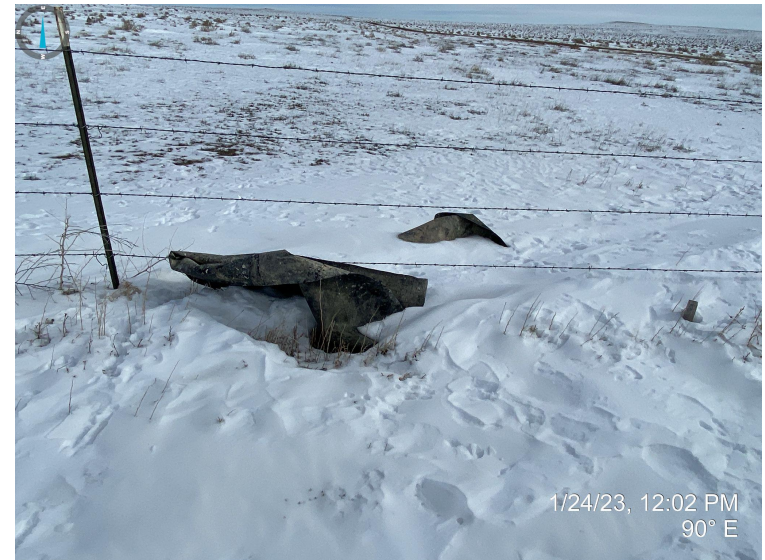
Photos 5, 6 & 7. Facing north, southeast, and east from the southeastern portion of the location. Photos illustrate various debris throughout the location that need to be removed and properly disposed of.

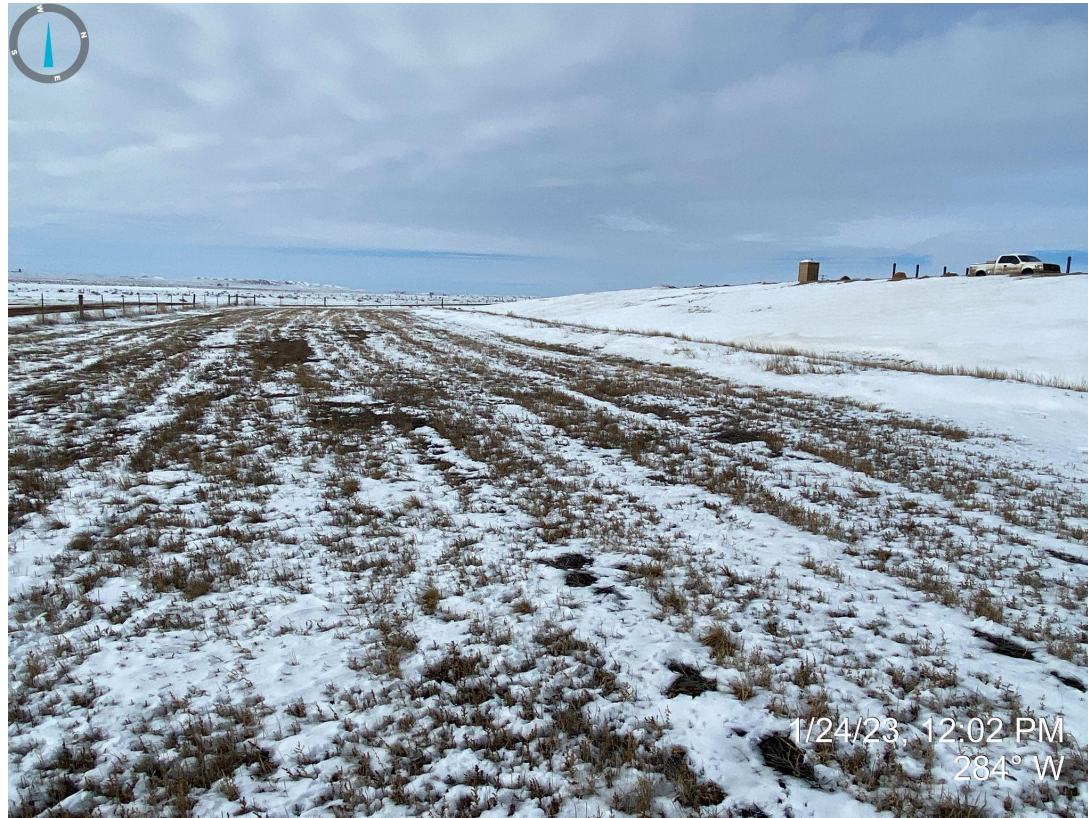
Photo 8. Facing west from the southern portion of the location. Interim reclamation activities appear to have been completed with evidence of vegetation throughout the disturbance areas. A follow-up inspection will be completed at a future date to ensure compliance with Rule 1003.

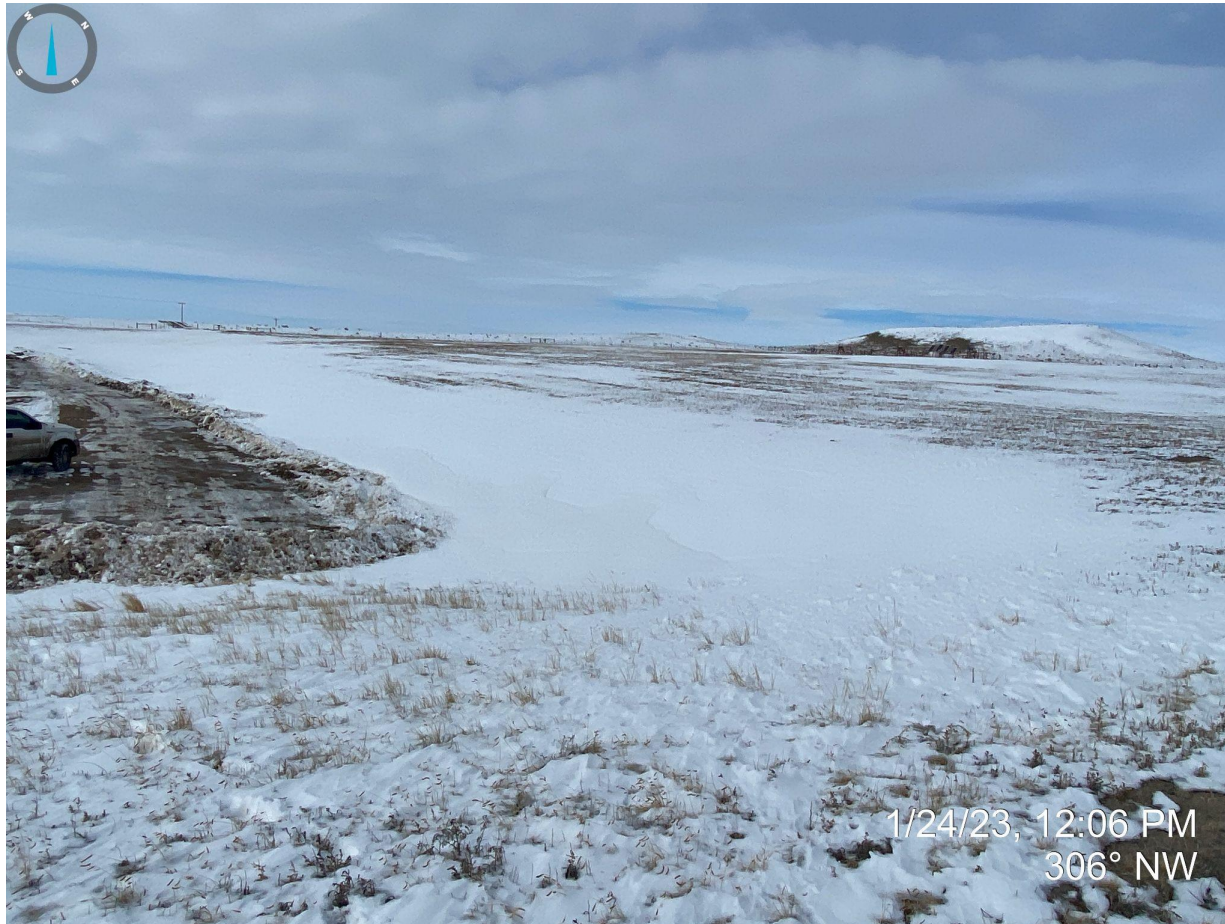
Photo 9. Facing northwest from the middle portion of the location; see comments in Photo 8.

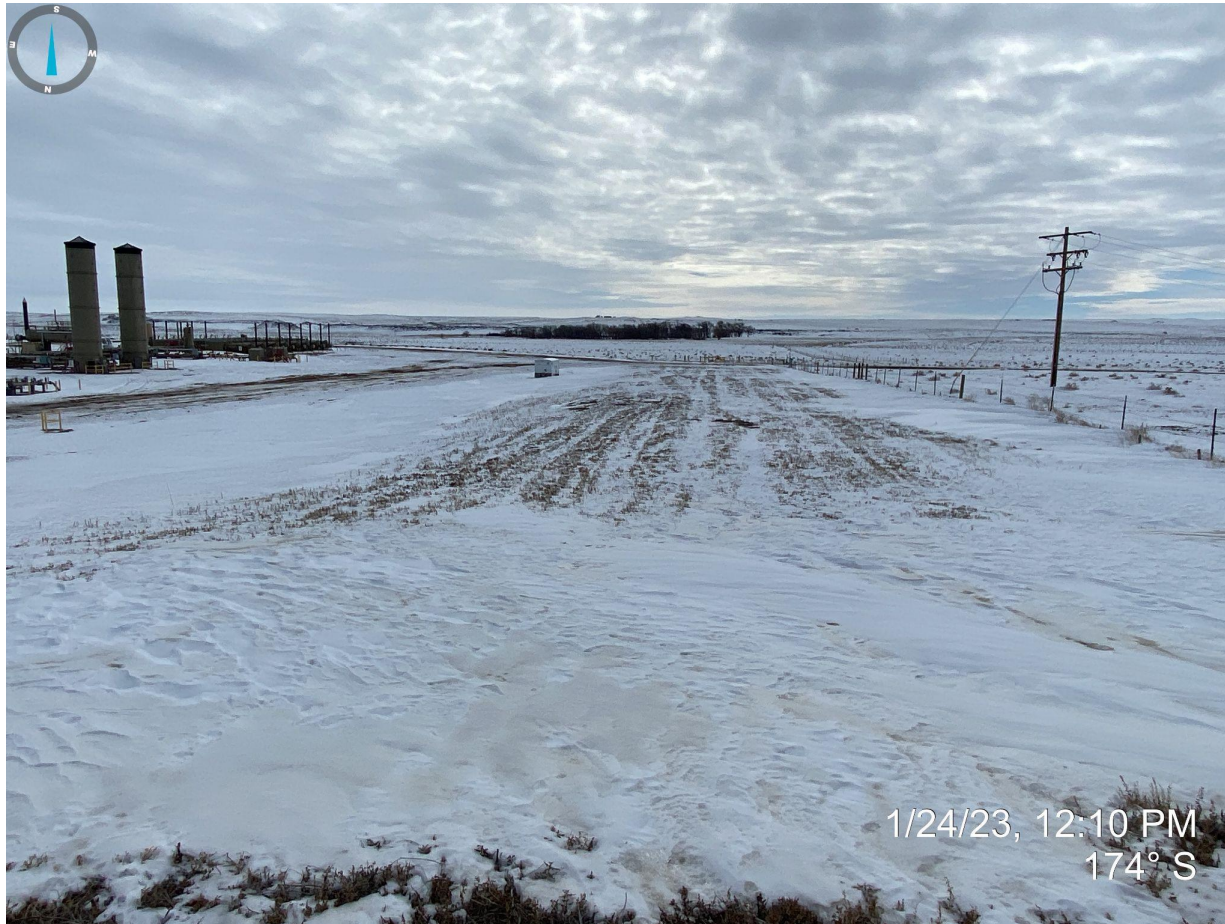
Photo 10. Facing south from the western/center portion of the location. See comments in Photo 8.

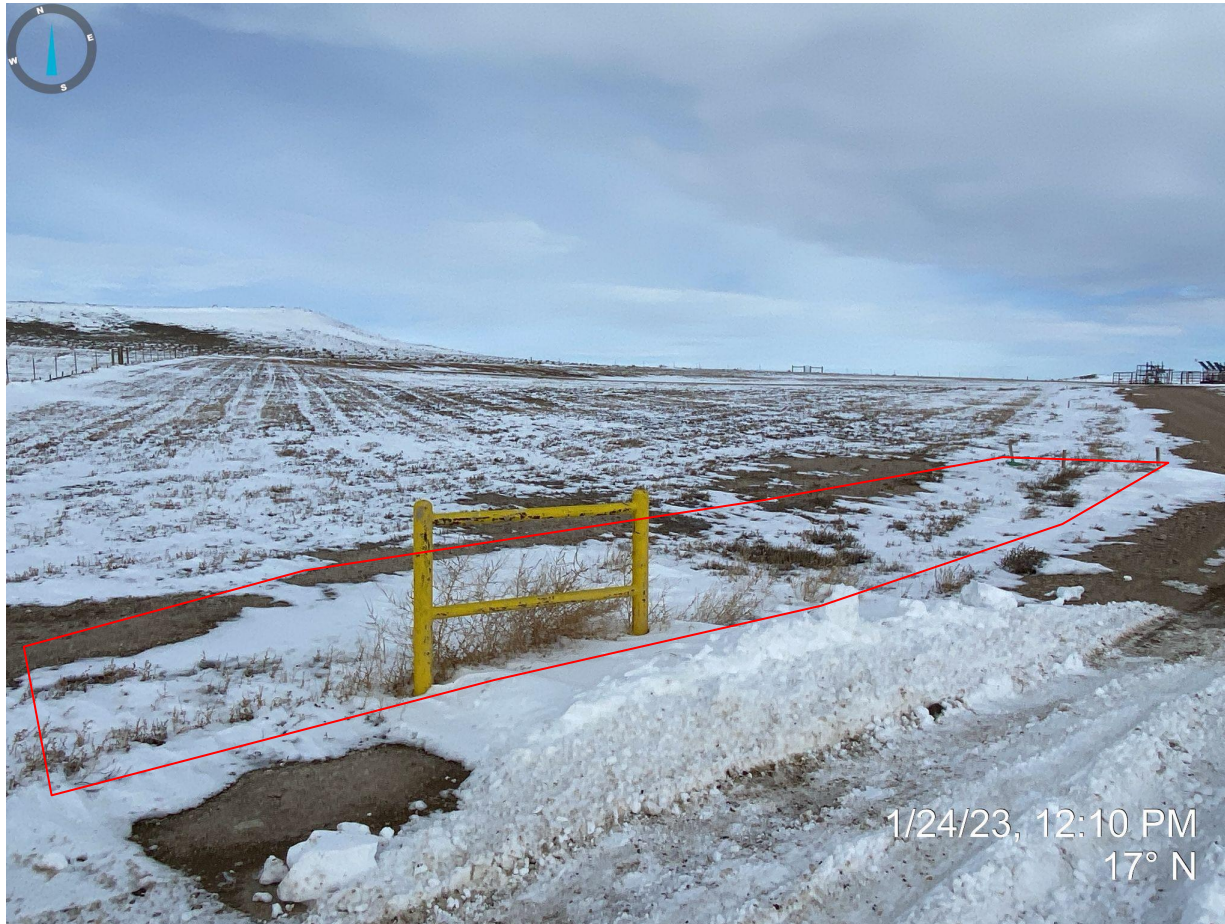
Photo 11. Facing north from the western/center portion of the location. See comments in Photo 8. Also pictured, undesirable vegetation (e.g. kochia and russian thistle) outlined in red.

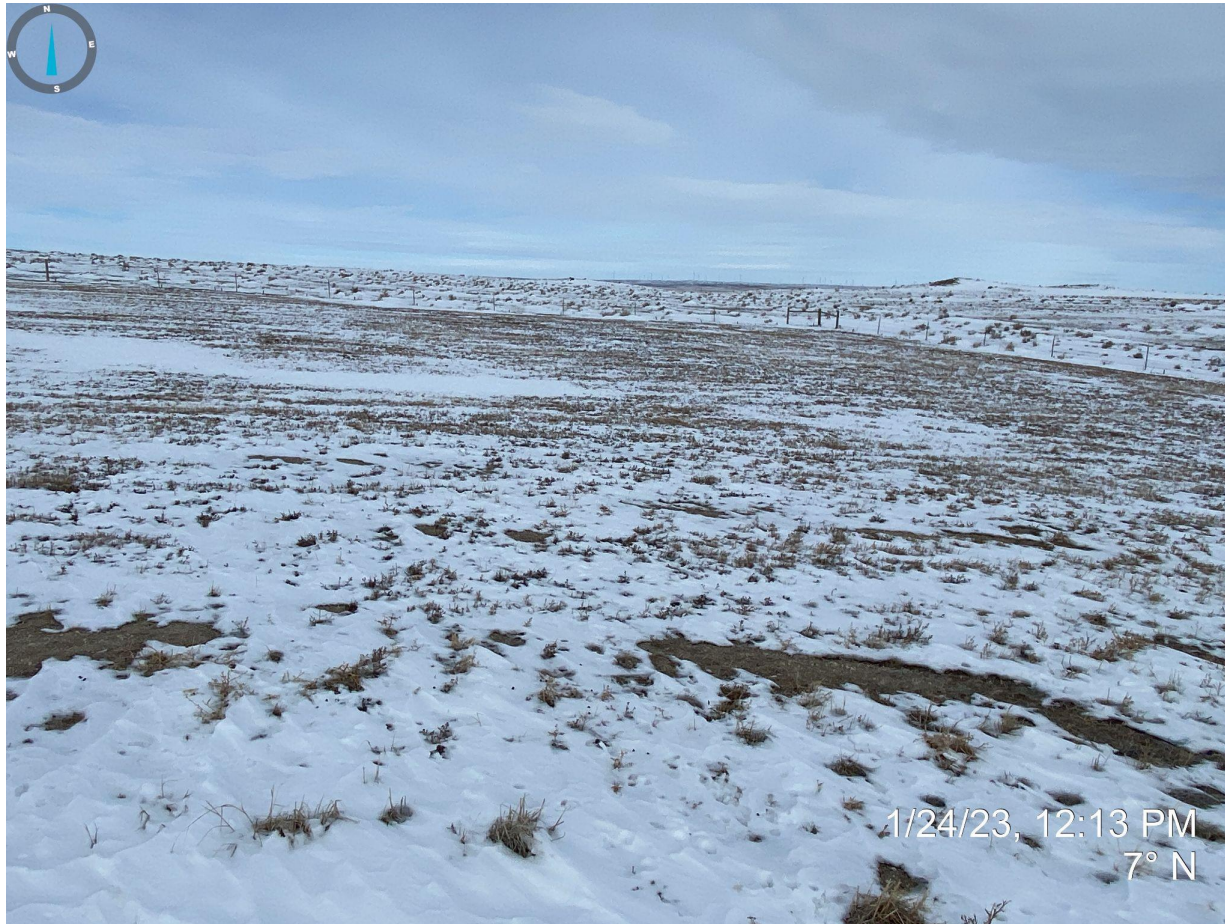
Photo 12. Facing north from the northwestern corner of the location. See comments in Photo 8.
