Interim Reclamation and Stormwater Inspection

Operator: NOBLE ENERGY INC - 100322

Location ID: 433090

Location Name: Rohn State LD04-68HN Multi

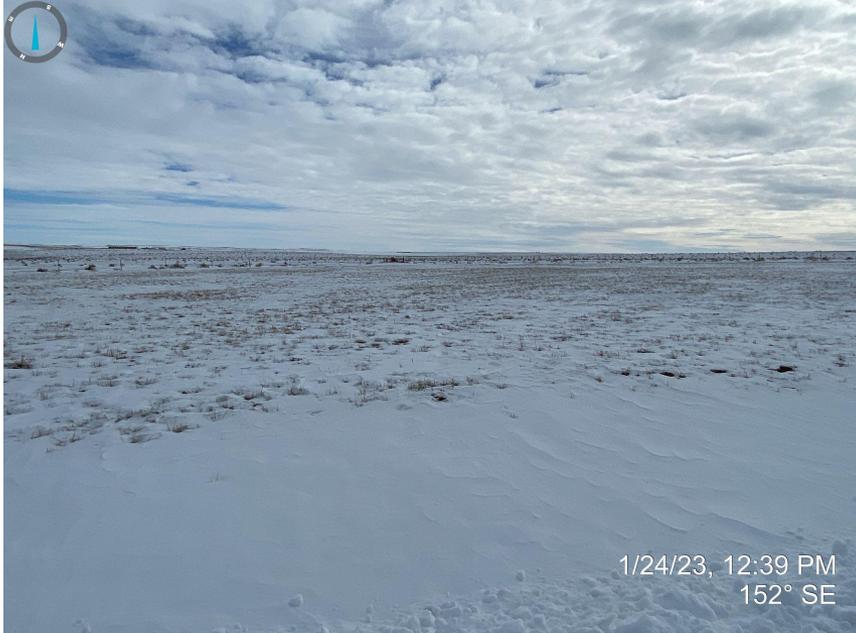
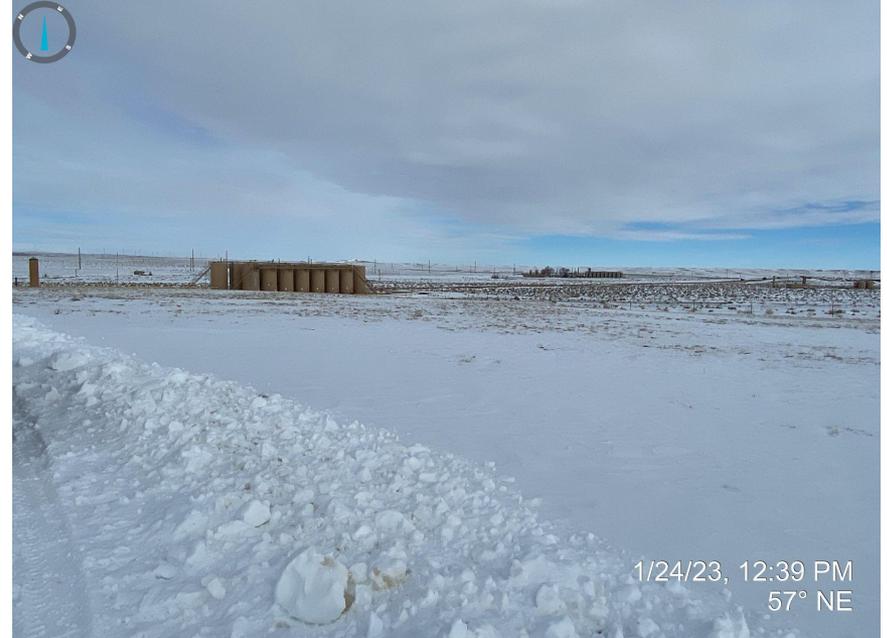
Photos 1 & 2. Facing southeast and northeast from the well locations. Photos illustrate that the disturbed areas appear to have been reclaimed and efforts of revegetation are evident. A follow-up inspection will be conducted at a later date to ensure compliance with Rule 1003.

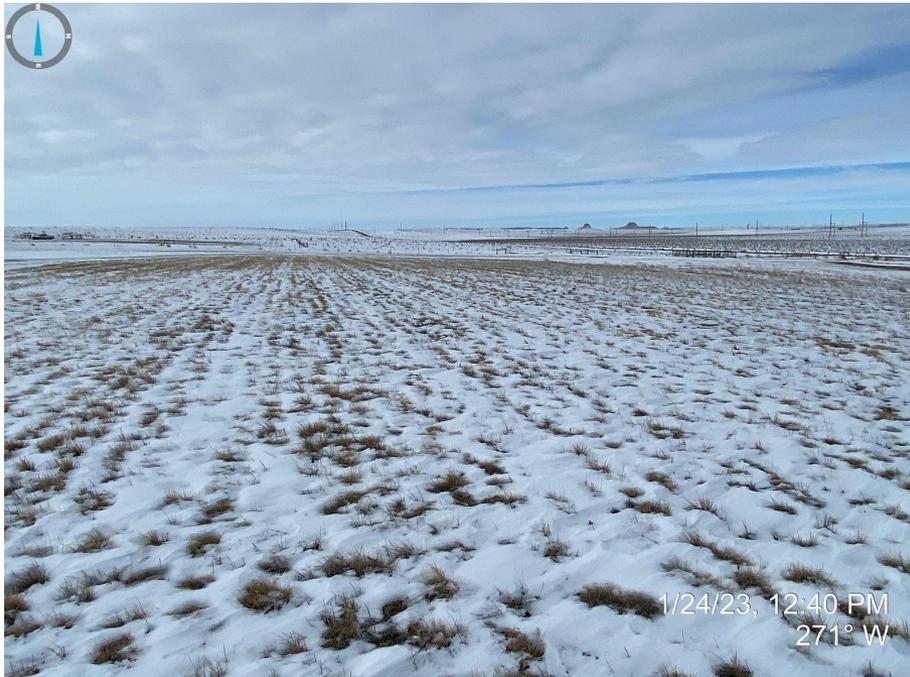
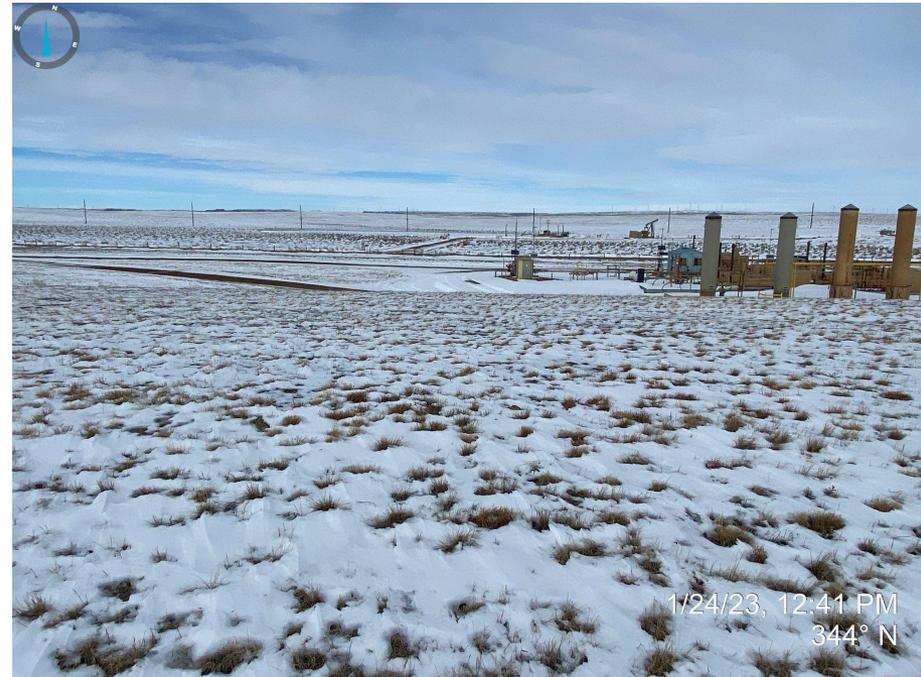
Photos 3 & 4. Facing west and north from the well locations. See comments in photos 1 & 2.

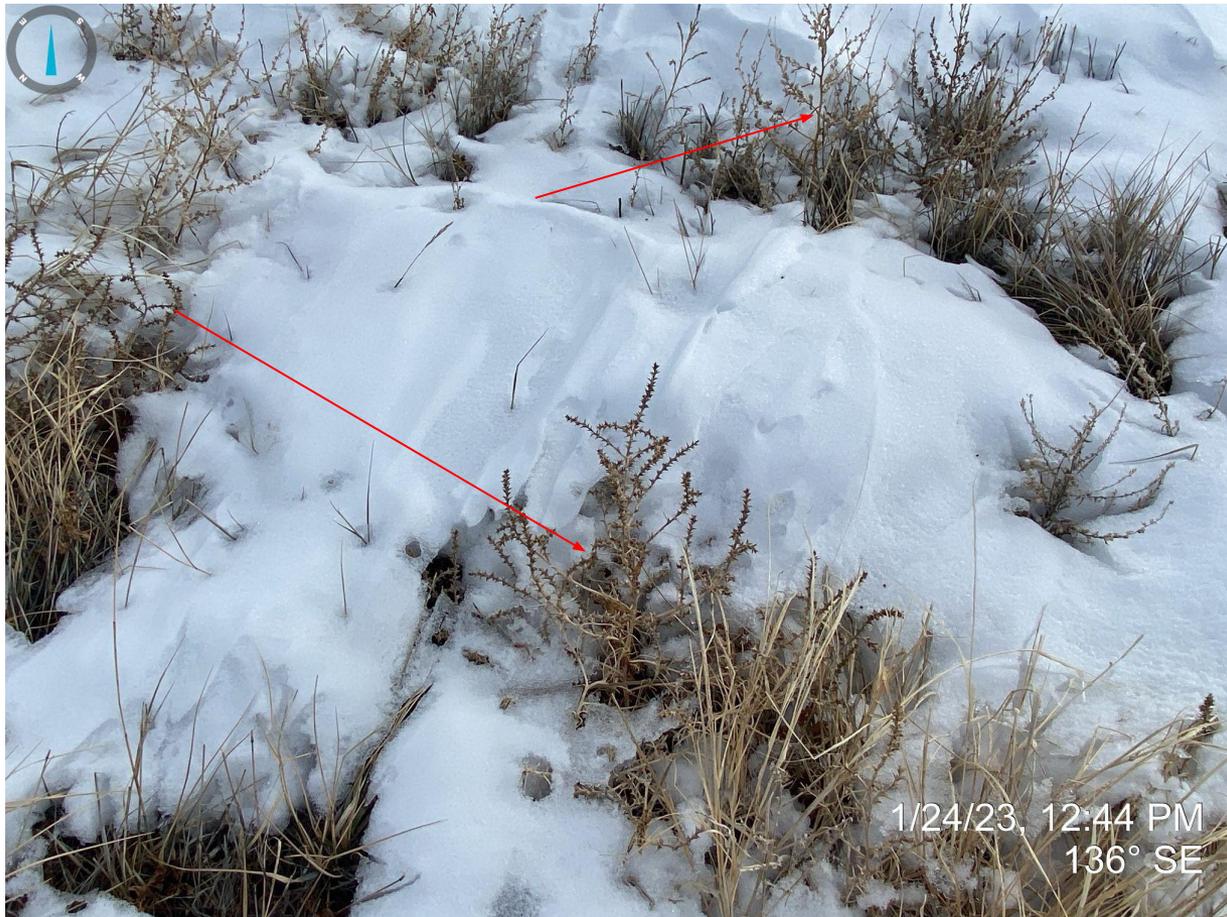
Photo 5. Close up photo of undesirable vegetation (e.g. russian thistle and kochia) that was observed throughout the location.

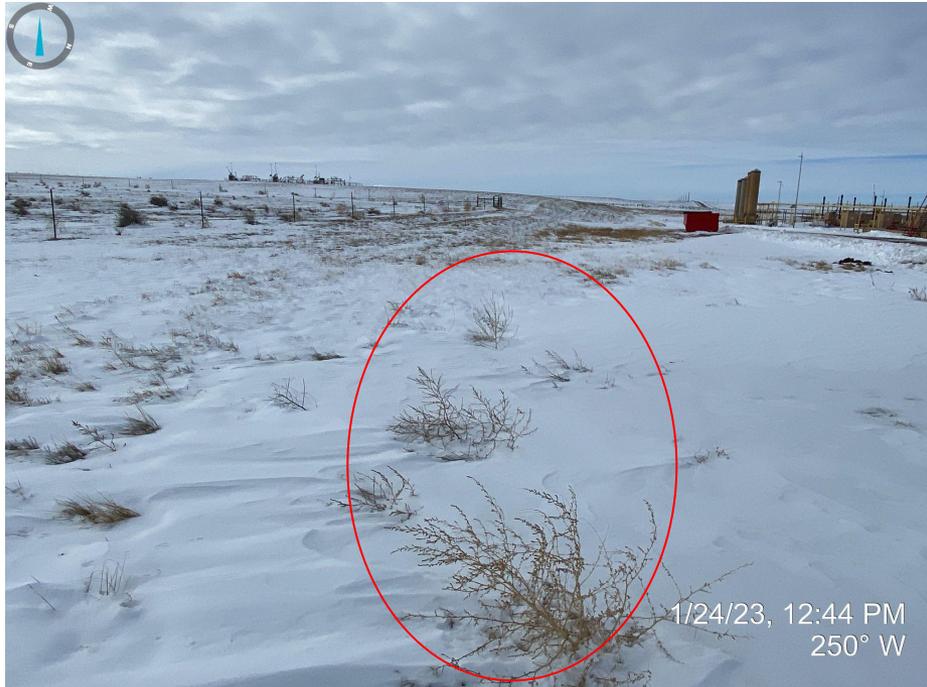
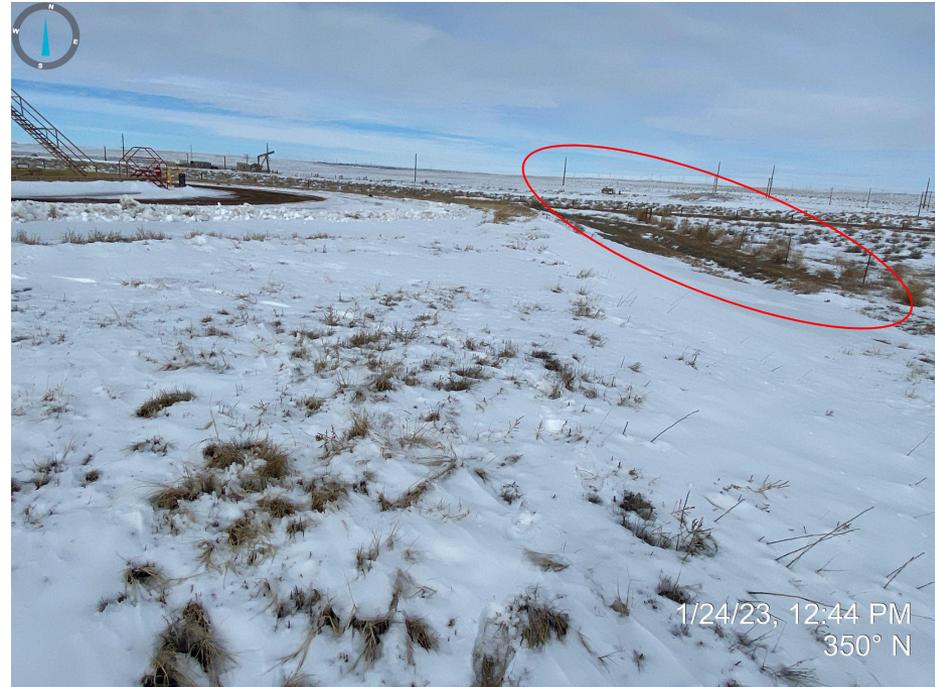
Photos 6 & 7. Facing west and north near the tank battery location. Photos illustrate evidence of undesirable vegetation (e.g. kochia and russian thistle).

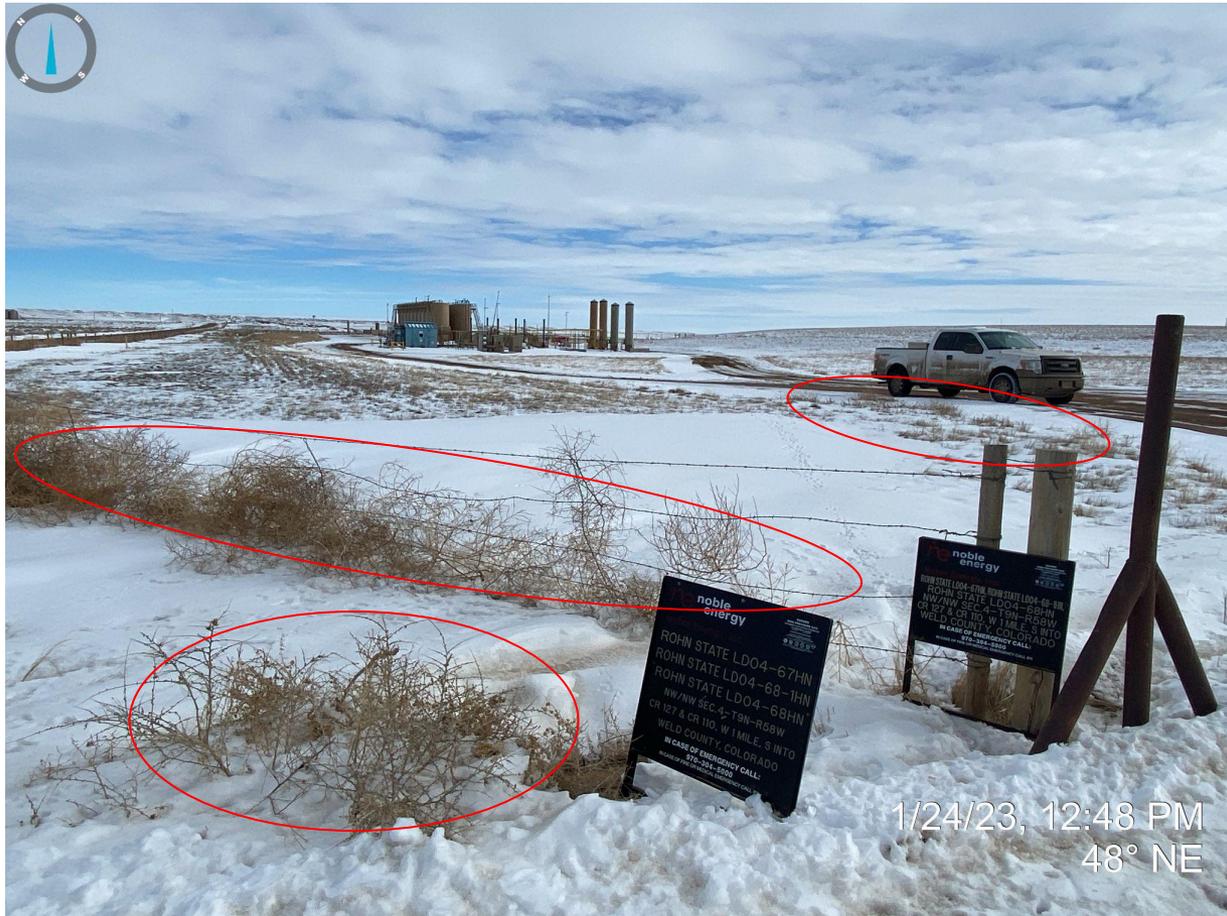
Photo 8. Facing northeast near the location's entrance. See comments in Photos 6 & 7.

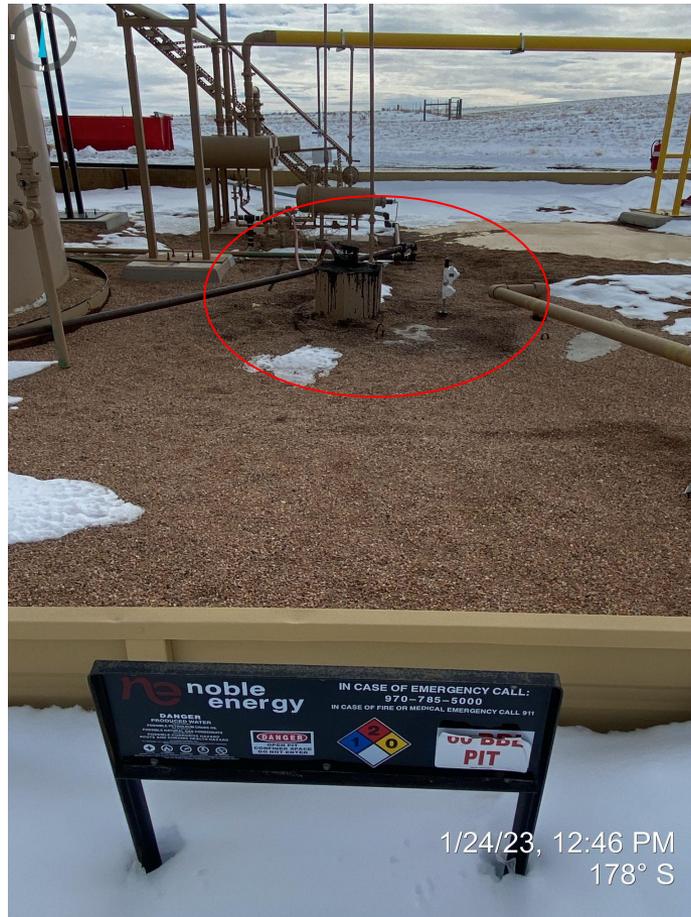
Photo 9. Facing south at buried vessel/pit. Photo illustrates stained soil and material on hatch. This needs to be cleaned and properly disposed of per Rule 912.a.
