Interim Reclamation and Stormwater Inspection

Operator: NOBLE ENERGY INC - 100322

Location ID: 422853

Inspection Photos
Location Name: Rohn State LD-10-63HN
Location ID: 422853

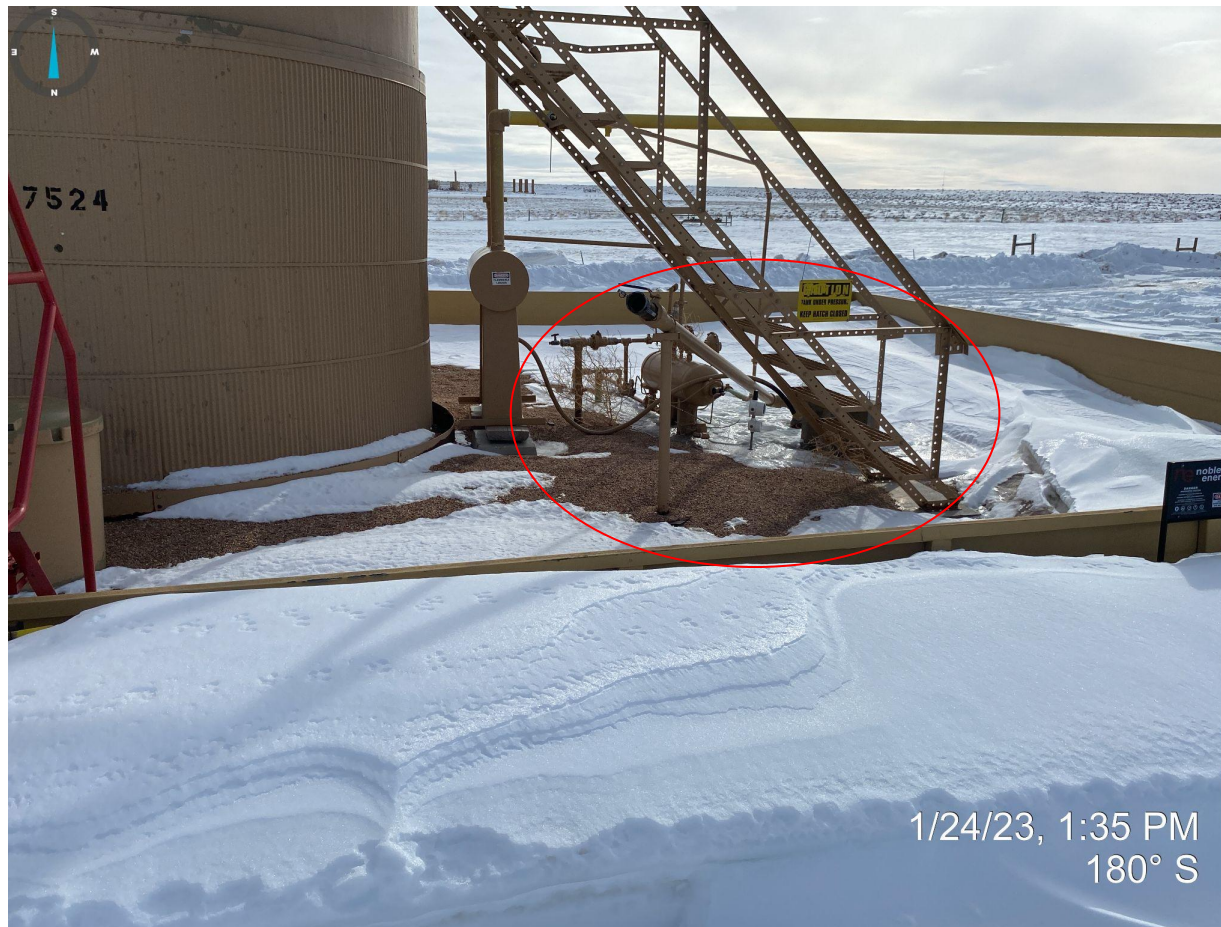
Photo 1. Facing south at the tank battery; undesirable vegetation (now considered debris) observed next to equipment. This should be disposed of as it presents a fire hazard.

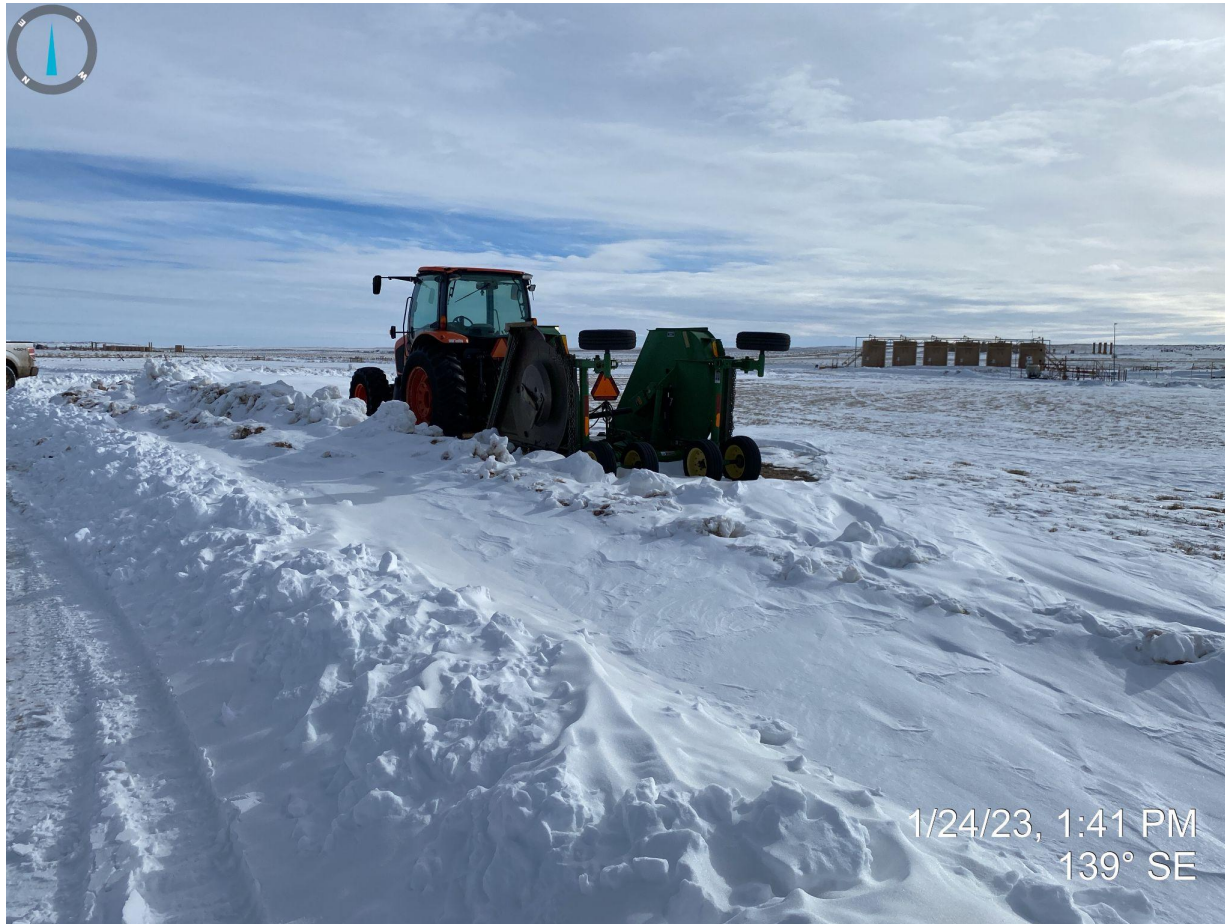
Photo 2. Facing southeast near wellheads. Photo illustrates unused equipment that is being stored on location and needs to be removed.

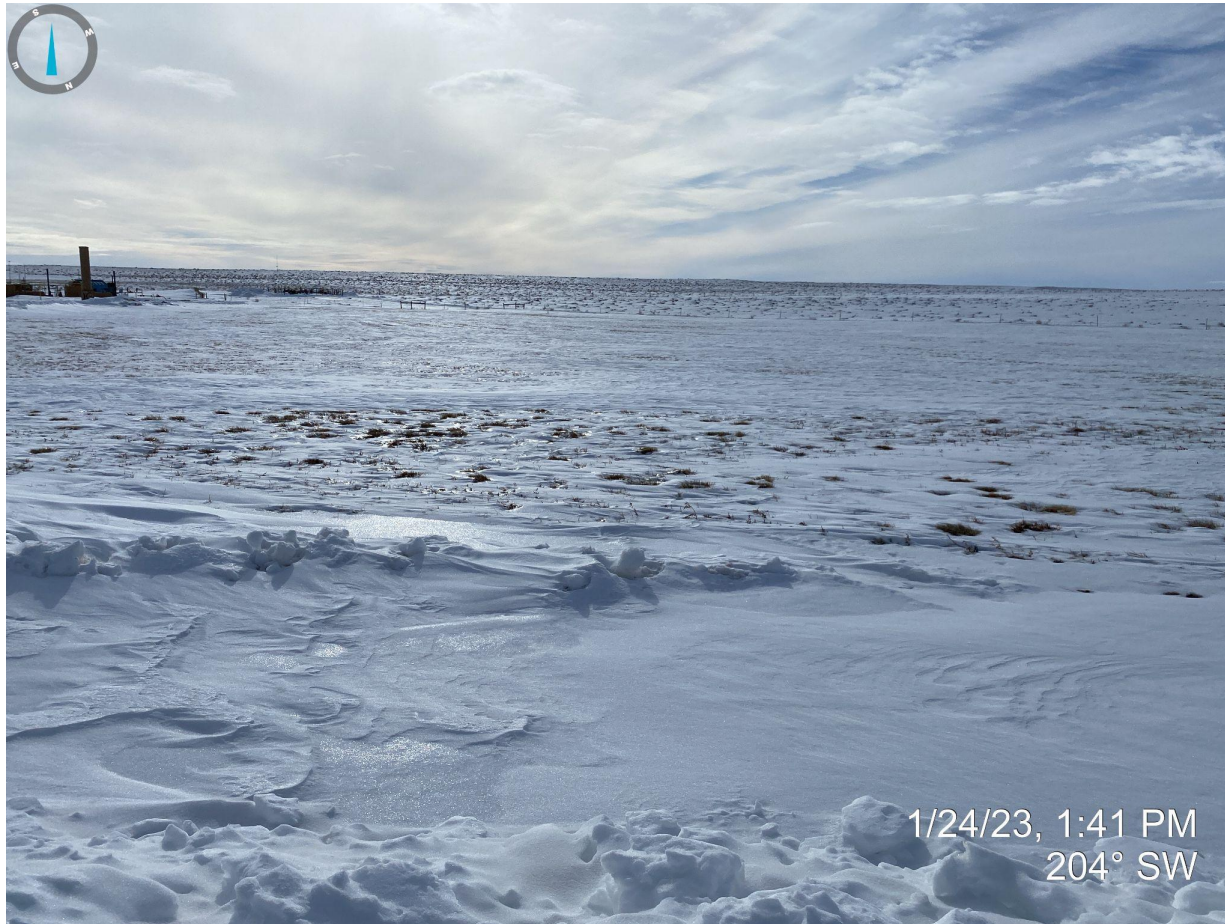
Photo 3. Facing southwest near wellhead. Photo illustrates that all unused portions of the location have been recontoured and graded for interim reclamation. An inspection will be scheduled at a later date to conduct a vegetation assessment and ensure compliance with Rule 1003.

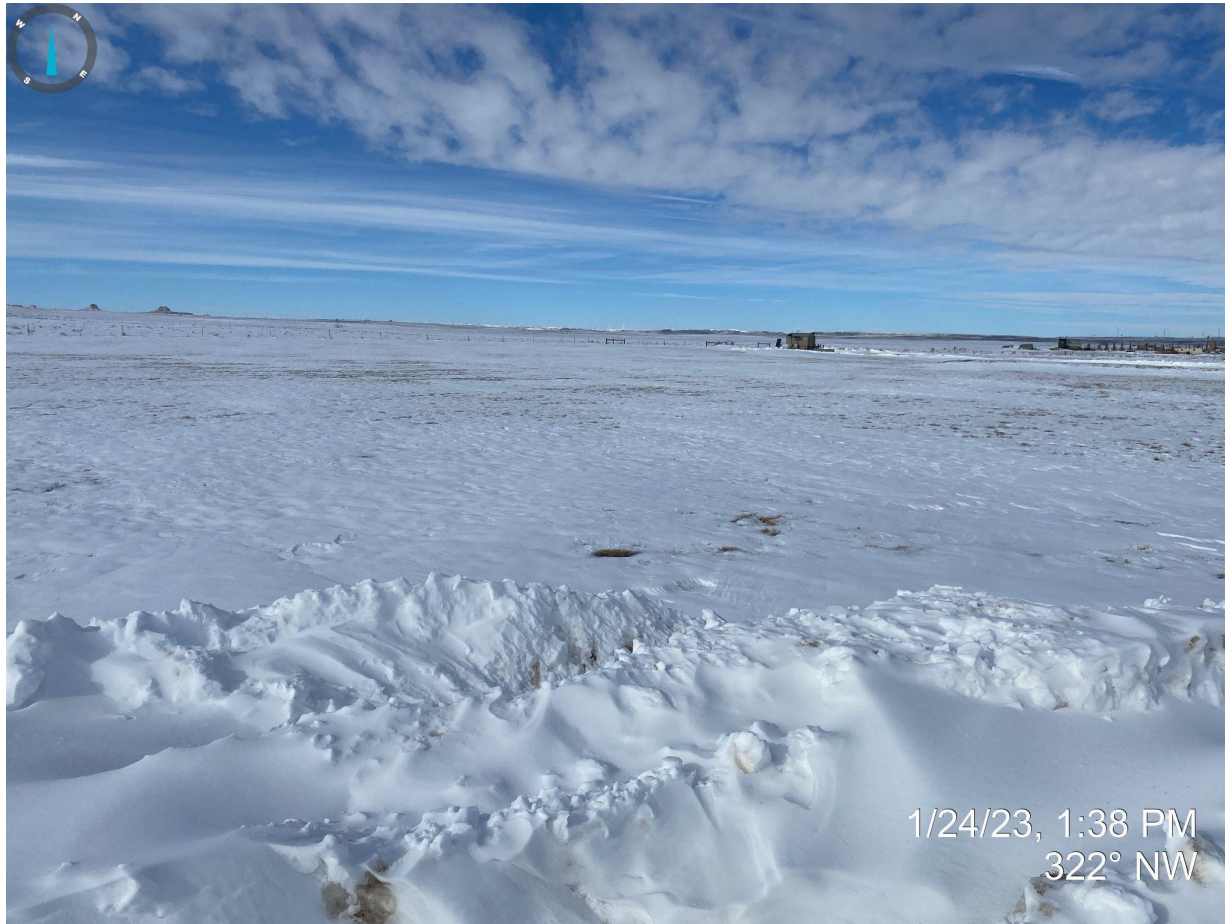
Photo 4. Facing northwest from tank battery location; see comments in Photo 3.

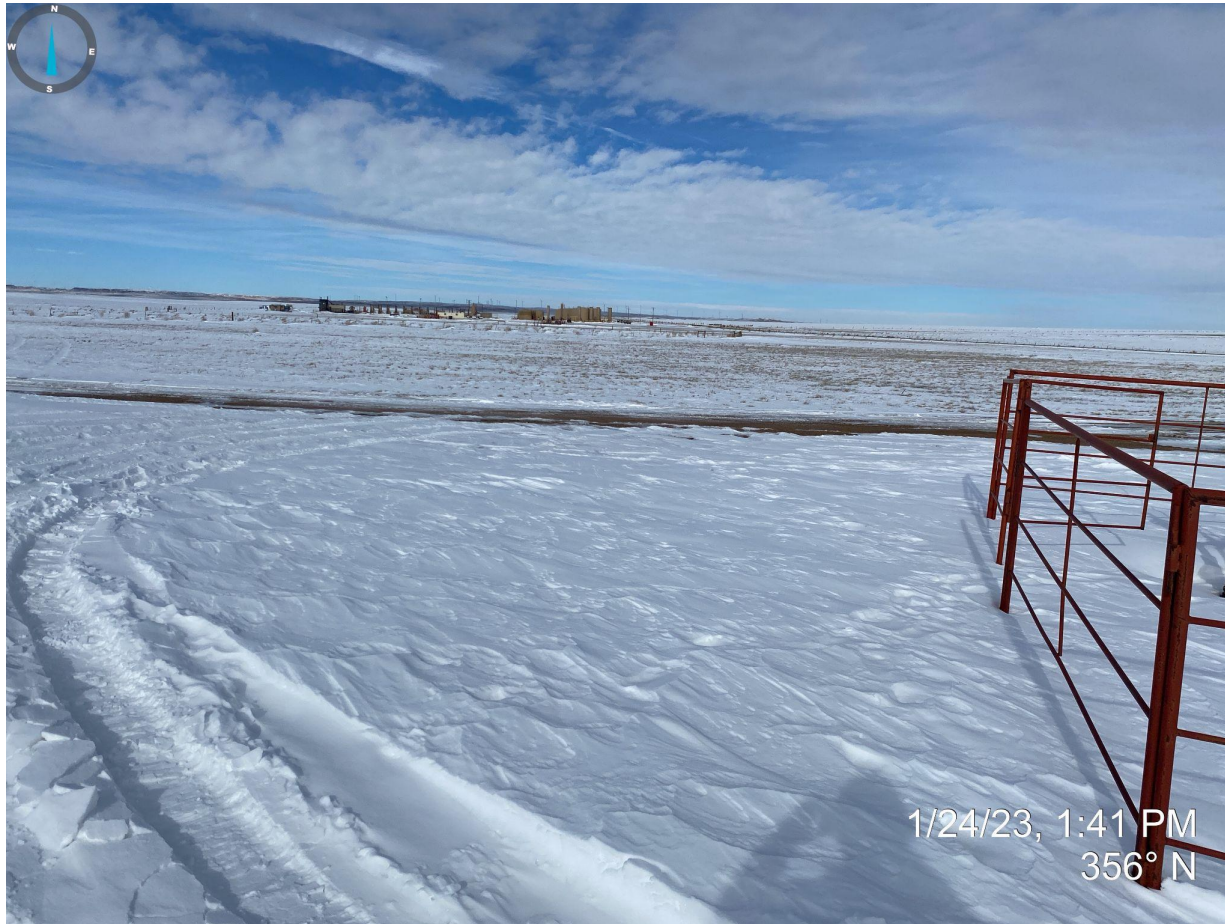
Photo 5. Facing north near the wellhead; see comments in Photo 3.
