Inspection Photos

Operator: TEP ROCKY MOUNTAIN LLC #96850

Location #440705

Garfield County, CO

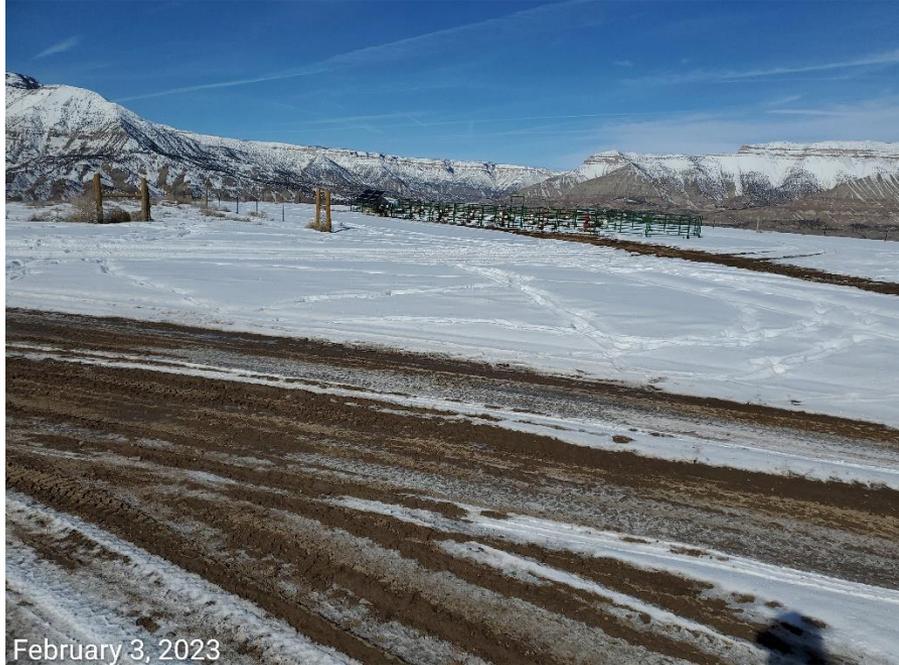
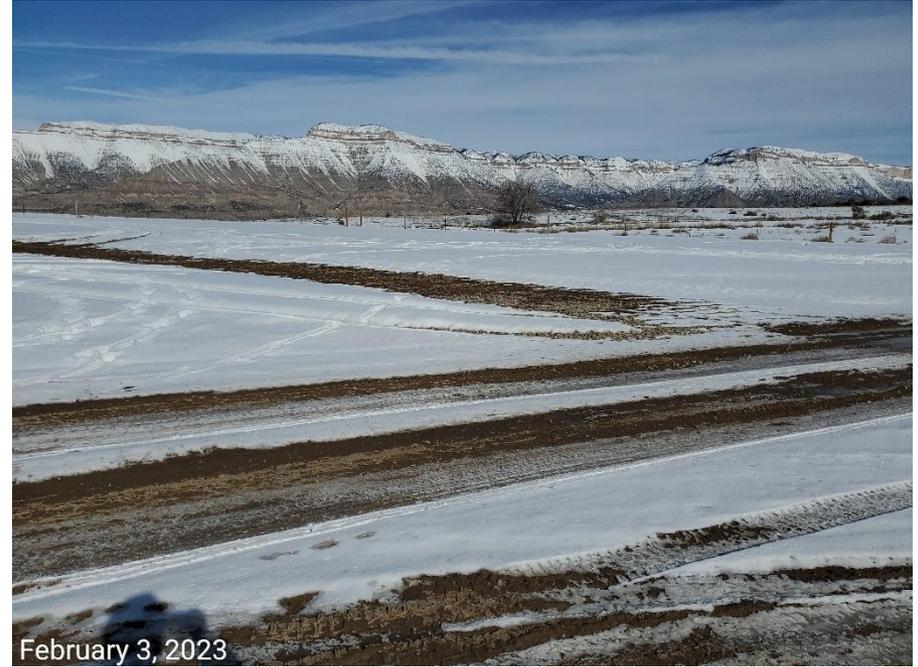
Photo 1: Photos 1-2 taken from the south end of the Location, and provide an overview of the Location from west, northwest, northeast to east. Photos also show areas of the current working pad between the wells, and the tank battery facility that are not reasonably needed for production operations, and require interim reclamation.

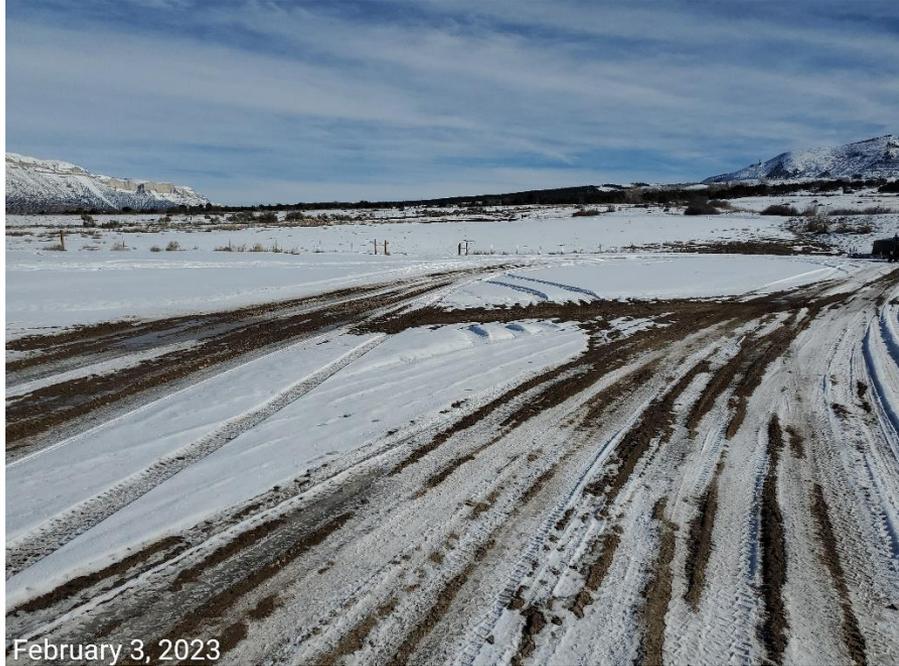
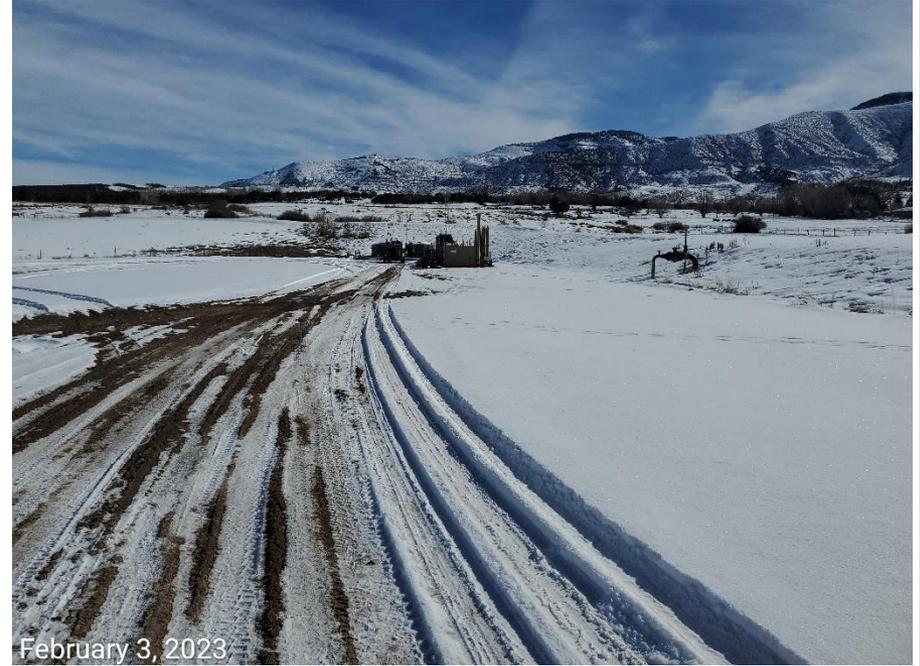
Photo 2: See comments under photo 1.

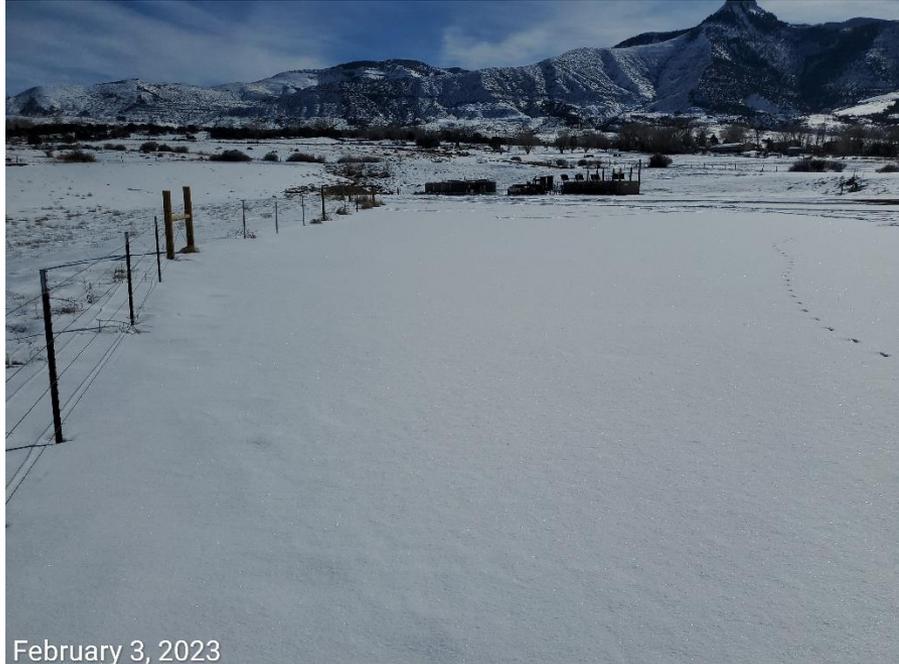
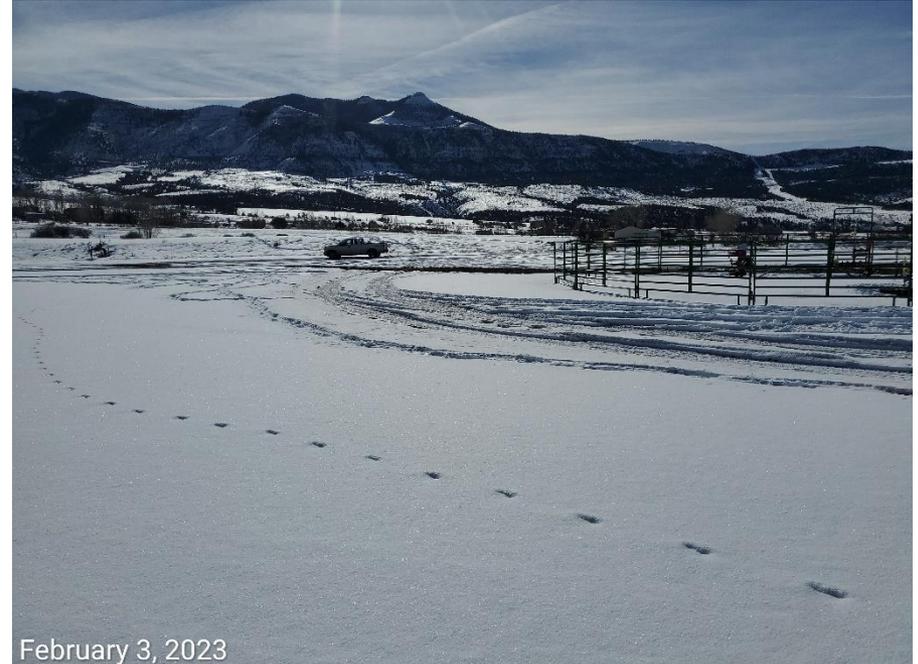
Photo 3: Photos taken from the northwest end of the Location, facing east and south. Photos show areas of the current working pad between the wells, and the tank battery facility that are not reasonably needed for production operations, and require interim reclamation.

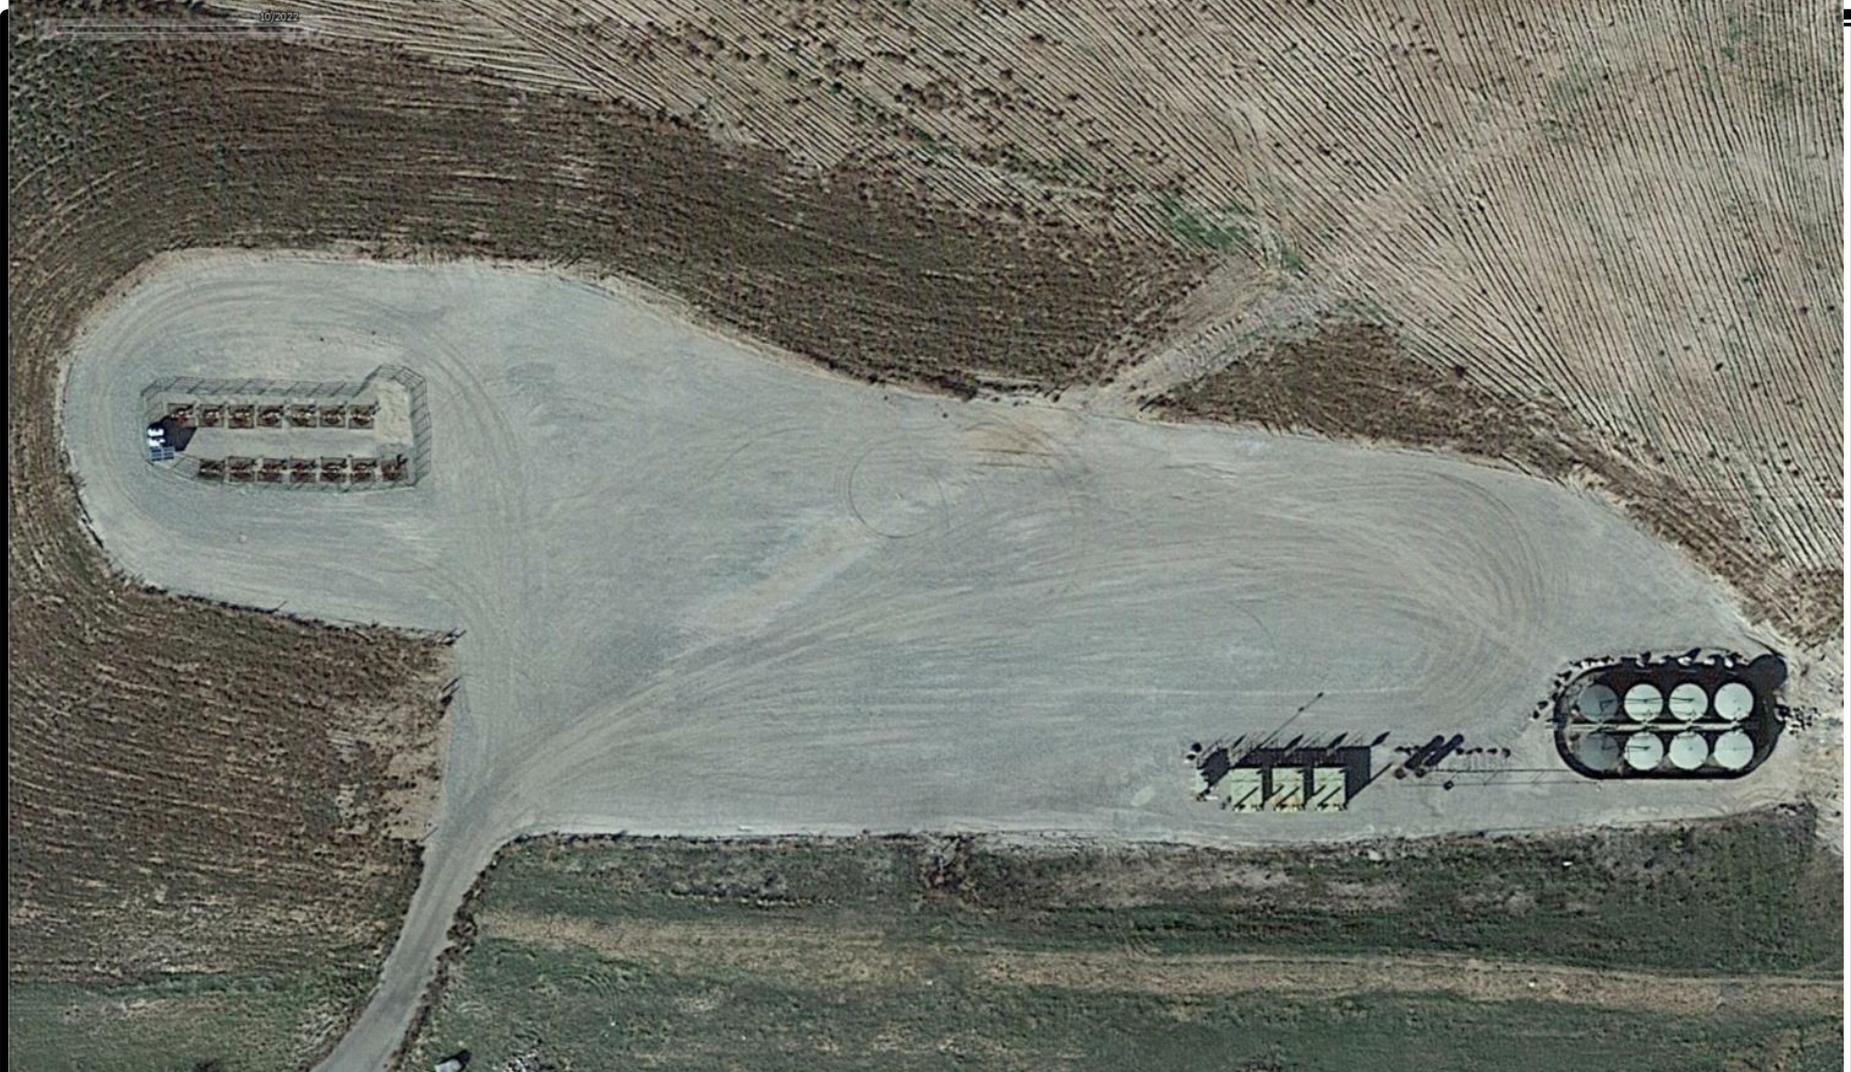
Photo 4: 2022 Google Earth Aerial image. Photos show areas of the current working pad between the wells, and the tank battery facility that are not reasonably needed for production operations, and require interim reclamation.

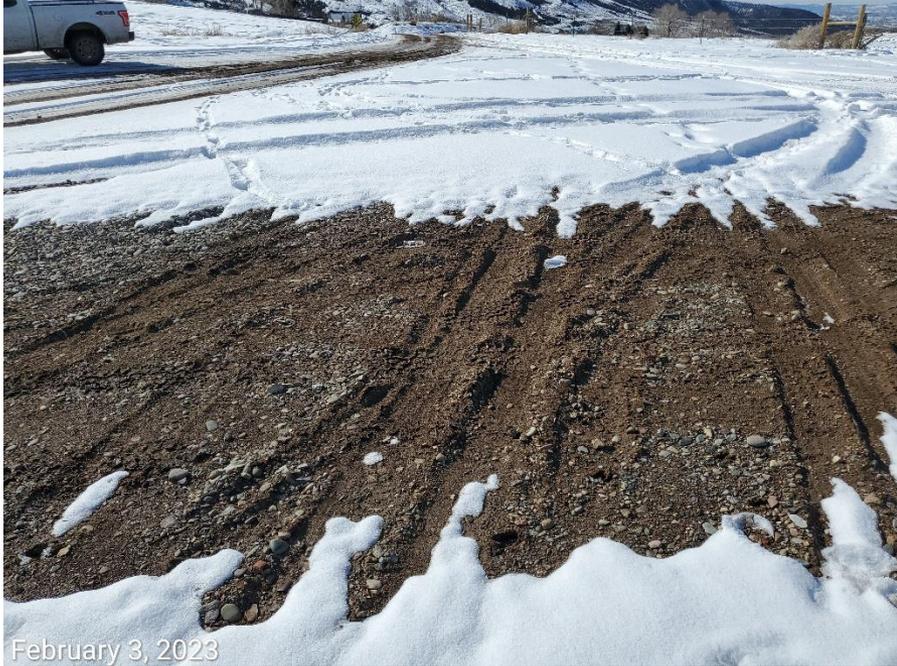
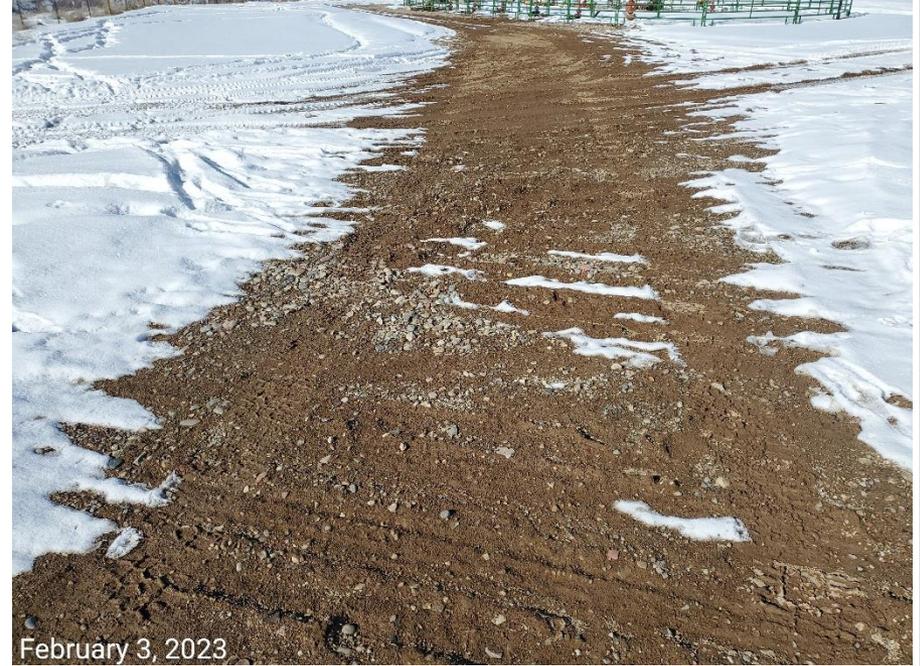
Photo 5: Photo example showing BMPs to stabilize the Location, and to minimize tracking and off-site sediment transport (Gravel, compaction, etc...) show signs of degradation; Ground was frozen at time of inspection, and Location was largely covered with snow, however BMPs that were observable appear to be insufficient. Maintenance advised.

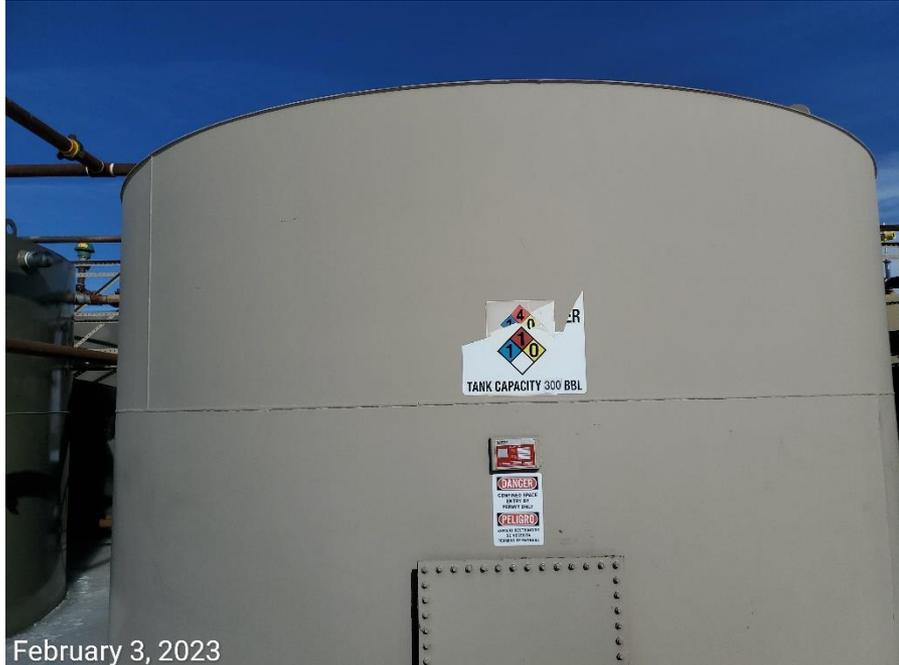
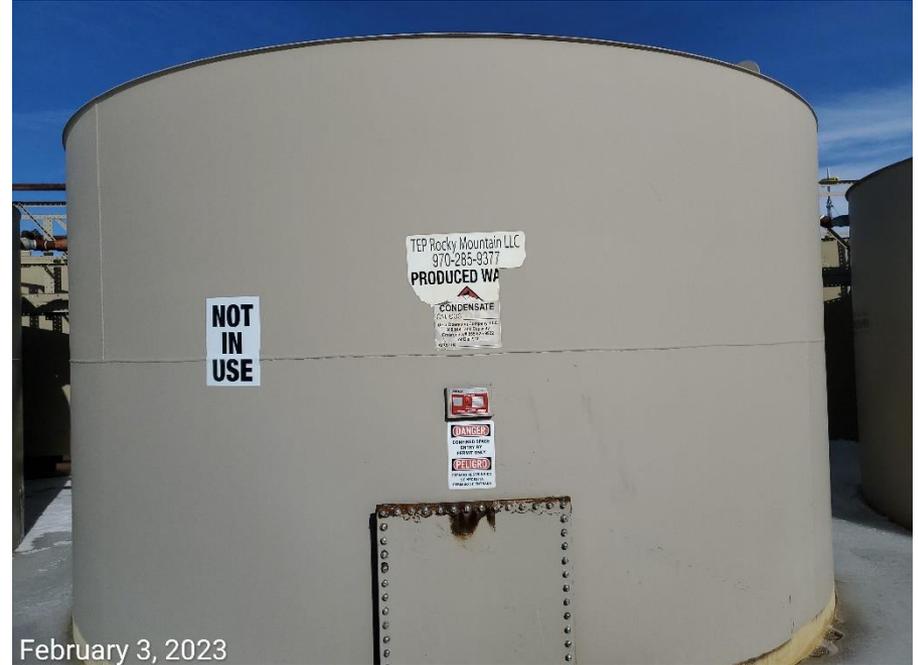
Photo 6: Photos show tank signage/labeling is either missing, or inaccurate.

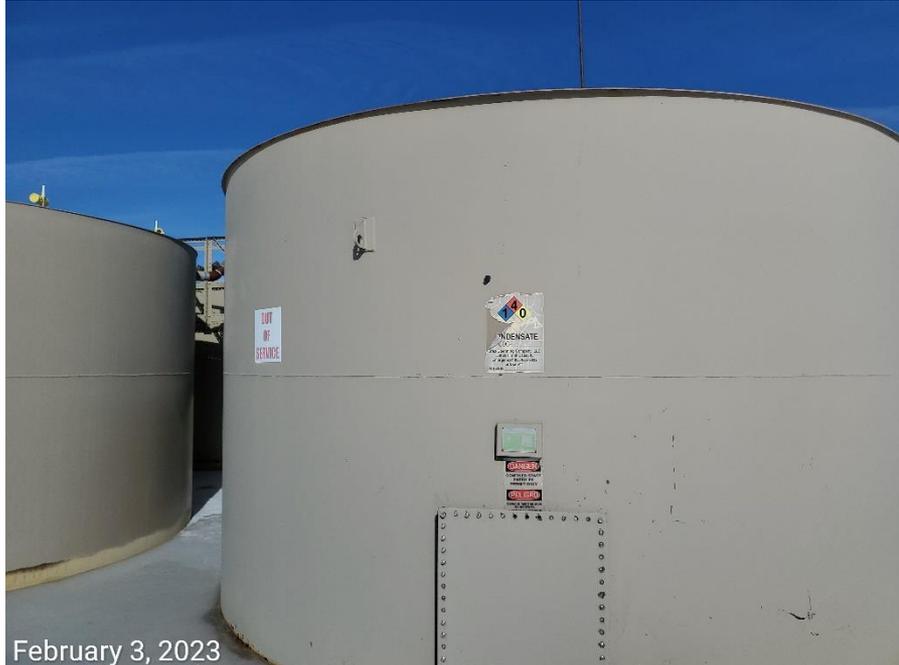
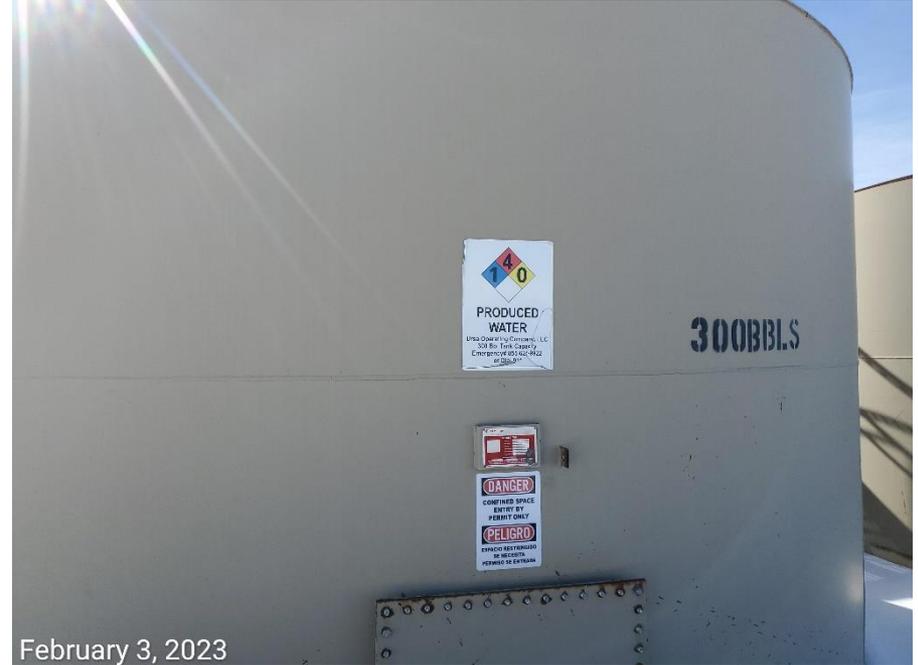
Photo 7: Photos show tank signage/labeling is either missing, or inaccurate.

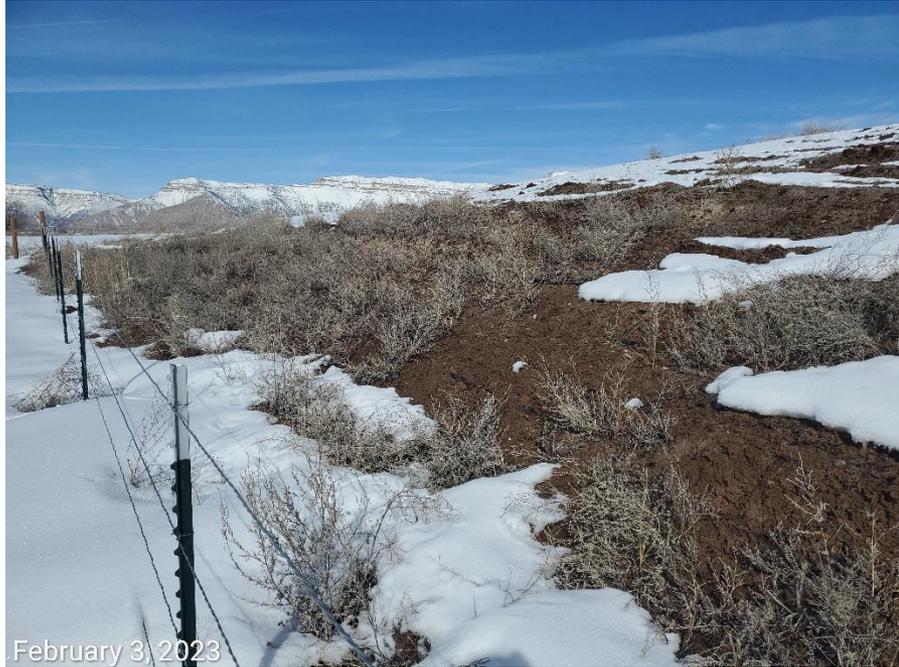
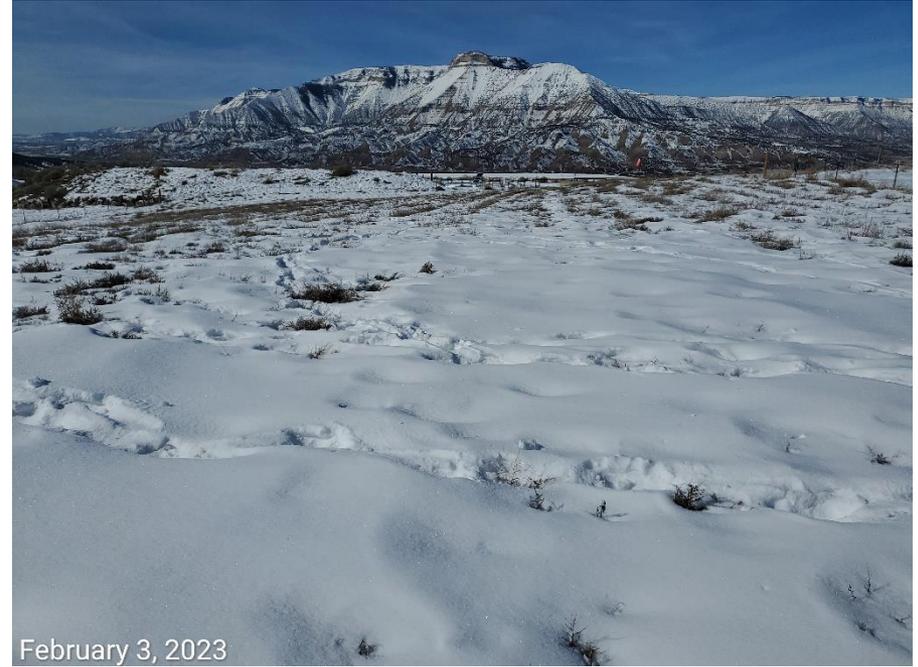
Photo 8: Photos example showing current reclamation areas; areas that were visible appear to be predominantly Undesirable Plant Species, such as *Salsola* sp., and *Kochia*- unclear if areas are progressing towards 1003 standards, and a followup inspection will be conducted to determine compliance with 1003 Rules.
