Interim Reclamation and Stormwater Inspection

Operator: VERDAD RESOURCES LLC - 10651

Location ID: 432694

Inspection Photos
Location Name: Shull Pad
Location ID: 432694

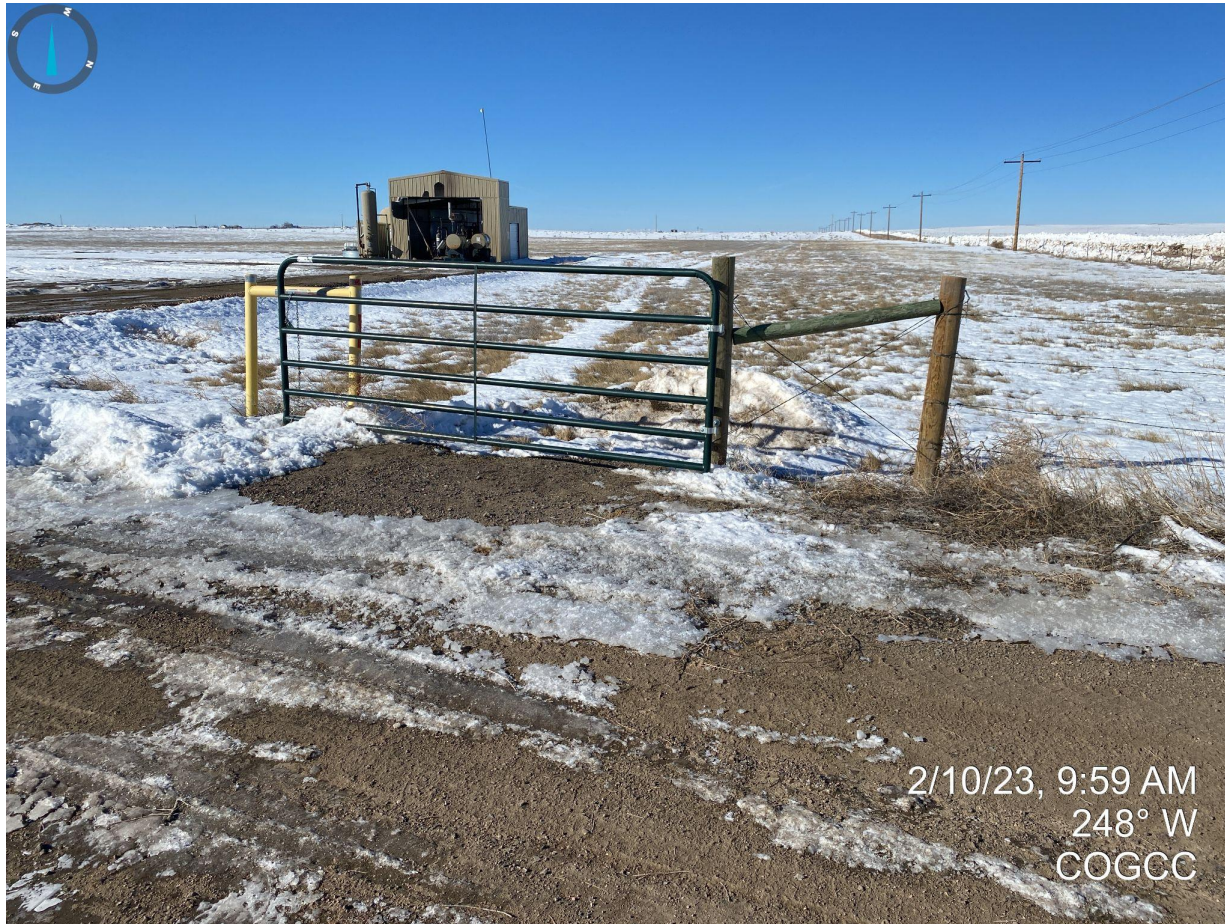
Photo 1. Facing west from the location's entrance. Photo illustrates the operator has managed the undesirable vegetation previously identified in inspection (Doc #696105694). The operator shall continue to manage the location for undesirable vegetation and debris in the future.

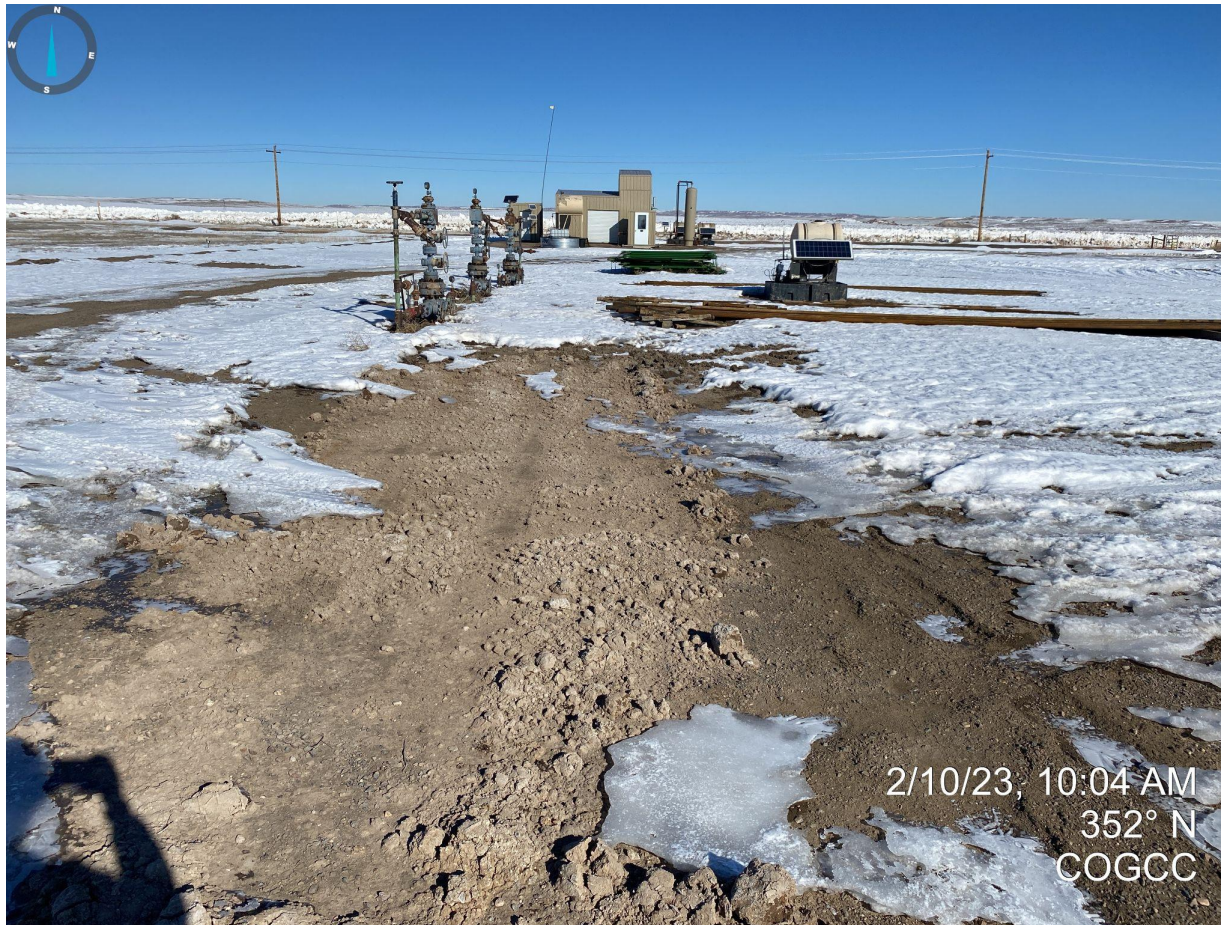
Photo 2. Facing north near the wellhead. The operator has removed the leaking tank from location and cleaned the stained soil. The other equipment pictured will be reinstalled after a nearby well is fracked, per 02/10/2023 phone call with Operator.

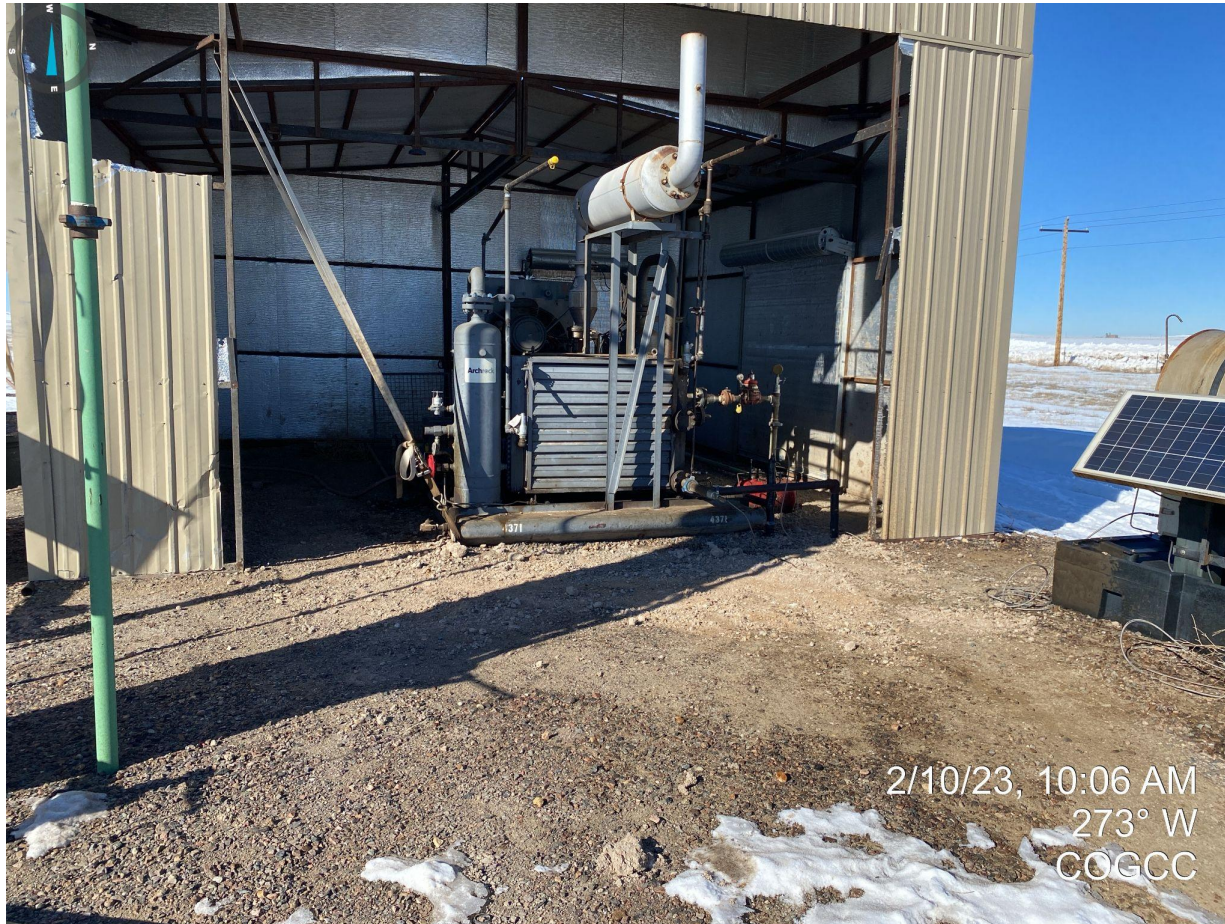
Photo 3. Facing west at compressor station. Photo illustrates that no wildlife protection devices (e.g. snow fence or similar) were installed when the antifreeze spill was observed during this inspection. Per 02/10/2023 phone call, Operator stated that they installed and took down snow fence after the antifreeze spill was cleaned up the first time (~01/24/2023). Operator will now have to reinstall wildlife protection device until spill is cleaned up.

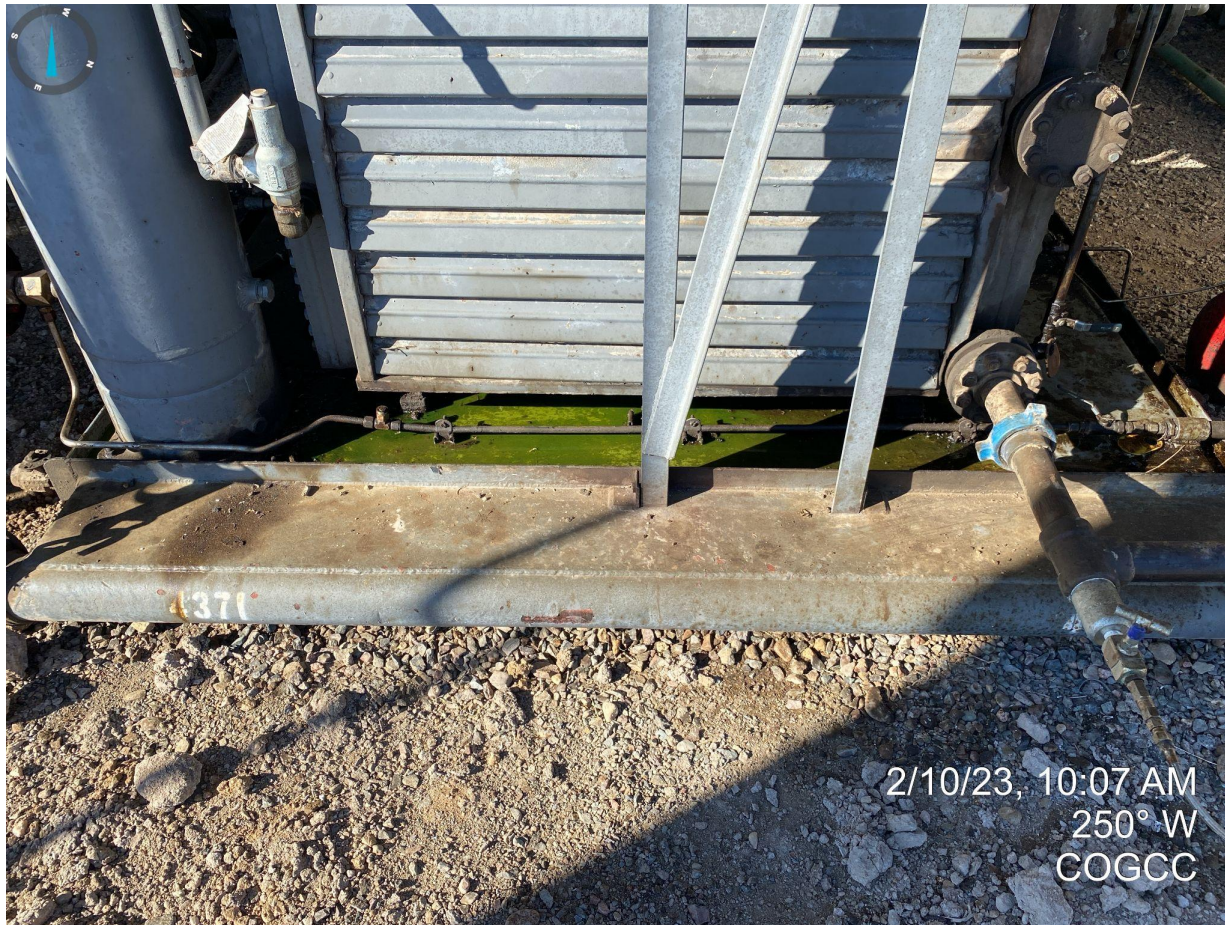
Photo 4. Close up photo of antifreeze spill observed on 02/10/2023.

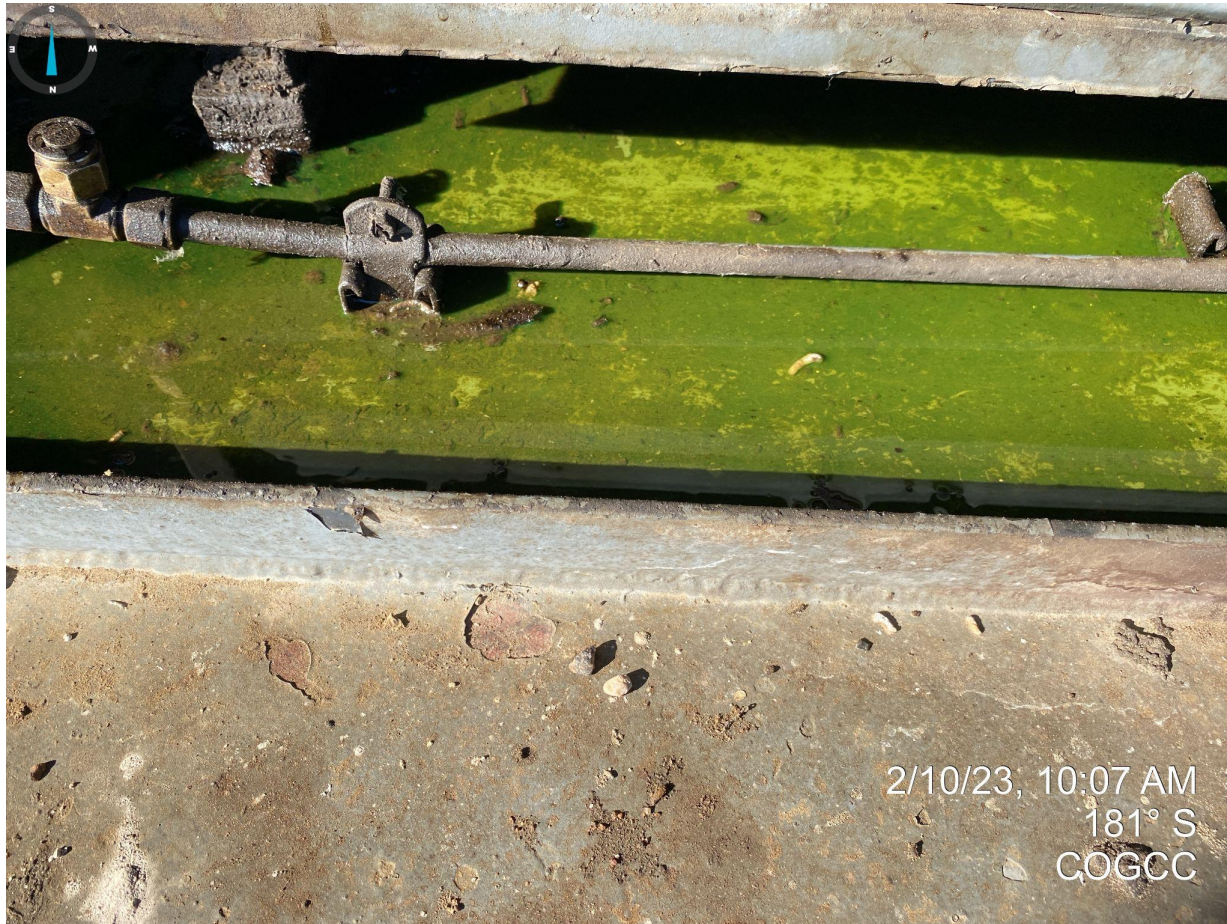
Photo 5. See comments in Photo 4.
