Inspection Photos

API: 071-06426

Operator: EVERGREEN NATURAL RESOURCES

Inspection Date: 2/14/2023

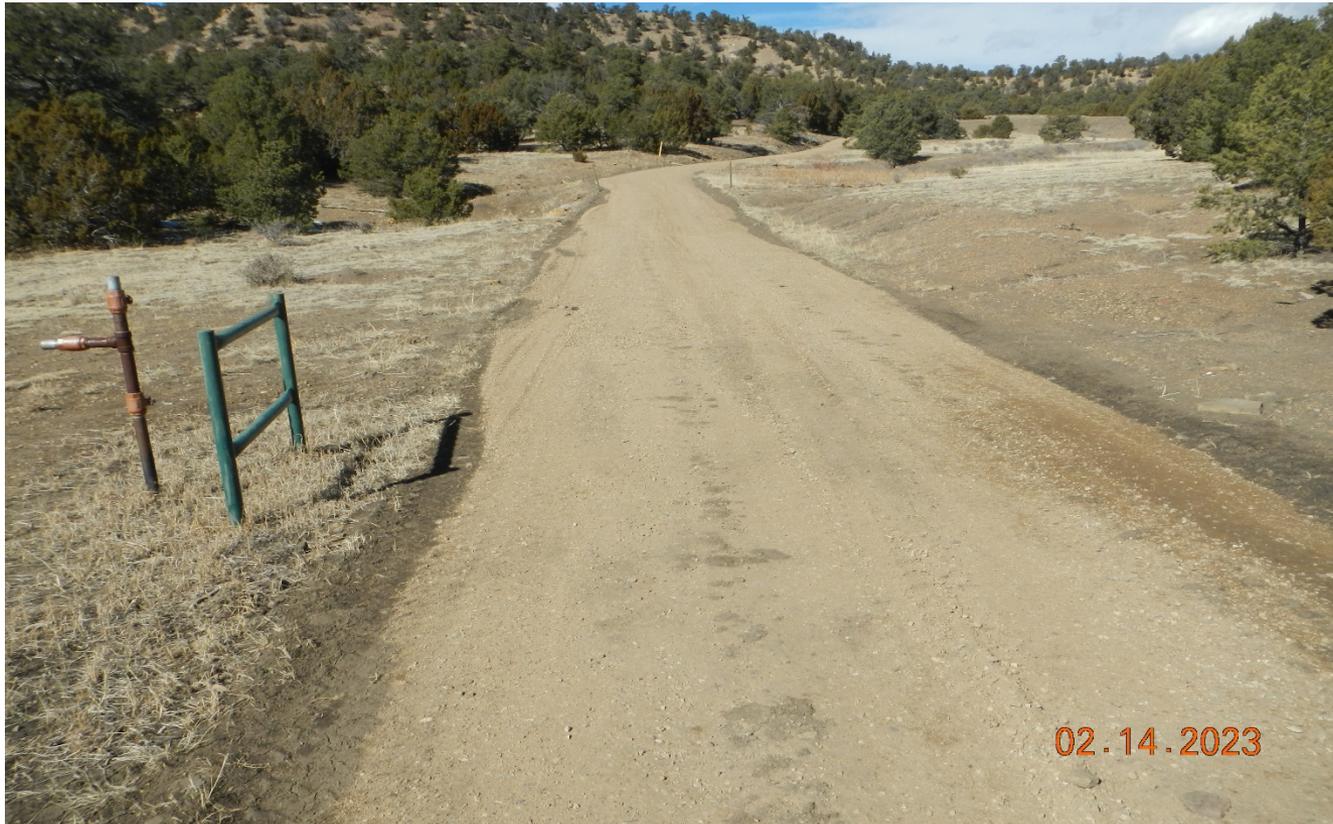
Photo 1. Facing north along the access road. There has been additional roadbase applied to the road and crowned.

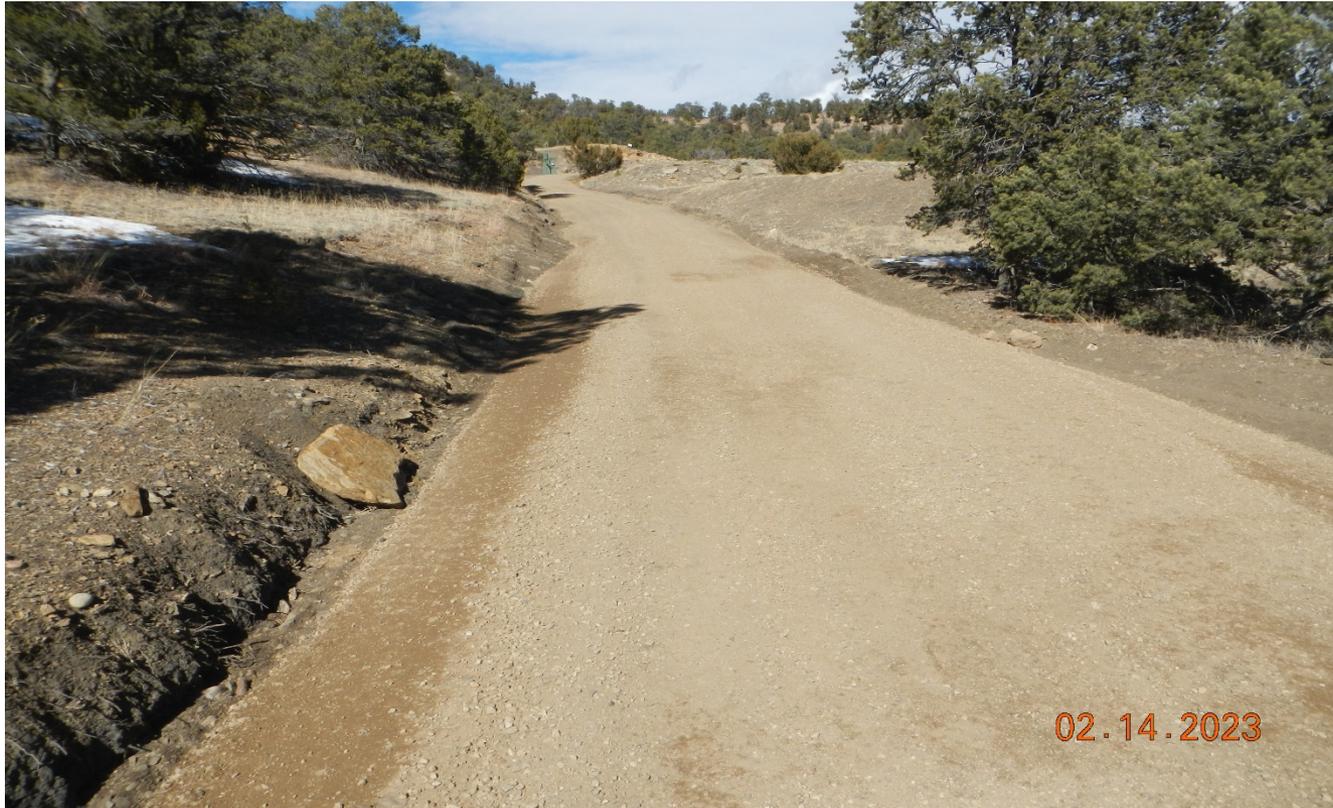
Photo 2. Facing north along the access road. The roadside which was eroded has been repaired but there is no BMP's to prevent erosion from reoccurring (e.g. check dams, riprap, culvert ect).

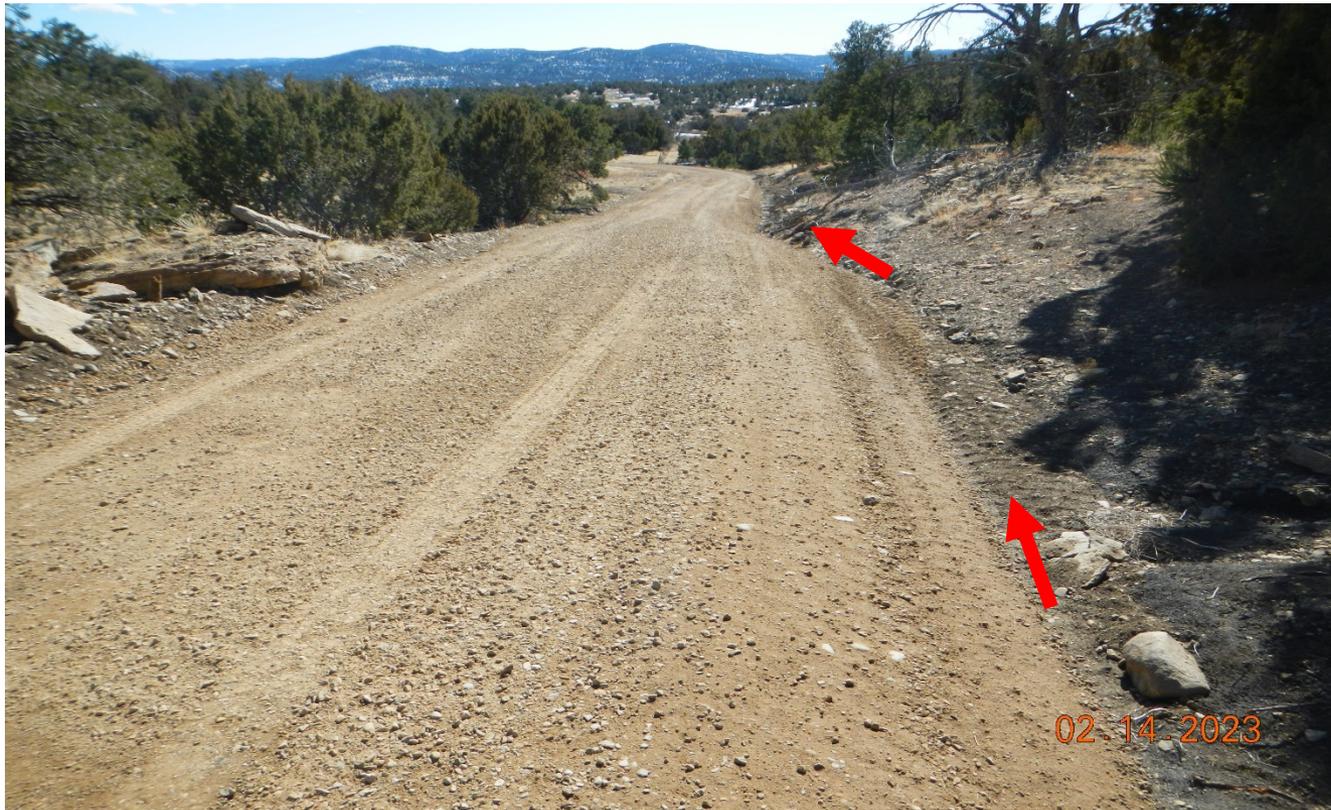
Photo 3. Facing back south toward the access road. This long stretch of road has no roadside BMPs to prevent erosion from reoccurring. Red arrow points to stormwater flow which will occur down the roadside.

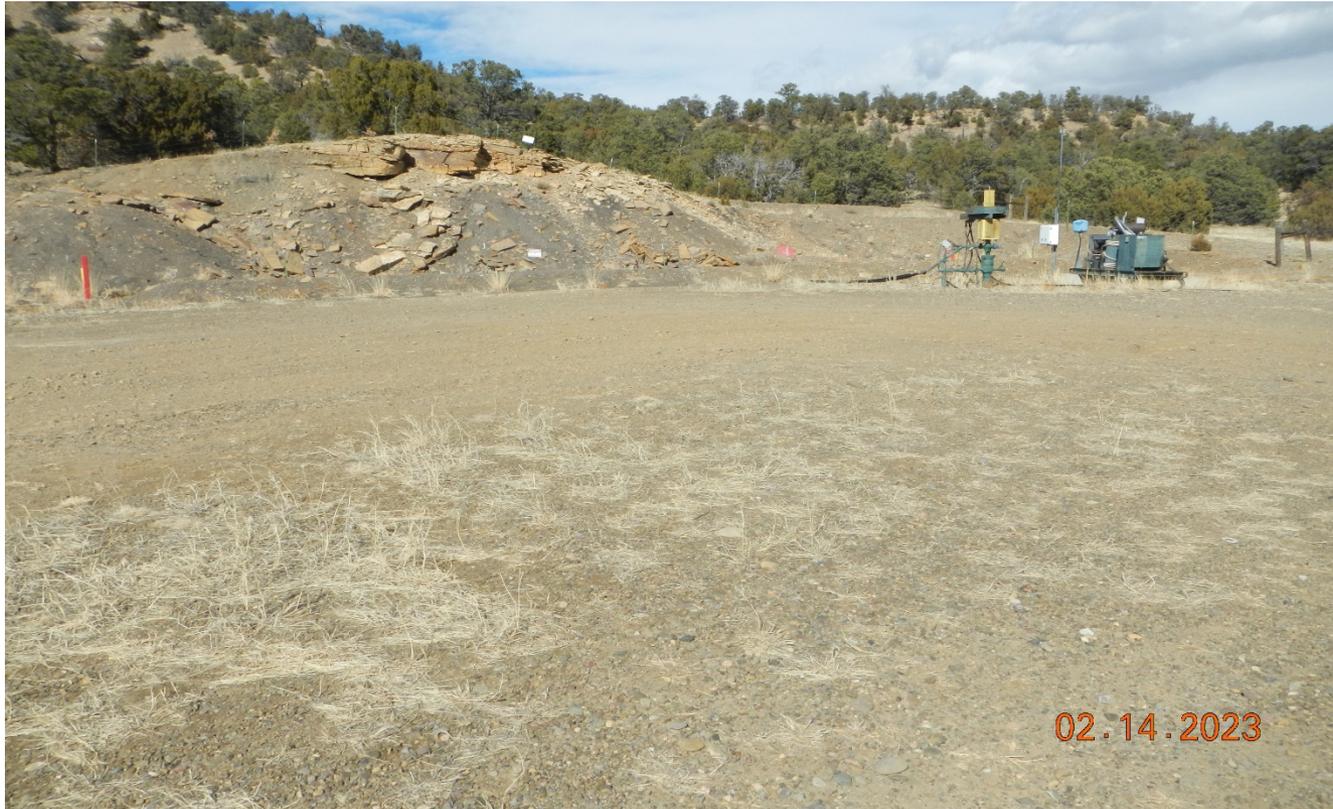
Photo 4. Facing toward the wellsite.
